CHAPTER IV

SOLUTION AND IMPLEMENTATION

4.1 Root cause of Failure: Clearance on arm and bracket

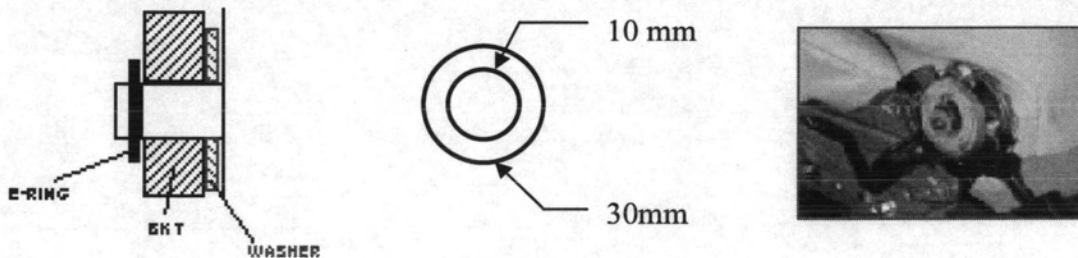
Figure 4.2: Plastic Washer Dimension

The result from investigation from affected part, it was found the excessive clearance between arm and bracket which it was out of standard and uncontrollable. These lead to the moveable of part and hitting noise between arm and bracket.

Defect clearance (actual): 3.4 mm

Permanent countermeasure: Add plastic washer thickness = 0.5 mm with inner diameter = 10 mm and outer diameter = 30 mm.

1. To prevent the outflow problem in market, the countermeasure has been taken by develop plastic washer with thickness of 0.5 mm and diameter of 3 mm. These can reduce the gap between arm and bracket which prevent hitting noise of its.

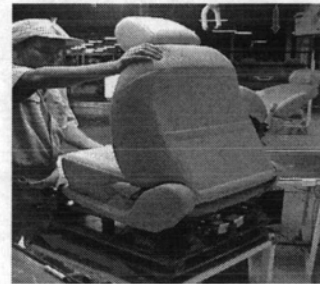
Figure 4.4: Seat Sliding Operation Failure

After confirm with claims part, the investigation for root cause of failure was found seat couldn't slide as customer complained. The problem could detect by customer while sliding the seat to adjust positioning and found product couldn't movable.

To eliminate root cause of failure and prevent recurrence problem, the investigation was took and it was found sliding groove width out of specification. These lead to seat sliding operation failure.

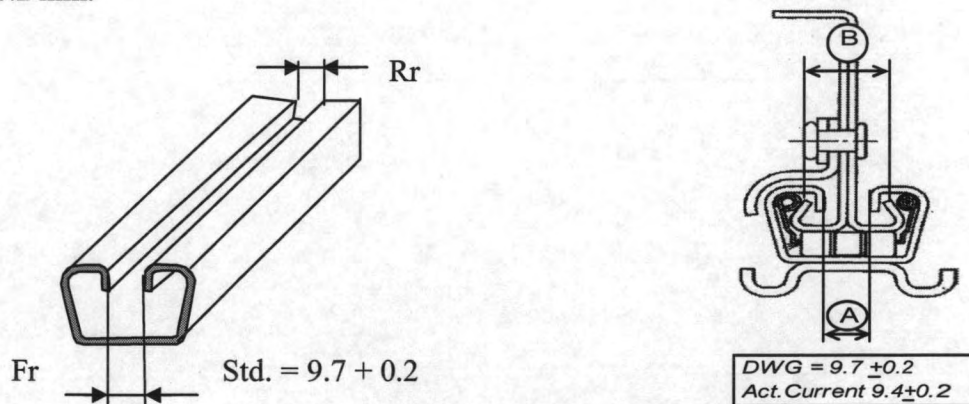
Figure 4.5: Sliding Groove Width

Defect clearance (actual): 9.25 mm

Permanent countermeasure: Control sliding groove width within specification 9.7 ± 0.2 mm.

1. To prevent the outflow problem in market, the countermeasure has been taken by control sliding groove width dimension within specification 9.7 ± 0.2 mm.

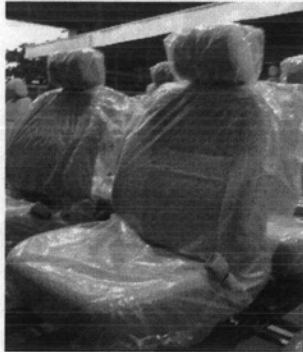
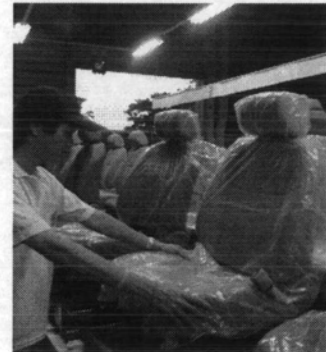
Figure 4.8: New cover plastic

To eliminate root cause of failure and prevent recurrence problem, the investigation was took more than 3 times to identify exact cause and found seat dirty before seat assembly in vehicle. The root cause was come from “Operator unintentionally touching seat part” in stocking area.

Permanent countermeasure: Design new plastic cover on seat.

1. To prevent the outflow problem in market, the countermeasure has been taken by implemented new plastic cover on seat.
