## **CHAPTER 4**

### **RESULTS OF TESTING AND INTERPRETATION**

On line partial discharge tests on Sirikit hydroelectric generator unit 2 was taken on 4 conditions of test procedure. The tests applied to each of coupler of three phases winding (total 9 couplers). The test data were displayed in form of partial discharge graphs. Using experience papers as defined in section 2.65 of CHATER 2. The measuring procedure was set up into four conditions of test in order to see some effects of temperature and load forces. That experience literature also guided to interpret the data of measurement and table of Chart I and Chart II were also very useful to guide to interpret all data of measurement of generator unit 2.

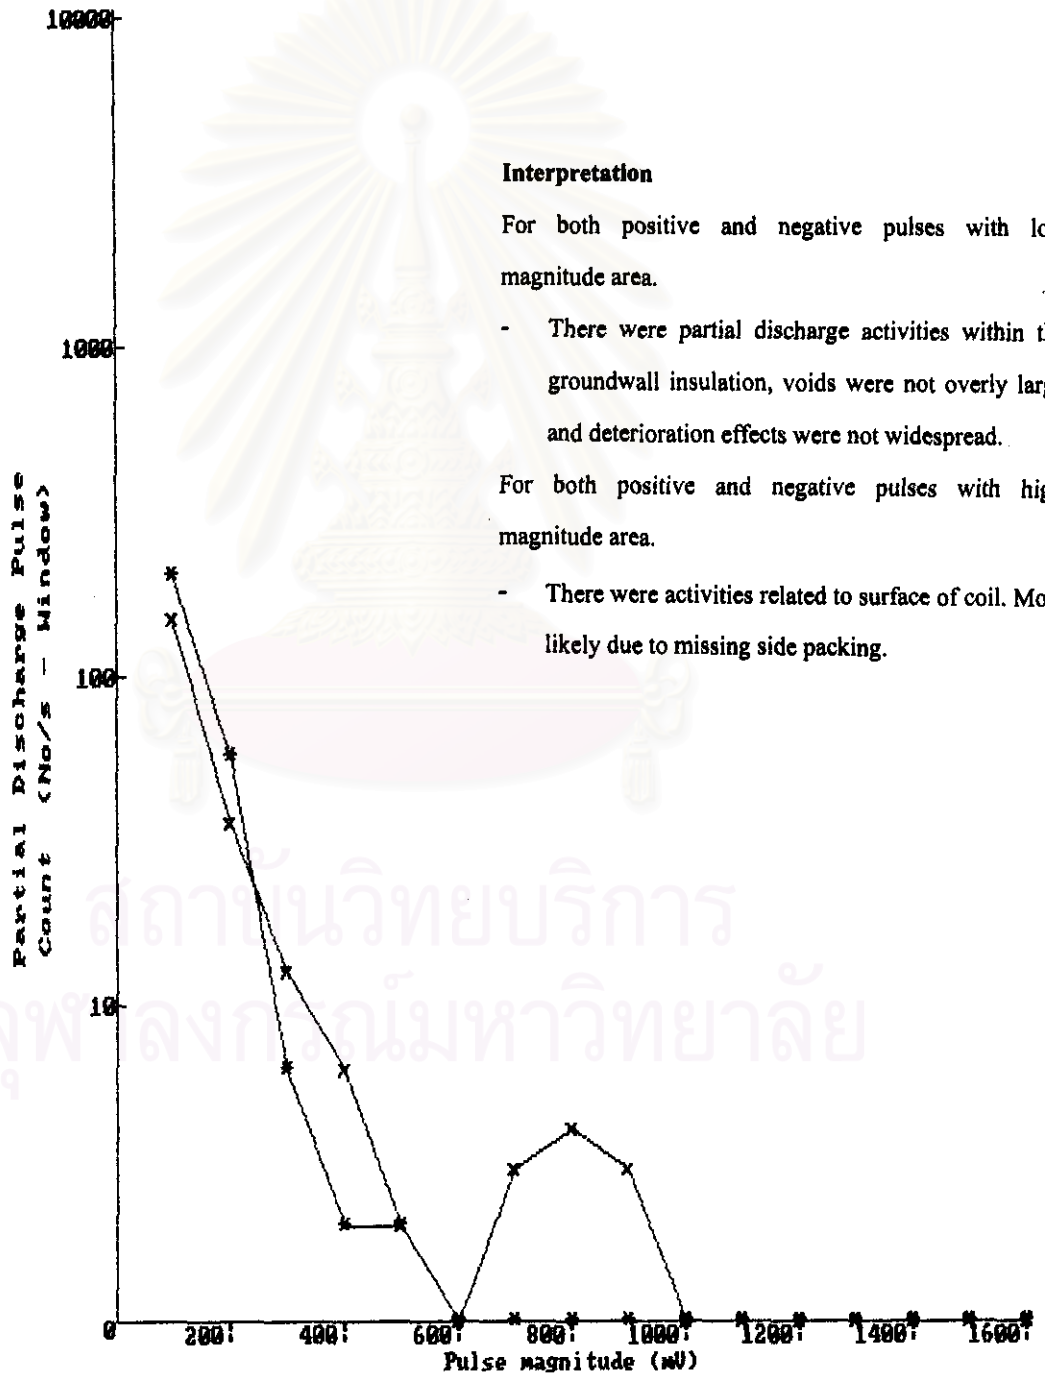
Fig. 4.1.1.1 Data measurement of A Phase, parallel 1

Winding parallel path1 of phase A showed internal discharge with high amount of total partial discharge activities that positive and negative pulses were similarly. The overall picture of winding path1 phase A had some delamination occurred within ground wall insulation and some surface deterioration. The high amount of NQN that over than450 means there were a lot of partial discharge occurred in this parallel path, such as internal discharge, slot discharge and interface discharge.

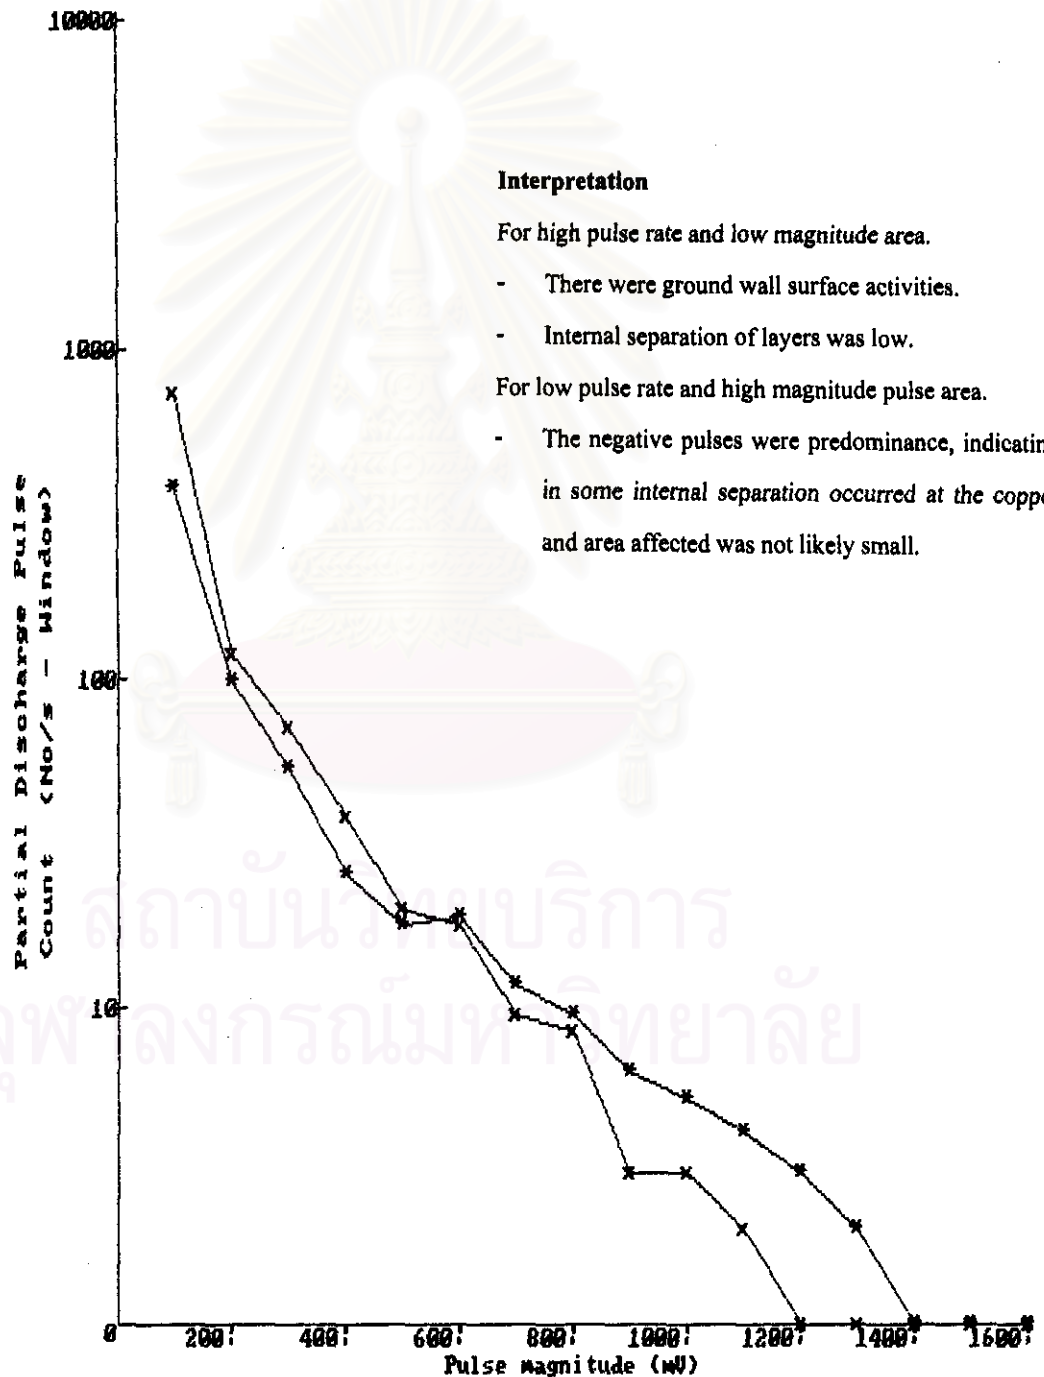
Fig. 4.1.1.2 Data measurement of A Phase, parallel 2

Winding parallel path2 of phase A showed higher amount of NQN than parallel path1, both positive and negative pulses were predominance, also both NQN were over 1000. These meant a lot of slot or surface discharge and internal discharge occurred within winding parallel path2. The overview of this path showed a lot of deterioration on insulation system at slot portion, coil-end portion and main ground wall insulation.

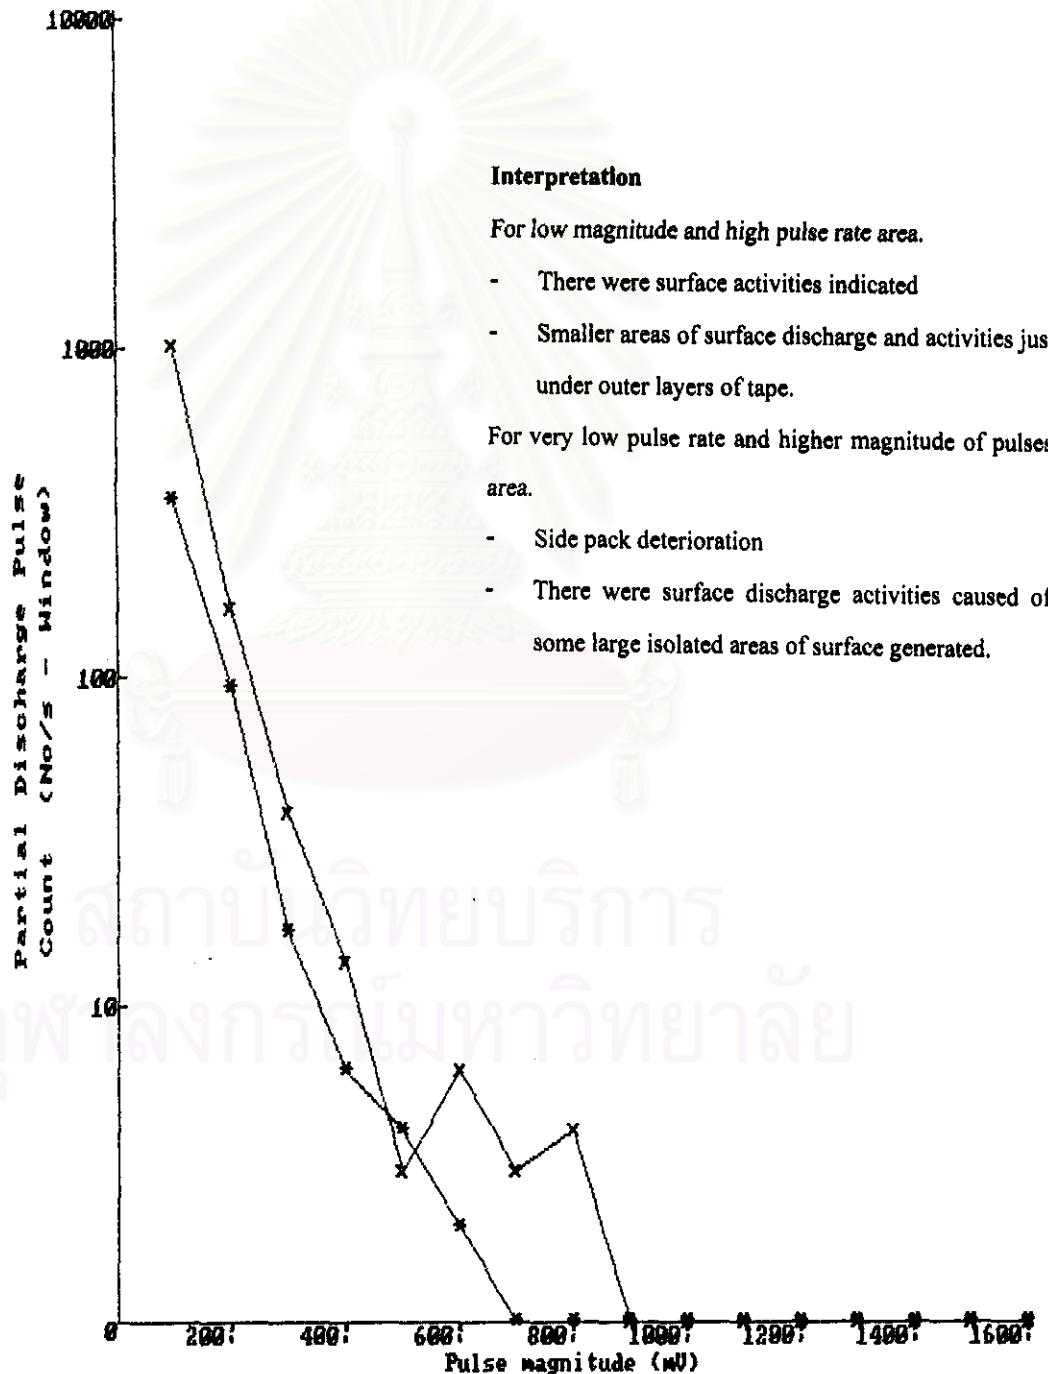
Fig. 4.1.1.3 Data measurement of A Phase, parallel 3

Winding parallel path 3 of phase A showed surface deterioration. The partial discharge activities were the same as winding parallel path1.

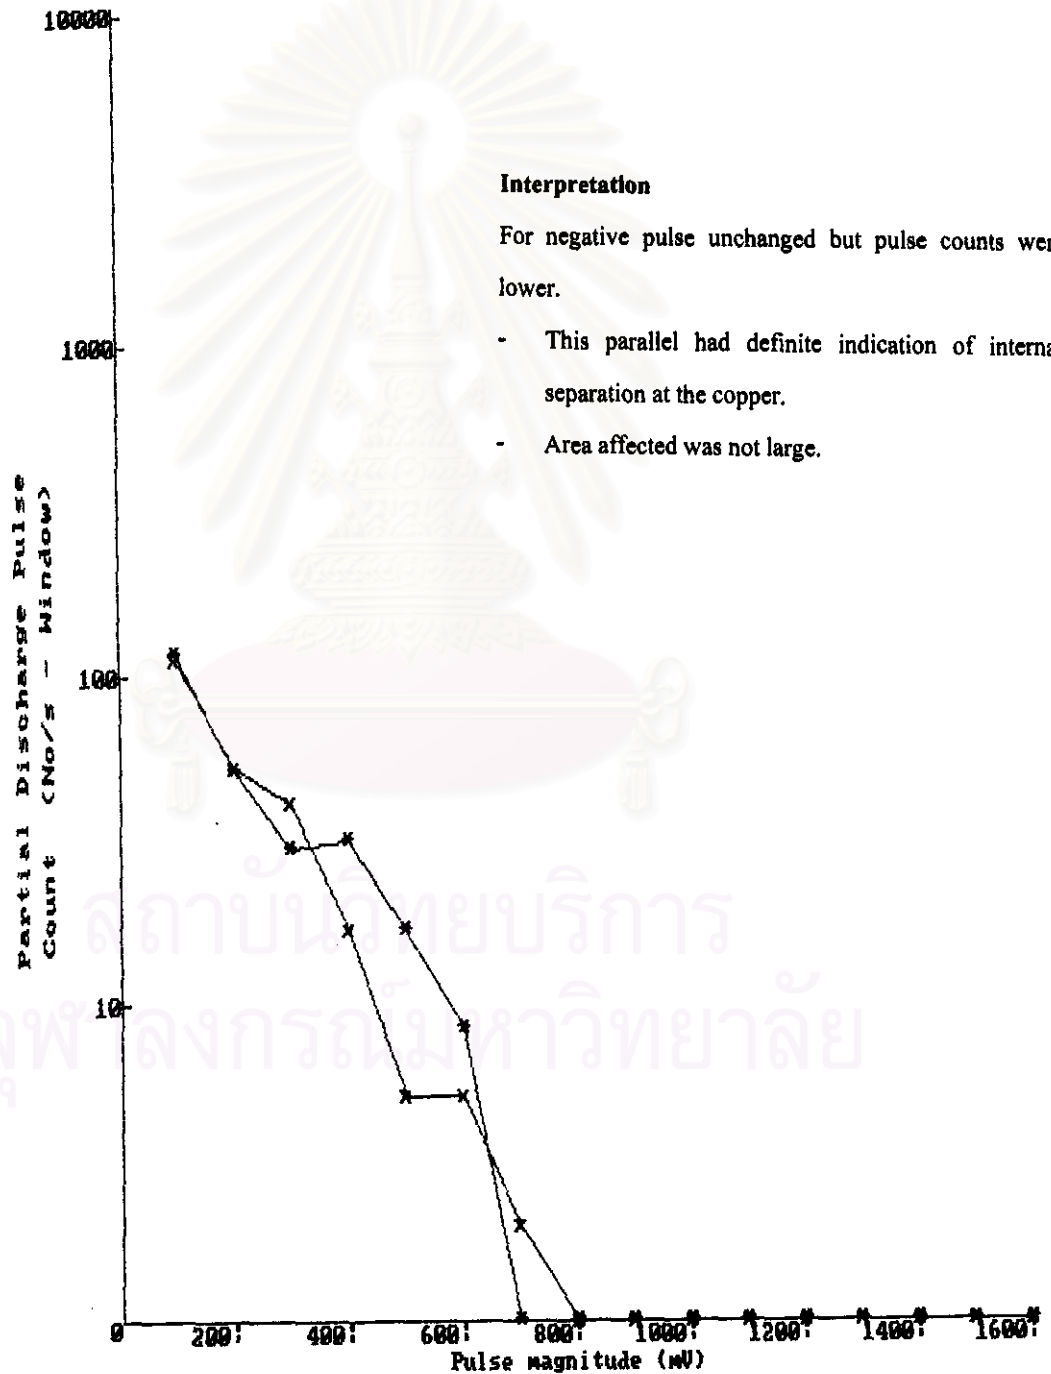
Fig. 4.1.1.4 Data measurement of B Phase, parallel 1

Winding parallel path 1, phase B showed negative pulse to be predominance together with positive pulses. These meant more internal discharge and surface discharge occurred because of ground wall delamination and coil surface deterioration.

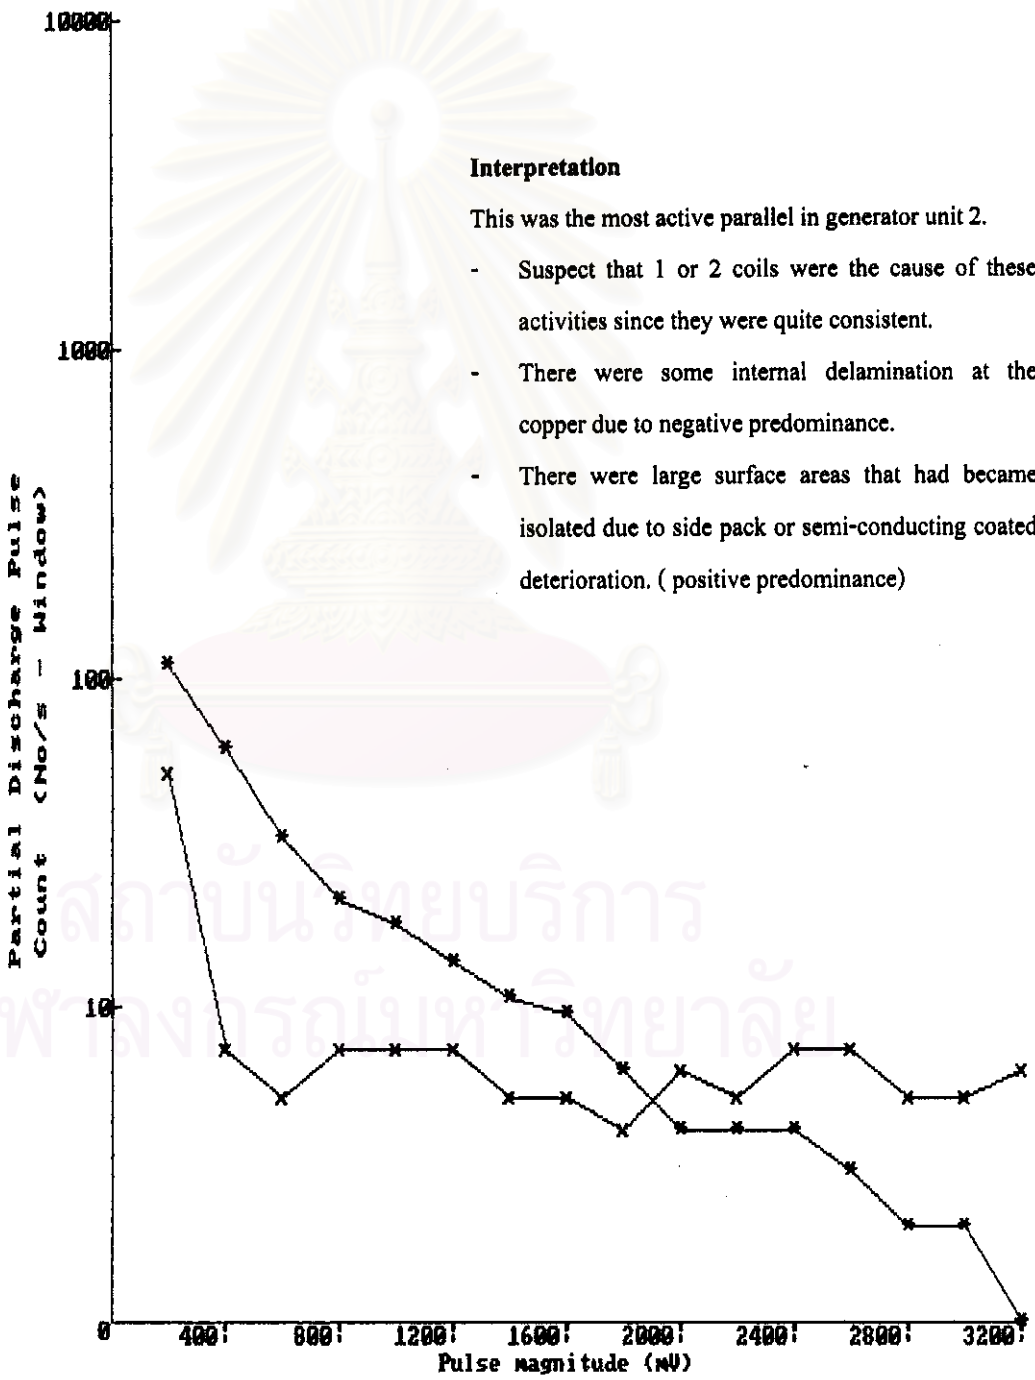
Fig. 4.1.1.8 Data measurement of C Phase, parallel 2

- This was the most active parallel in generator unit 2.
- Suspect that 1 or 2 coils were the cause of these activities since they were quite consistent.
  - There were some internal delamination at the copper due to negative predominance.
  - There were large surface areas that had become isolated due to side pack or semi-conducting coated deterioration. ( positive predominance)

Winding parallel path 2 of phase C showed large amount of discharge occurred within winding (very high values of both NQN). The negative pulses was predominance and positive pulses were also predominance. There were a lot of ground wall delaminations and surface deteriorated occurred within stator winding. High amount of both NQN (over 1000) showed a lot of deterioration within insulation system and may be more pollution inside.

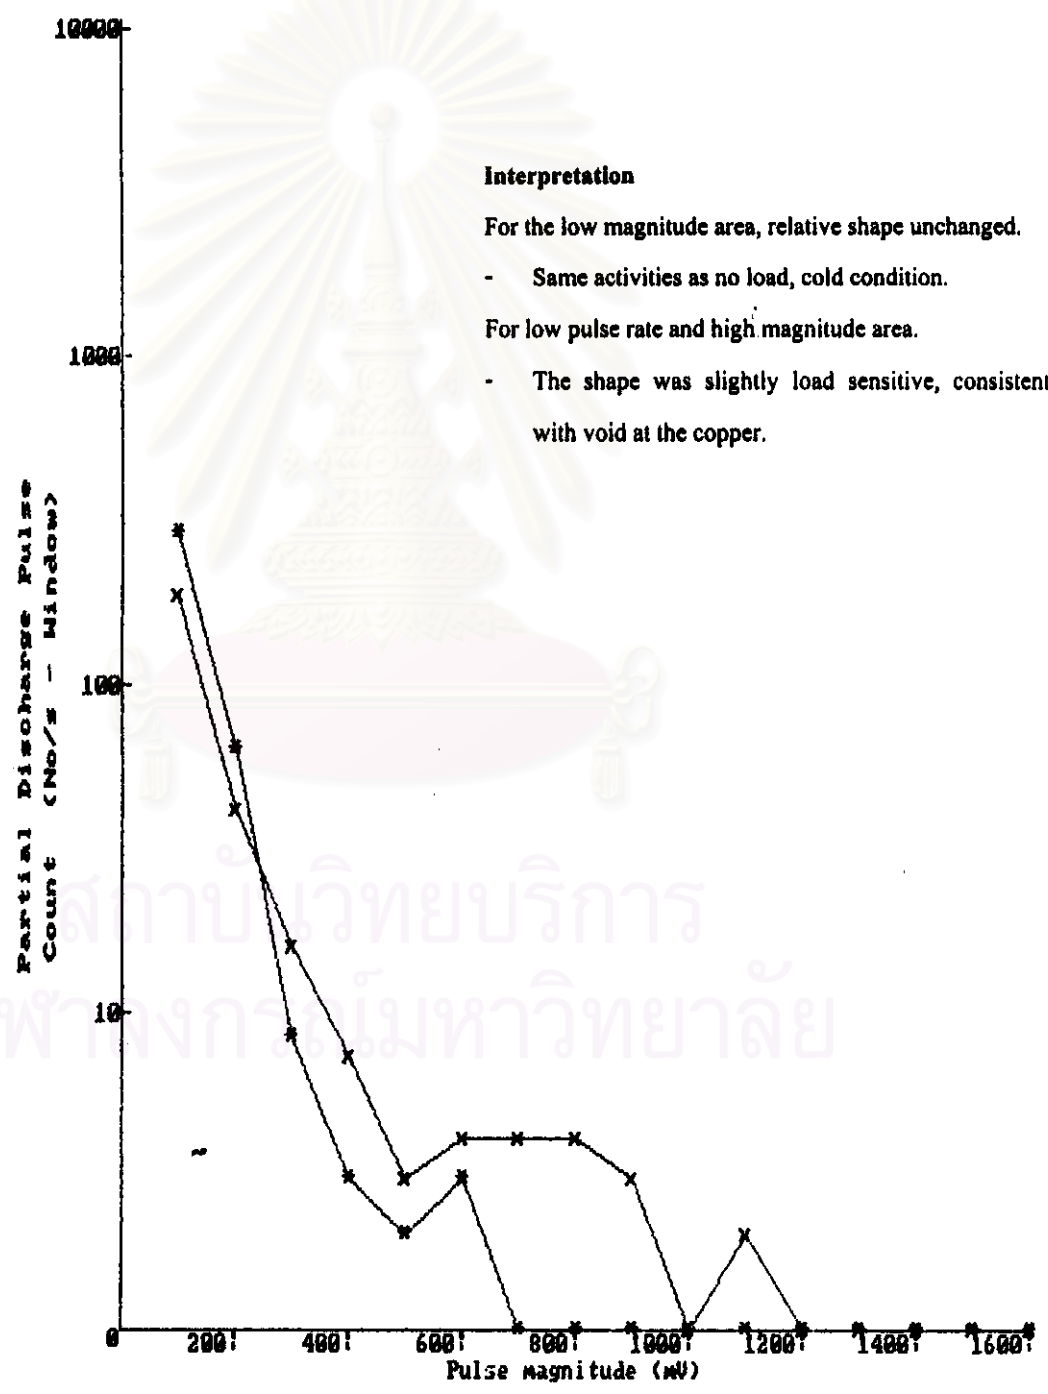
Fig. 4.1.2.1 Data measurement of A Phase, parallel 1

For the low magnitude area, relative shape unchanged.

- Same activities as no load, cold condition.

Winding parallel path 1, and 3, phase A showed high value of both NQN and had internal separation in ground-wall and some surface deterioration. The total partial discharge activities were slightly increased more than no load condition.

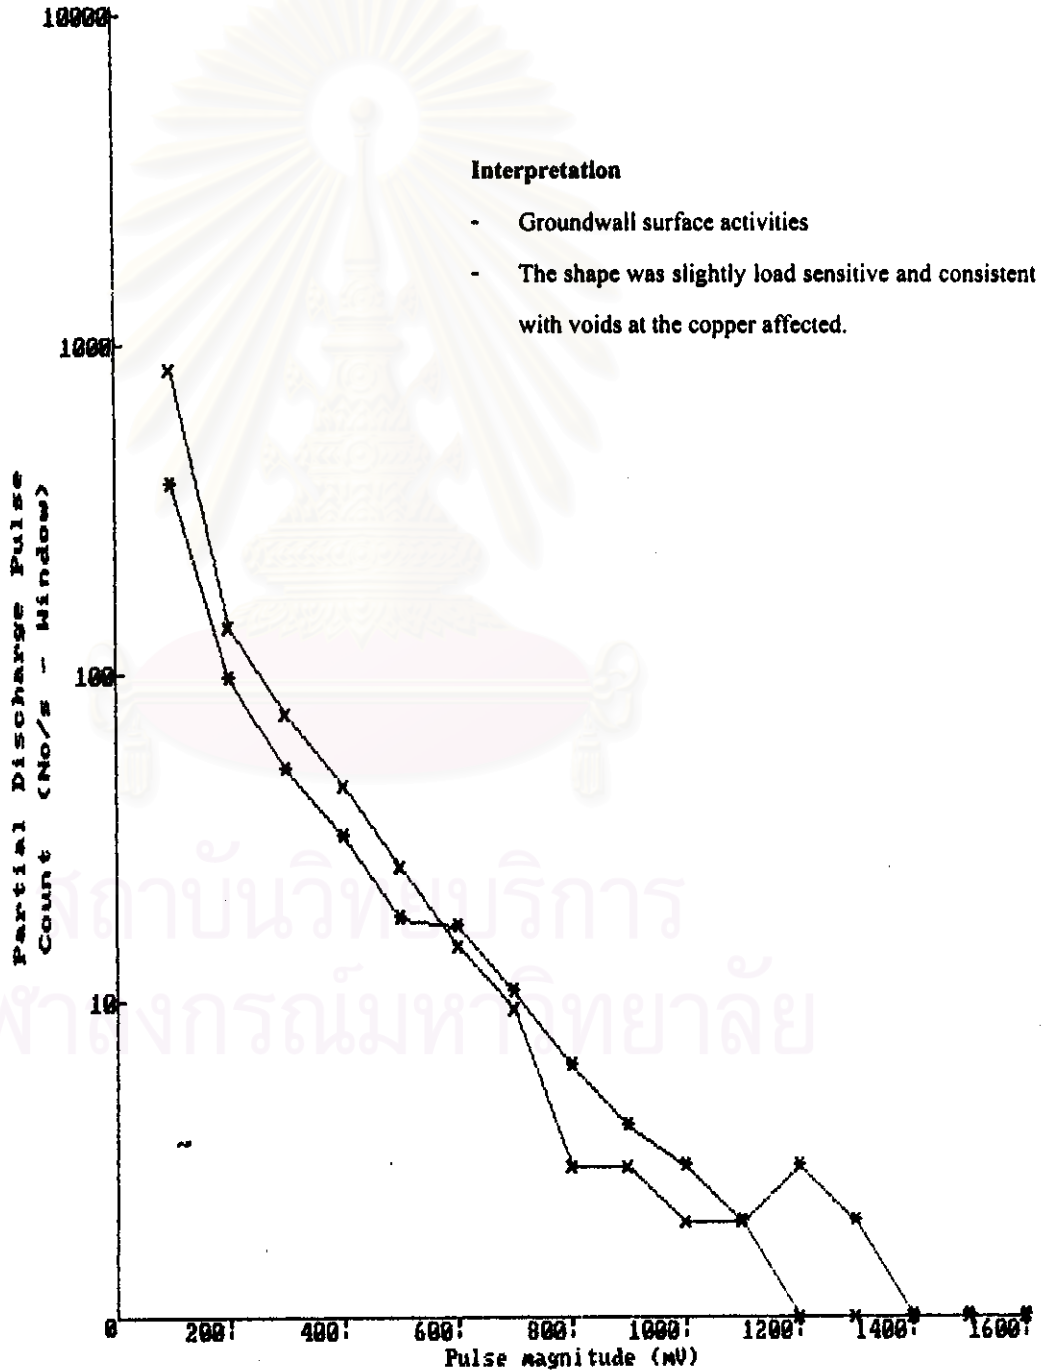
Fig. 4.1.2.2 Data measurement of A Phase, parallel 2

Winding parallel path 2, phase A showed higher amount of NQN and both positive and negative were predominance. These activities were slightly increased higher than no load condition. These meant overall picture of winding had deterioration on surface of coils at slot portion, delamination on ground wall insulation and deterioration on coil end portion.

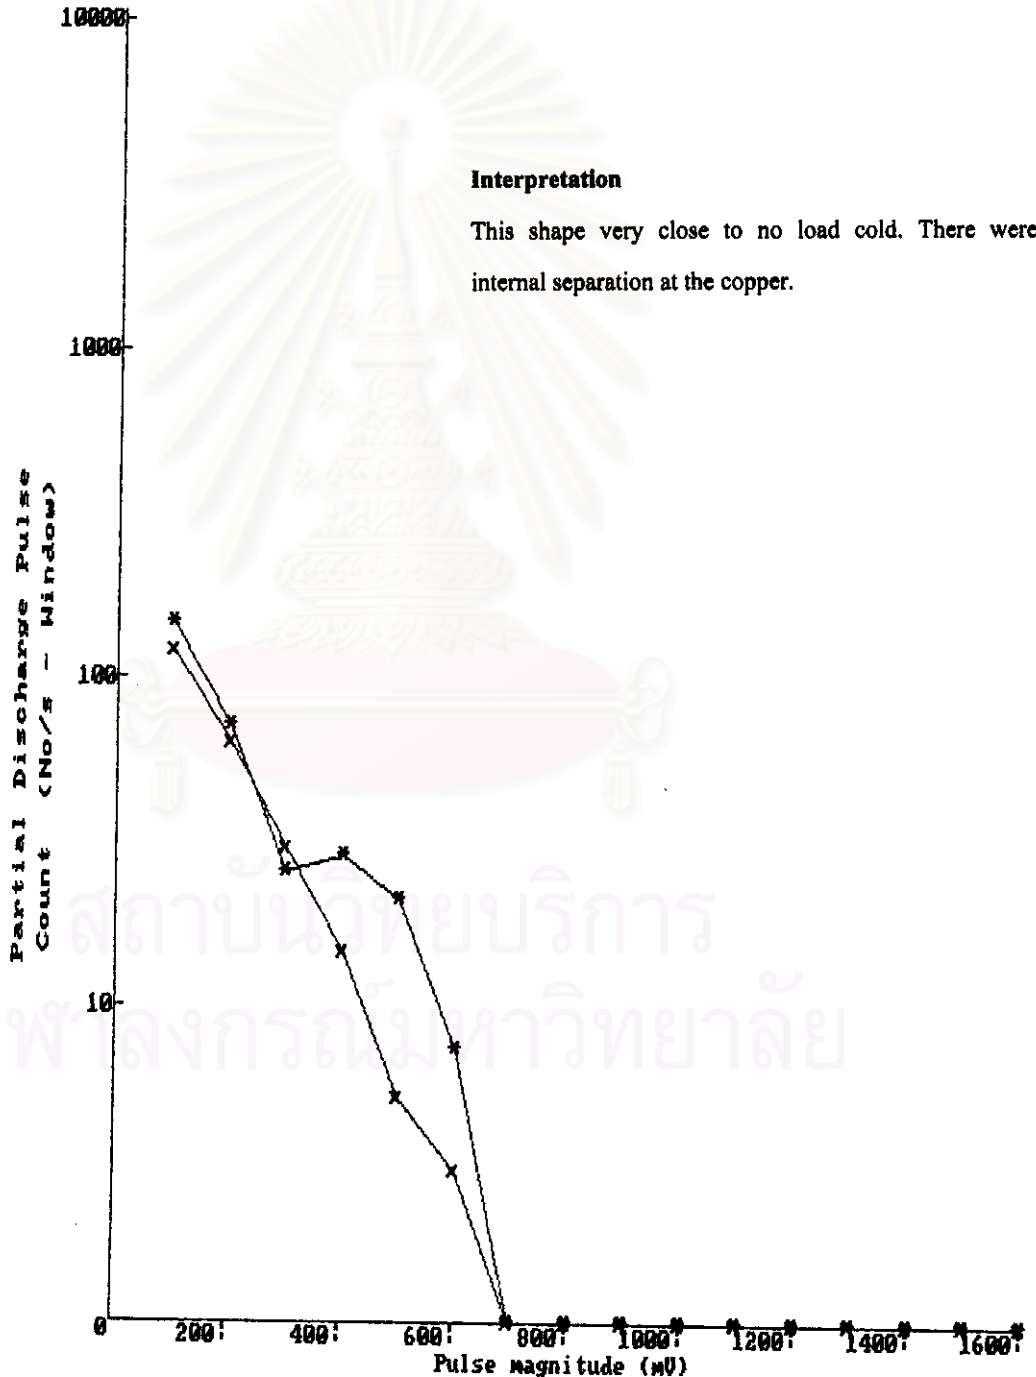
Fig. 4.1.2.4 Data measurement of B Phase, parallel 1

Winding parallel path 1, phase B showed internal discharge and slot discharge due to both negative and positive pulses were predominance. The magnitude and pulse rates were slightly higher than no load condition. There was deterioration on winding at slot portion and delamination with in ground wall.

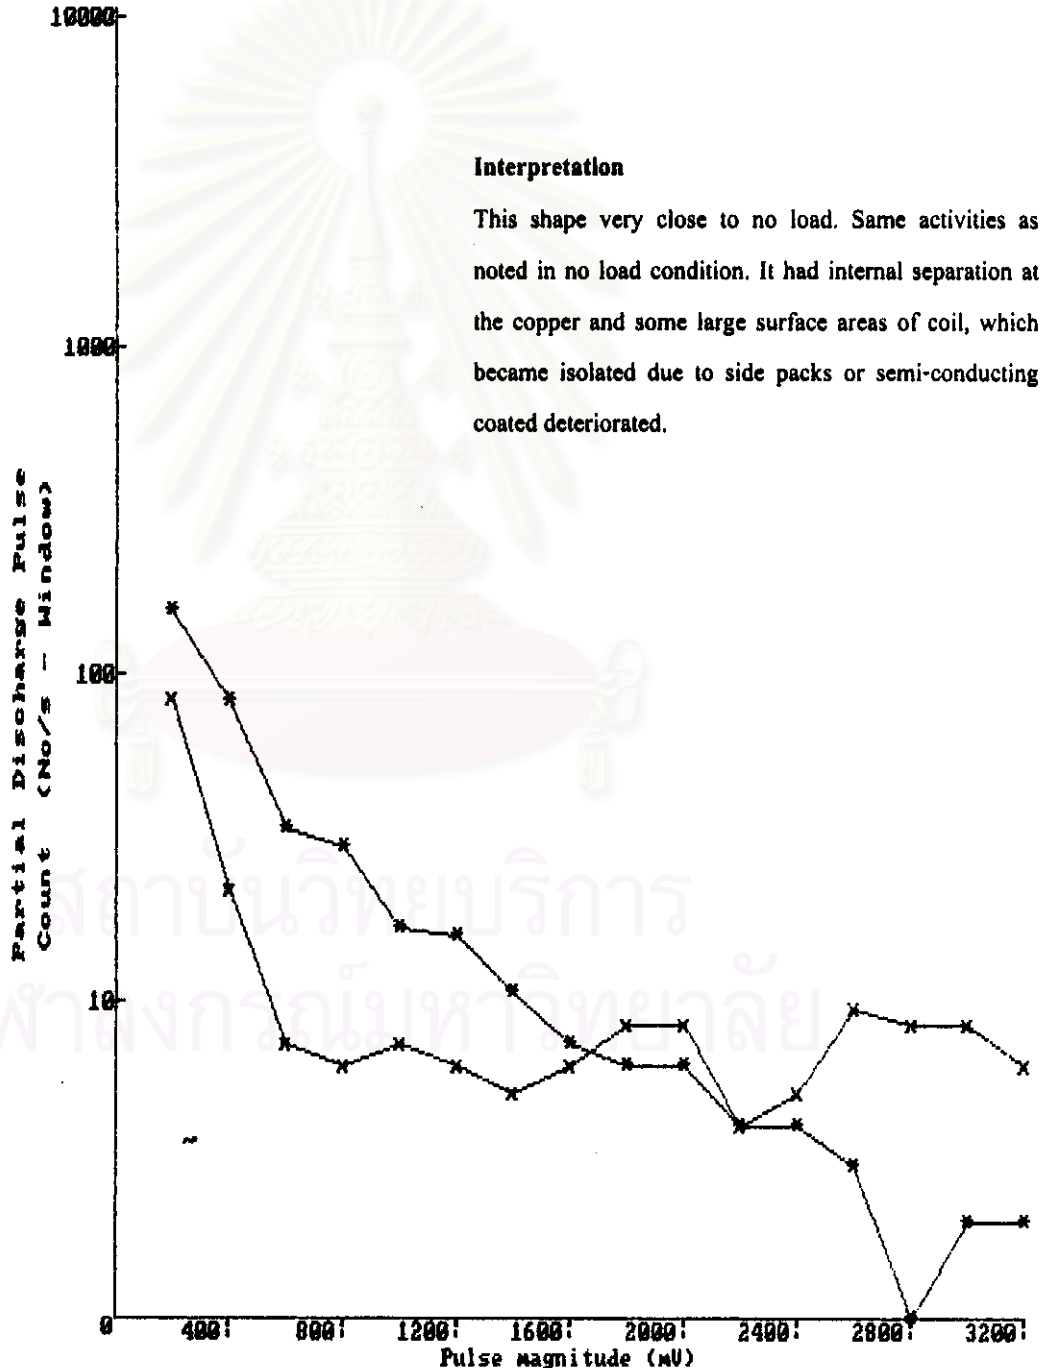
Fig. 4.1.2.8 Data measurement of C Phase, parallel 2

Winding parallel path 2, phase C showed very high amount of NQN and both positive and negative were predominance. These showed a lot of deterioration occurred on anywhere

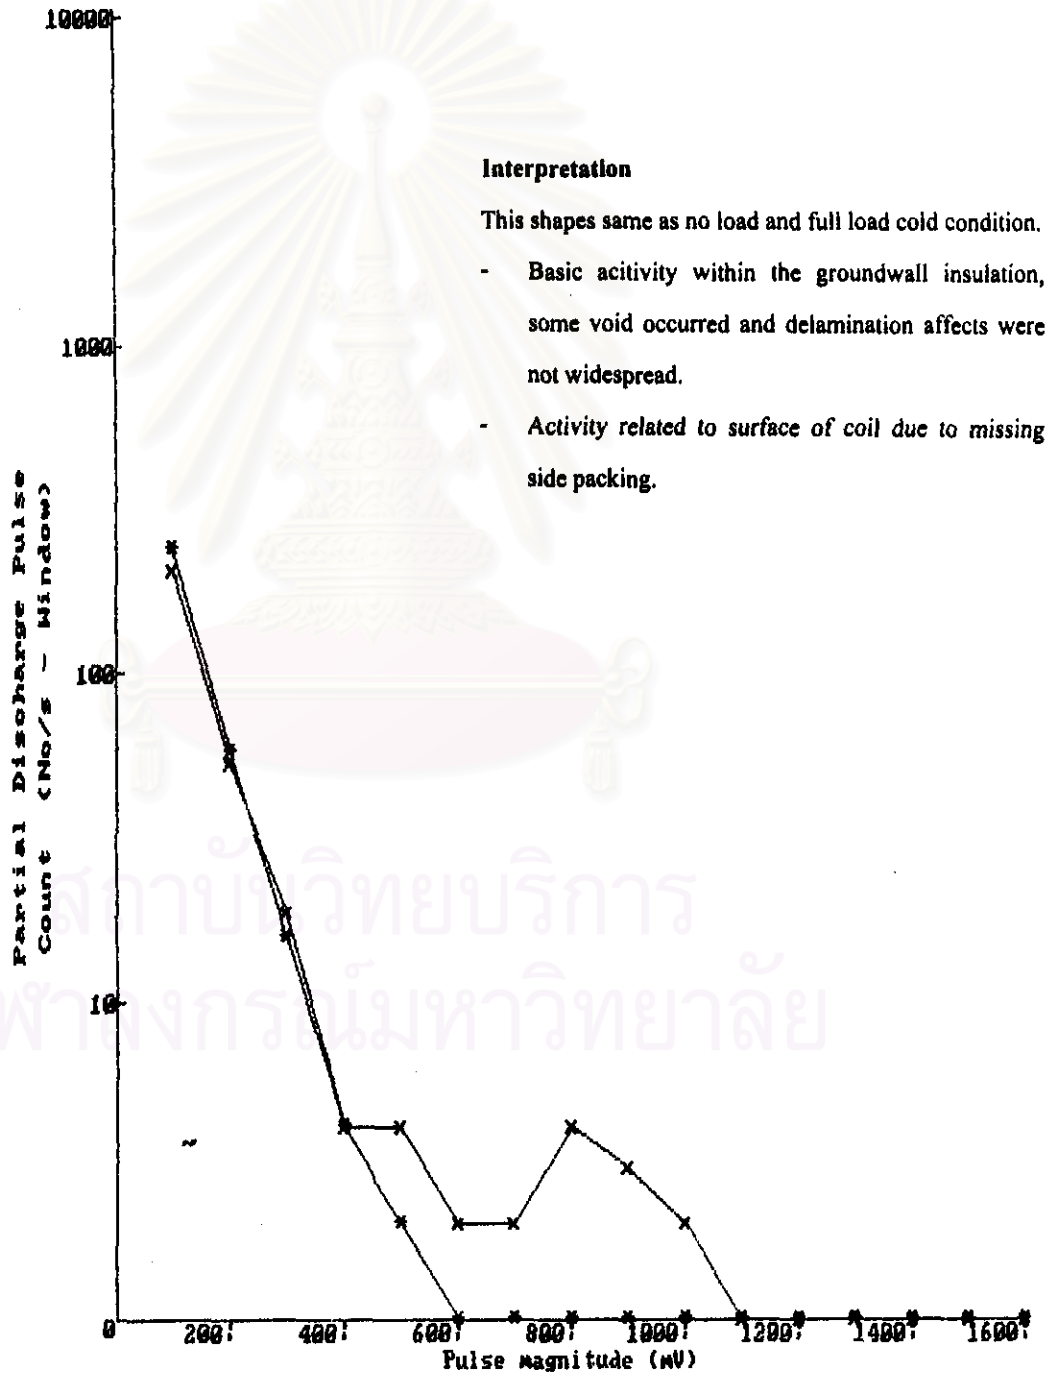
This shapes same as no load and full load cold condition.

- Basic activity within the groundwall insulation, some void occurred and delamination affects were not widespread.
- Activity related to surface of coil due to missing side packing.

Winding parallel path 1 of phase A showed the similarly pattern of graph with two conditions at above mentioned, but the total NQN, magnitude and pulse rate were higher. These meant large amount of partial discharges had occurred when temperature increased. Both negative and positive pulses were equal and predominance to show that internal discharges were occurred within winding cause of delamination in ground wall insulation.

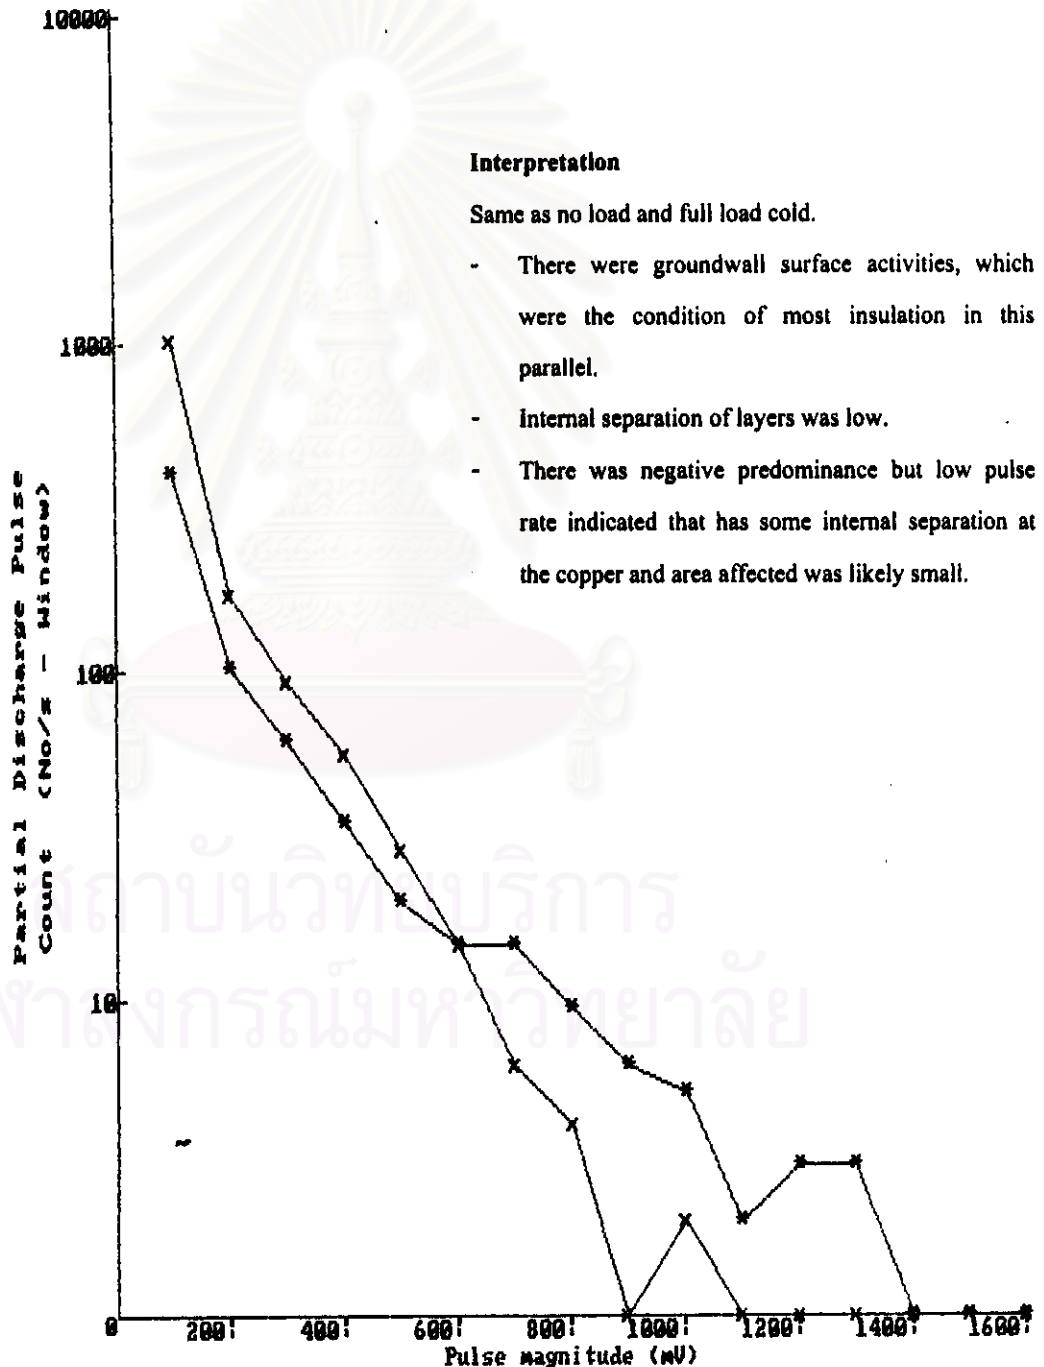
Same as no load and full load cold.

- There were groundwall surface activities, which were the condition of most insulation in this parallel.
- Internal separation of layers was low.
- There was negative predominance but low pulse rate indicated that has some internal separation at the copper and area affected was likely small.

Winding parallel path 2 of phase A were the same as path 1, there were internal discharges and surface discharges occurred within winding. Surface discharges had occurred higher than the last two conditions that might be effected from high temperature. These meant some deterioration occurred within surface area of coils in slot portion.

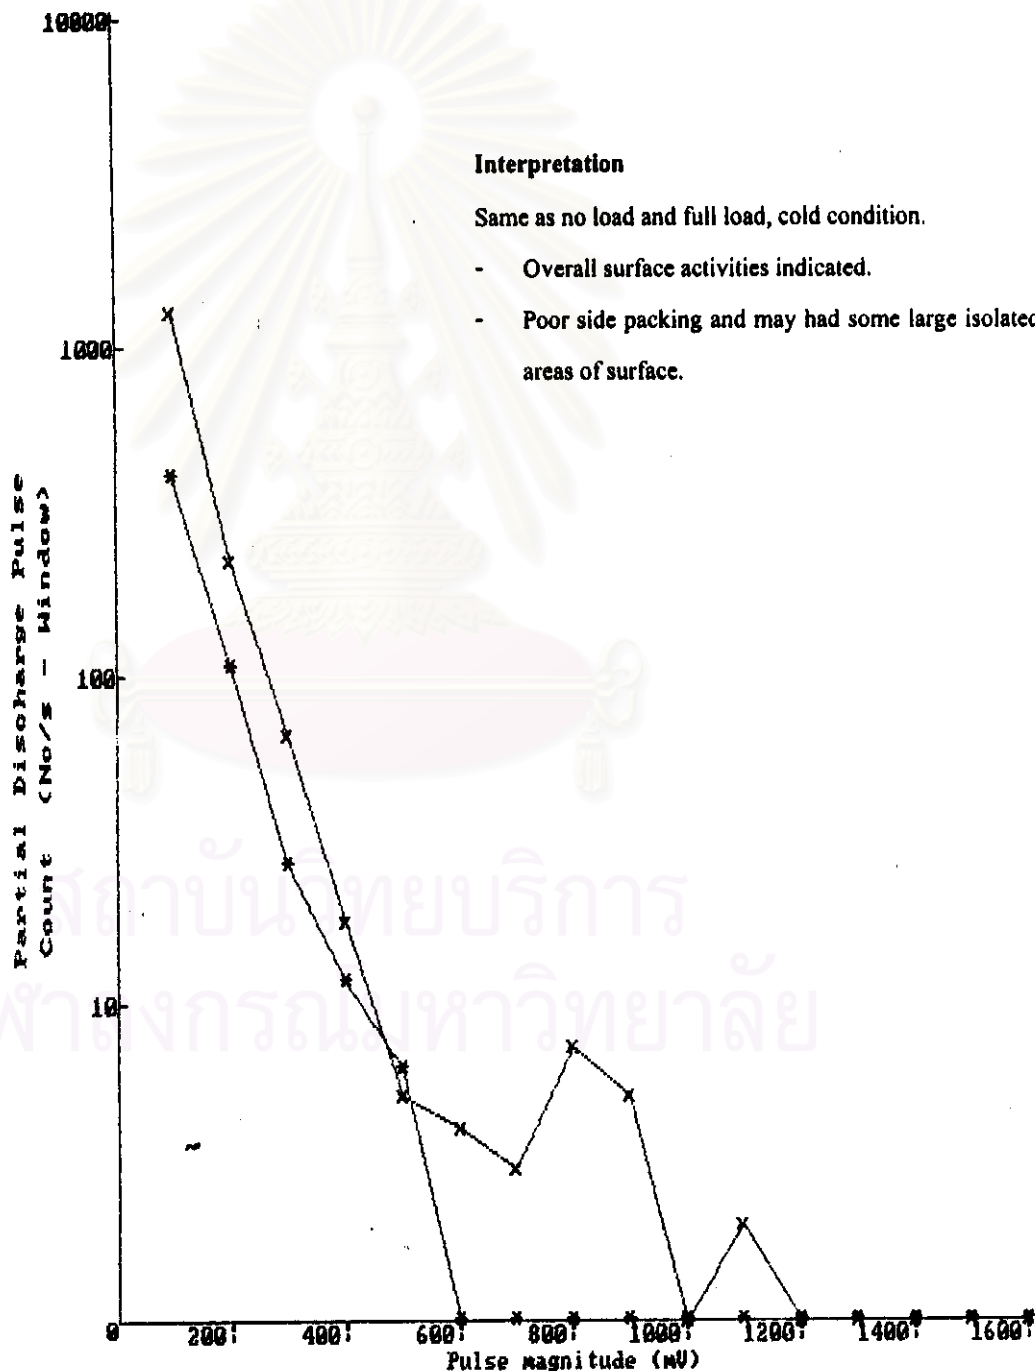
Fig. 4.1.3.3 Data measurement of A Phase, parallel 3

Winding parallel path 3 of phase A showed internal discharge and surface discharges same as path 1, however positive pulses were predominant than negative pulses cause of high vibration and high temperature. Then, there were some deterioration occurred within surface area of coil in slot portion when increased vibration and temperature by full load operation.

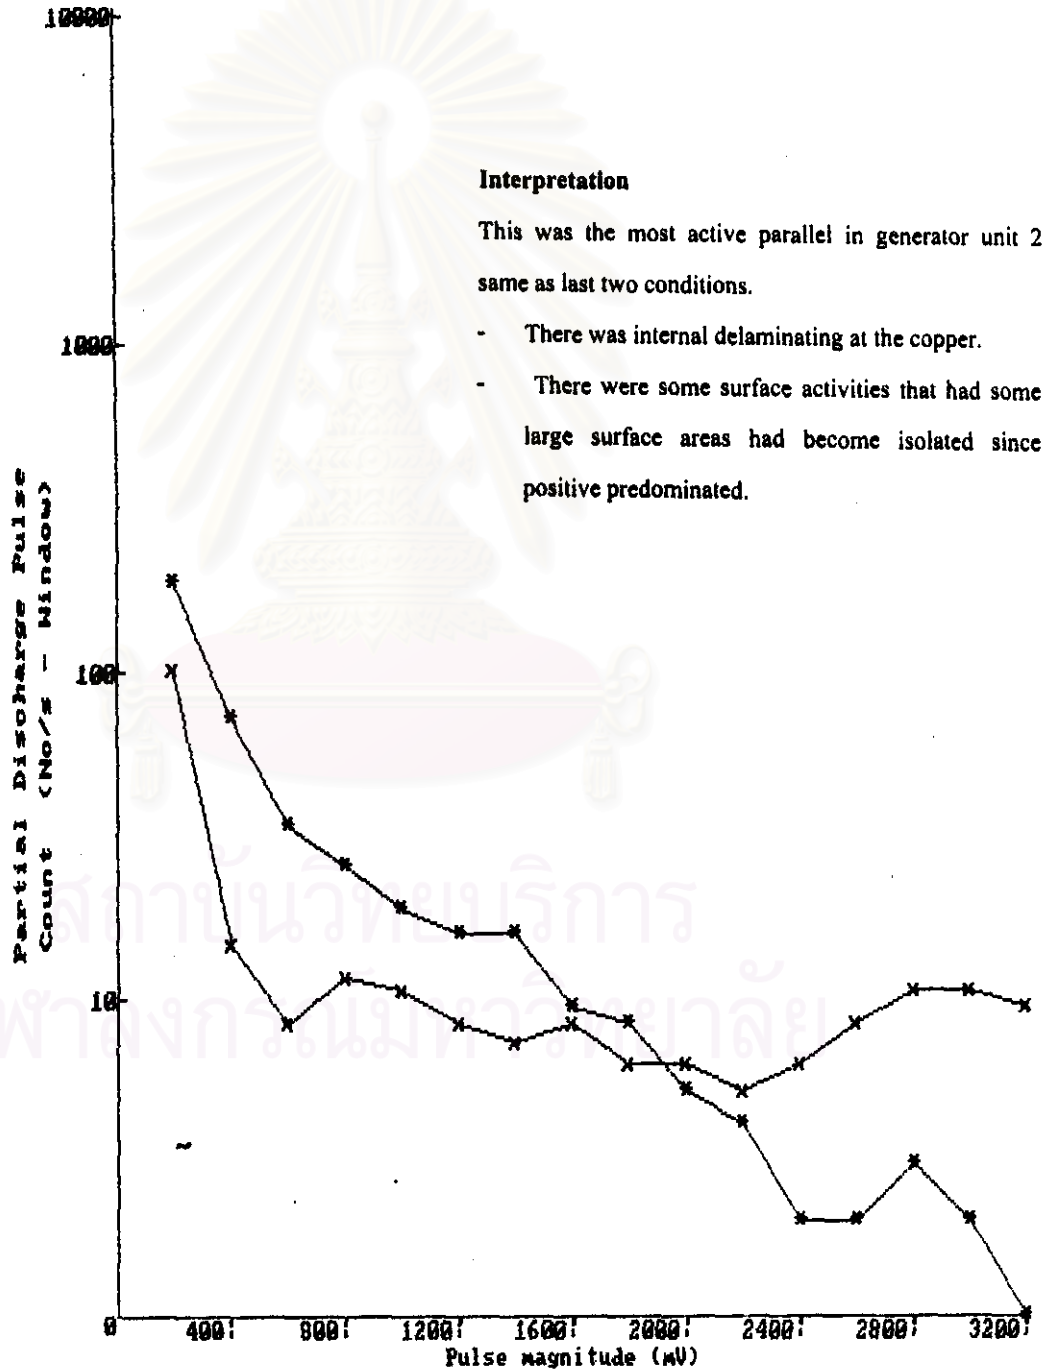
Fig. 4.1.3.8 Data measurement of C Phase, parallel 2

Winding parallel path 2 of phase C showed the same pattern of curves as two conditions in the first stage. With higher vibration and temperature, there was large amount of partial discharge activities occurring. The negative pulses were predominance, showing in high interface discharges occurring. There were delaminating between copper conductor and main ground insulation. However, the positive pulses were also predominant, meaning in high surface discharges occurring on coil surfaces. The overall picture showed high partial discharge activities occurred around stator winding (high amount of NQN, high magnitude and pulse rate).

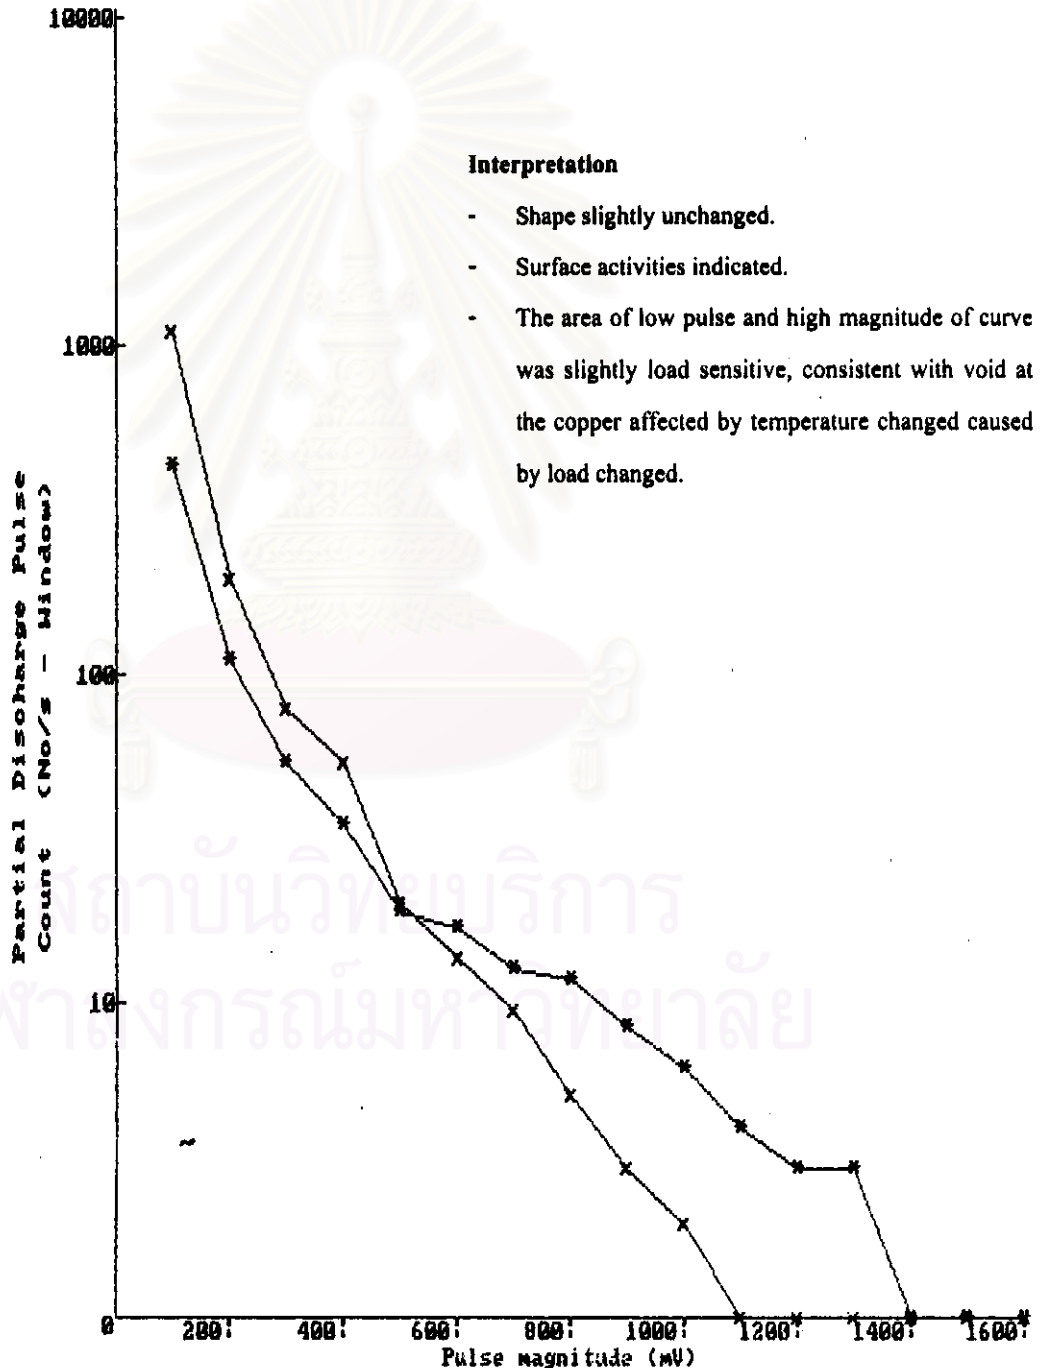
Fig. 4.1.4.2 Data measurement of A Phase, parallel 2

Winding parallel path 2 of phase A had high partial discharge activities, both positive and negative pulses were predominance. There were a lot of surface discharges and internal discharges within winding insulation. These meant high deterioration of coil surface occurring and also delaminating within ground wall insulation.

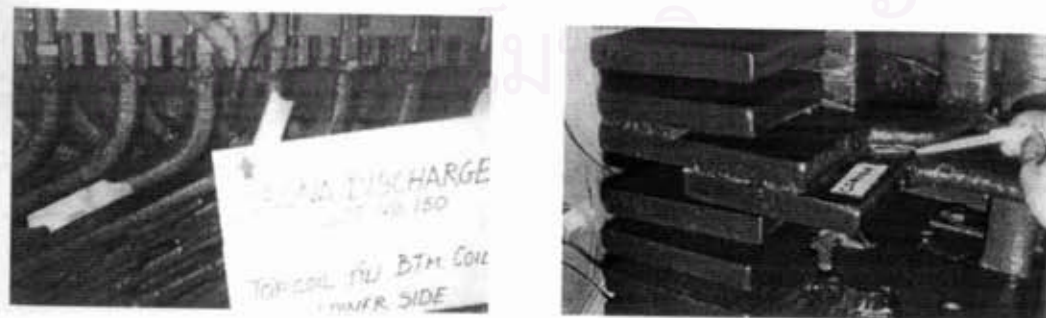
Fig 4.3.1 A lot of surface discharges occurred within end winding

- a). A lot of Surface discharges occurred around end caps and jumpers of top end winding as shown in Fig. 4.3.1
- b). Serious Surface discharges occurred on coil surfaces at straight portion, which located over slot portion.
