CHAPTER VIII

ROCK PORTAL SLOPE STABILITY ANALYSIS

MASTER THESIS: *GEOMECHANICAL ASPECTS AND THEIR APPLICATIONS TO THE DIVERSION TUNNEL STABILITY AT CHIEW LARN DAM SITE, CHANWAT SURAT THANI*

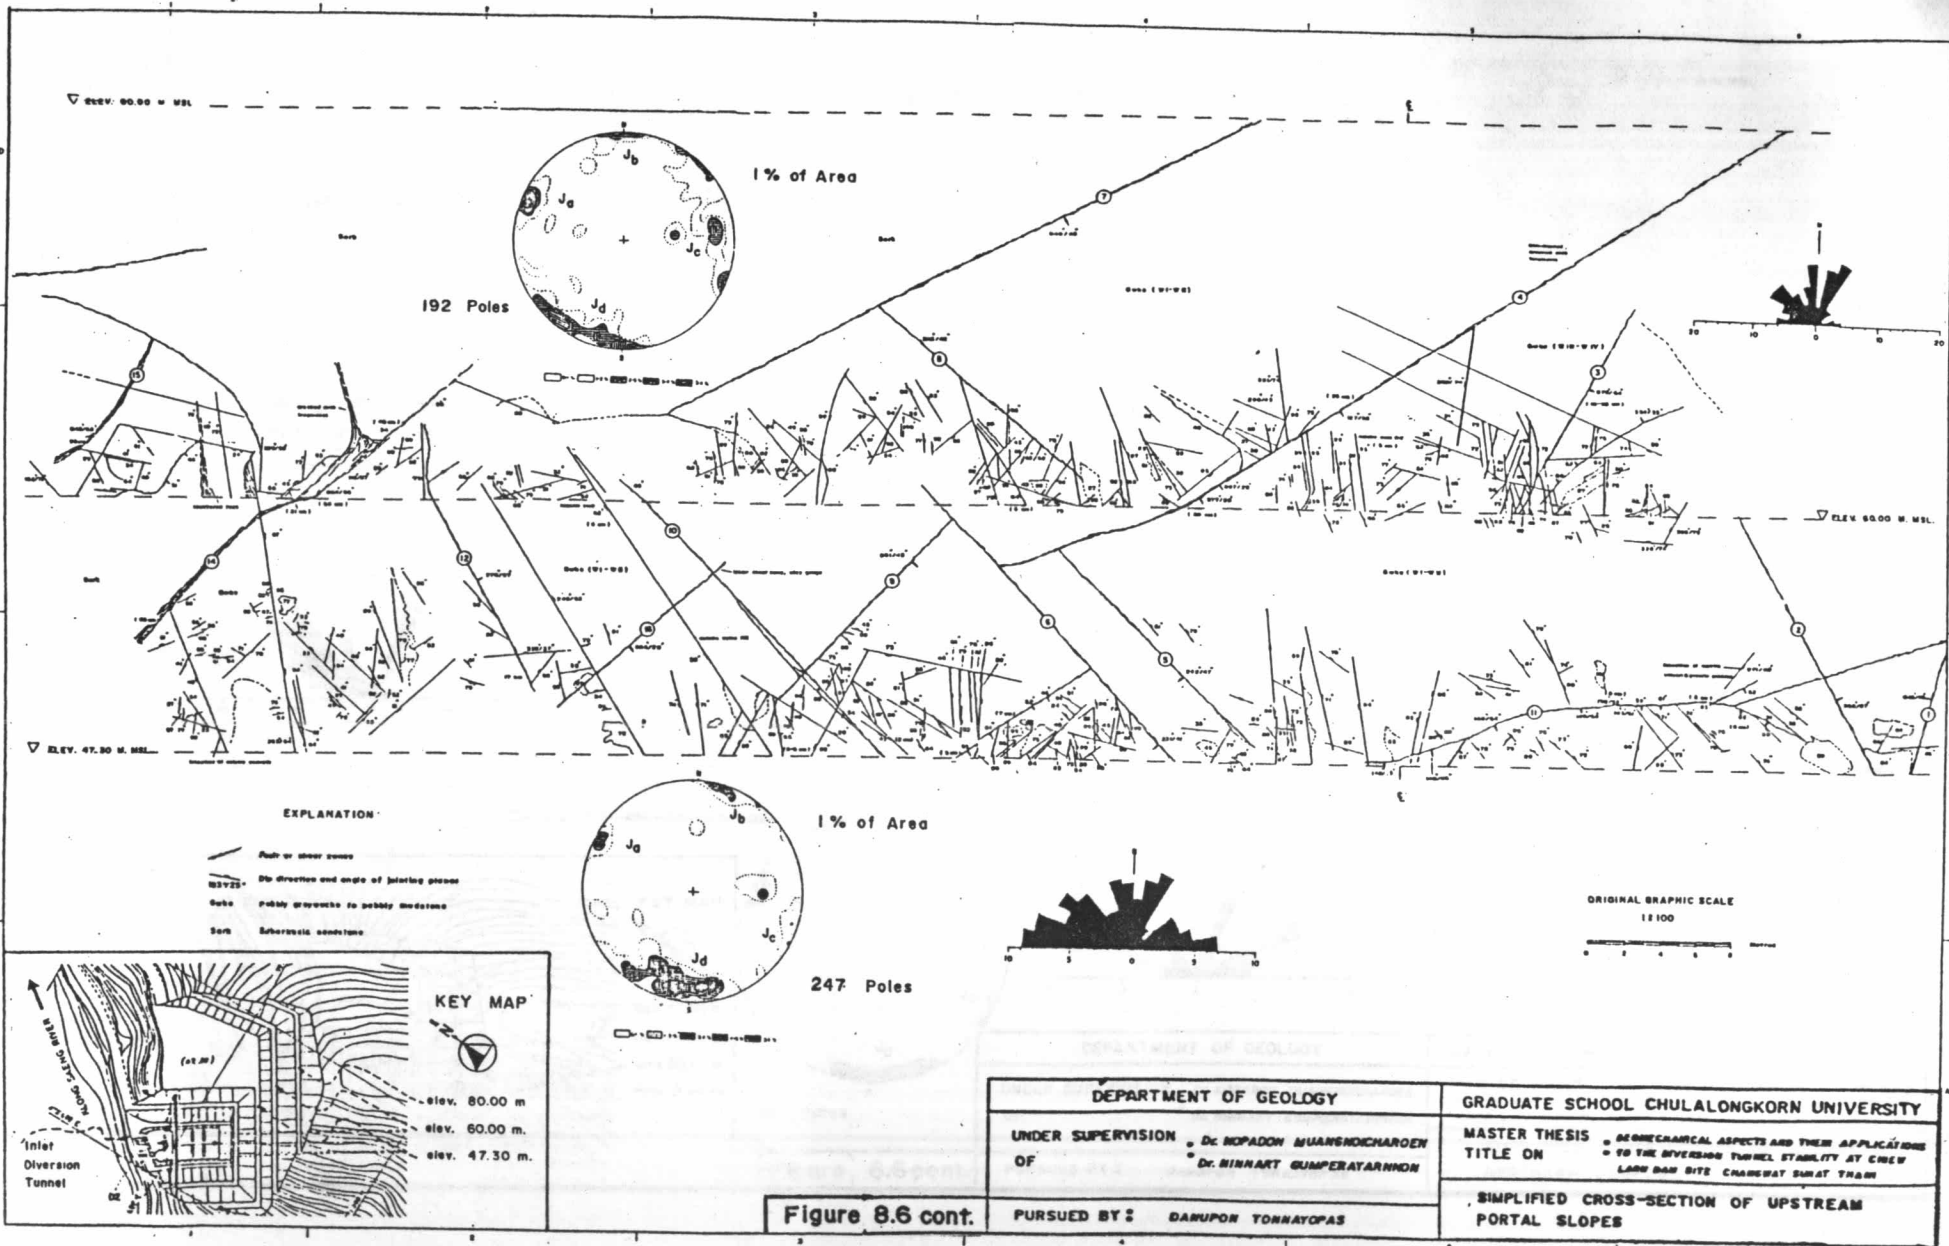
Figure 8.6 cont.

The rocks are subarkosic sandstones and slightly weathered pebbly graywackes. The subarkosic sandstones overlie the pebbly graywackes with a sharp contact as illustrated in Figure 8.6. The rock mass quality is good for both rock types. The observed stability condition is stable and from the analysis result, it is also stable.

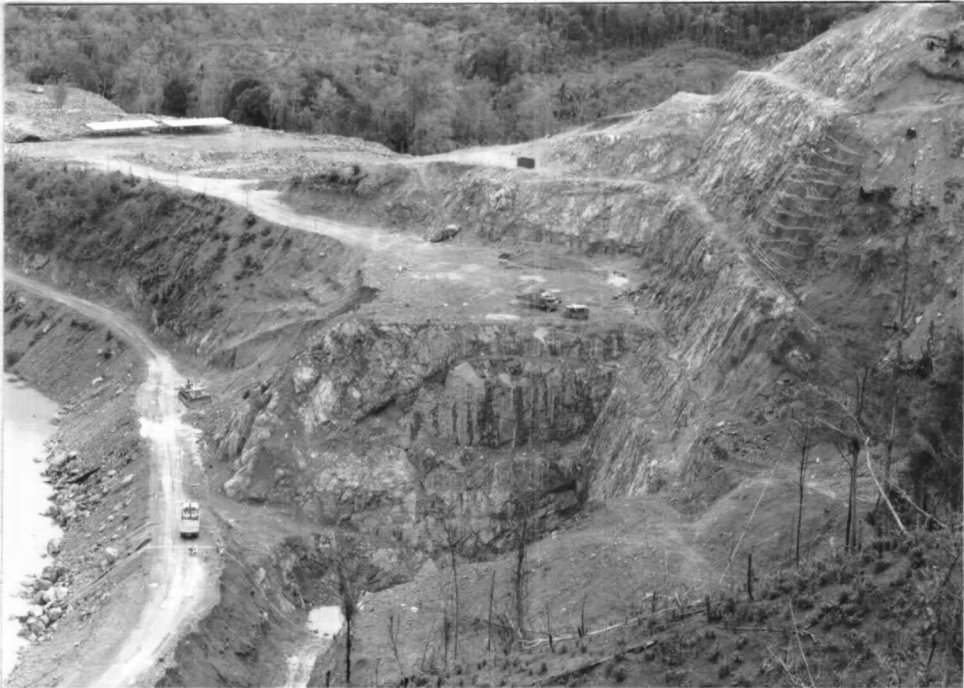
Figure 8.8 Panorama of upstream diversion tunnel.

The excavation of the diversion intake reached from elevation 90.00 m down to elevation 10.00 m. The rocks in the vicinity of the upstream portal consist pebbly graywackes to pebbly mudstones. The pebbly graywackes slightly to moderately weathered or at least intersected by several wide major shear zones of

highly weathered pebbly graywackes are massive. It is crossed by some major discontinuities, some of which are partly clay filled, others are unfilled.

The orientation and the traces of major discontinuities are illustrated in Figures 8.6 and 8.7. These discontinuities are favorable oriented, with respect to the slope stability, as they dip into the rock mass. In a case of two discontinuities, the line of intersection also dips into the slope. For the left channel side of the diversion tunnel upstream portal, however, the orientation of the discontinuities is less favorable and at the elevation 41.50 to 47.30 m two small wedges were inferred (Figure 8.8). They might become unstable once the excavation reaches the final depth, provided that the discontinuities are assumed persistent.

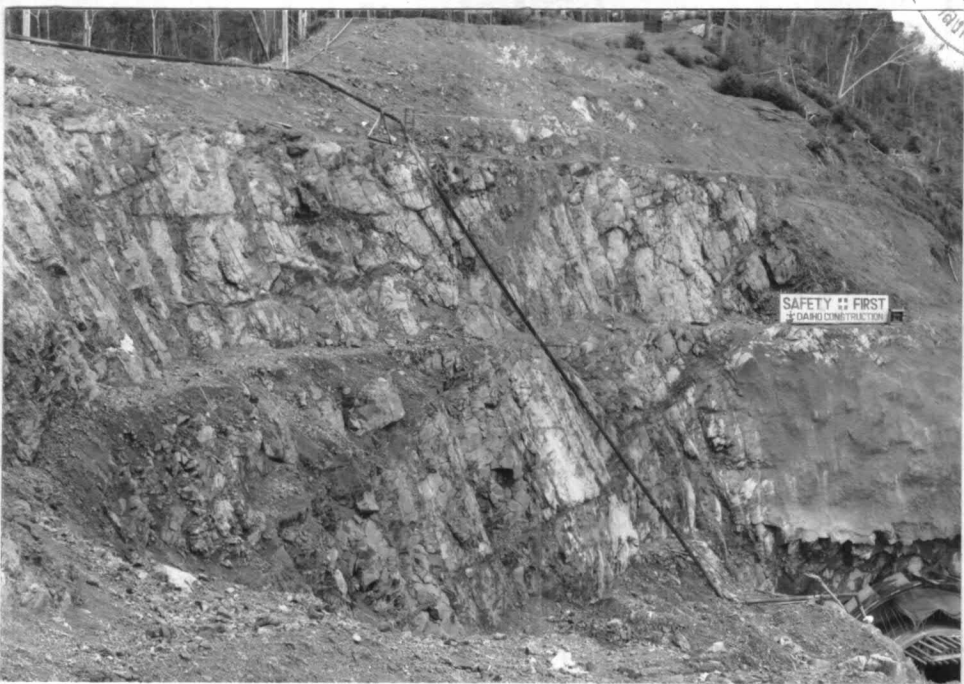
Figure 8.9 Panorama of downstream diversion tunnel.

The geologic condition at the downstream portal is more critical as the rocks more weathered and fractured than at the upstream side (Figures 8.8 and 8.9). The rocks of downstream portals similar to the zone above elevation 60.00 m at the upstream portal.

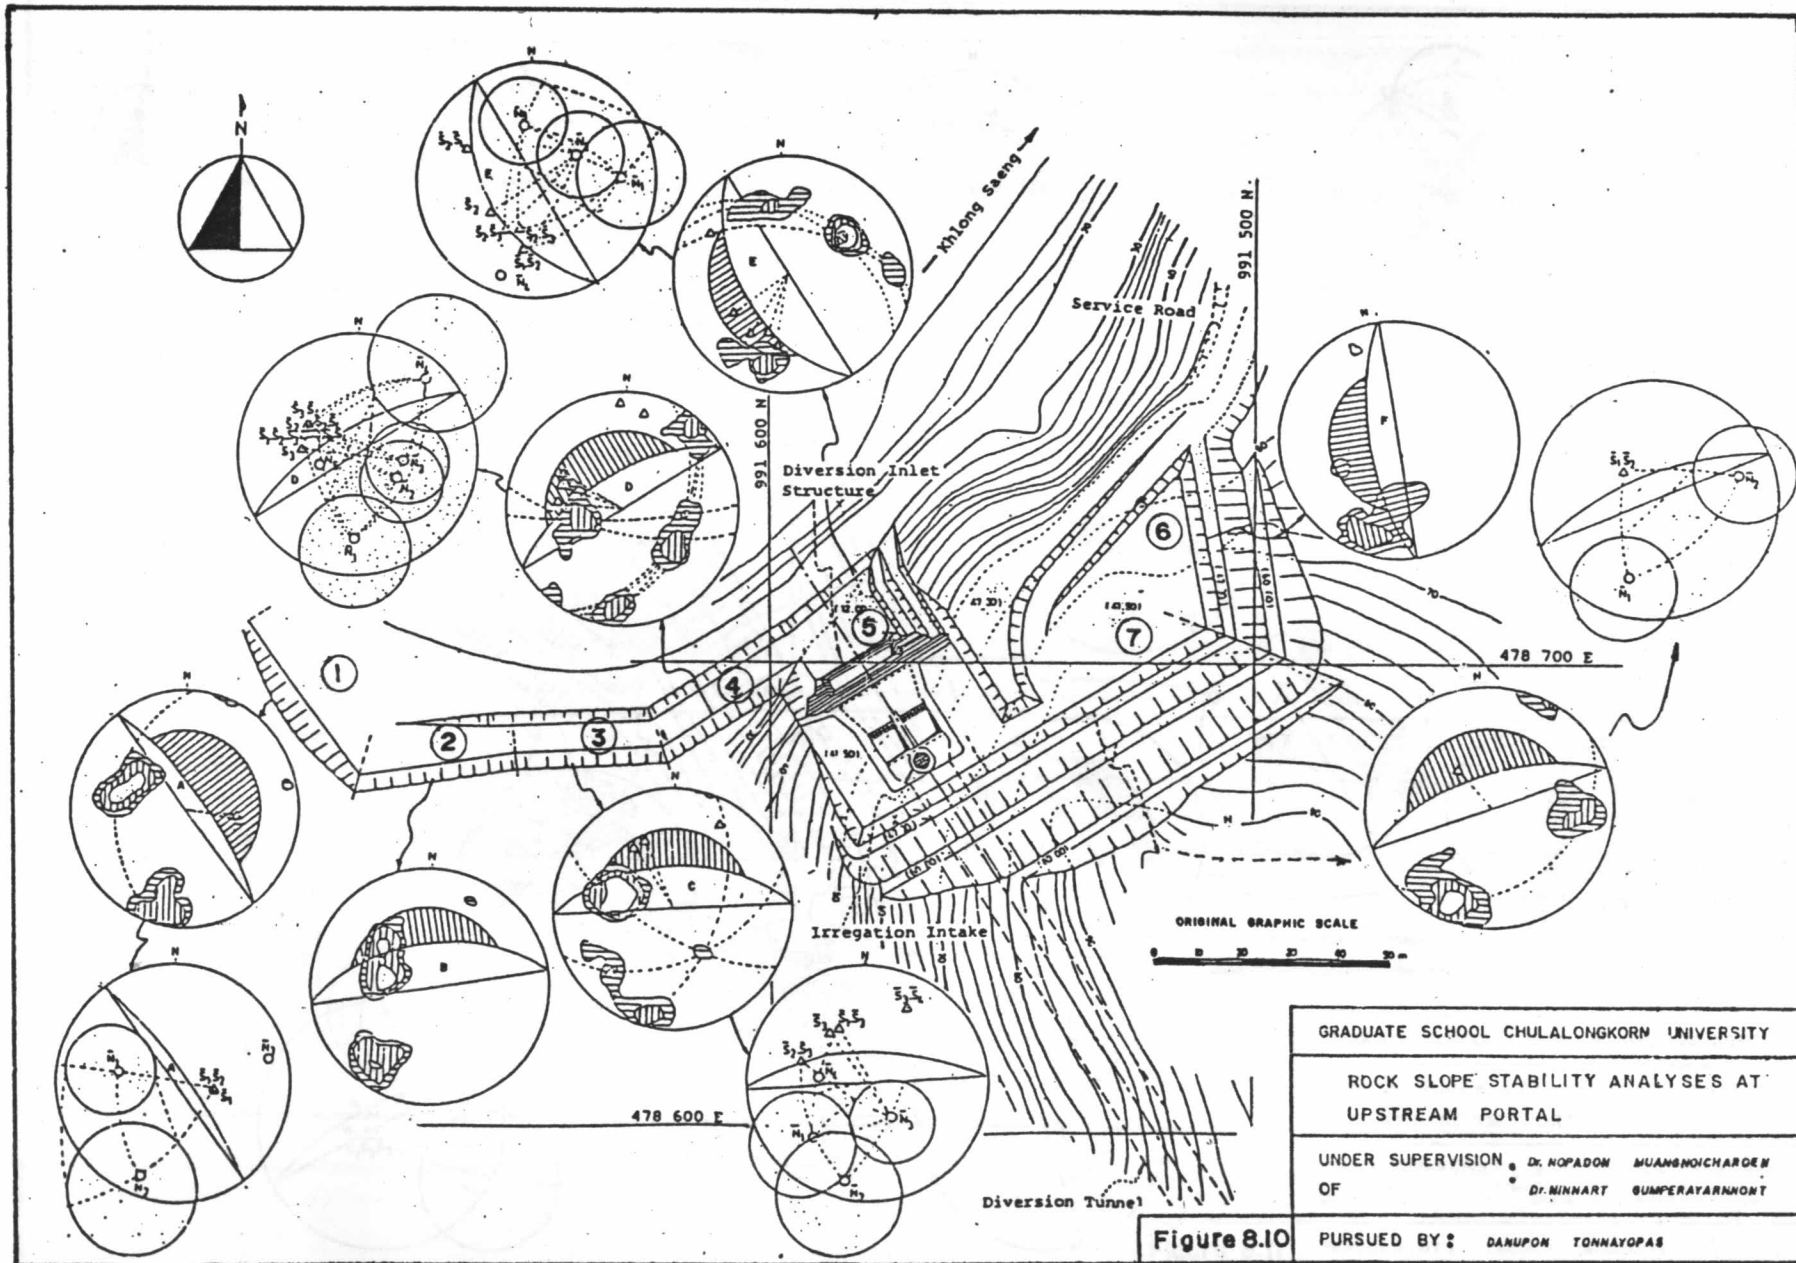
GRADUATE SCHOOL CHULALONGKORN UNIVERSITY	
ROCK SLOPE STABILITY ANALYSES AT UPSTREAM PORTAL	
UNDER SUPERVISION OF	DR. NOPADON MUANGNOICHAREN DR. MINNART GUMPERAYARNONT
FIGURE 8.10	PURSUED BY: DANUPON TONNATOPAS

The rocks are highly weathered pebbly gray-wackes with very poor quality rock masses. A set of discontinuities is generally close spacing. An occasional seepage at the height 1-2 m above the slope toe always occurs after the rainfalls. The set of the discontinuities is of the continuous shear planes with clay gouge of about 10-15 cm thick and bands of crushed rock fragments. The joint surface coating material is commonly limonite with very low to low wall strength. The observed stability condition is unstable. The potential failure might be the rock falls and rock slides in both in both plane and wedge failure types. From the analysis, it shows that the subarea is unstable, the failure may occur in the direction of N60°-85°W with a plung of 40°- 50°. The safety factor is 0.66-1.34.

The rocks are highly weathered pebbly gray-wackes with the very poor quality rock masses. The most continuous seepage during the rainy season was found at 1-2 m above the slope toe. The potential failure surface was found only in a 5 m section on the west side of slope where the small wedge failures were presented. But the stability condition from the analysis for the whole subarea is unstable. The potential failure is in the direction

plunge of N34°W/39° and N24°W/30° with the safety factors equal to 0.95 and 1.07 respectively. The orientation of a stable slope in this subarea should be trending S87°W or roughly east-west with a dip equal to or less than 40° to the north.

The rocks are highly weathered pebbly graywackes with fair quality rock masses. A large continuous seepage occurs during rainfall at about 1 m above the slope toe. The observed stability is stable and so is the stability condition from the analysis result.

The rocks are moderately to highly weathered pebbly graywackes with the fair quality rock masses. Two main potential failure surfaces which tend to give a wedge failure along the line of intersection of these planes are illustrated in Figure 8.10. The analysis result indicates that the stability condition is unstable. The direction of failures will be plunging 50°- 52° to S80°- 84° E with the safety factor equals to 0.51-0.55. The orientation of a stable slope should be trending N36 W with dip equal to or less than 60° toward the northeast.

The rocks are moderately weathered pebbly graywackes with the poor quality rock masses. The observed stability condition is unstable, the plane failure might occur on the weakness plane which moderately dips follow that of the slope face in direction

N33°W/55°. From the analysis result, the subarea is unstable. The potential failure will occur in the direction S24°- 60° W/46°- 47° with the factors of safety equal to 0.75 and 0.78. The orientation of a stable should be trending S33°E with the dip equal to or less than 42° to the southwest.

The rocks are slightly weathered pebbly graywackes with the very poor quality rock masses. Two joint sets with limonite veneers and with clay filled are mainly distributed. An occasional seepage after rainfalls is normally found. The observed stability condition is unstable. A small scale wedge failure might occur along the lines of intersection of the weak planes. From the analysis result, the stability condition is unstable, the wedge failures may occur on the lines of intersection in the direction N44°W/57° with safety factor equals to 0.81. The orientation of a stable slope should be trending S65°W with dip equal to or less than 57° to the northwest.

For the further excavation, the orientation of a stable slope should trend S57°W or roughly east-west with the dip equal to or less than 44° to the north.

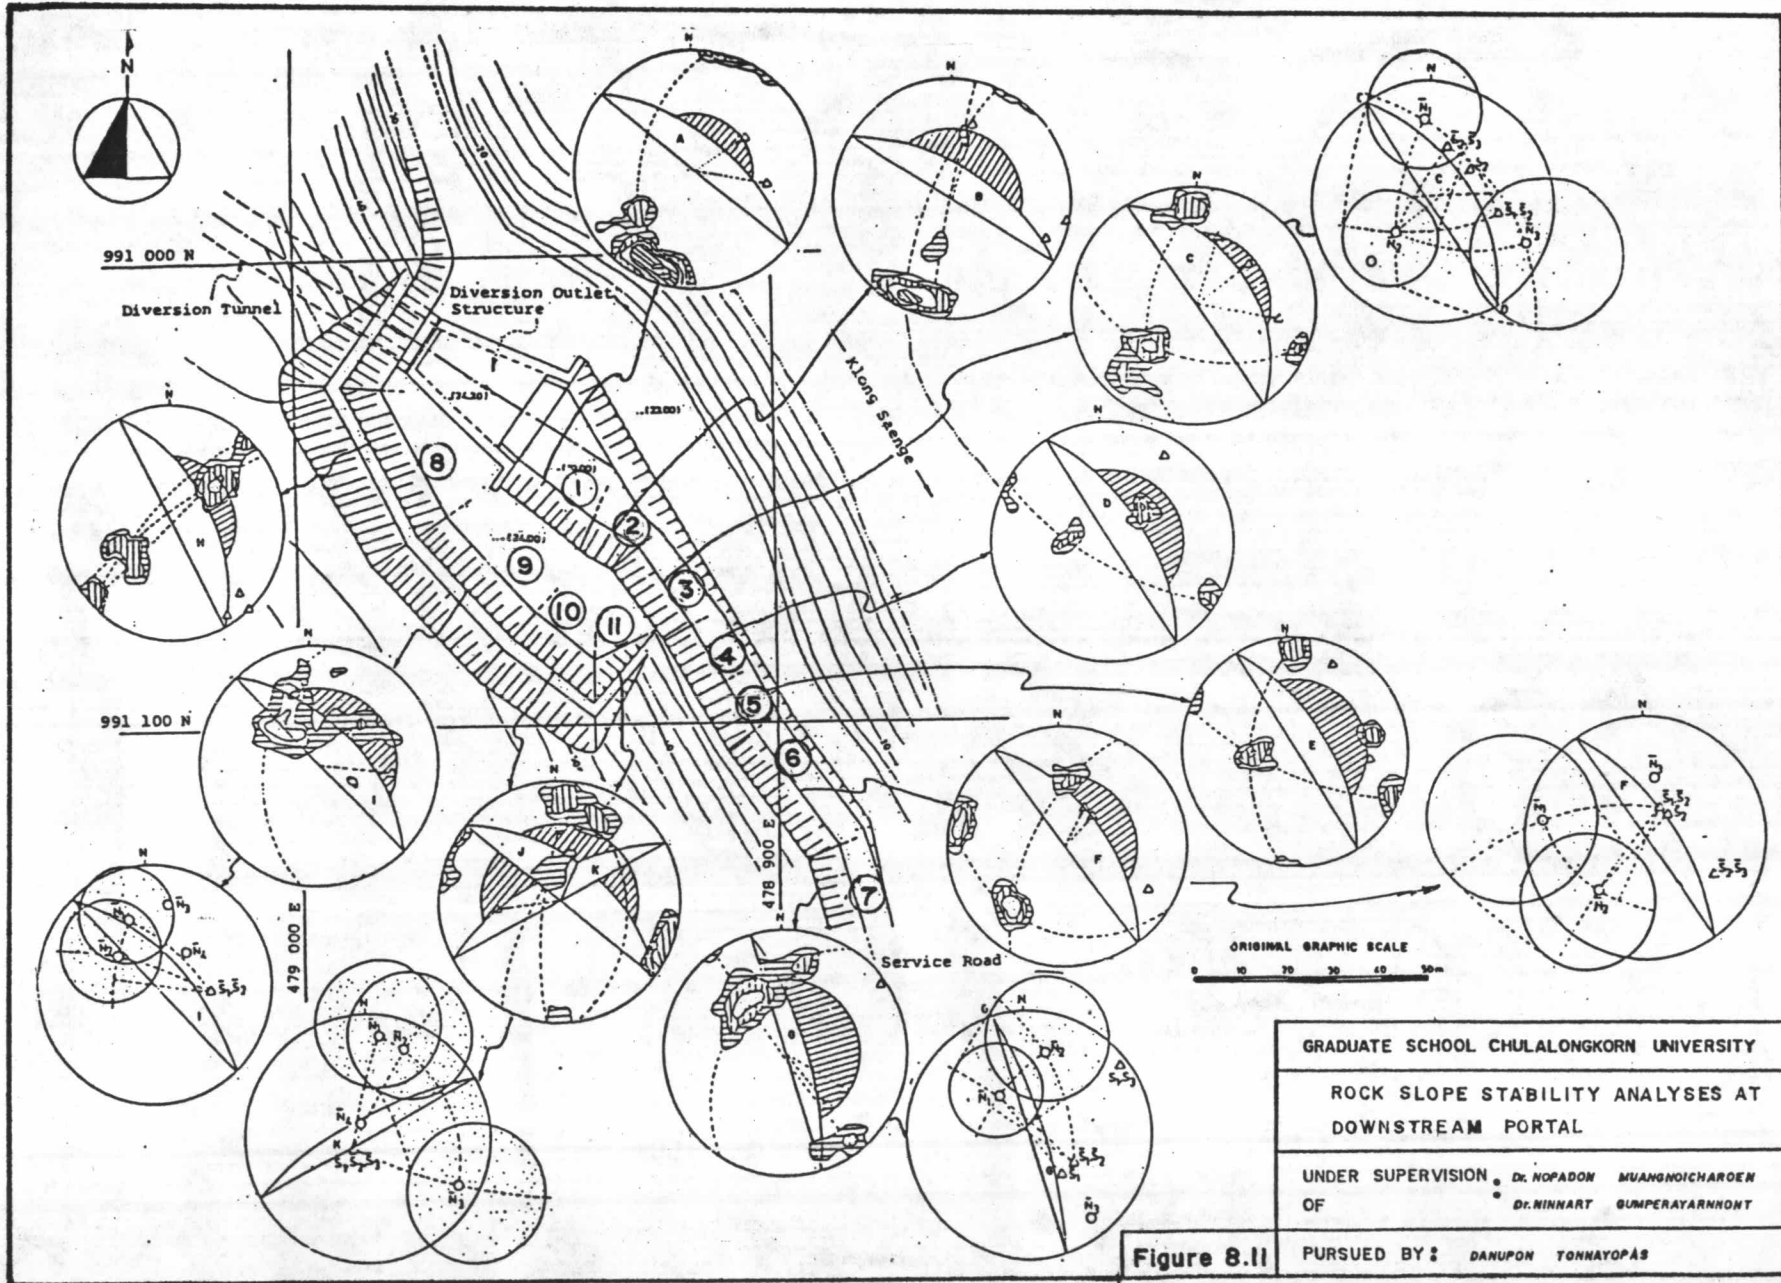
Figure 8.11

The rocks are slightly weathered pebbly graywackes. There are two main sets of discontinuity. One is the discontinuous vertical joints dipping in the same direction as that of the slope face. The other is of the shear planes with the thin layers of crushed rock fragment. An occasional seepage through the shear planes is common after a heavy rainfall. The rock mass quality is good. The observed stability condition from the analysis result is also stable.

The rock are slightly to moderately weathered pebbly graywackes largely with limonite staining. Two main continuous joint sets plus few random joints are distributed. The rock mass quality is good. The observed stability condition is also good. The stability condition from the analysis result is also stable.

The rock are fresh to moderately weathered pebbly graywackes with the predominant veneers of limonite. An occasional rock slide might occur on any plane of weakness which emerges on the master joint plane, should the slope be further excavated to the joint. The stability condition from the analysis is unstable. The potential plane failure is in the direction $N50^{\circ} E/44^{\circ}$ with the

factor of safety equals to 0.70. The orientation of a stable slope is trending N33°W with the dip equal to or less than 44° to the northeast.

The rocks are slightly to moderately weathered pebbly grawackes generally with limonite veneers. The rock masses quality are fair. The observed stability condition and the analysis indicate that it is stable.

The situation of stability condition and result are the same as Subarea D-4, that is, the subarea is rather stable.

The rocks are moderately pebbly greawackes in the lower part and moderately to highly weathered in the upper part. The limonite veneers are commonly occurred. A large amount of seepage occurred at 2.5-4.5 m above the slope toe and tended to be continuous through the rainy season. The rock masses quality are poor. The observed stability condition is unstable. The plane failure tends to occur with an aid of the toppling from the vertical tension joint. The stability analysis result indicated that it is unstable and the sliding may occur in the direction N45°E/62° and N29°E/61° with the safety factors equal to 0.51 and 0.49 respectively. On this slope a plane failure can occur on the discontinuity itself.

The rocks are moderately weathered pebbly graywackes. There are three main predominant joint sets while the shear planes with the filling of crushed rock fragments, clay gouge and limonite are predominance. The rock masses quality are poor. The observed stability condition is unstable. The potential failure might occur on the shear plane in the direction almost parallel to slope face. The stability condition from the analysis result is unstable with the sliding direction of S37°/44° and S46°E/42° on the shear plane. The safety factor is 0.79 for both directions of failure. The orientation of a stable slope should be trending N14°W with the dip equals to or less than 53° to the northeast.

The rocks are slightly weathered pebbly graywackes. The shear planes with crushed rock fragments, clay gouge and limonite are predominant. An occasional seepage is largely through the shear planes after a rainfall. The rock masses quality are good. The observed stability condition as well as the analysis result suggest a stable condition.

The rocks are moderately to highly weathered pebbly graywackes. The multiple shear planes are generally distributed in this subarea. The rock masses quality are poor to fair. The observed stability condition is unstable. The rock falls and small wedge failures along the intersection line of the shear planes were observed. The stability condition from the analysis is unstable. The plane failure with an aid from toppling may occur in the direction S80 E/38 with the safety factor equals to 0.80. The orientation of a stable slope should be trending N40°W with the dip equal to or less than 52° to the northeast.

The rocks are moderately to highly weathered pebbly graywackes. The rock masses quality are fair to good. The observed stability condition is good. The stability condition from the analysis is stable.

The rocks are moderately to highly weathered pebbly graywackes in the lower part and highly weathered in the upper part. The distribution of discontinuities are the same as in subarea D-10, the only difference between the two subareas is the slope face orientation. The rock masses quality are poor to fair. The observed stability condition is stable though some rock falls from the upper part might occur. The stability condition from the analysis is stable.

If the lubricating effect from groundwater as well as the water diversion is taken into a consideration, this slope face should be designed conservatively. At least the slope angle should be equal to dip angle of the potential plane failure. The orientation of a stable slope should trend N34°W with the dip equals to or less than 62° to the northeast.
