CHAPTER VII

HYDROLOGICAL INVESTIGATION

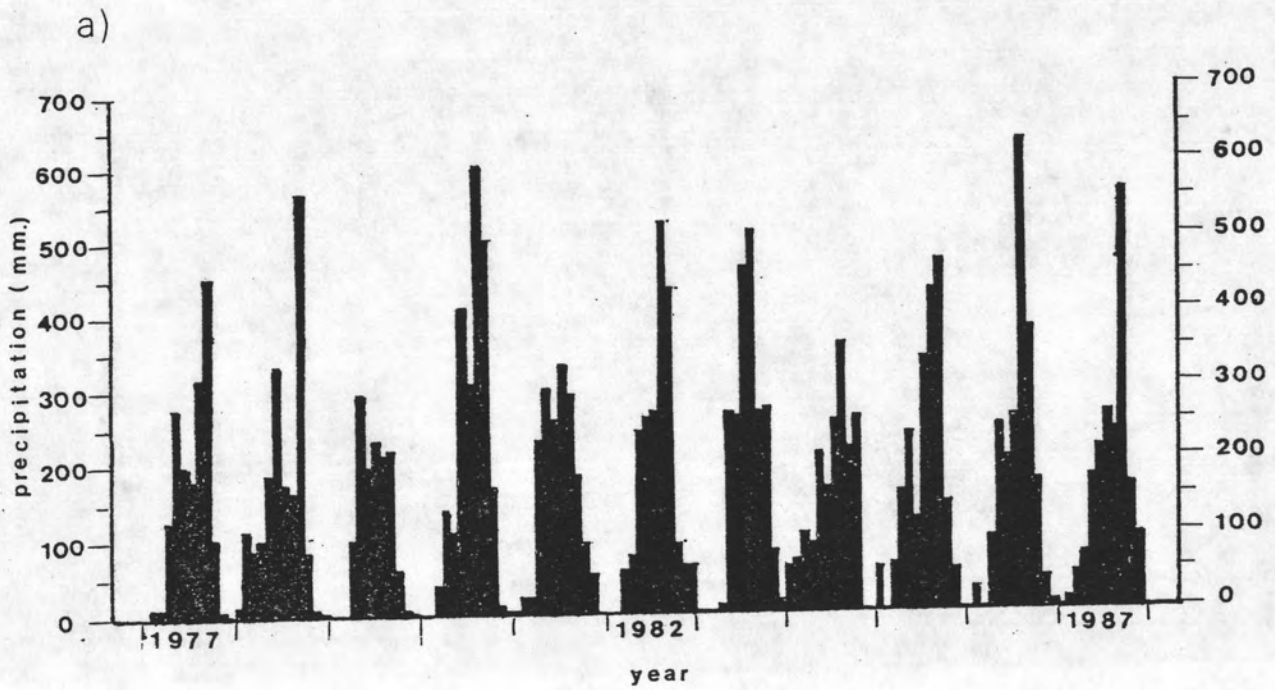
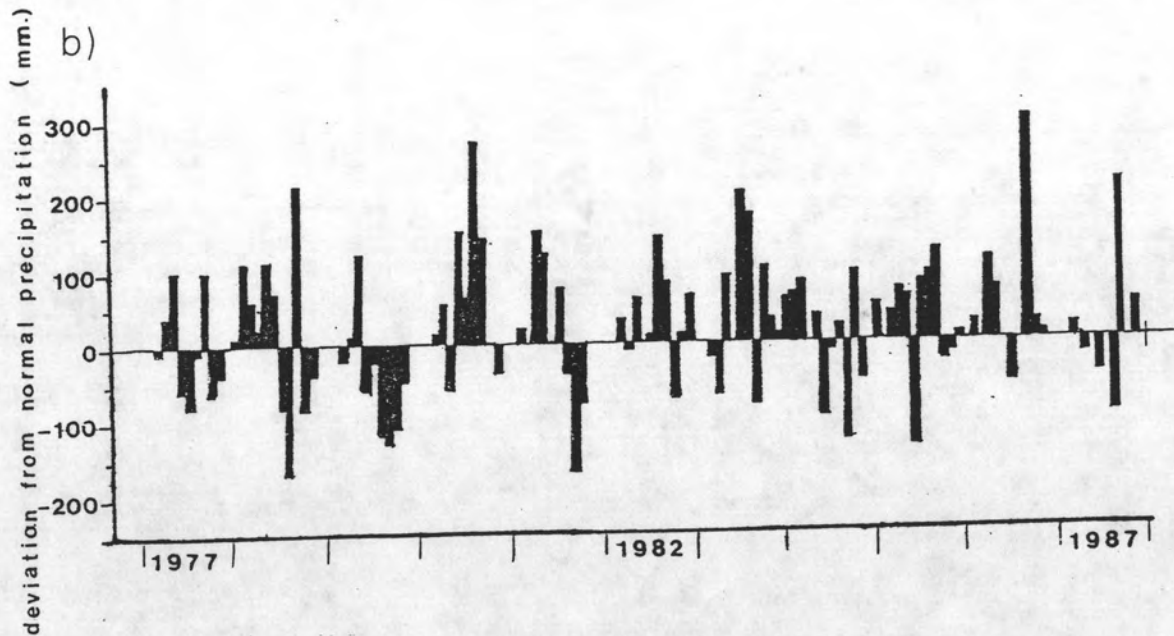
Figure 7.1 Record of rainfall in Prachinburi.

A record of ten years of rainfall in Prachinburi from the Meteorological Department was illustrated as the histograms as shown in Figure 7.1a. The data indicate that the rainy season normally lasts from May to October. The heaviest rainfall generally comes during July to September with an average monthly rainfall of 350 mm., while the average annual precipitation is 1,900 mm. In August, 1983 and 1986 when the landslides occurred, the precipitations were highest, almost twice as much of the normal value (Figure 7.1b).

Thus, these failures are directly related to the heavy rainfall.

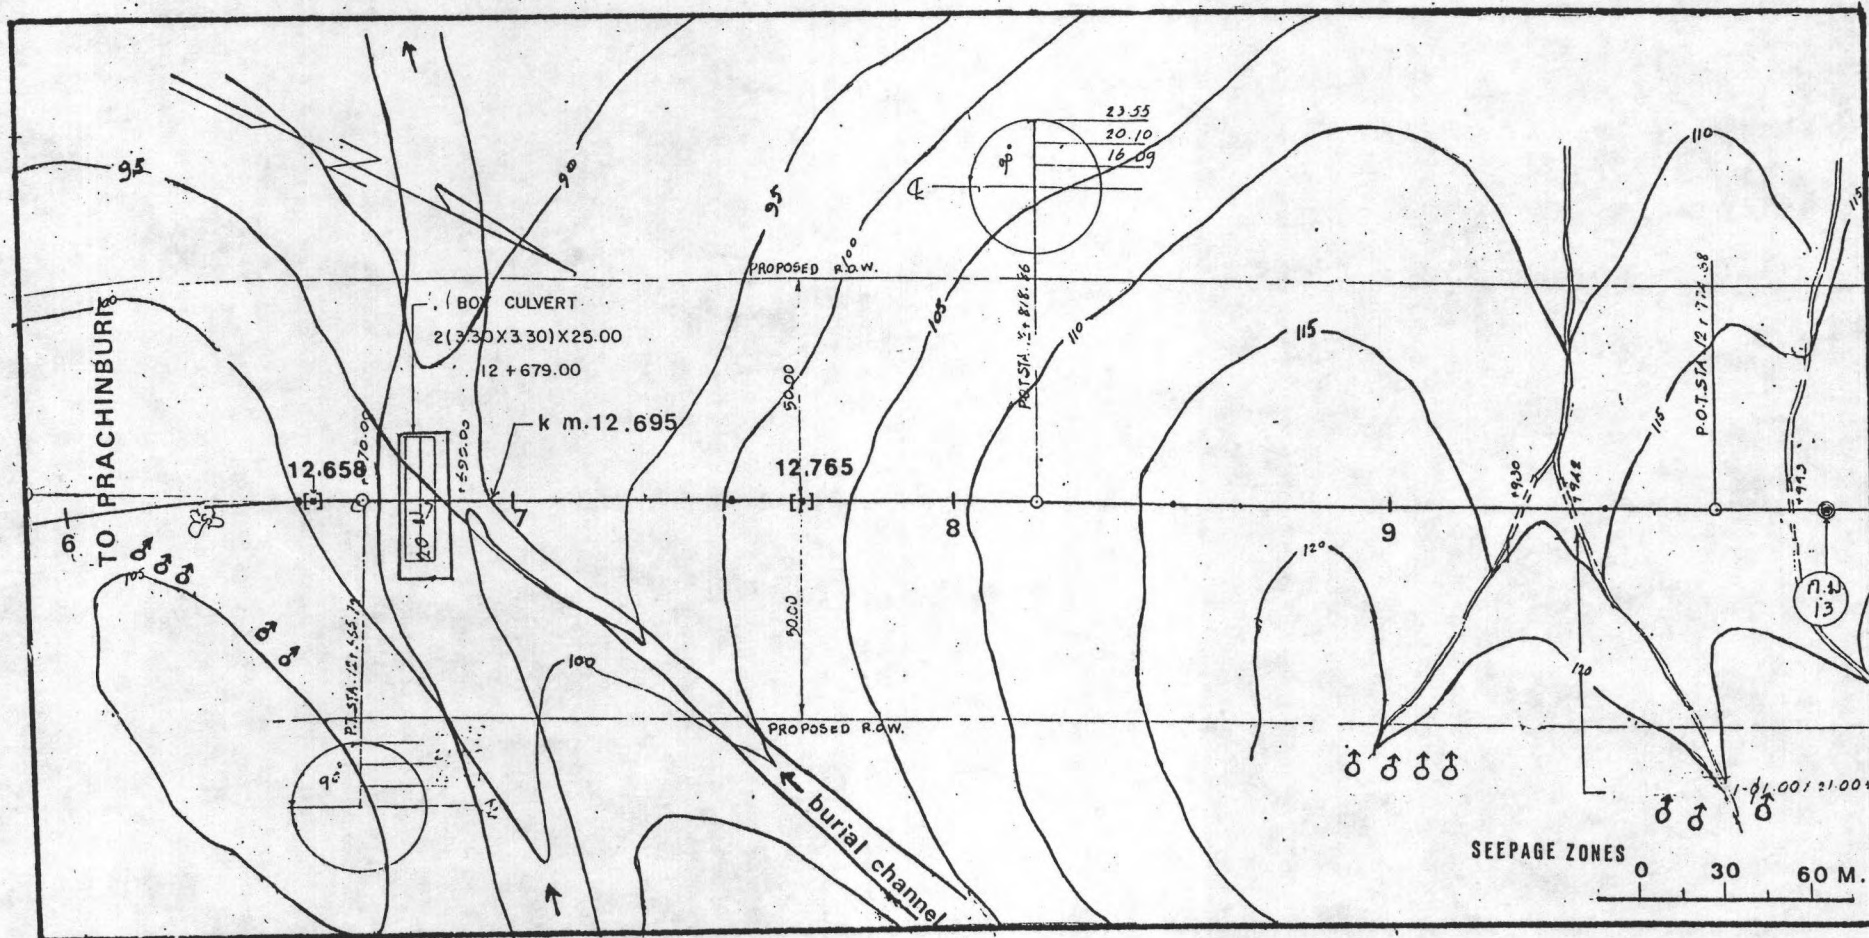
Figure 7.2 Original topographic detailed of study area of embankment failure.

The study of the original detailed topography and topographic profiles of the study area reveals that there is a small natural drainage channel jointing the main stream at KM.12.695 (Figure 7.2).

This natural drainage was blocked by the embankment fill and no discharge allowance was prepared for this drainage channel. The blockade of the running water may be the additional cause of slope failures here.
