CHAPTER II

HISTORY OF SLOPE FAILURES

The highway embankment on the colluvial slope between KM.12.658 and 12.765 was constructed across a 5 meter wide stream valley. Since the heavy rainfall period in 1981 three repeated failures have occurred at this location. The total restoration cost has been estimated by the Department of Highways to be about 14 million bahts. The history of these slope failures is as follows.:

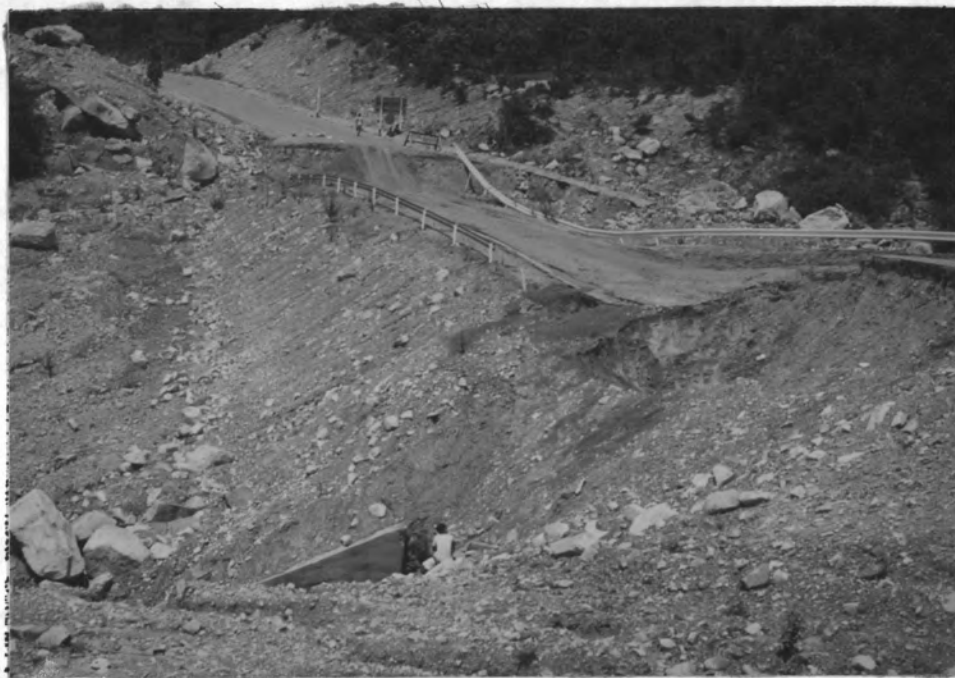
In 1981 during the rainy season the first failure occurred on the filled highway embankment(5 to 9 meters high) between KM. 12.650 and KM. 12.750 where a box culvert [2 (3.30 x 3.30) x 20 meters at KM. 12.678 to KM. 12.684.6] was buried (Figure 2.1). Unfortunately, no systematic study on the failure nature was performed then.

Figure 2.1 First failure on the embankment and box culvert between KM. 12.650 and KM. 12.750 in 1981. The photograph was taken looking uphill toward Khao Yai National Park.

The reconstruction of the first failure was done in the following year. The damaged embankment and box culvert were removed and replaced with a reinforced concrete bridge of 8 meters wide from KM. 12.658 to KM. 12.714. The bridge consisted of following sections (1 x 8.00) + (1 x 10.00) + (1 x 20.00) + (1 x 10.00) + (1 x 8.00).The construction cost was estimated to be 3,470,000 bahts.

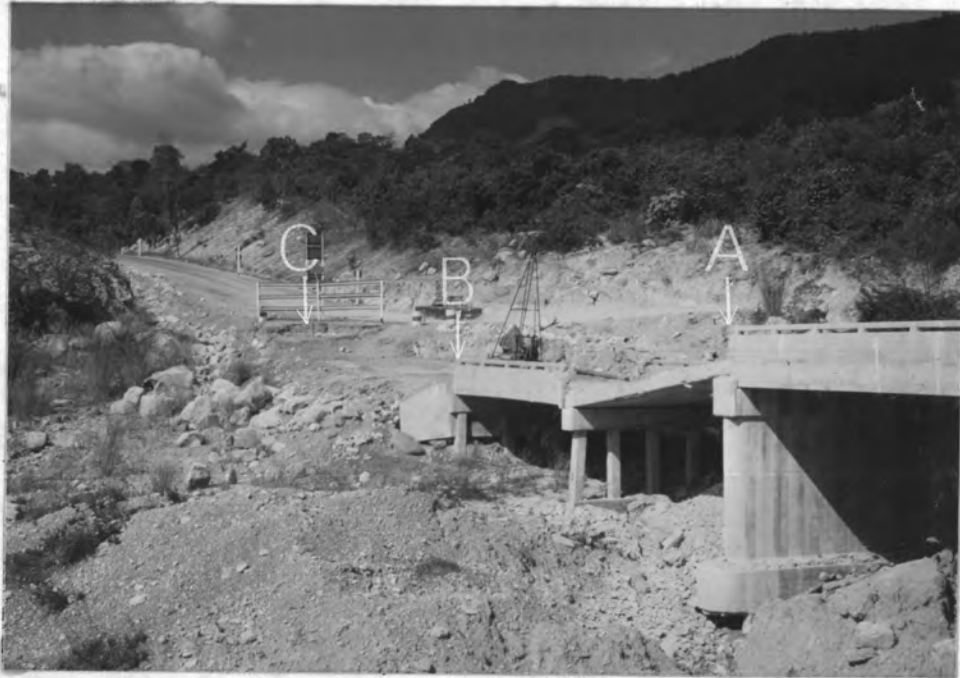
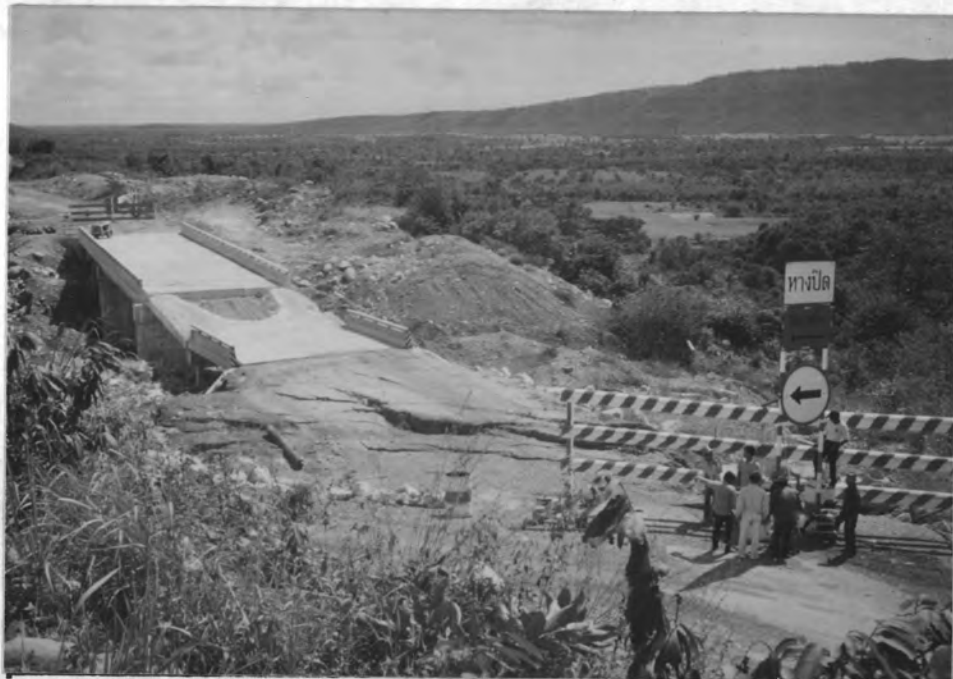
One year after the remedy, the second failure occurred again in August, 1983 when 506 mm. of rainfall was recorded. A bridge approached abutment between KM. 12.714 and KM. 12.745 (northern abutment) failed while the bridge between KM.12.696 and KM. 12.714 was damaged (Figures. 2.2, 2.3.)

In this failure a detailed geotechnical investigation was done by the author. The slope failure was a debris slide with the type of movement of translation. The failure surface was uncertain, but believed to be along the interface between the colluvial soil and firm bedrocks.

The movement of the bridge approached abutment was oblique to the bridge. The vertical displacement of tension cracks were observed both on the road pavement and on the side slope. The major tension cracks formed a very clear concave upward scarp which cut across the road centerline at KM. 12.745. The vertical displacement of 0.40 to 1.50 meter was observed at this major scarp. The construction of temporary road and bailey bridge was 230,000 bahts in 1985.

Figure 2.2 Second failure on the bridge and bridge approached abutment between KM. 12.696 and KM. 12.745.

- a) The photograph was taken looking up hill toward Khao Yai National Park.
A- KM. 12.696, B- KM. 12.714, C- KM.12.745
- b) The photograph was taken looking downhill toward Prachinburi.

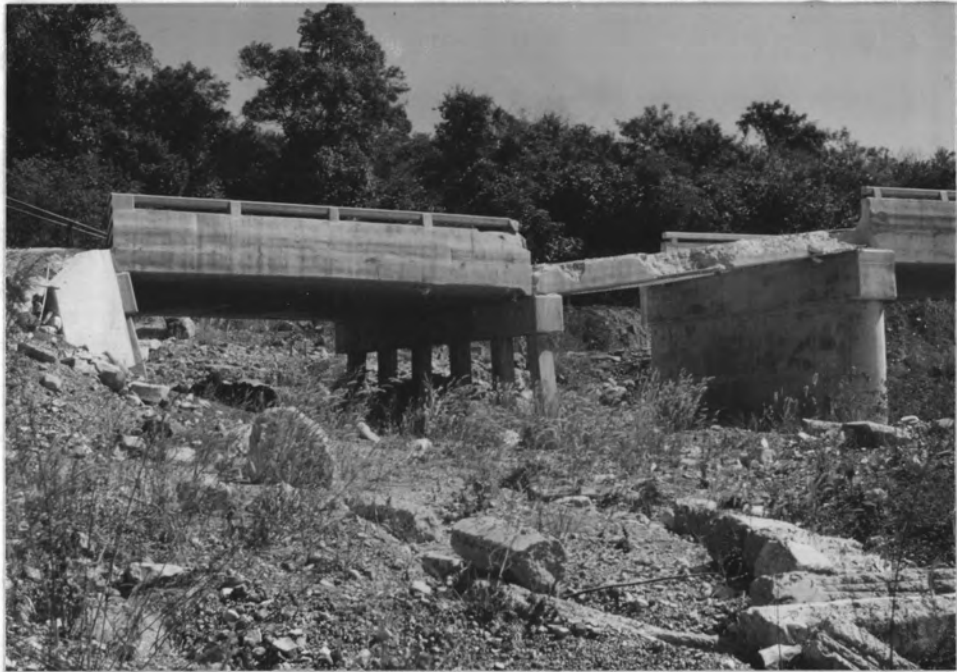
Figure 2.2(cont.) c) Damaged bridge between KM. 12.696
and KM. 12.714

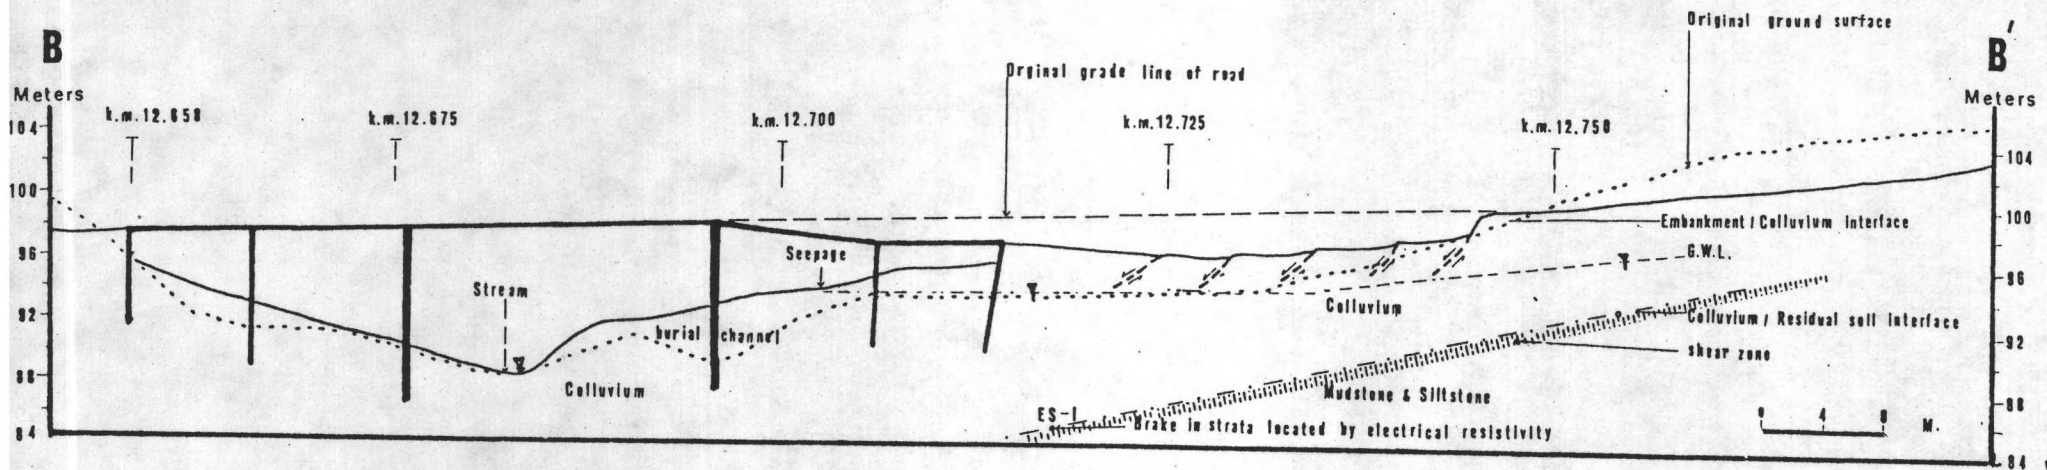
Figure 2.3 A cross-section parallel to the road centerline, showing the damage bridge and bridge approached abutment for failure in 1983.

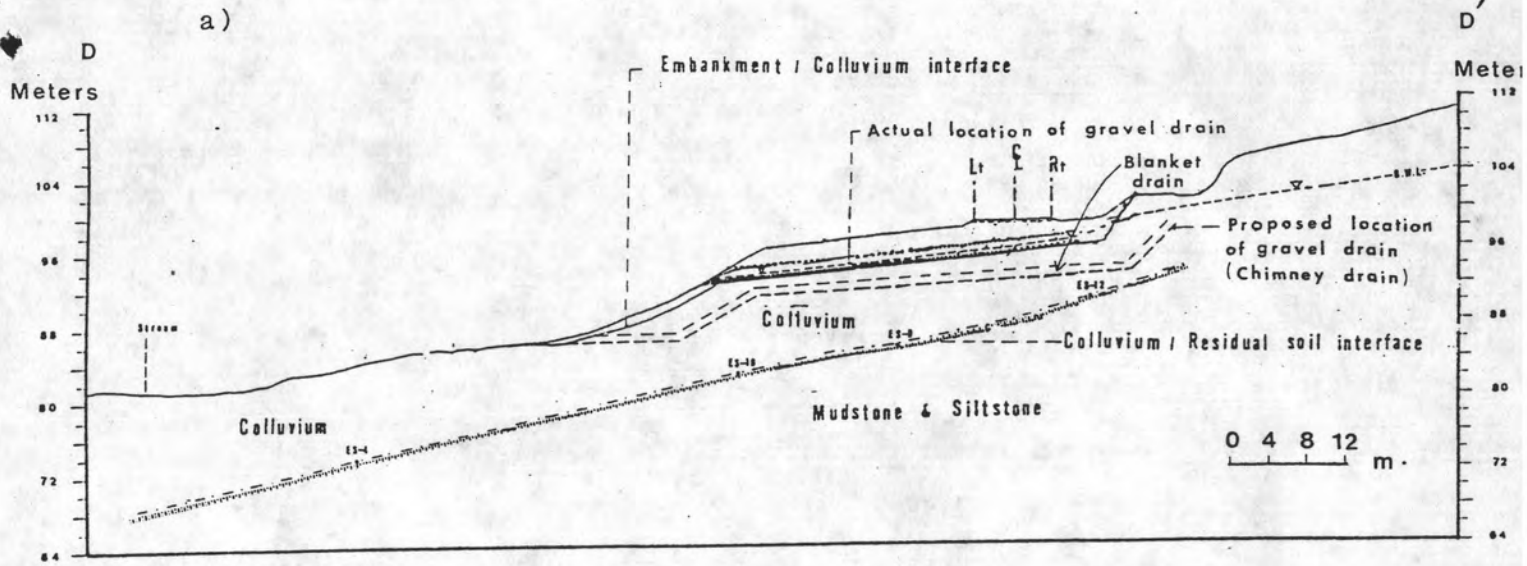
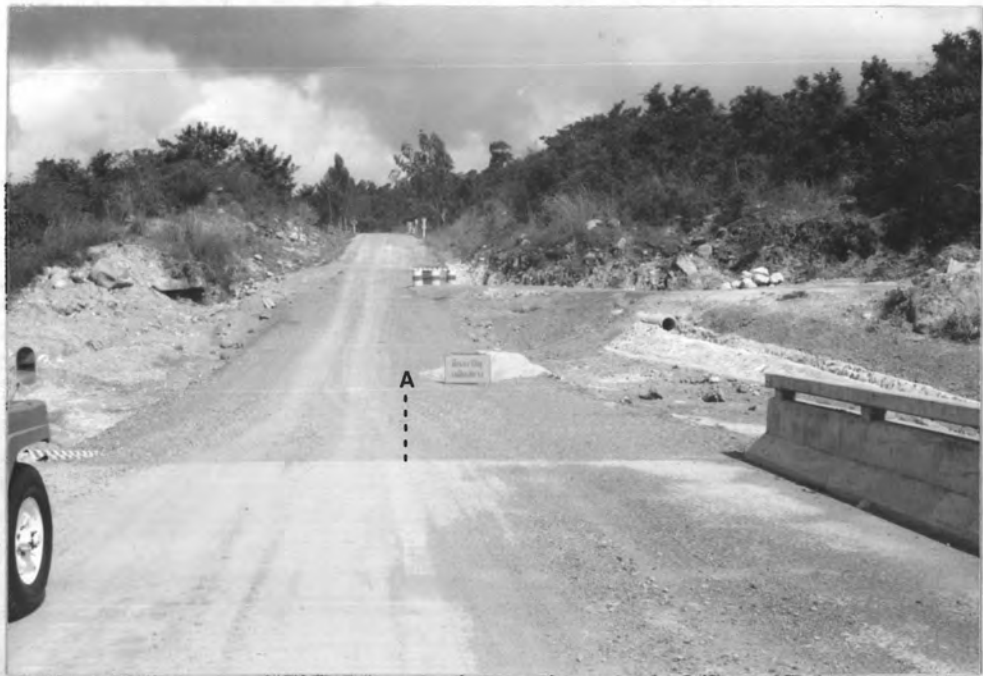
Figure 2.4 Remedial measure of second failure in 1983.

- a) The typical cross-section showing the proposed and actual location of gravel drain
- b) The finish second remedial construction in April, 1985. The photograph was taken looking up-hill toward Khao Yai National Park.

The remedial work done in the dry period of 1985 and completed in April 1985 was to remove the damaged approached abutment from KMs 12.714 to 12.750. A new embankment fill with 1.5m-thick of pervious materials to form an inclined "Chimney" drain and a nearly-horizontal drainage blanket to intercept and remove seepage through the embankment was recommended. The result from subsurface investigation revealed that this gravel drained layer was not installed at the location proposed in design (Figure 2.4 a,b). This construction cost was estimated to be 4,550,000 bahts.

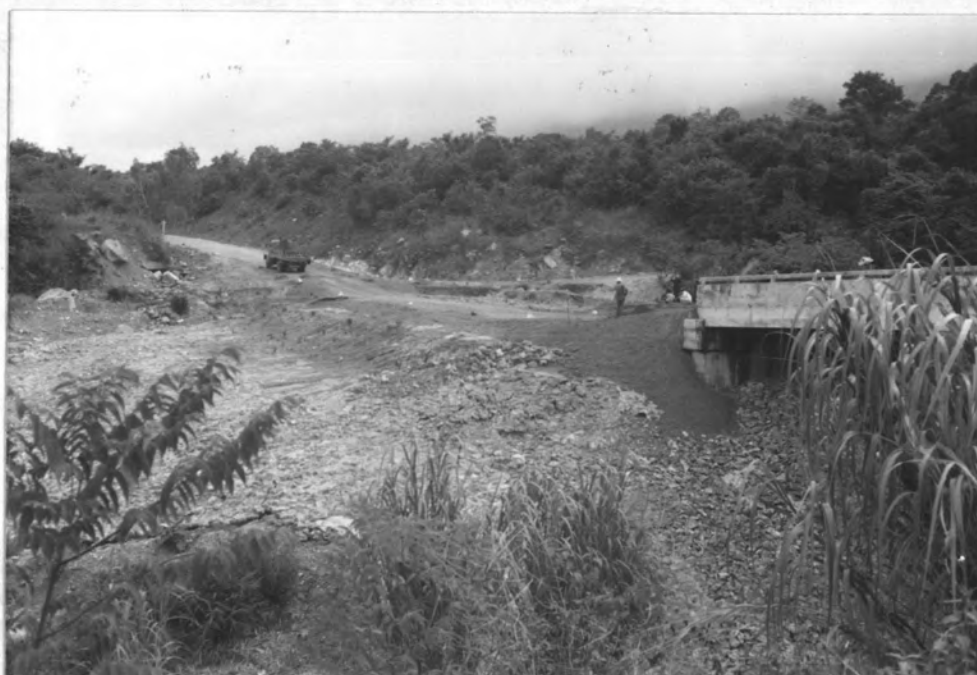
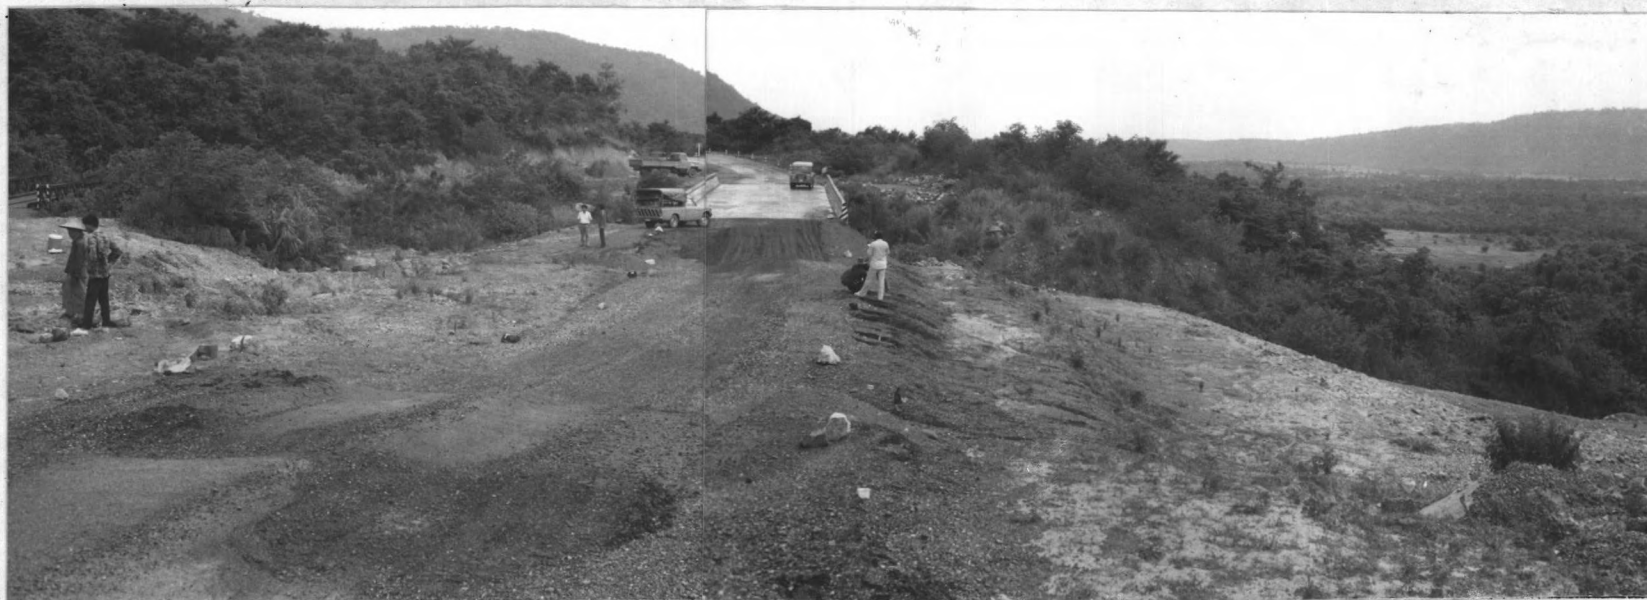
Again, the tension cracks were noticed in August-September, 1985 which was the month of heavy rainfall (Figure 2.5 a,b). In August 1986 which had the highest rainfall of 623 mm. a record of ten-years period, a bigger slide and larger deformation occurred on this embankment (Figure 2.6 a,b). The failure spread progressively up-slope from the initial movement location in 1985 (Figure 2.7).

Figure 2.5 Initial failure of embankment in August, 1985.

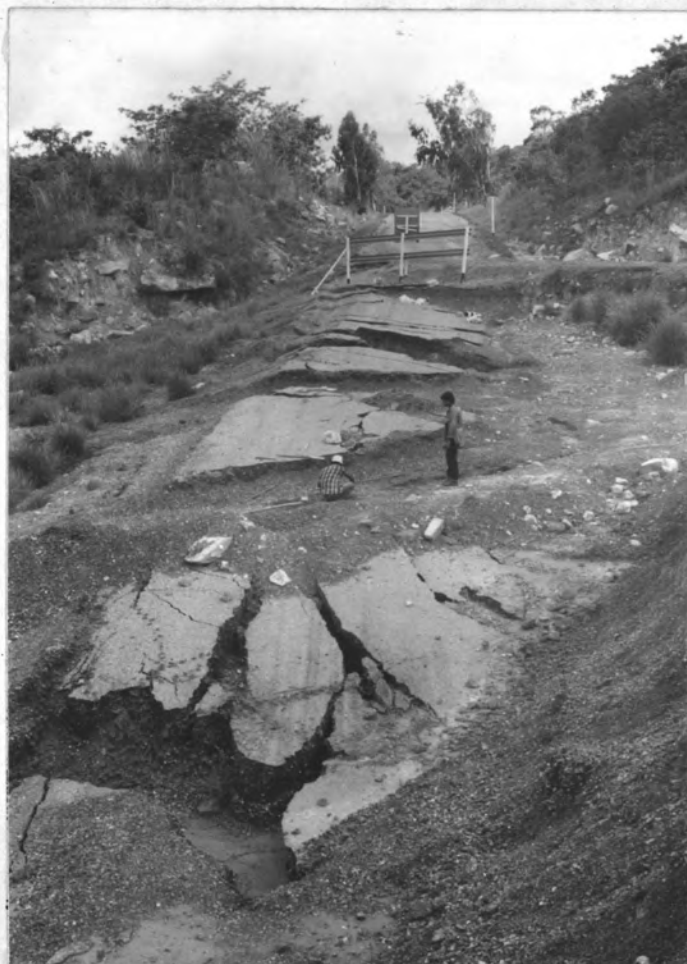
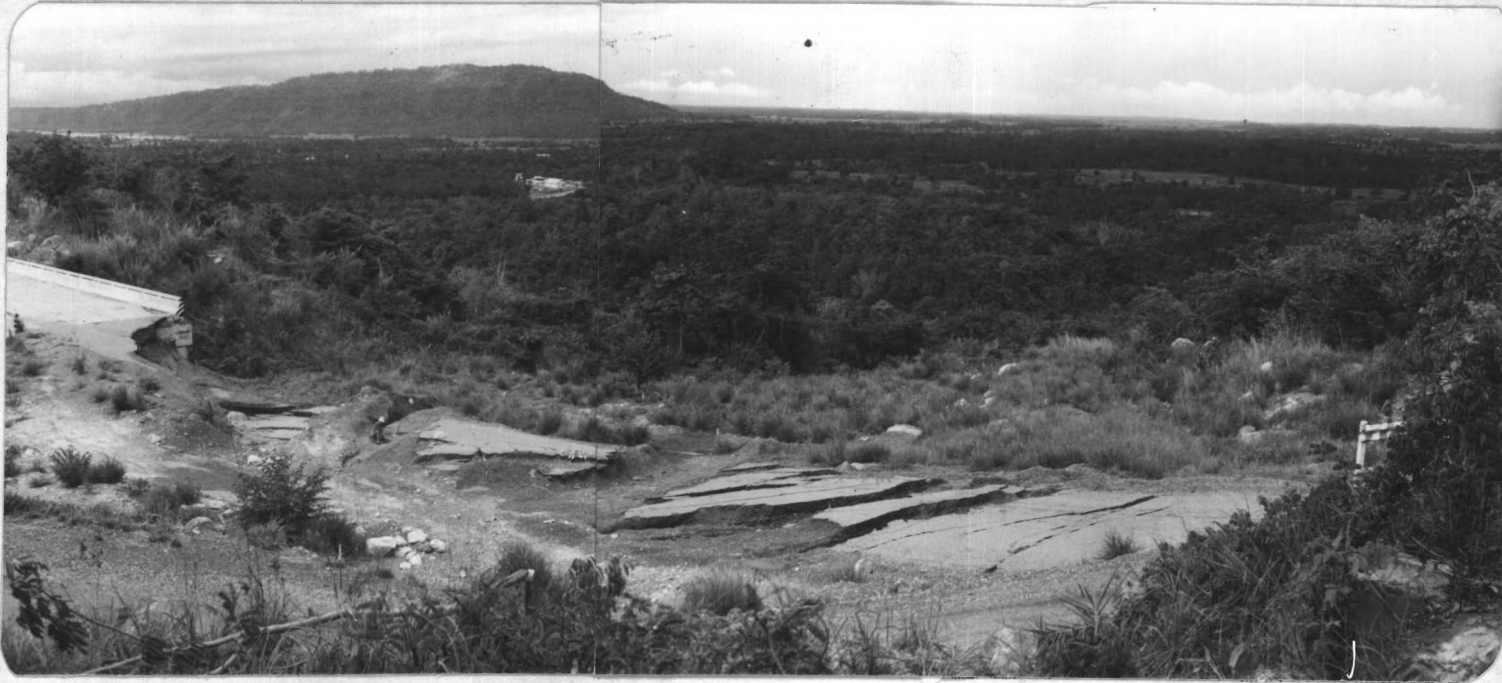
The slope failure was a debris slide with the translation movement. The colluvial mass moved along the colluvium and firm-bedrocks interface.

Figure 2.6 Failure of the embankment
in August, 1986.

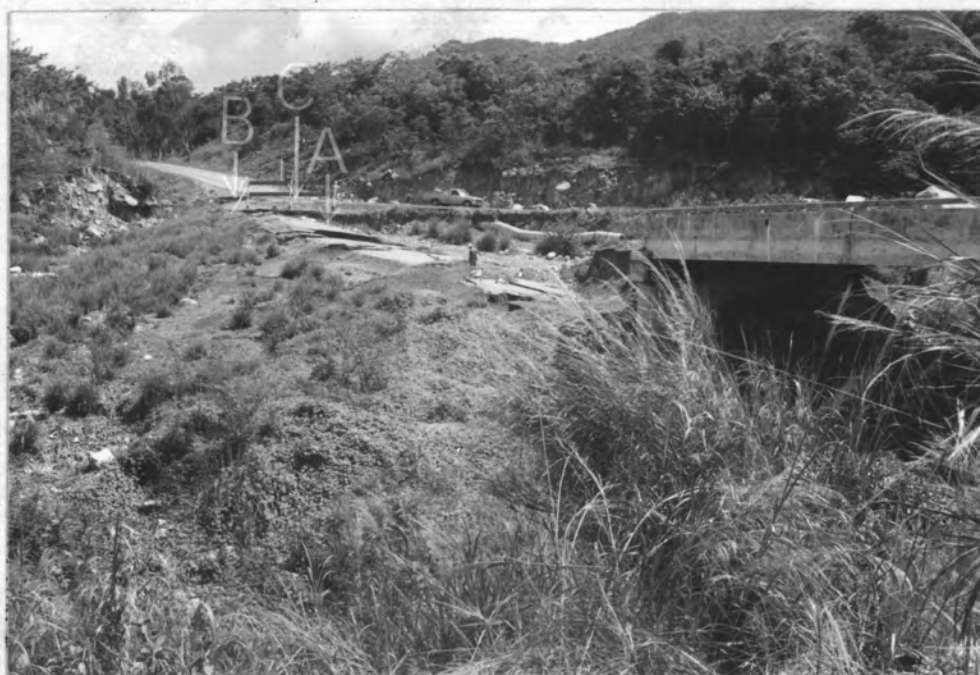
The major tension cracks of 1985/1986 failures formed a very clear concave upward scarp which cut the road centerline at KM. 12.753 and KM. 12.762 (Figures 2.7 and 2.8). The vertical displacement in 1985 was 0.50 meter while the larger amount of displacement occurred in 1986. The maximum horizontal displacement was measured to be about 1.6 meter, the vertical displacement 1.65 meter at the major scarp (Figure 2.9 a) and 2.8 meters at the contact of bridge approach abutment (Figure 2.9 b). Many tension cracks also developed both on the highway embankment and colluvial slope near the toe of this embankment (Figure 2.10 a, b). The evidence of fresh soil movement was observed both in the colluvial slope and along the stream course (Figure 2.11 a,b).

Figure 2.7 Major crack of failitre in 1985/1986.

A- major crack 1985, B- major crack 1986

C- KM. 12.762

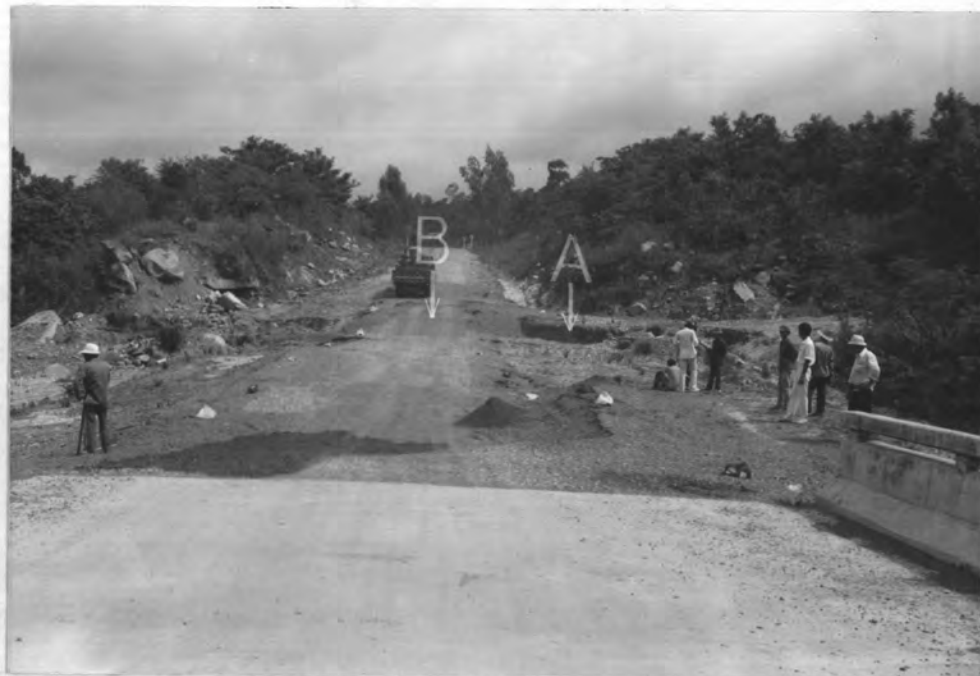
Figure 2.8 Major crack of failure in 1985.

A- major crack 1985 B- KM. 12.753

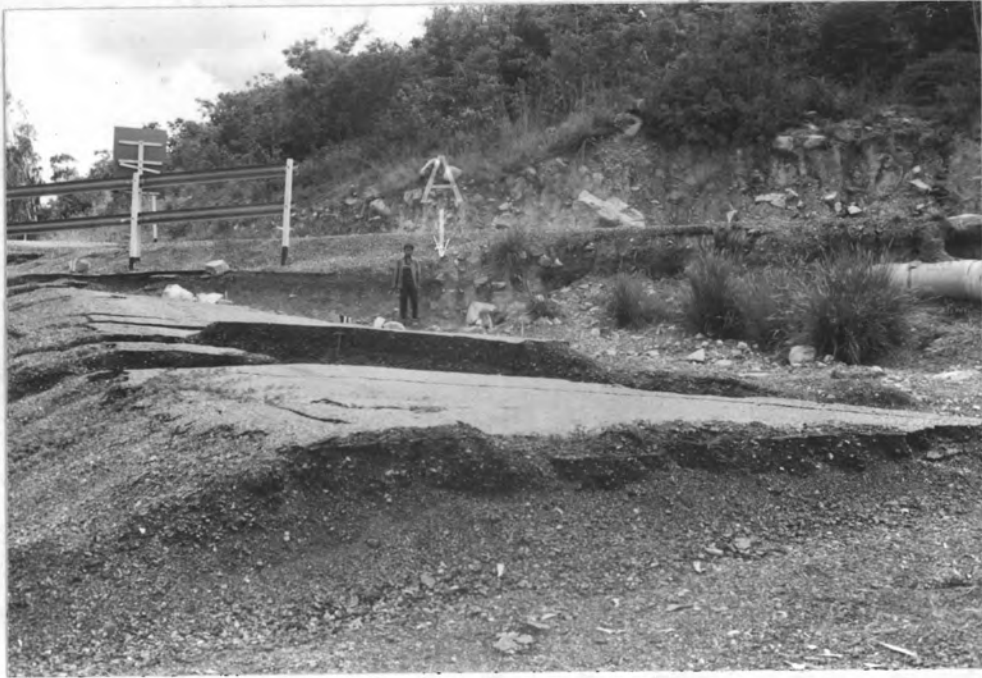
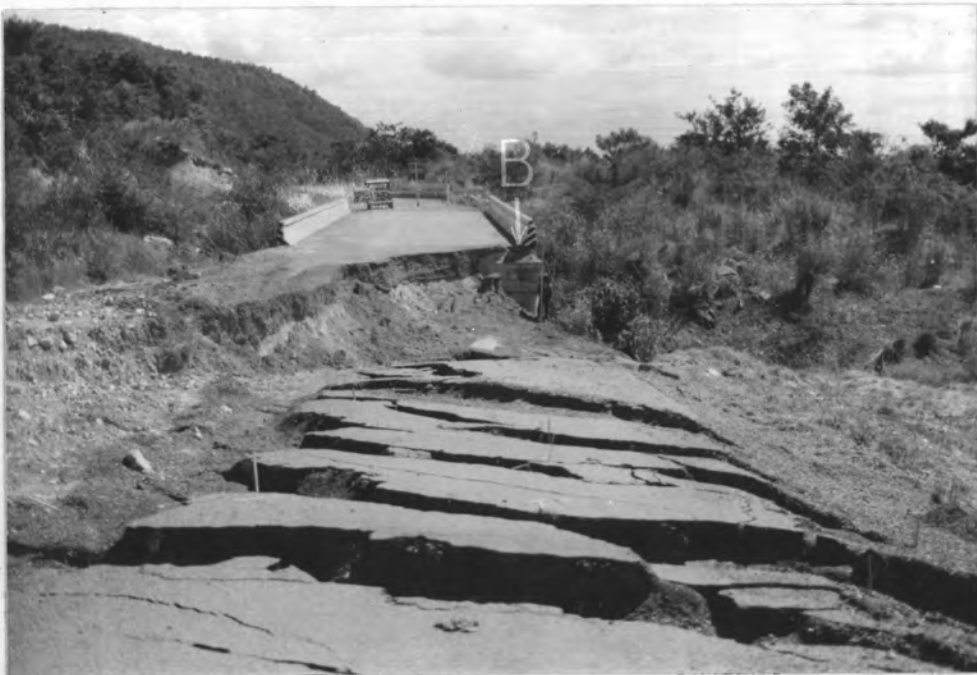
Figure 2.9 Vertical displacement at the major scarp, in 1986.

a) about 1.65 meter at A

b) about 2.80 meters at B

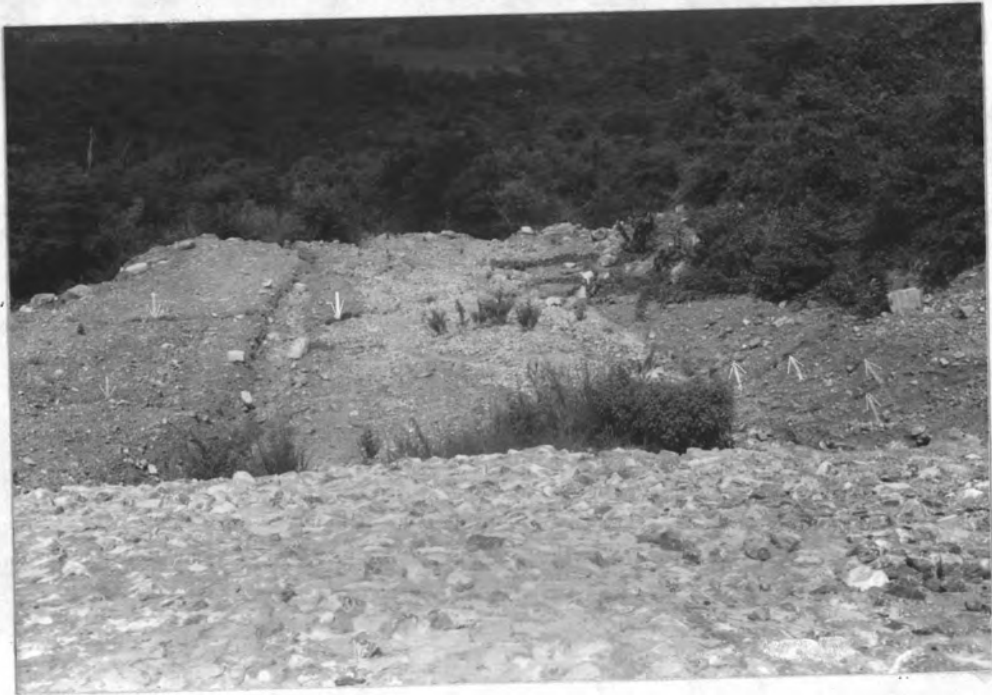
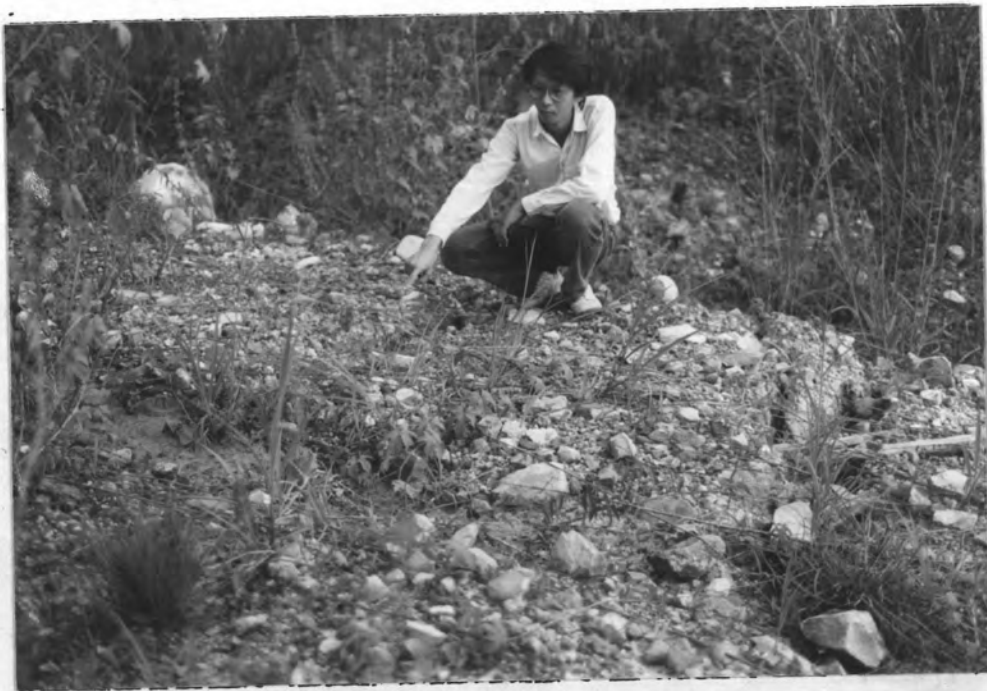
Figure 2.10 Tension cracks in the colluvial slope near the toe of the embankment slope

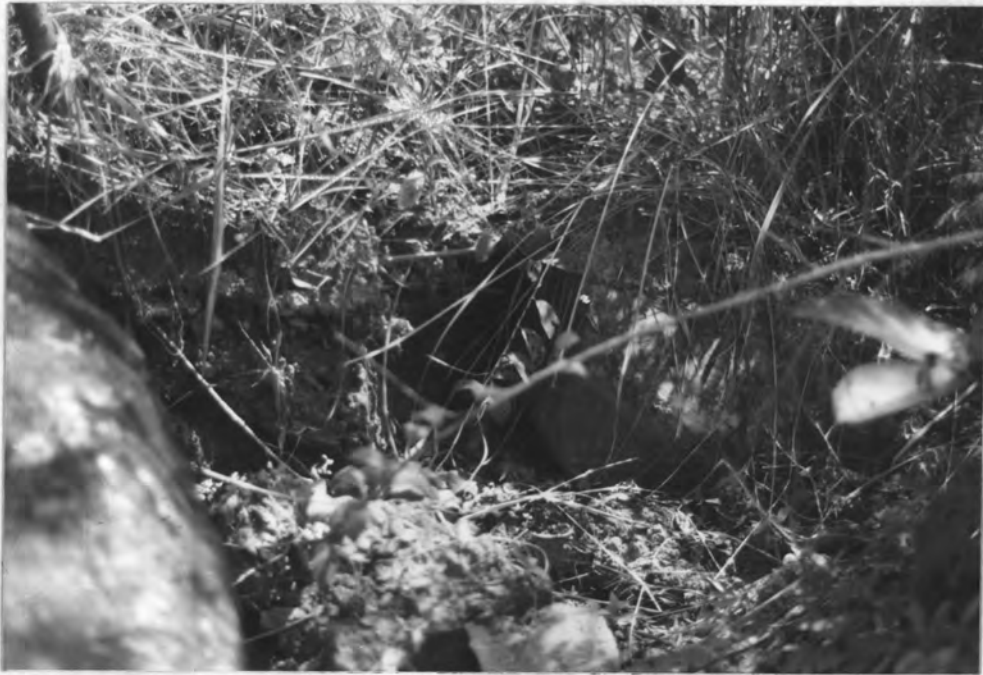
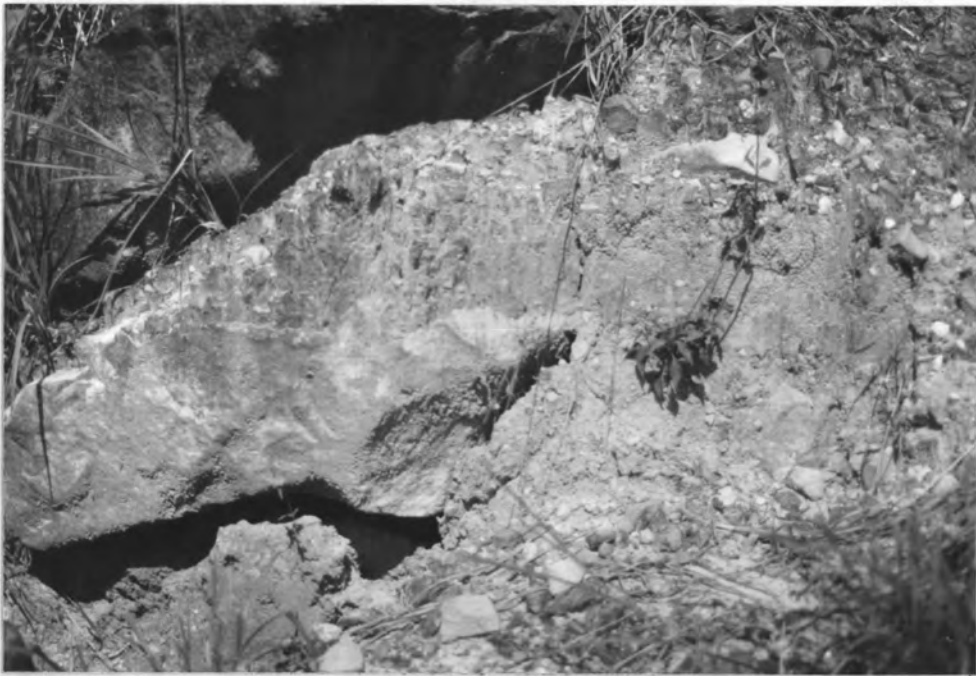
Figure 2.11 The fresh soil movement in the colluvial slope.

a) At station KM.12.743 offset road
centerline 61 meters Lt.

b) At station KM.12.724 offset road
centerline 73 meters Lt.

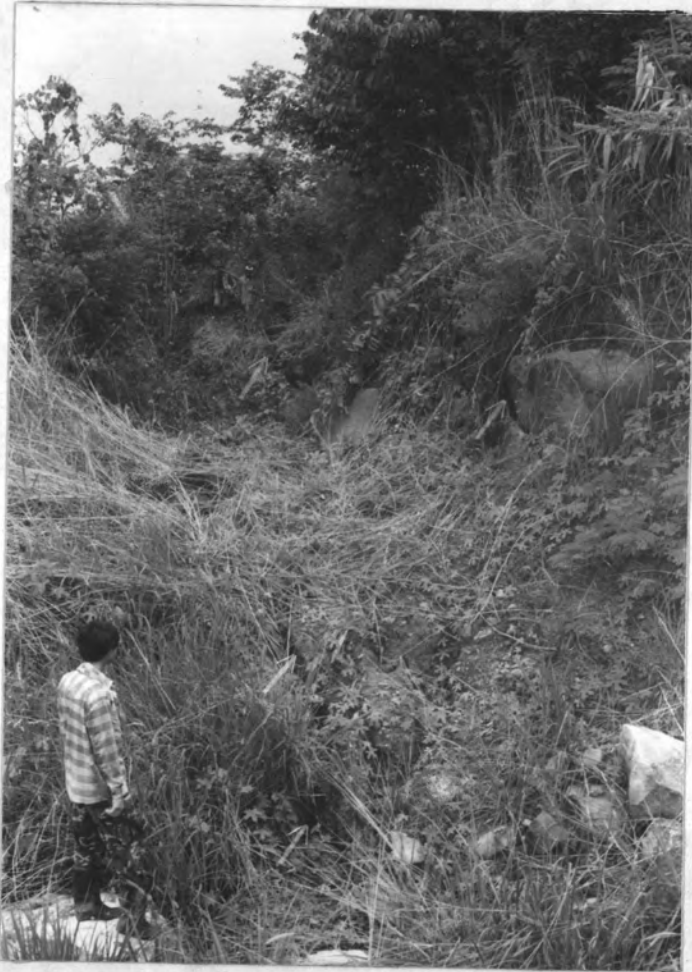
The evidence of fresh mass movement and the extension of major cracks upslope indicate that this slope has a progressive failure or active landslide (Figures 2.12, 2.13).

Figure 2.12 Fresh soil movement
(at the arrow point)
at the natural landslide
scarp.

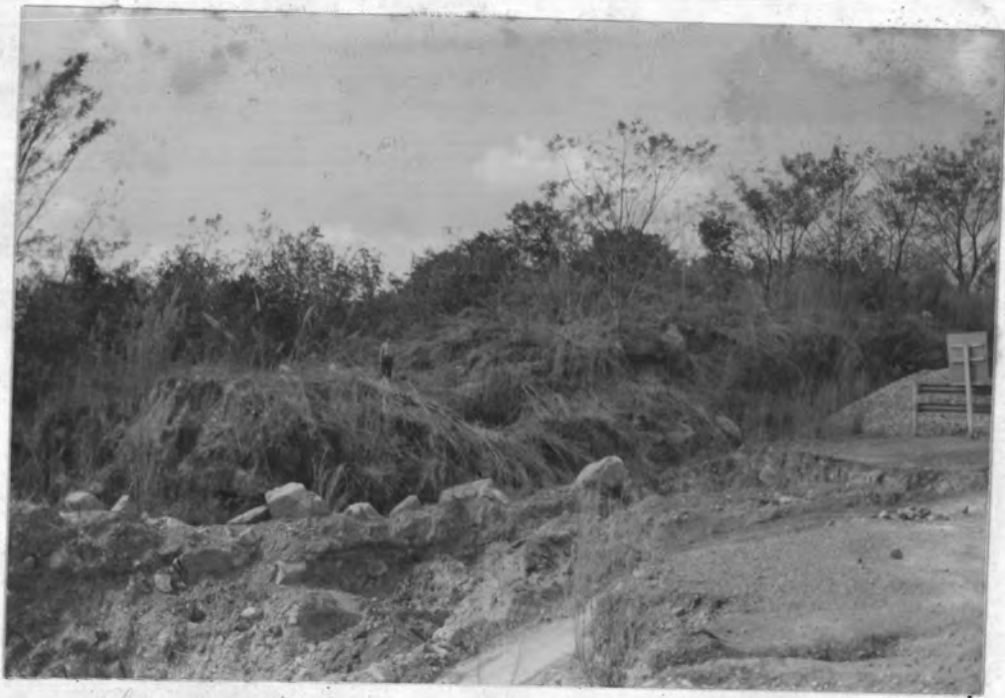
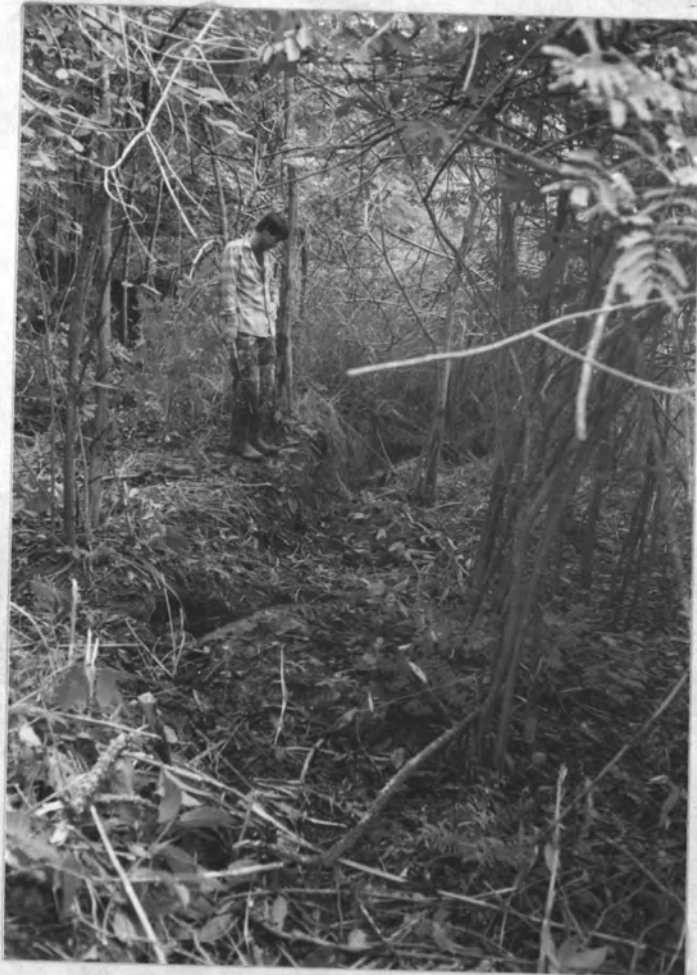
Figure 2.13 Progressive of tension cracks upslope.
