CHAPTER 6

EVIDENCES OF DEBRIS FLOW-FLOOD ACTIVITIES IN THE ALLUVIAL FAN

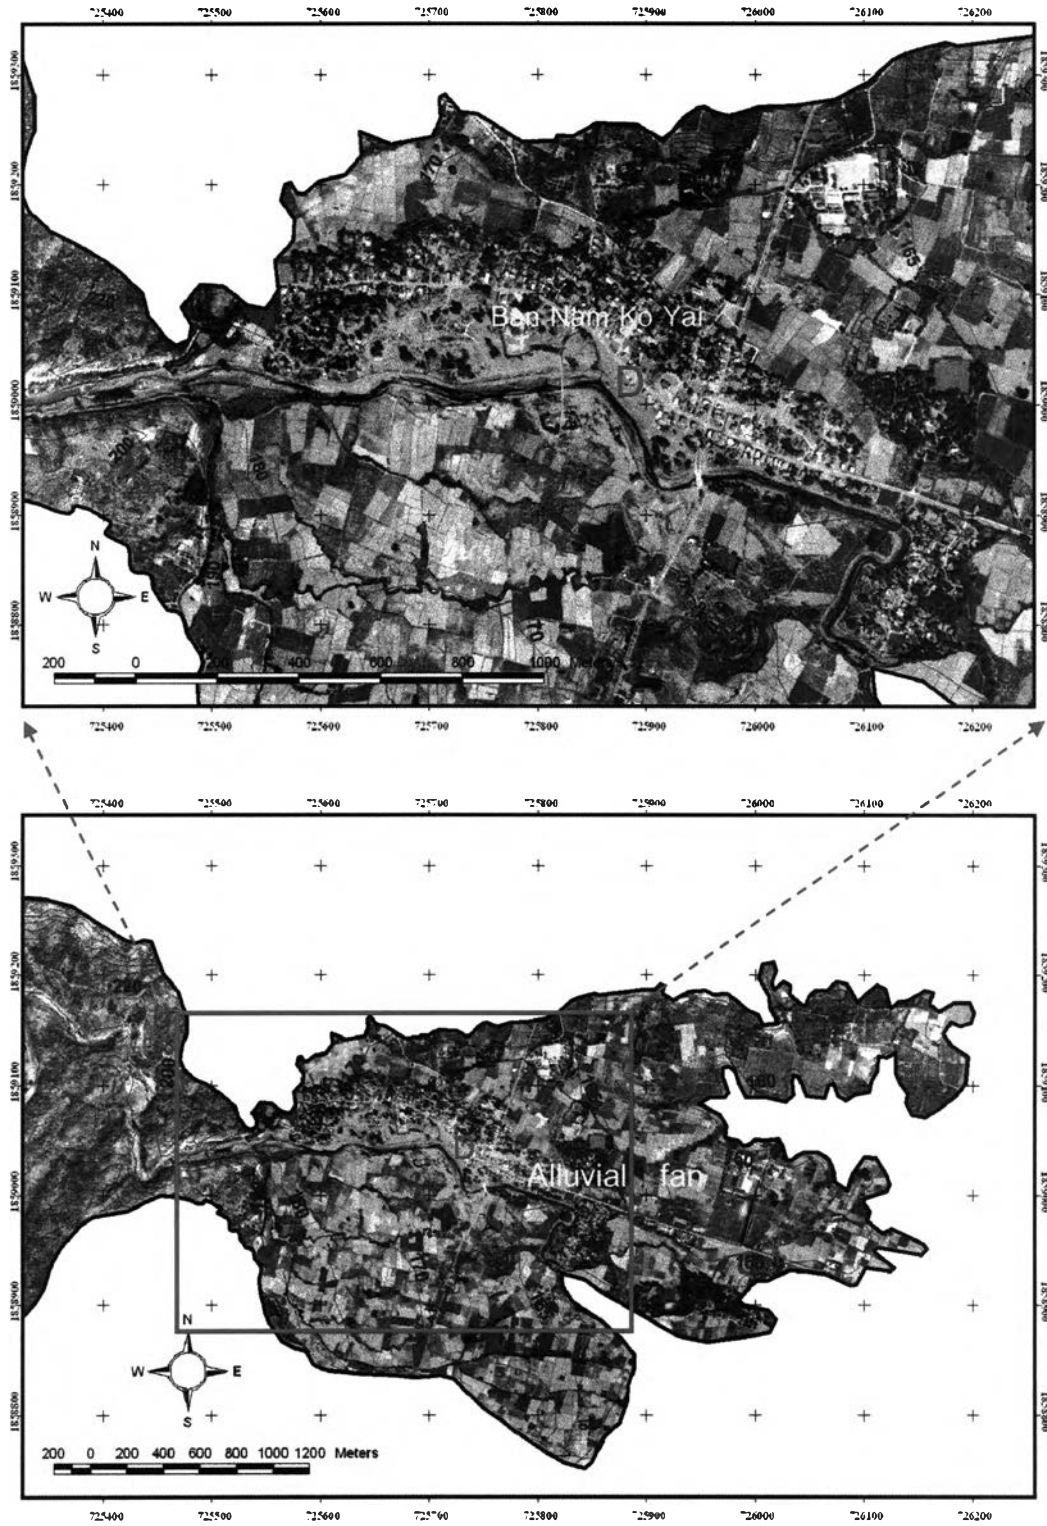
The expanded features of orthophotographs (1:25,000 scale) acquired on 9 January 2002 in Figures 6-4 and 6-5 clearly show the current traces and tracks of debris flood evidenced from the distinctively active alluvial fan deposits. The deposits mainly occurred on the northern bank of the alluvial fan area where the flood severely damaged houses and orchards once existing there as seen in the 1974 aerial photographs and 1996 orthophotographs (Figures 6-2 and 6-3).

Figure 6-3 Orthophotograph (1:25,000 scale) acquired on 9th January 2002 (after the 8/11 flow-flood occurrence) showing the distinctive active alluvial fan deposit. The main area on the northern bank of Nam Ko Yai stream with populated settlement of Ban Nam Ko Yai (brown color zone surrounding the D location) was strongly damaged.

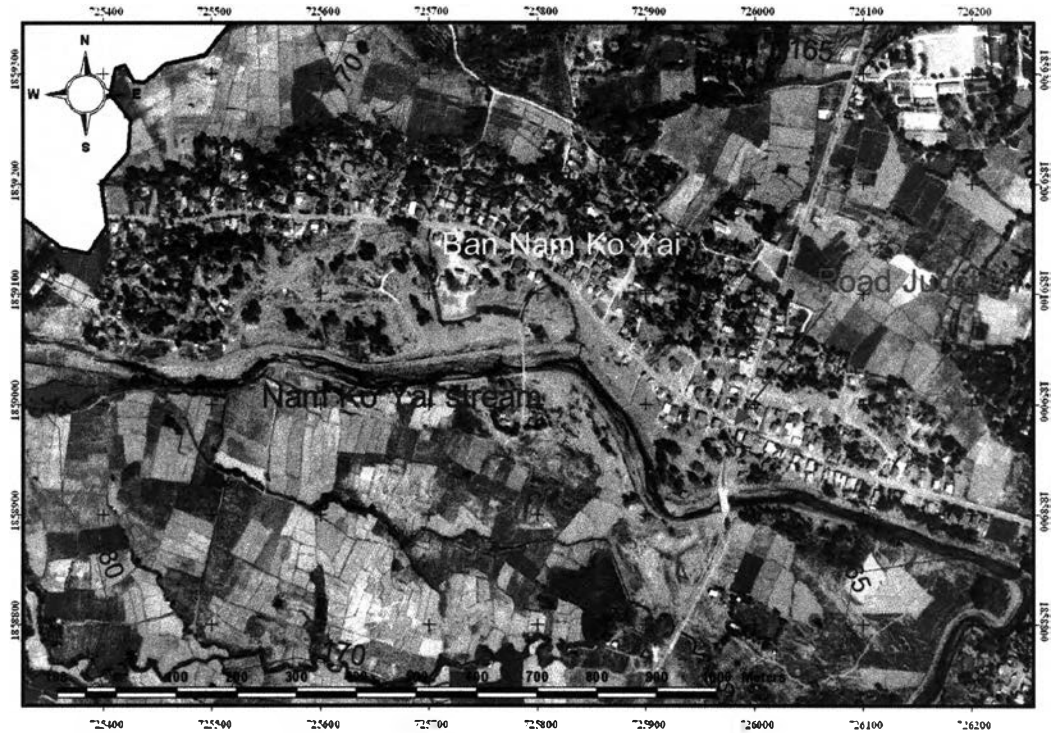
changes between 1974 and 1996. A clear activeness of erosion and deposition was presumed to be caused by the 8/11 flow-flood event (Figure 6-4).

Figure 6-4 Expanded features of orthophotograph (1:25,000 scale) acquired on 9th January 2002 (after the 8/11 flow-flood occurrence) showing the clear traces and tracks of flow-flood from the evidences of the distinctively active alluvial fan deposit (in brown color area) that mainly covered and severely damaged houses and orchards in the northern bank of Nam Ko Yai stream. (Note: the road-junction location in this figure will be used to refer to the same location in Figure 6-5)

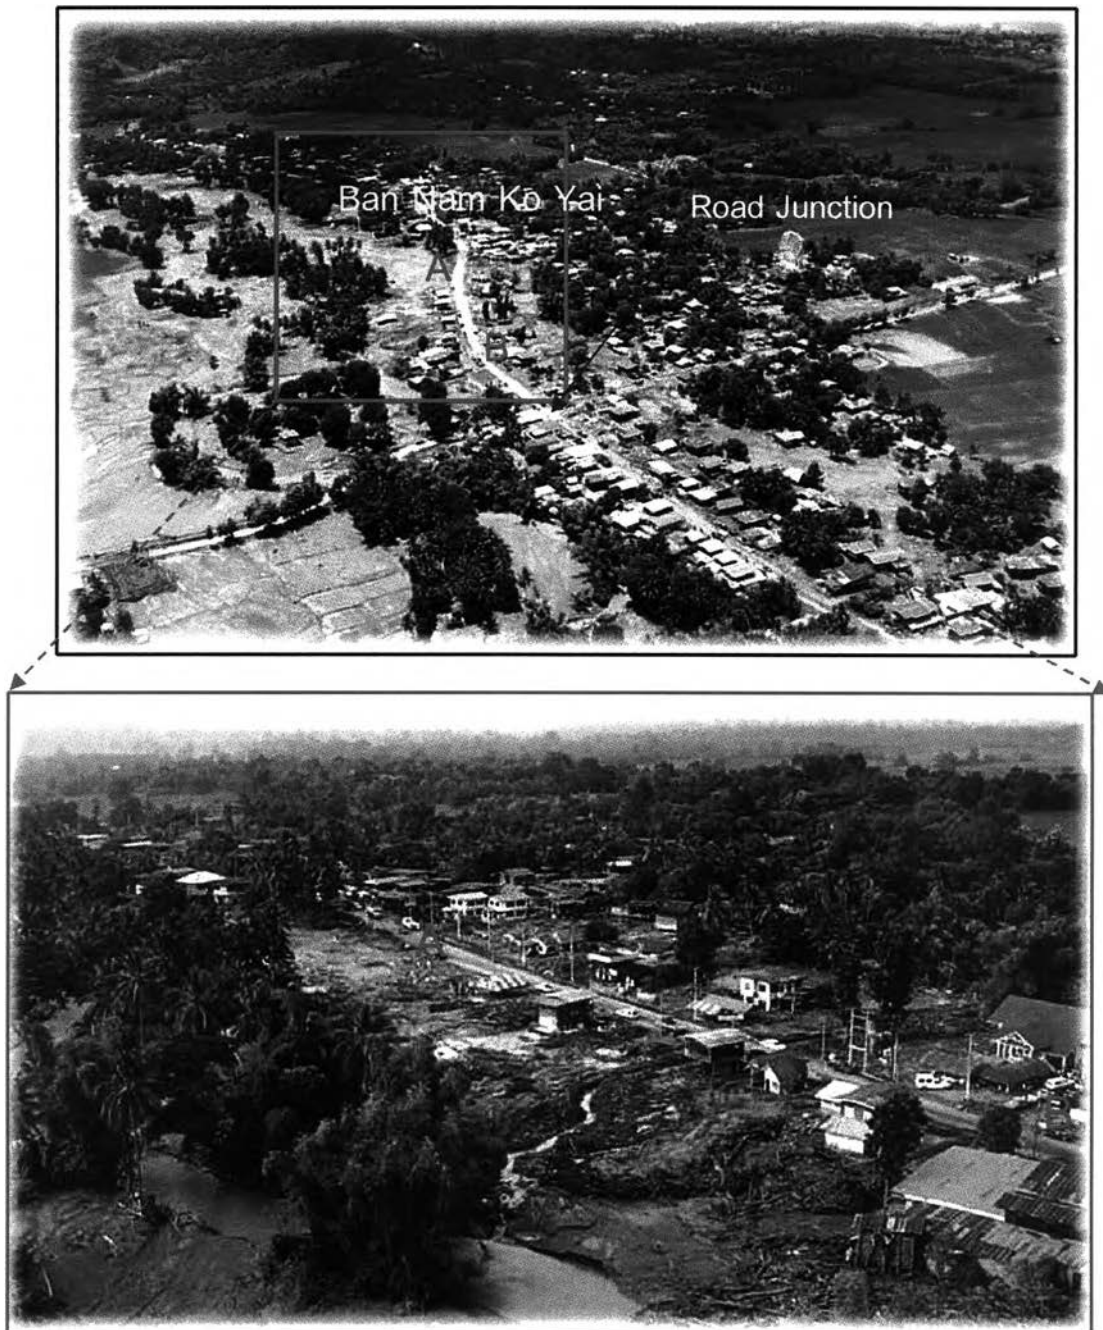
Oblique aerial photographs taken after the flood were also the important information sources to characterize the extent of the deposit and validate the analyzed result. The oblique aerial photographs (Figure 6-5) of the severely damaged houses and orchards of Ban Nam Ko Yai perceivably illustrate characteristics and extent of a large volume of the active alluvial fan deposits by the 8/11 flow-flood occurrence. It was noted that the alluvial fan deposit mass on the roads (as seen in Figure 6-5) had been already removed while the debris were still left as in the original manner in the surrounding area. Besides, the fast-moving flow-flood battled and caused damage to houses and other infrastructures during the course of the 8/11 event had also been illustrated as some examples in Figure 6-6.

According to the oblique aerial photographs of the severely damaged settlement area (Figure 6-5), they illustrate characteristics and extent of a large volume of an active alluvial fan deposit. The ground visit was also conducted to investigate and record the flow-flood levels in this area. The flood levels were established from the mud traces on house walls and trees. It was found that the highest level of the flow-flood, 190-200 cm above ground surface, was located in the most severely damaged zone at locations A and B (Figure 6-8). It was also noted that these were the two locations facing the straight course of Nam Ko Yai stream before the channel changed its direction abruptly southerly further downstream. Here, the flood jumped over-bank to destroy houses and orchards and claim lives.

Figure 6-5 Two oblique aerial photographs perceptibly illustrating the characteristics and extension of a large volume of deposited sediments as evidences of 8/11 incidence.

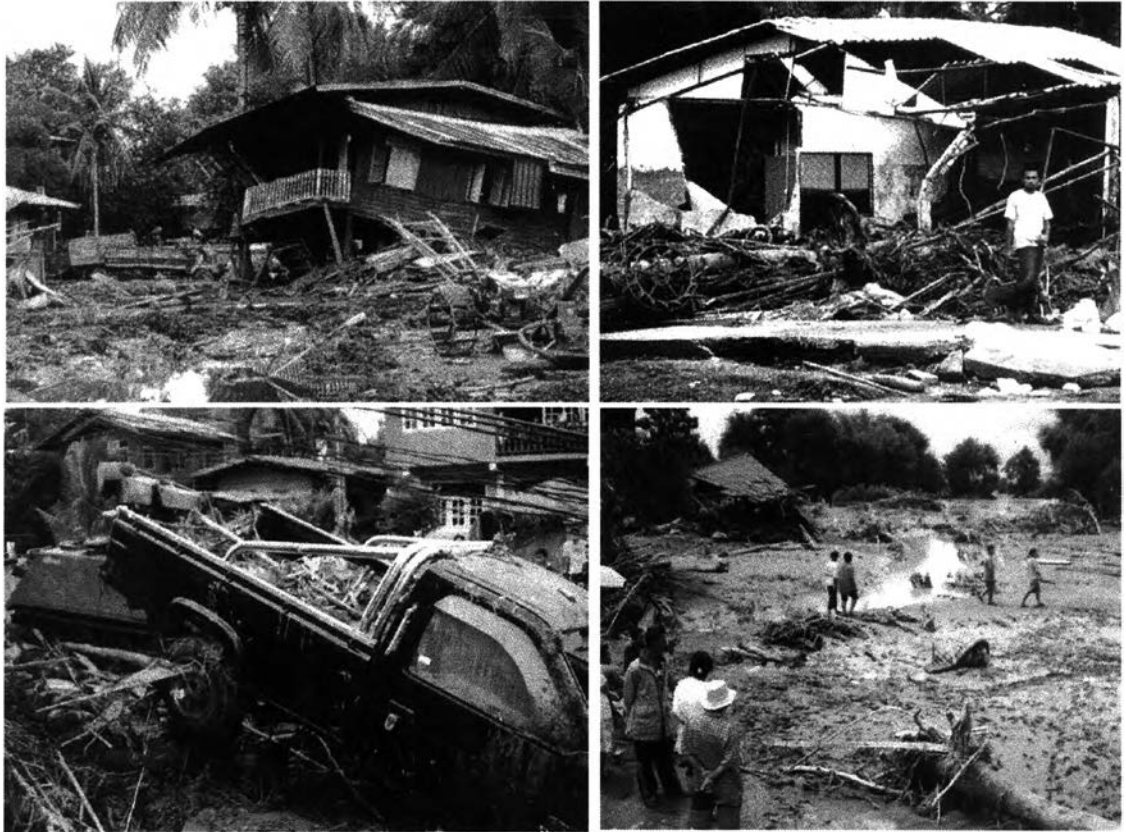
Figure 6-6 Four photographs showing some examples of seriously structural damage of houses and other infrastructures in Ban Nam Ko Yai (in the area between A and B in Figure 6-5) battered and caused by the fast-moving 8/11 flow-flood.

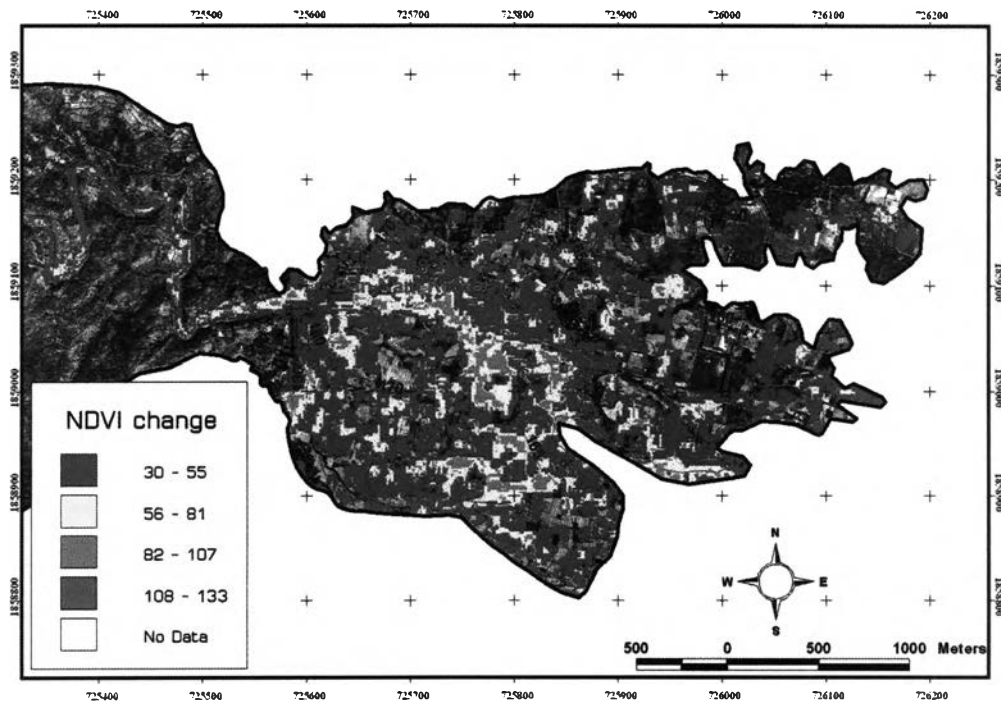
In the multi-spectral Landsat 7 ETM+ imageries analysis, evidence of the alluvial fan deposit from the 8/11 event were analyzed using NDVI value. NDVI value was also used to detect the depositional locations on the alluvial fan (Figure 6-7). Oblique aerial photographs (in Figure 6-5) of the depositional location in alluvial fan area taken after the event were used to characterize the extent of the deposit and validate analyzed result of NDVI value. It is remarked that the high value of NDVI change (56-107) in Figure 6-7 generally conformed the areas of the most serious damage in Figure 6-5. that covered an area of about 3.49 square kilometers from the total area of about 6.29 square kilometers of the alluvial fan. It is noted that the depositional locations from the 8/11 event cover more than 55 % of the total area of the alluvial fan.

Figure 6-7 Detection change of NDVI value in the depositional location of the alluvial fan (expanded from Figure 3-21) overlain on the orthophotograph (1:25,000 scale) acquired on 9th January 2002 (as shown in Figure 6-3).

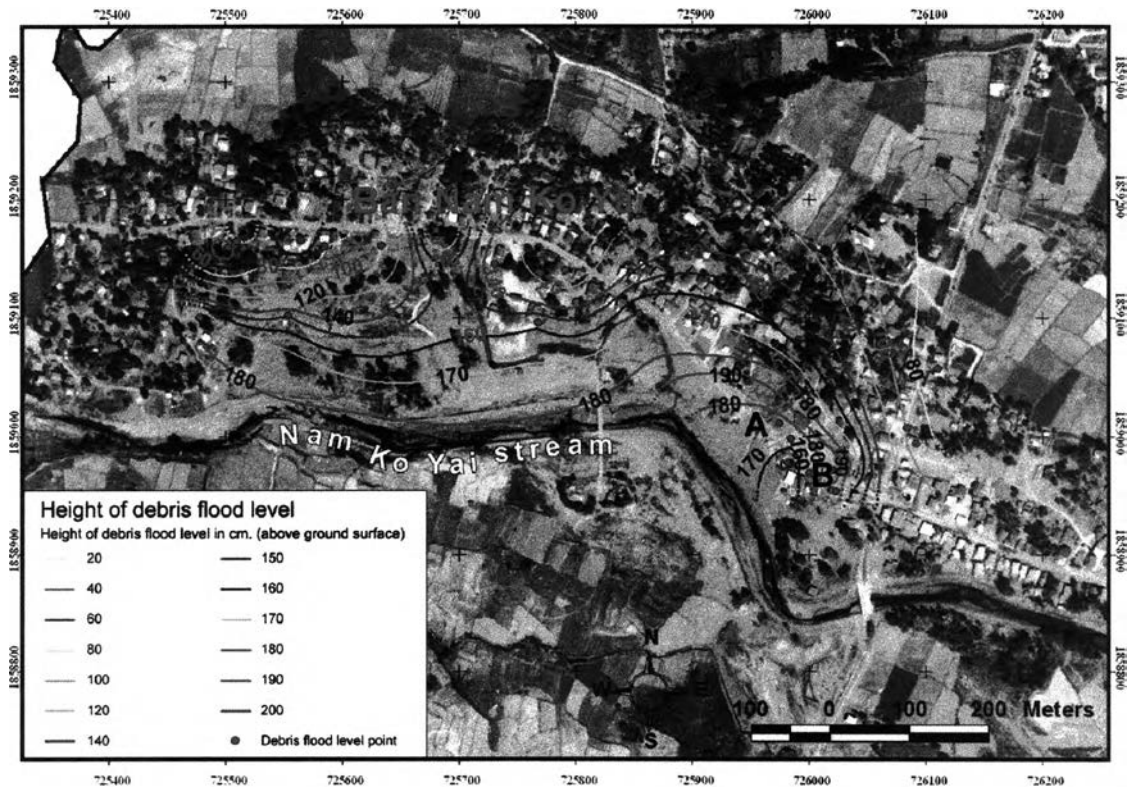
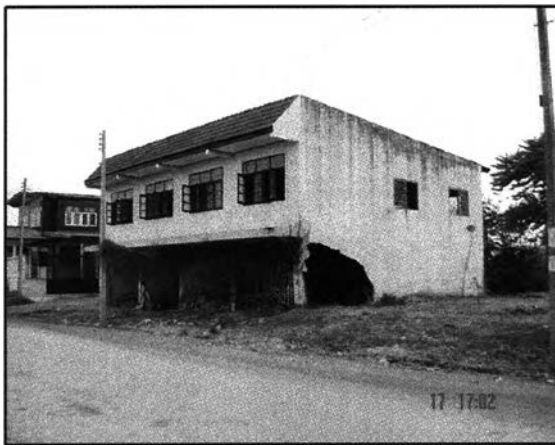
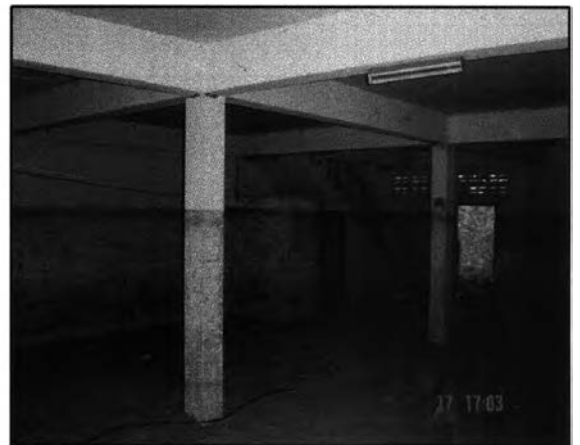
Figure 6-8 Height map of the flow-flood levels detected from the mud traces on the trees and house walls (as illustrating in the attached photographs below the map) in the severely damaged area of Ban Nam Ko Yai after the fast-moving 8/11 flow-flood

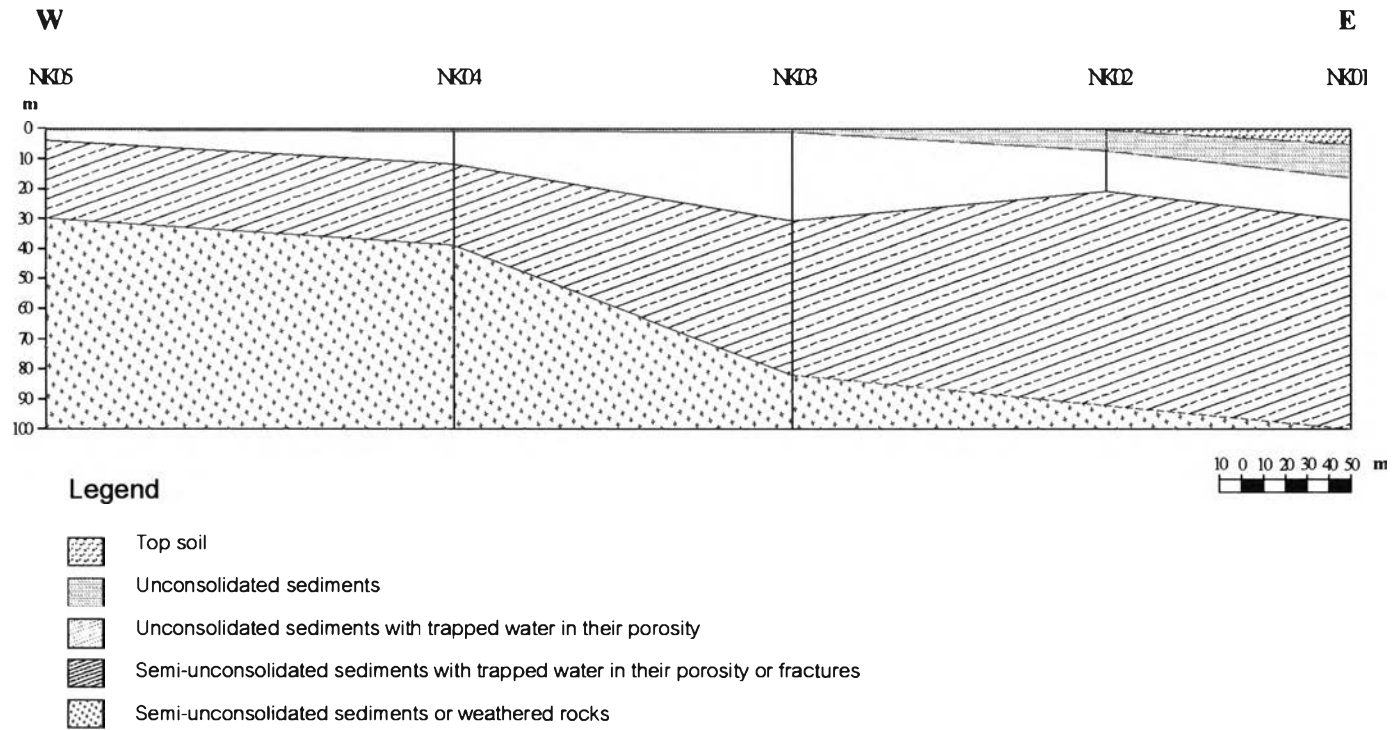
According to the resistivity survey in the alluvial fan along the lines NK 01 – NK 05 (as shown in Figure 6-9) to identify the local subsurface geology (thickness and depth of the previous alluvial fan deposits), the results revealed four sedimentary units at a total depth of less than 100 m below ground surface (Figure 6-10). The lowest unit was semi-unconsolidated sediments or weathered rocks of at least 70 m thick to the west with the bed top be noted at a depth of about 30 m below ground surface, and much thinner, less than 10 m to the east, with the bed top be noted at the depth of about 80 m below ground surface.

The overlying second unit was semi-unconsolidated sediments with trapped water in the bed openings. Thickness was 25-70 m and increased to the east. Its shallow horizon was 5 m below ground surface in the west to about 10-20 m to the west. These two lower units are never exposed near the site, but are at surface in the surrounding hills.

The third unit was unconsolidated sediments with trapped water. Thickness was in the range of 5-30 m. The thickest part of this third unit was near the NK 03 line in the central part, where the depth to the top of the unit was from a few meters down to 15 m below ground surface further to the east. The fourth and uppermost unit was of unconsolidated sediments with a thickness of a few meters in the west to 10 m in the east. The fourth unit was commonly exposed on the ground surface along all survey lines, except in the east where it was completely covered by recent topsoils.

Figure 6-10 Cross-section of the resistivity survey interpreted from the five survey points (NK 01 – NK 05 as shown in Figure 5-9) that revealed four sedimentary units lying less than 100 m below ground surface.

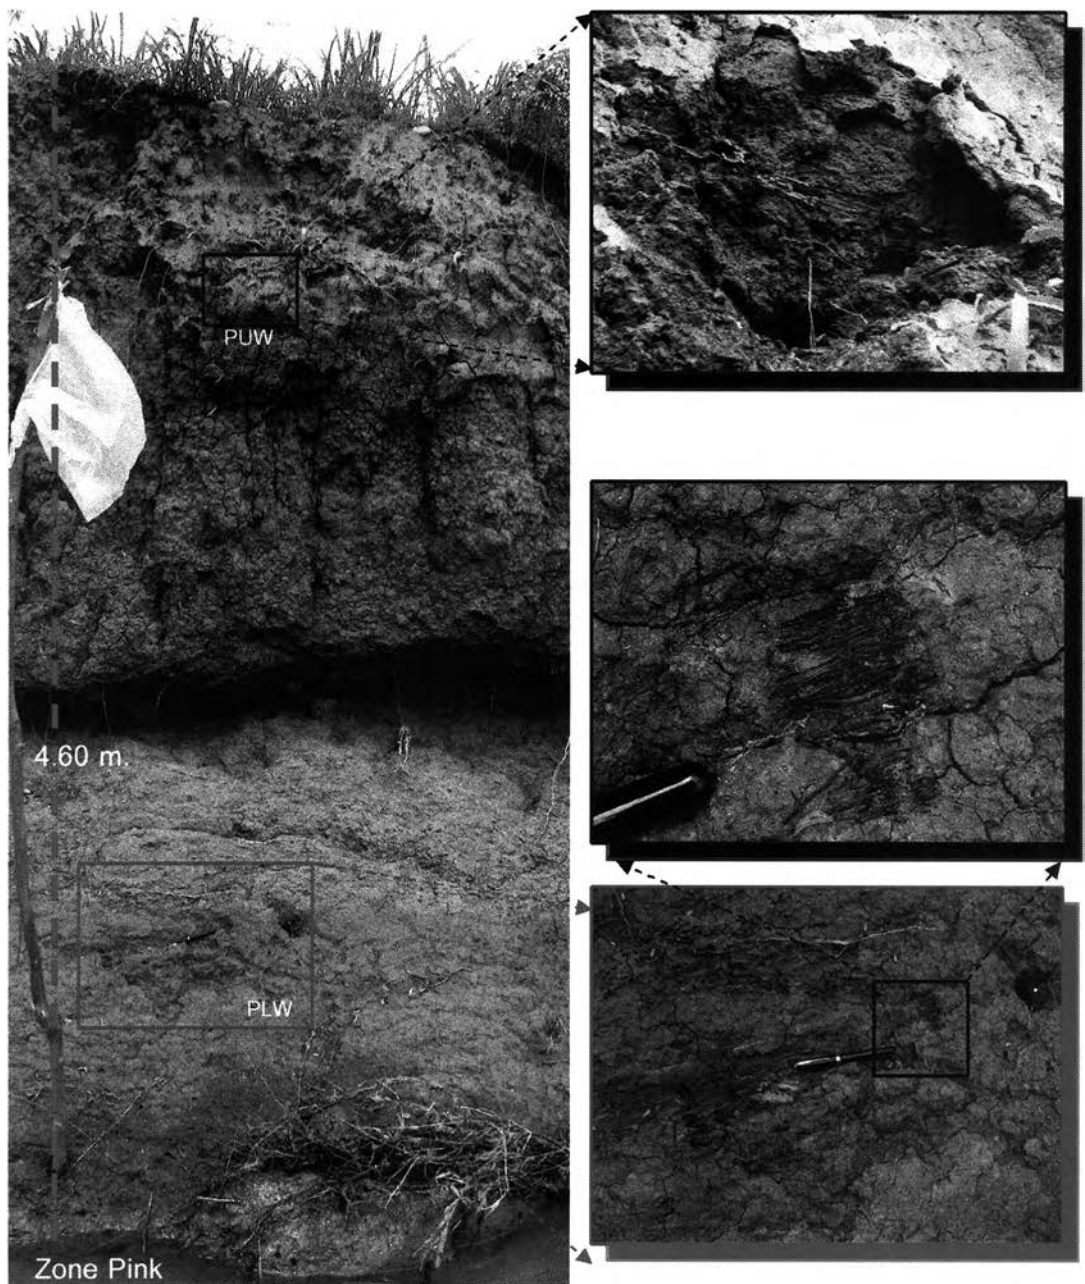
Significant evidences of the previous flows-floods found in the uppermost fine-grained fluvial and debris flood unit were two preserved wooden debris fragments, one at the lower part (location PLW) and the other at the upper part (location PUW) of the Pink section (Figures 6-16 and 6-17). It is noted that the PLW sample of the lower location was charcoal characteristic with fibrous texture whereas the sample of the upper location (PUW) was the pale brown wood with rather complete wooden texture (as shown in Figure 6-17). These preserved wooden debris were dated by radiocarbon dating method to have absolute ages of deposition between 2,618 \pm 35 before present and post-1950, respectively.

From these radioactive dating results, it is strongly confirmed that this is an active alluvial fan and the debris flow-flood processes had occurred at least twice before the recent 8/11 disastrous event.

Figure 6-16 Photographs illustrating the general characteristics in the uppermost fine-grained fluvial and debris flood unit at the zone Pink (referred to Figures 6-9 and 6-11) and the preserved large wood debris at the lower part (PLW) and at the upper part (PUW) locations.

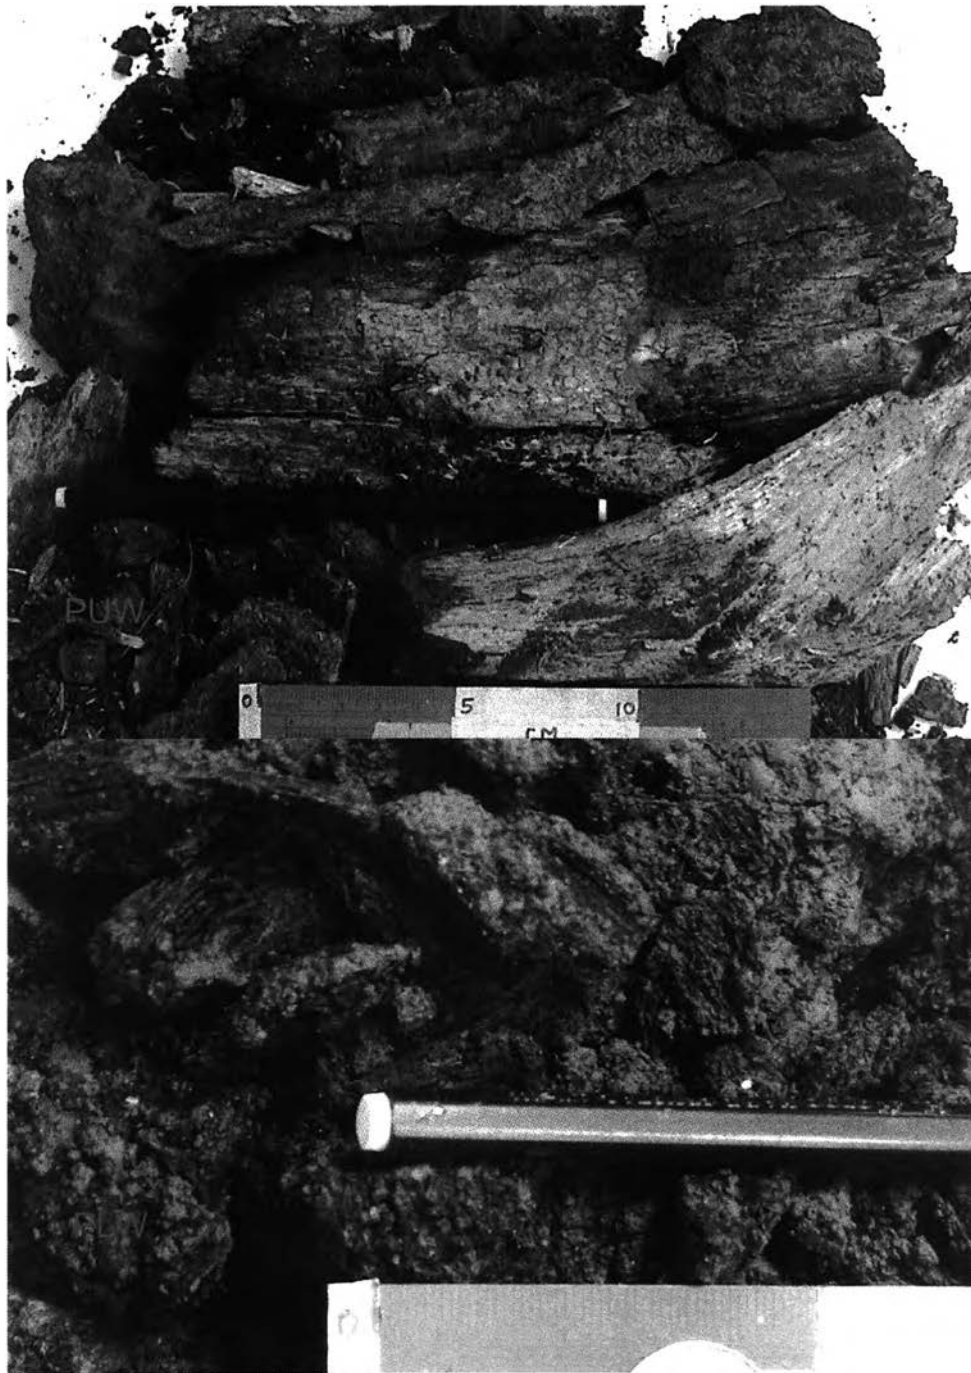
Figure 6-17 Closed-up photographs of the collected wood debris samples from the preserved locations at PLW and PUW (as shown in Figure 6-16) illustrating their general characteristics of charcoal characteristic with fibrous texture and pale brown wood with rather complete wooden texture, respectively.
