## CHAPTER IV

### SOLUTION AND IMPLEMENTATION

#### 4.1 Recommended Corrective Actions

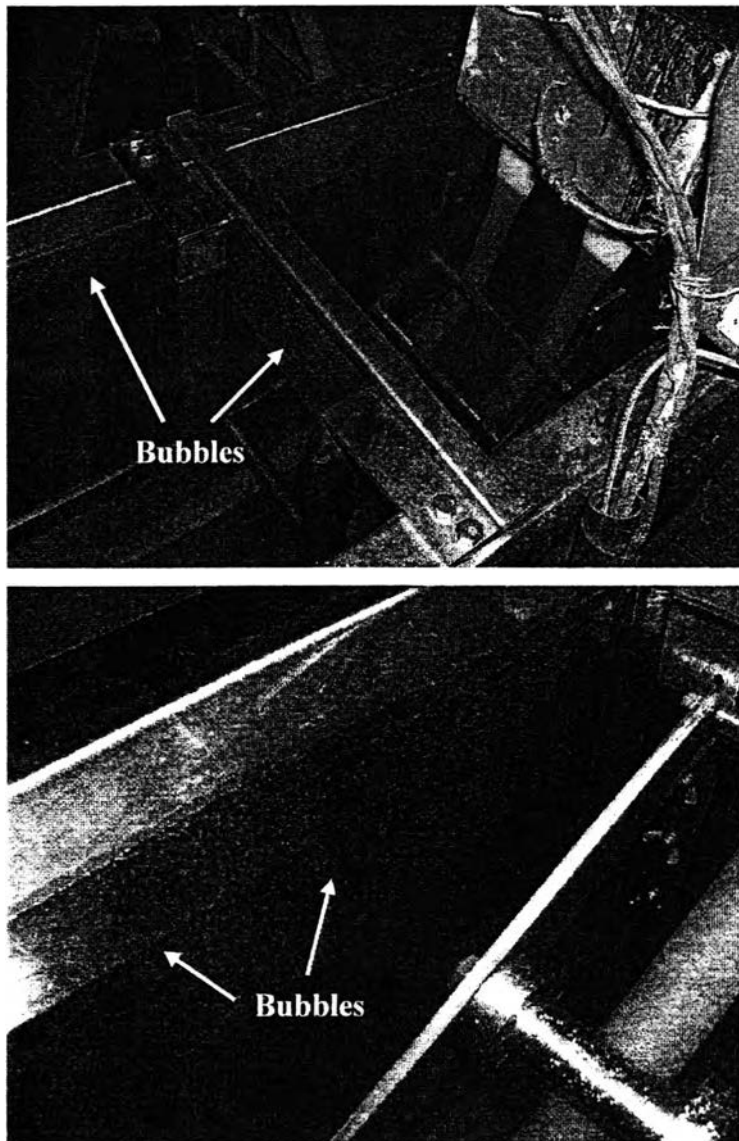
The results from the experiment concluded that bubbles in chilled water of quenching bath influenced breakage times of PP bands of the study line. Figure 4.1 shows bubbles in chilled water of quenching bath. Bubbles stay everywhere in chilled water of quenching bath which made from stainless steel.

**Figure 4.1: Bubbles in Chilled Water of Quenching Bath**

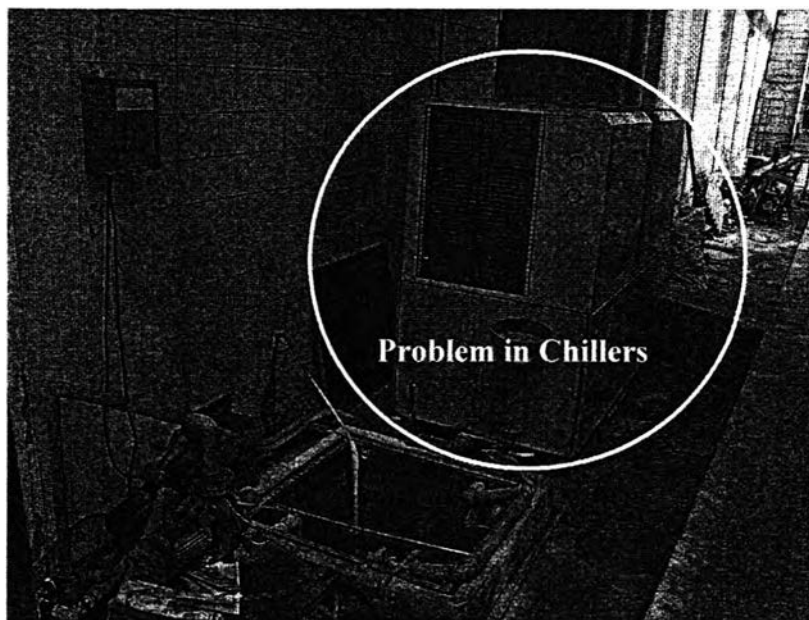
After checking chilled water flow system of the study line, it was found that there are no leakages in the system such as in water pipes and in water baths of quenching and cooling process. It was speculated that bubbles in chilled water of quenching bath came from chillers itself (as shown in figure 4.2) which supplies chilled water directly to PP-band lines including the study line.

**Figure 4.2: Problem in Chillers Supplying Chilled Water to PP-band Lines**

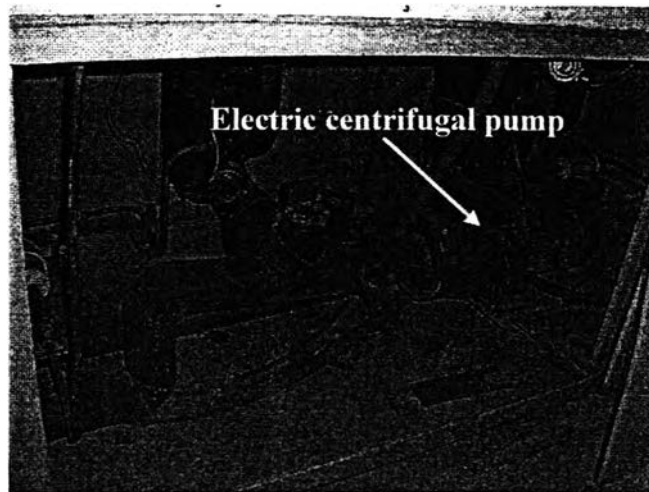
The primary study for cause of bubbles in chilled water was directed at chillers. Therefore, maintenance team was formed to find the causes of bubbles in chillers by checking all possible causes. The maintenance team found that electric centrifugal pump or water pump (as figure 4.3) in the chillers was leaked between O-ring seal of motor shaft in electric centrifugal pump and pump fan, because erodent seal which is caused outside air combined with chilled water to the chillers system. Figure 4.4 and 4.5 show air intake point and O-ring seal whereas figure 4.6 shows side view of electric centrifugal

**Figure 4.3: Electric Centrifugal Pump in Chillers**

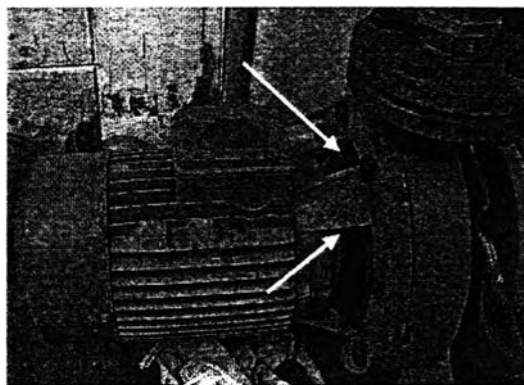
**Figure 4.4: Air Intake Point**

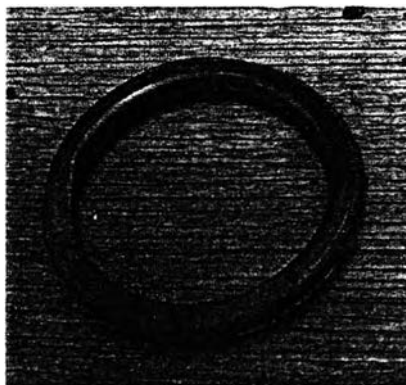
**Figure 4.5: O-ring Seal Problem of Electric Centrifugal Pump**

After changing of O-ring seal in electric centrifugal pump, it was found that there are no bubbles in chilled water of the chillers and also no bubbles in chilled water of quenching and annealing baths of PP-band lines including the study line. Figure 4.9 shows chilled water in quenching bath with no bubbles. Breakage failure dramatically reduced because of no effect from bubbles in chilled water to destroy surface of PP bands before stretching process in stretching oven.

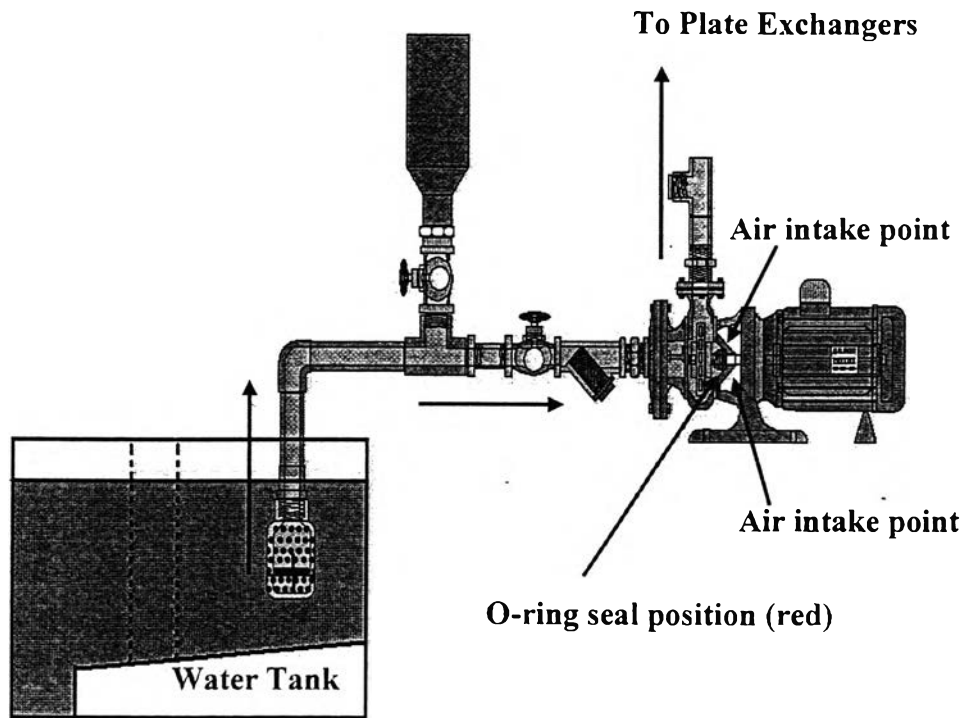
Figure 4.6: Side View of Electric Centrifugal Pump in Chillers

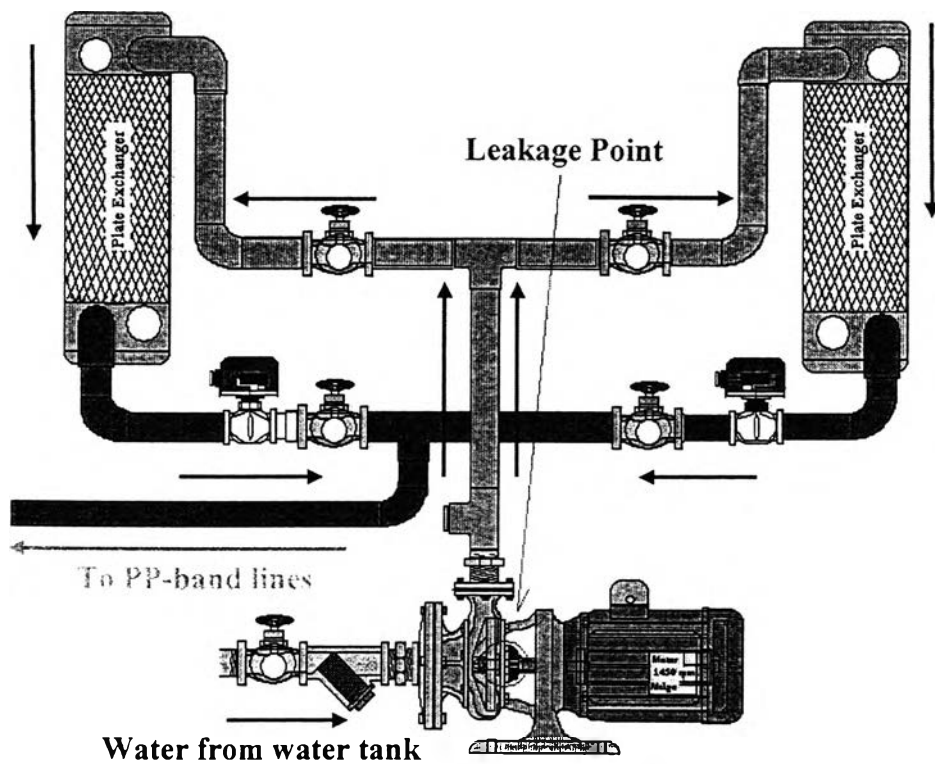
pump, O-ring seal position and air intake point. Figure 4.7 shows point of leakage with water flow system which electric centrifugal pump sucked water from water tank to plate heat exchangers for chilled water before go to each PP-band lines.

Figure 4.7: Flow of Water in Chillers and Leakage Point in Electric Centrifugal Pump

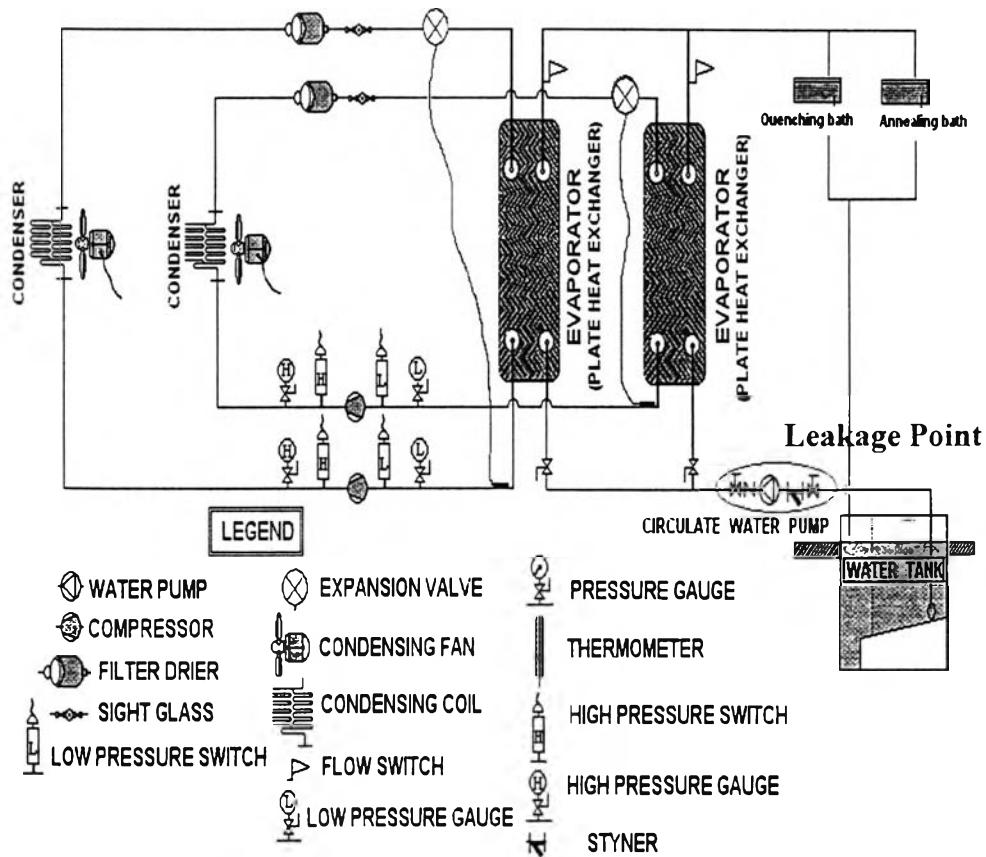
**Figure 4.8: Circuit of Chillers**

Figure 4.8 depicts circuit of chillers and flow of water starting from water tank, passing through circulate water pump (leakage point) and going to evaporators (plate heat exchangers) for chilled water supports quenching and annealing baths in PP-band lines.
