PHYSICAL PROPERTIES AND STRUCTURES OF RIVER BANK SEDIMENTS IN BANG BAN CANAL, AMPHOE BANG BAN, CHANGWAT PHRA NAKHON SI AYUTTHAYA

Mr Theerachet Chaomeepurm

A Project Submitted in Partial Fulfillment of the Requirements for the Degree of Bachelor of Science Program in Geology Department of Geology, Faculty of Science, Chulalongkorn University Academic Year 2016

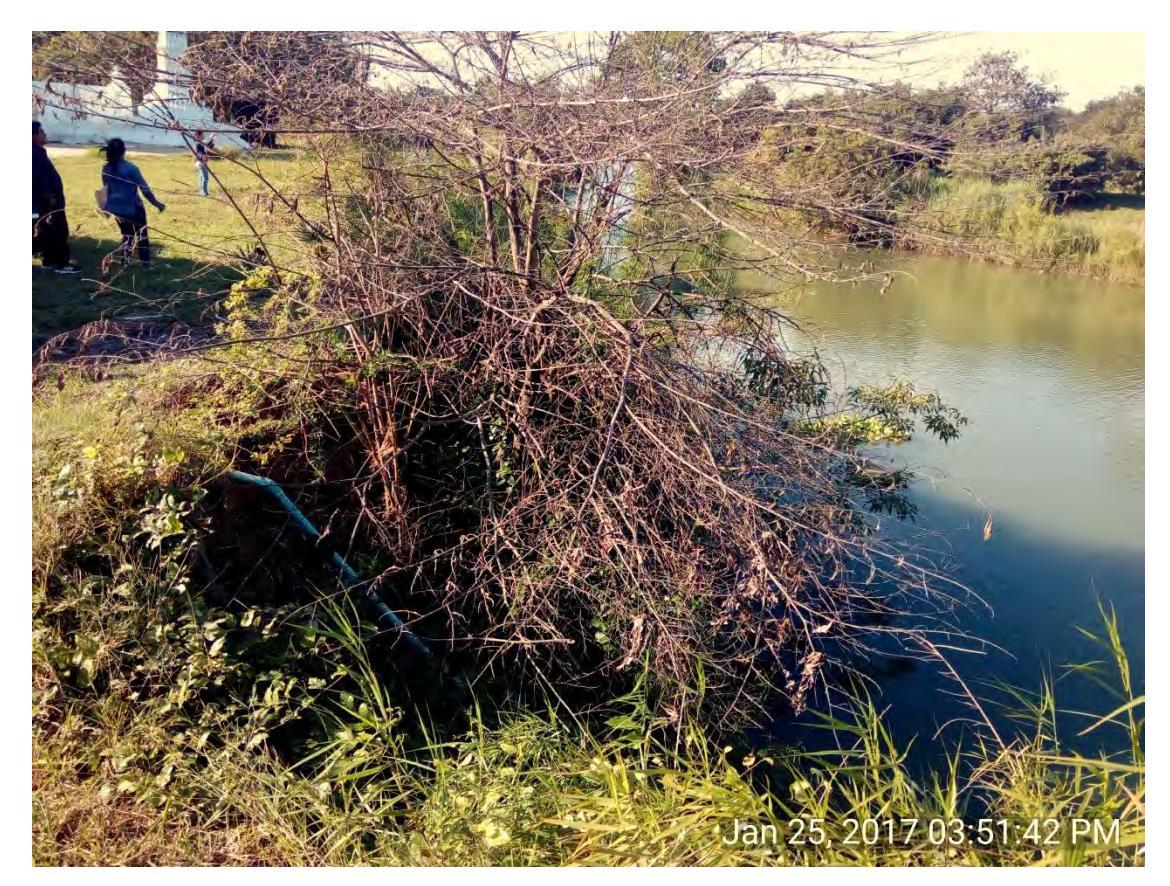
Figure 5. River bank failure at Wat Bang Ban, alongside Bang Ban canal.

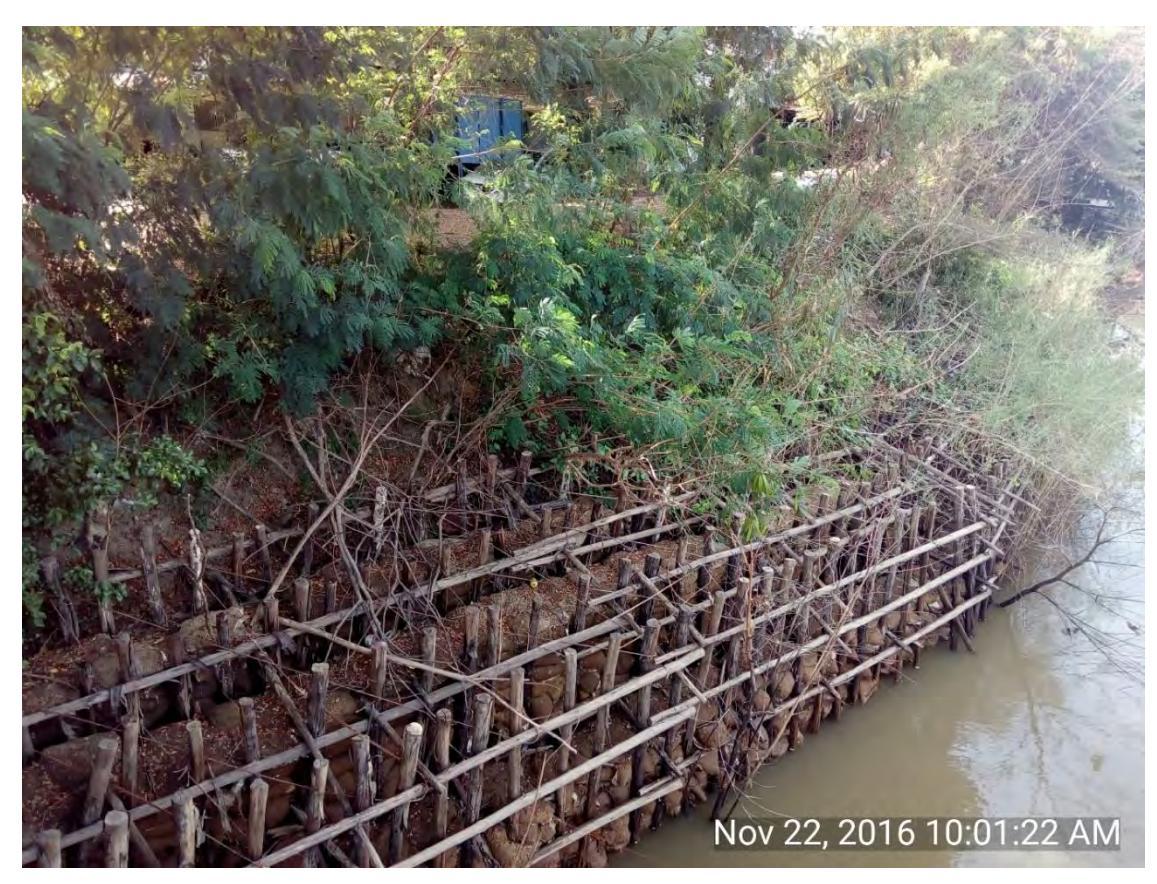
Figure 6. River bank failure protection alongside Bang Ban canal.

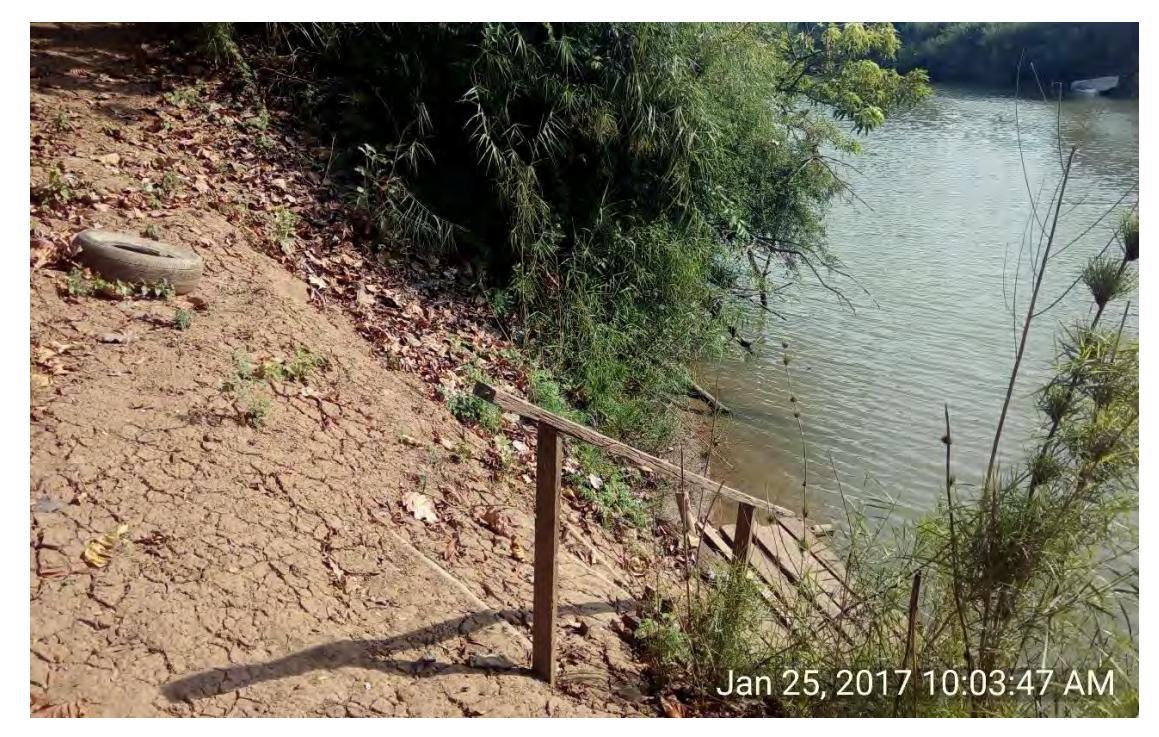
Figure 11. Bank slope near the borehole BC1 location.

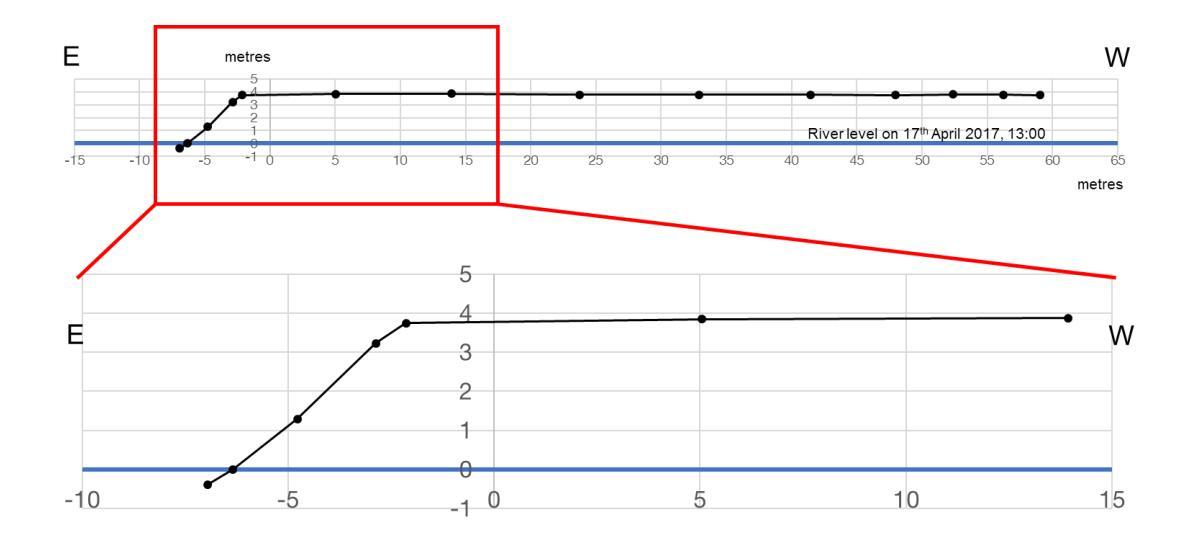
Figure 31. River bank height profile

Bank height = 4.13+2.07 = 6.2 metres (estimated) Bankfull height = 2.07 metres Bank/bankfull height ratio = 6.2/2.07 = 3.00Bank slope = 0.8582Bank slope = 40.64° True bank slope = 45.66°

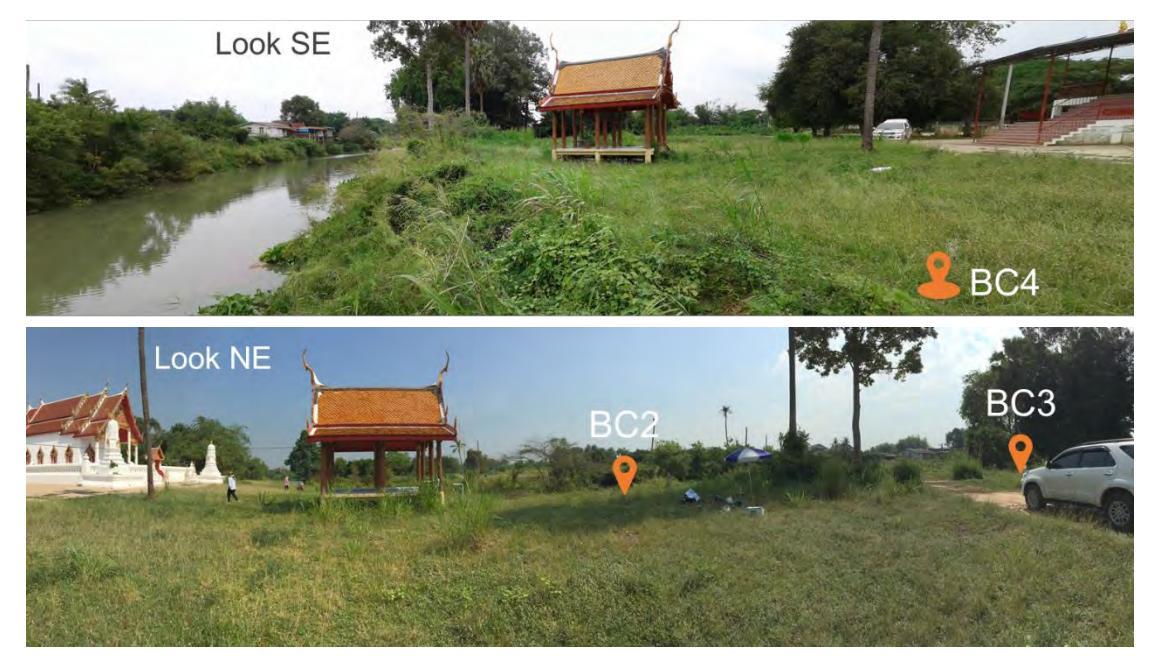
Figure 32. Vegetation at Bang Ban canal.

We found that the river bank failure tends to occur in the residential area more than the unused land. This may be caused by the lack of vegetation; there is no root to bond soil together. Therefore, to grow plants along the river bank can alleviate river bank failure.

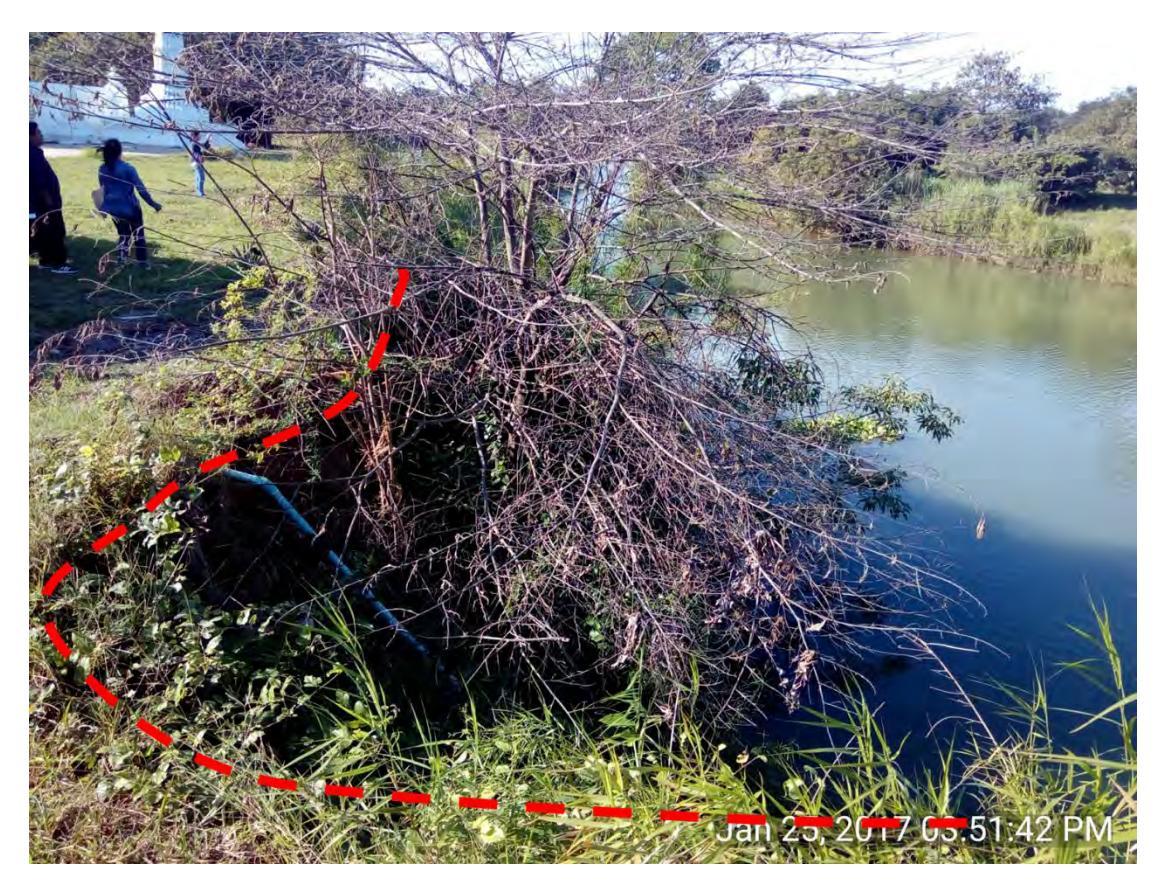
According to table 9., we can conclude that river bank in Wat Bang Ban is at very high risk of erodibility and this can lead to river bank failure. Bank height ratio and bank materials mainly contribute BEHI score. Therefore, during rapid drawdown, river bank should be monitored carefully because of the higher bank height ratio and increase of pore pressure in soils.

Figure 33. River bank failure at Wat Bang Ban.

Moreover, the river bank height from water level at Wat Bang Ban is 4.13 metres (on 17th April 2017) which is then calculated and considered as very high risk in BEHI. Bank slope is 45 degrees which is considered as low risk. When all factors are calculated, according to Bank Erosion Hazard Index (BEHI), river bank at Wat Bang Ban is classified as very high risk of erodibility.
