**BIOTIC AND ABIOTIC FACTORS AFFECTING DETERIORATION
OF CHUDHADHUJ PALACE MUSEUM**

**A Dissertation Submitted in Partial Fulfillment of the Requirements
for the Degree of Doctor of Philosophy Program in Environmental Science**

Chulalongkorn University

This study was carried out at Chudhadhuj palace museum which situated at Sichang Island. It was concentrated on the study of deterioration caused by abiotic factor and biotic factor affecting on Chudhadhuj palace museum.

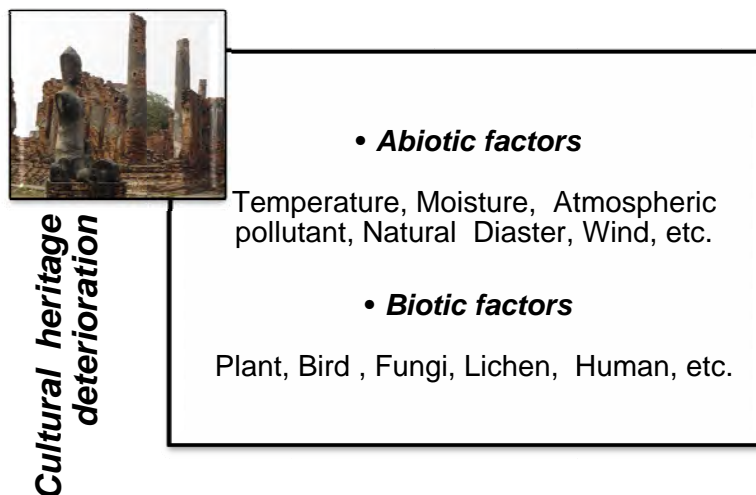
Figure 2.1 The factors causes the cultural heritage deterioration

Unfortunately, most of the cultural heritage is irreplaceable or non - renewable resource (New Zealand Historic Places Trust, 2004). Depending on the materials and surrounding, many cultural heritages have been deteriorating causing by both abiotic factors and biotic factors shown in Figure 2.1.

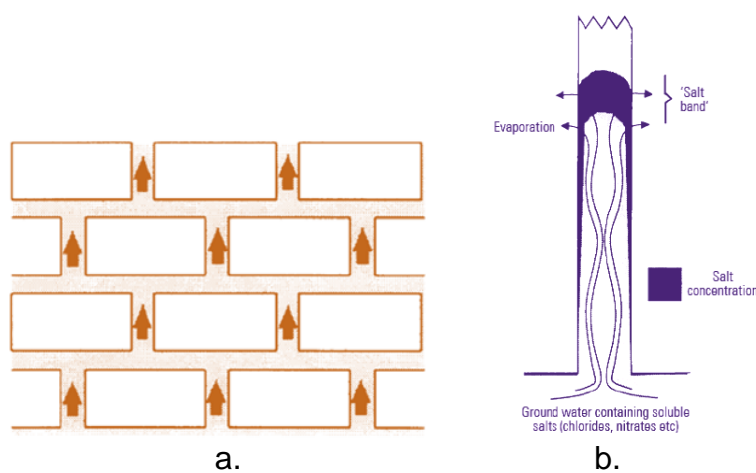
Figure 2.7 The mechanism of salt attack : a. water rising through porous material and b. salt attack mechanism from rising damp (Safeguard Europe Ltd., 2007)

Because of high salt concentrations often cause extensive fretting and crumbling of the lower parts of material (Ahmad and Rahman, 2007). These deterioration were explained by the mechanisms proposed that concerned with the thermodynamic and kinetic factors influencing crystallization pressure, hydration - osmotic pressure, mineral dissolution and thermal expansion (Scherer, 2004 ; Rodríguez - Navarro and Doehne, 1999)

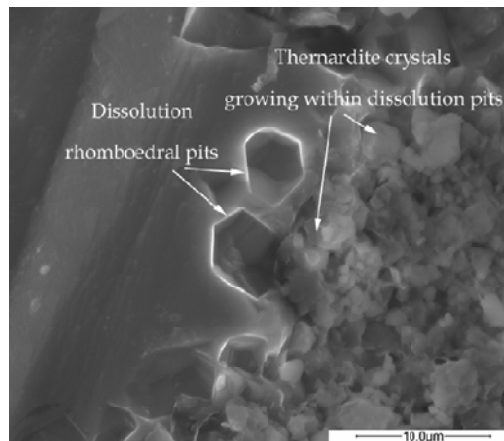
Figure 2.8 Scanning electron microscopy photomicrograph of calcite grains showing etch pits filled with Na_2SO_4 crystals (Ruiz - Agudo et al., 2007)

pressure and crystallization pressure. Hydration results in large volume expansion, about 314 % as the anhydrous phase of sodium sulfate (thenardite) converts to its decahydrate phase or mirabilite (Tsui et al., 2003). It causes the mechanical stress by the crystallization pressure (Espinosa et al., 2007).

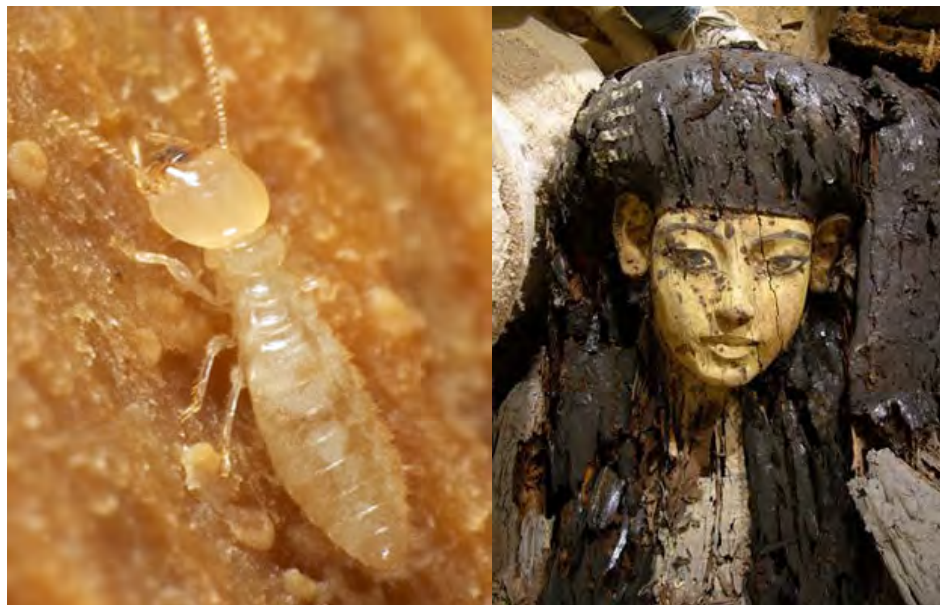
Figure 2.25 The wooden cultural heritage deterioration by termite : a. termite and b. The Fragile painted mask of a wooden coffin, Egypt's Valley of the King, badly damaged by termites (Carter, 2008)

Termites have been admitted that they are causing severe deteriorated problems on wooden heritages (Figure 2.25) and predominant insect species that have to monitor carefully (Table 2.6).

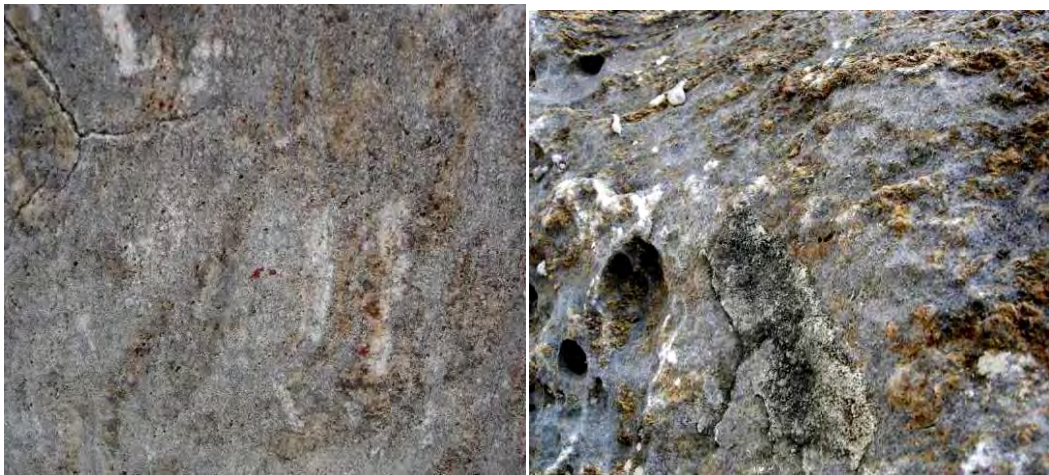
Figure 3.13 Historical stone inscription surface

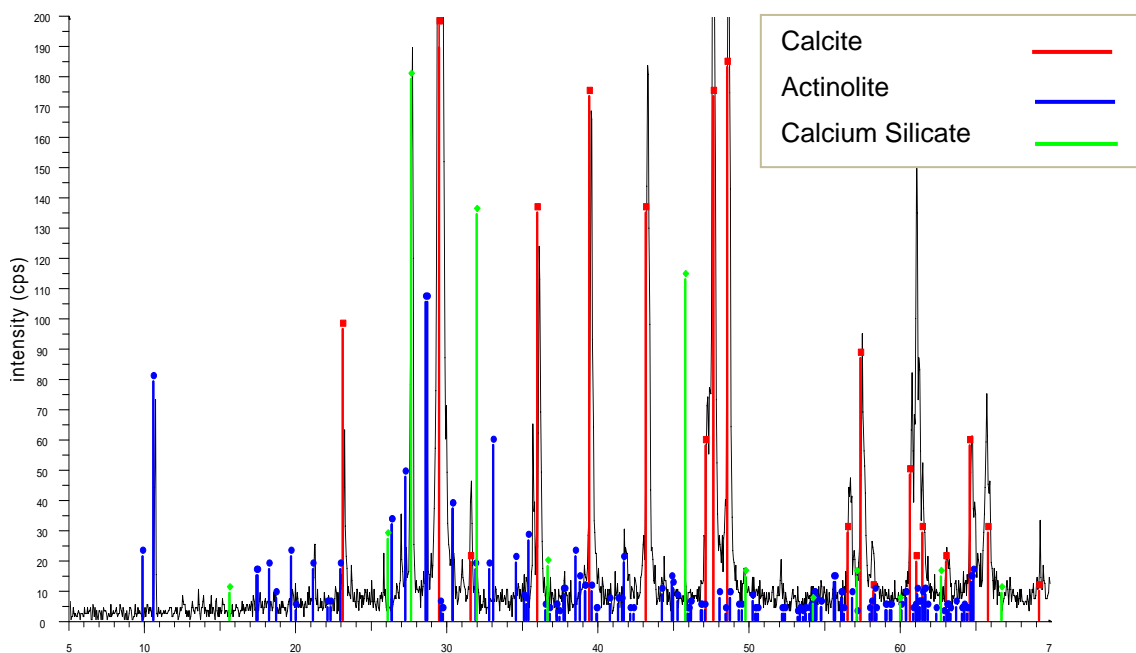
Figure 3.15 The diffractogram of stone : Rain water - Ambient condition cycles

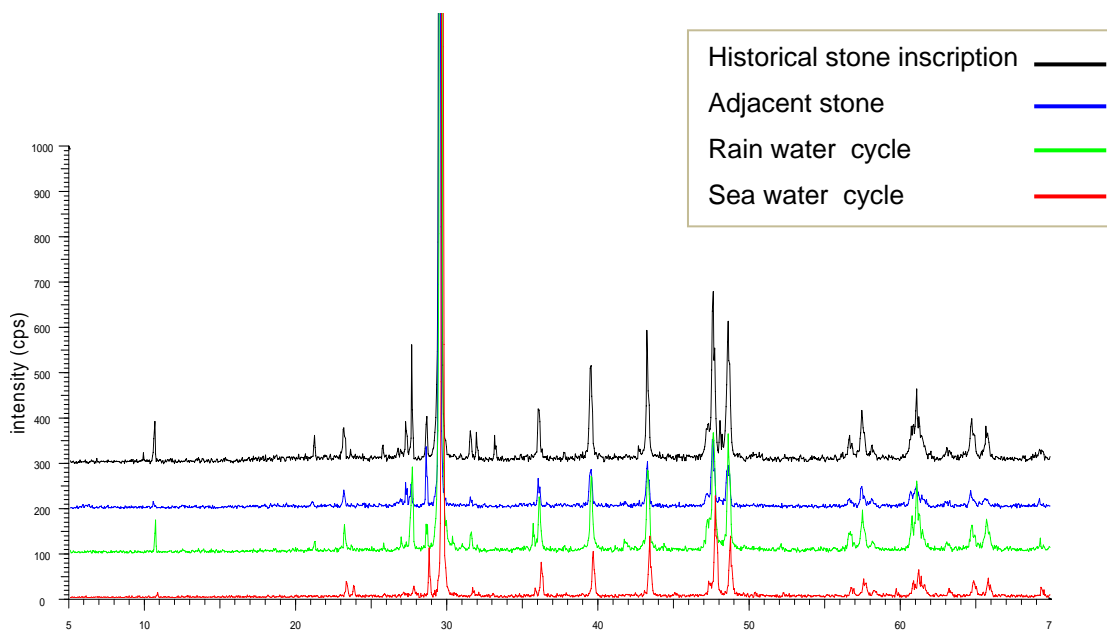
Figure 3.16 The diffractogram showed the comparison of peak patterns of stone samples from the historical stone inscription, adjacent hill stone, simulation cycle stones, both in rain water and sea water treatments

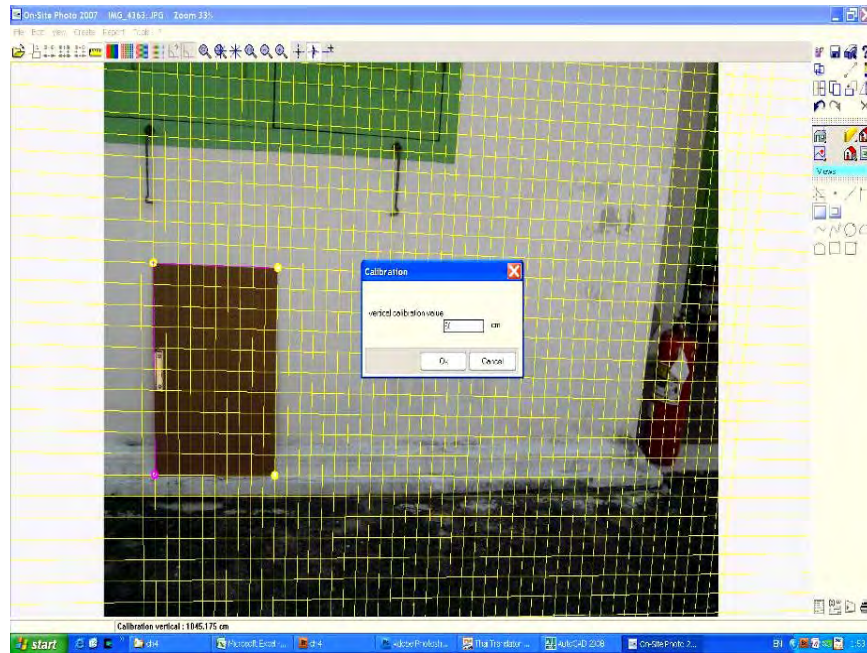
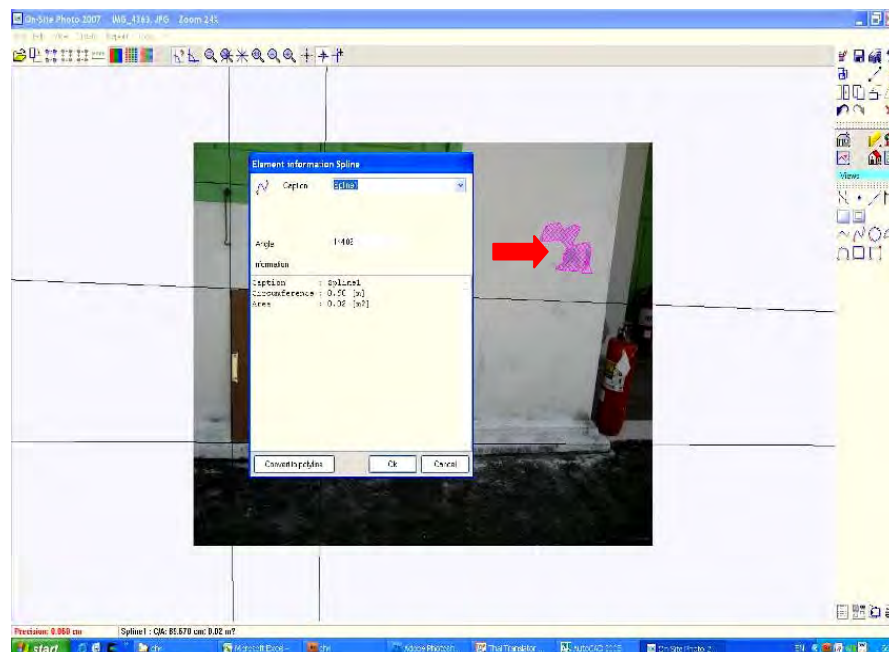
a. Co - ordinate system arrangement

b. Co - ordinate scaling correction

d. Calculation of damaged areas

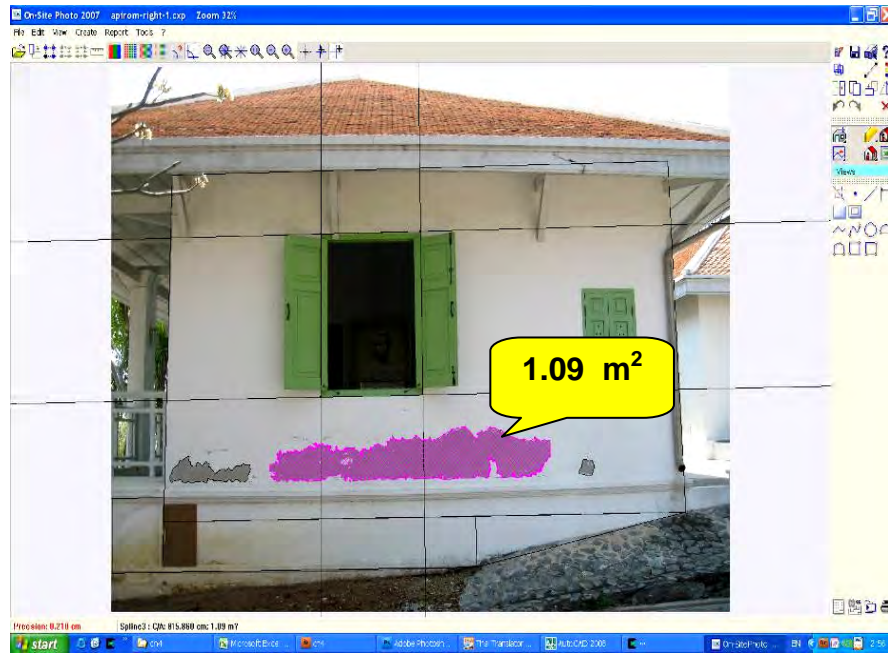
Figure 4.7 The example of damaged area analyzed by image processing

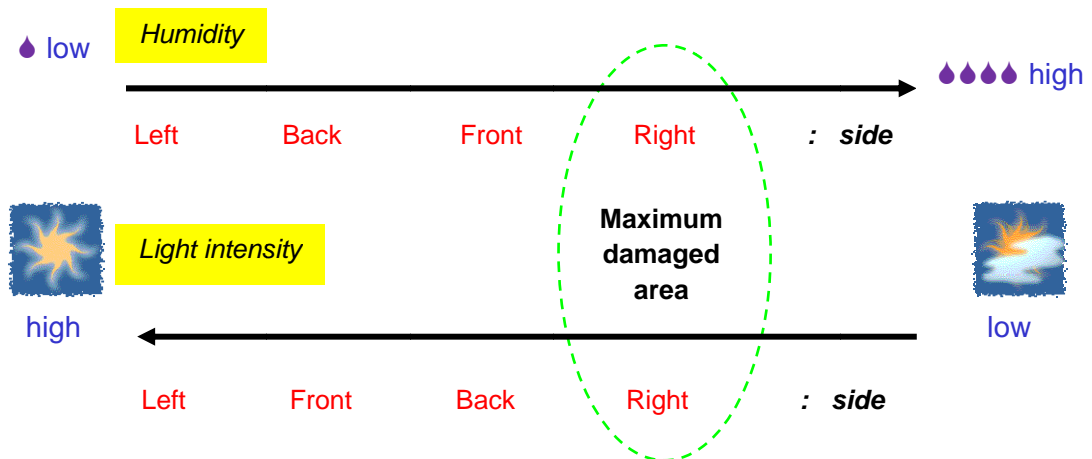
Figure 4.9 The result diagram of humidity and light intensity values

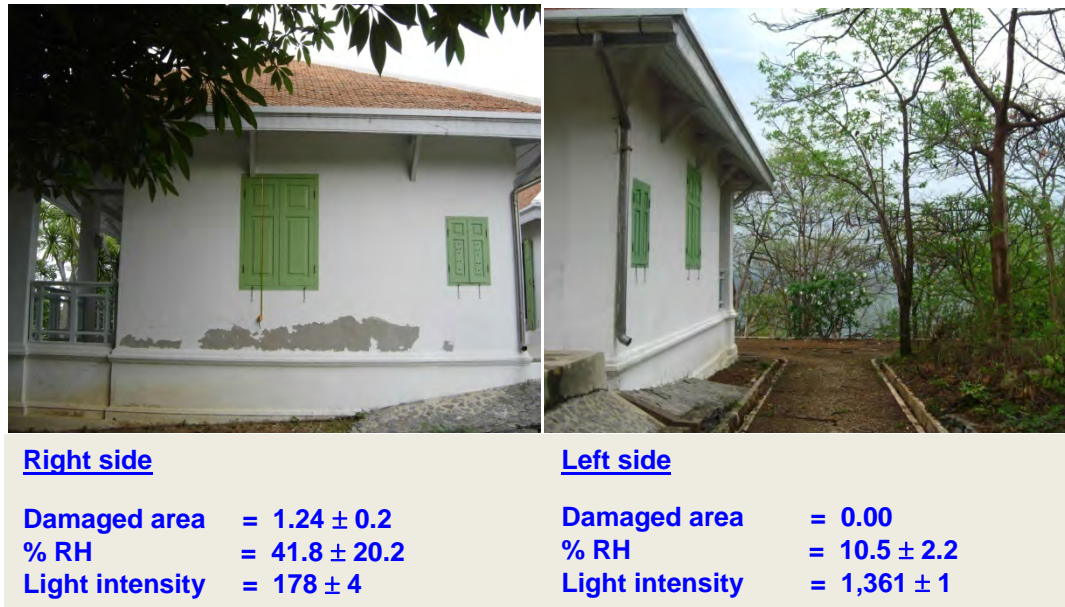
Figure 4.10 The comparative of abiotic factors affecting on the right and left sides of Apirom residence

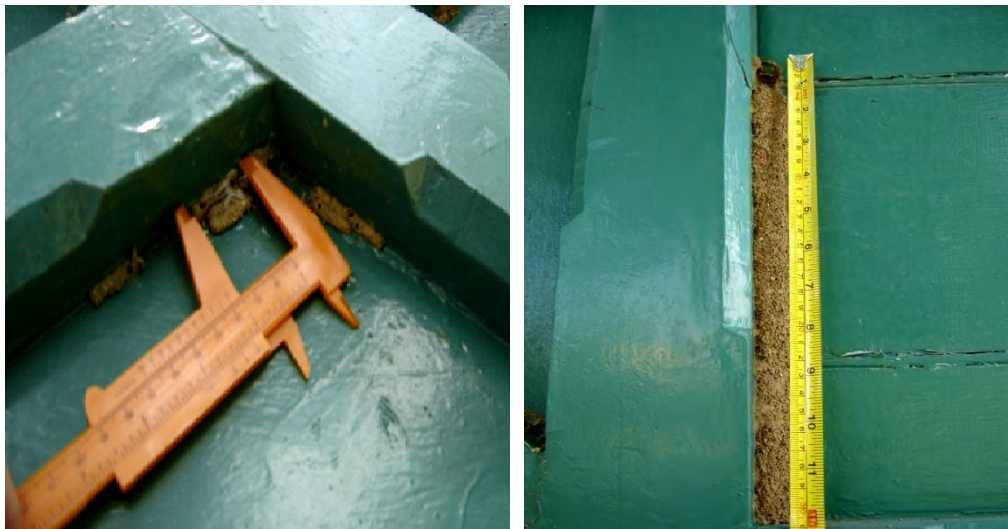
Figure 5.1 The characterization of insects nests on structural materials

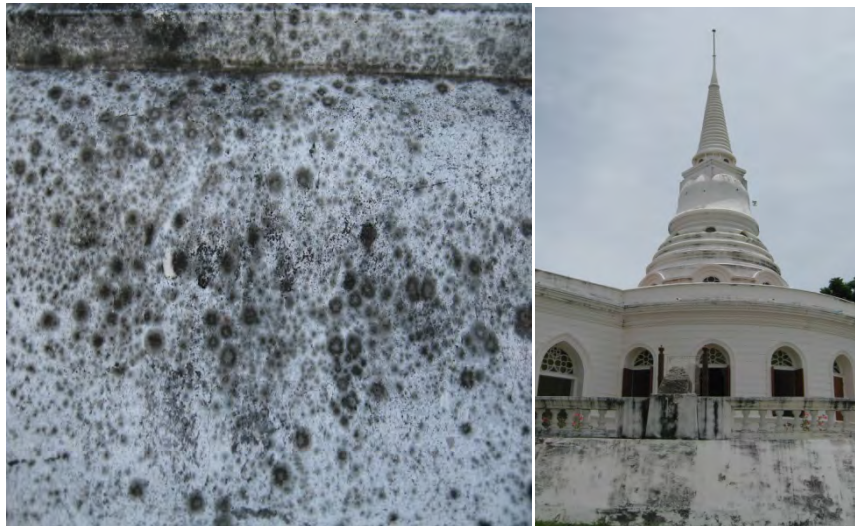
Figure 5.4 The characterization of fungi stains at Aussadangkhaniimit Temple

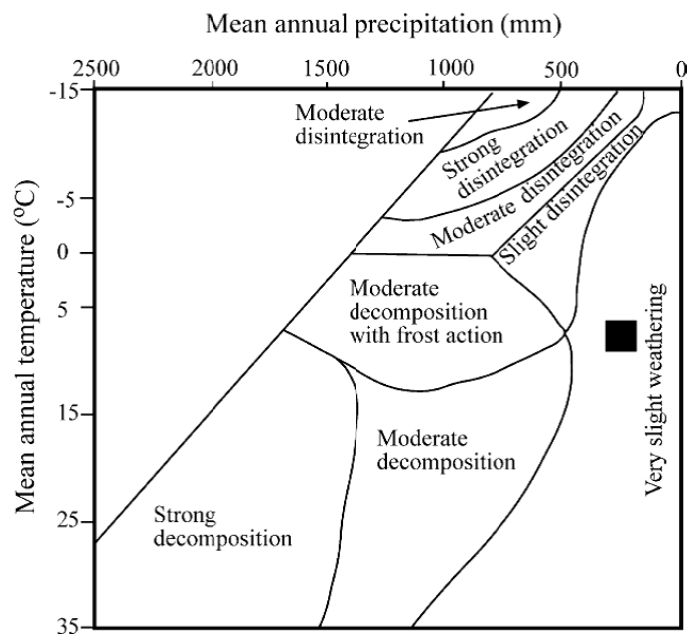
Figure 6.1 Relationship between climate and type of weathering (Fookes et al., 1970)

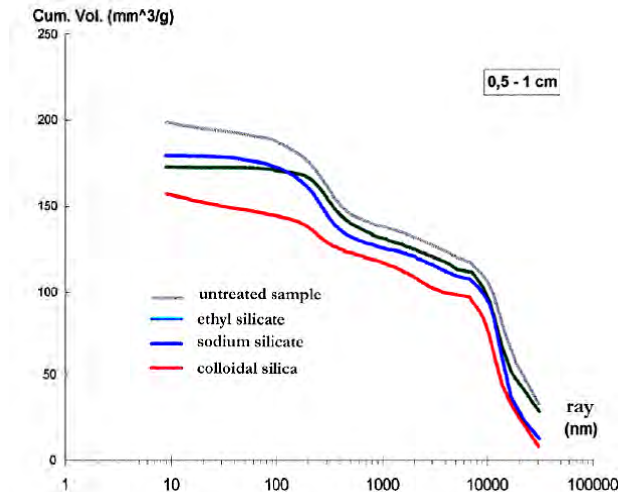
Figure 6.2 Cumulative volume curve of the different products at 0.5 -1 cms. depth (Zendri et al., 2007)
