วิทยานิพนธ์นี้เป็นส่วนหนึ่งของการศึกษาตามหลักสูตรปริญญาวิทยาศาสตรมหาบัณฑิต

THE EFFECT OF POST AND CEMENT TYPES ON VERTICAL ROOT FRACTURE RESISTANCE
IN ENDODONTICALLY TREATED TEETH

Department of Operative Dentistry

Chulalongkorn University

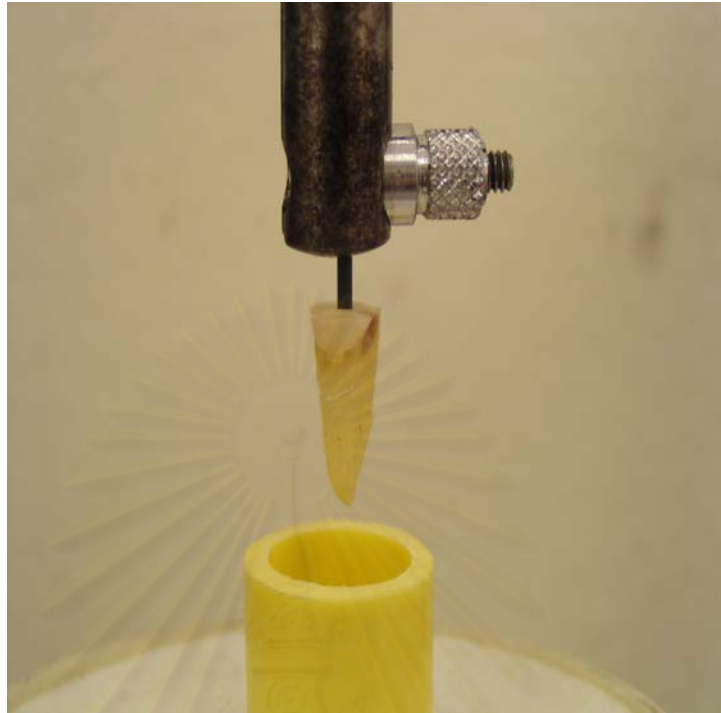
Figure 1 The tooth embedded in dental stone using surveyor

12 mm of post space was prepared by using C-Post Drill no 2 (Bisco Inc., Schaumburg, IL, USA). The cylindrical carbon fiber post with 2 diameters, on apical section with 1.2 mm and the coronal section with 1.8 mm diameter, was used (C-post[®], Bisco Inc., Schaumburg, IL, USA). The post was cemented with resin cement (C&B Cement[®], Bisco Inc., Schaumburg, IL, USA) in group I and with zinc phosphate cement (Hybond[®], Shofu Inc., Kyoto, Japan) in group II. Both cements were mixed according to manufacturer's instruction. The cement was applied on the post surface and immediately seated by finger pressure. The teeth were placed in a static loading device (Durometer[®], Pacific Transducer Co., Los Angeles, CA, USA) with 3 kg of pressure for 10 minutes as recommended by Saupe, Gluskin and Radke (1996). The cement was allowed to set and excess cement was removed. Then the teeth were embedded in dental stone (Whip Mix[®], Whip Mix Corporation, Louisville, KY, USA) at the center of PVC pipe (2.5 mm in diameter) along their long axis using a surveyor (fig 1).

The sectioned surface is 3 mm above the plaster level, corresponding to the position of alveolar bone clinically as recommended by Turner (1982). After stone setting, the core was built to 5 mm height by using dual-cured composite resin (Biscore[®], Bisco Inc., Schaumburg, IL, USA) and All-bond 2 (Bisco Inc., Schaumburg, IL, USA) according to manufacturer's instruction. Tofflemire matrix was placed around the cervical third of the tooth for placing the material.

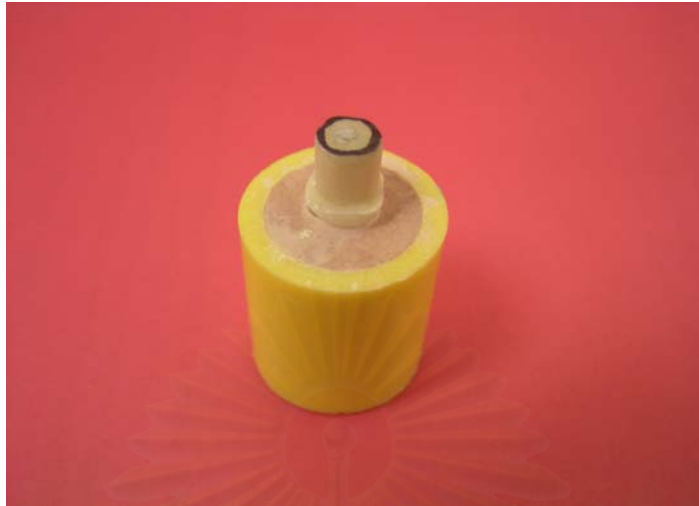
Figure 2 Occlusal surface with permanent pen to make a similar diameter of the core

After complete polymerization of resin composite, similar cylindrical shape of composite cores (4 mm in diameter) were made. All composite cores were prepared approximately by hand as closely to the final shape as possible. The permanent dark circle was marked on the occlusal surface. The axial wall of composite core was cut with cylindrical diamond bur. Shank of diamond bur was placed perpendicular to the base of ring as possible, and the cutting was made follow permanent dark line (fig 2).

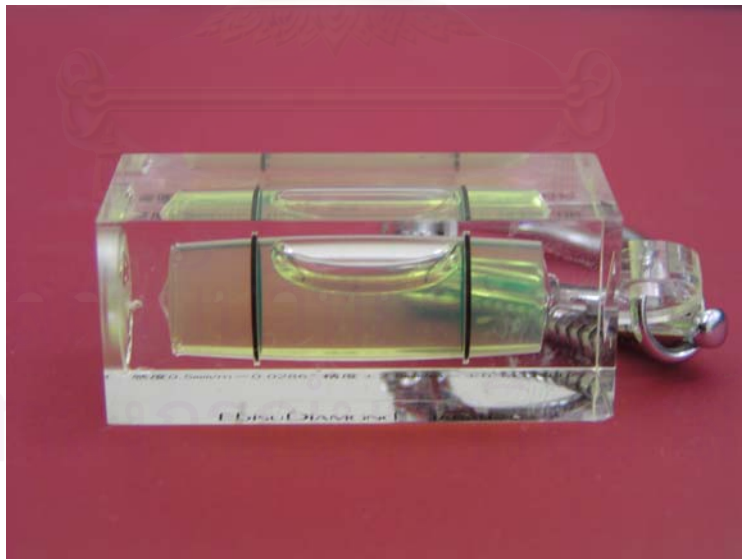
Figure 3 A level for checking occlusal paralleling of the core

After that a level was used to check whether occlusal surface of the core is parallel to the base of its ring (fig 3). All procedures were made by the same operator. The sample that was ready to test was shown in fig 4.

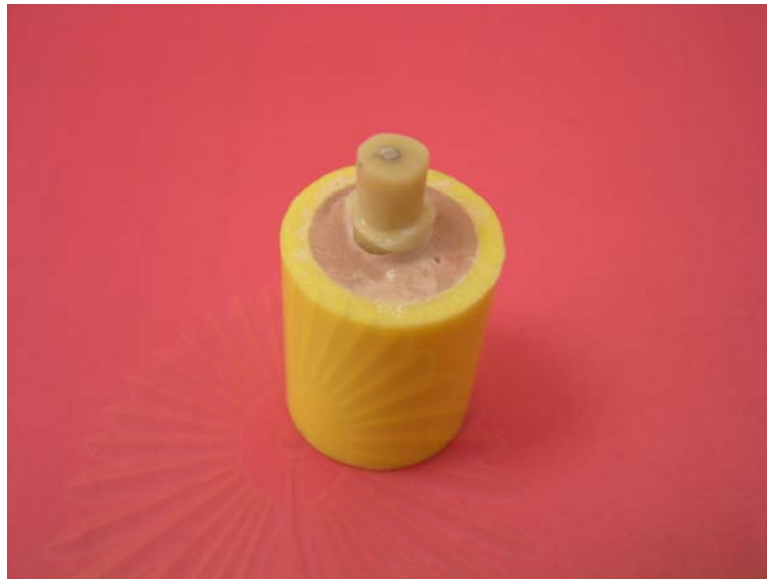
Figure 4 Cylindrical composite core with 4 mm in diameter, perpendicular axial wall, and parallel occlusal surface

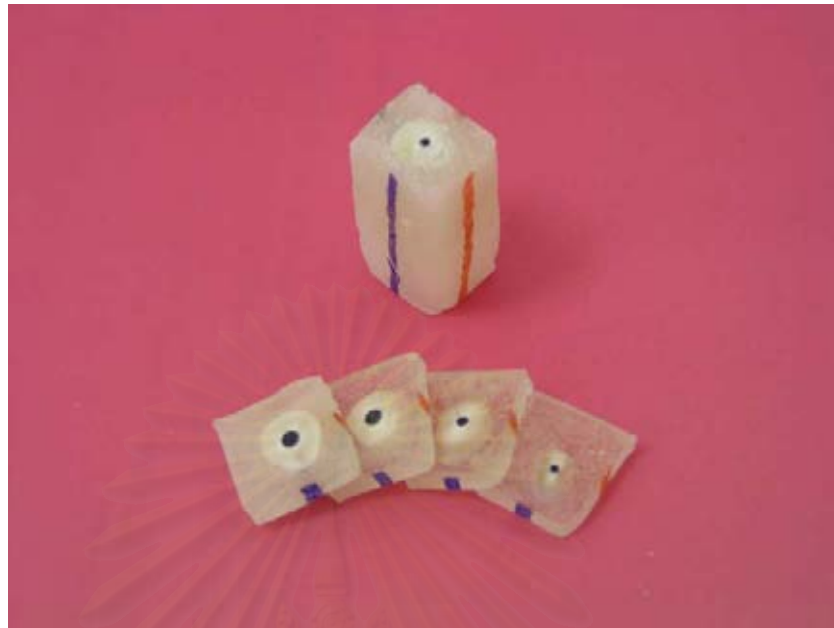
Figure 6 Samples after embedded in clear acrylic resin
and cut with Isomet saw

After vertical root fracture resistance was tested, all samples were removed from dental stone. Patterns of fracture and direction of fracture site were examined. The odd number samples in every group were evaluated for direction of fracture and root thickness. Composite core was removed. The root part of selected samples was embedded in clear acrylic resin (Takilon[®], Rodent S.R.1, Milan, Italy). Resin was allowed for setting, then the samples were marked on resin block to identify the root surface and sectioned horizontally with a low speed cutting machine (Isomet 1000[®], Buehler, Lake Bluff, IL, USA) (fig 6). The first cut will be made 3 mm below the cut surface, and three more sections were made at 3 mm intervals apical to the first one. The root thickness was measured between root surface and root canal wall. The measurement was performed at labial, palatal, mesial and distal site in every section in order to investigate the relation between root thickness and direction of fracture.

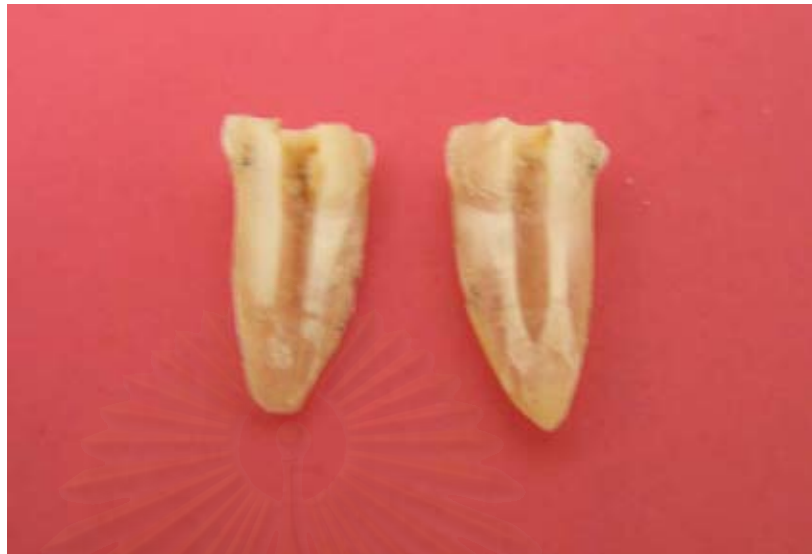
Figure 7 2 pieces of root after separation

The fracture surface of the paired number samples or complete vertical root fracture in every group were grooved at the fracture line approximately 0.5-1 mm depth using separating disc, and then separated into 2 pieces (fig 7). All samples were proceeded with standard technique for Scanning Electron Microscope (SEM) sample preparation and observed under SEM (5410LV, JEOL LTD., Tokyo, Japan).

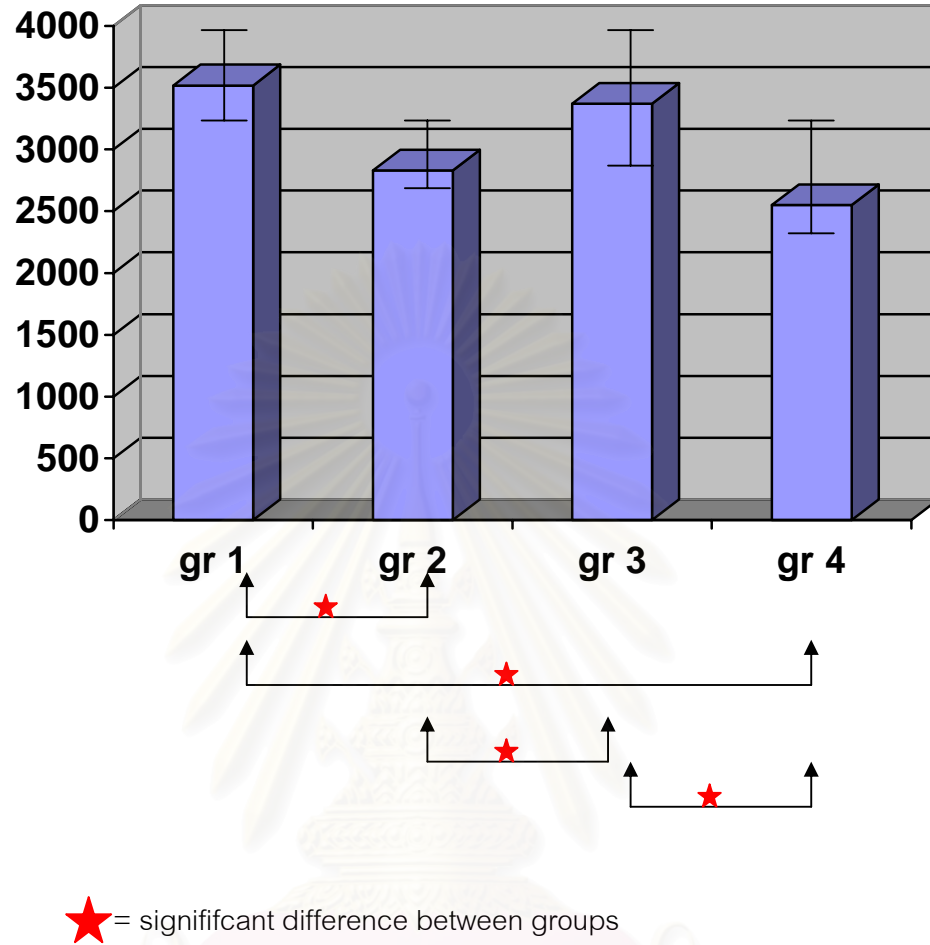
Figure 8 : Bar graph represented means load at fracture ,standard deviation and significant difference between groups

The mean fracture load in teeth restored with carbon fiber post and resin cement (group I) provided the highest value of 3,517.30 newtons, followed closely by teeth restored with stainless steel post and resin cement (group III) at 3,368.90 newtons. While teeth restored with ParaPost and zinc phosphate cement (group IV) showed the lowest mean fracture load which was only 2,549.60 newtons.

The statistic analysis of the data using 2-way ANOVA could be interpreted that vertical fracture load was affected by types of cement ($p=0.000$). In contrast, types of post had no effect on vertical root fracture load ($p=0.051$). Moreover, no significant difference was found between post and cement interaction ($p=0.537$), which indicated that there was no joint influence of the post and cement on vertical fracture load. Results of multiple comparison using Scheffe test ($P=0.05$) were showed in figure 8 and appendix table 2. There were significant differences of vertical fracture load between group I and II, group II and III, group III and IV, and group I and IV.

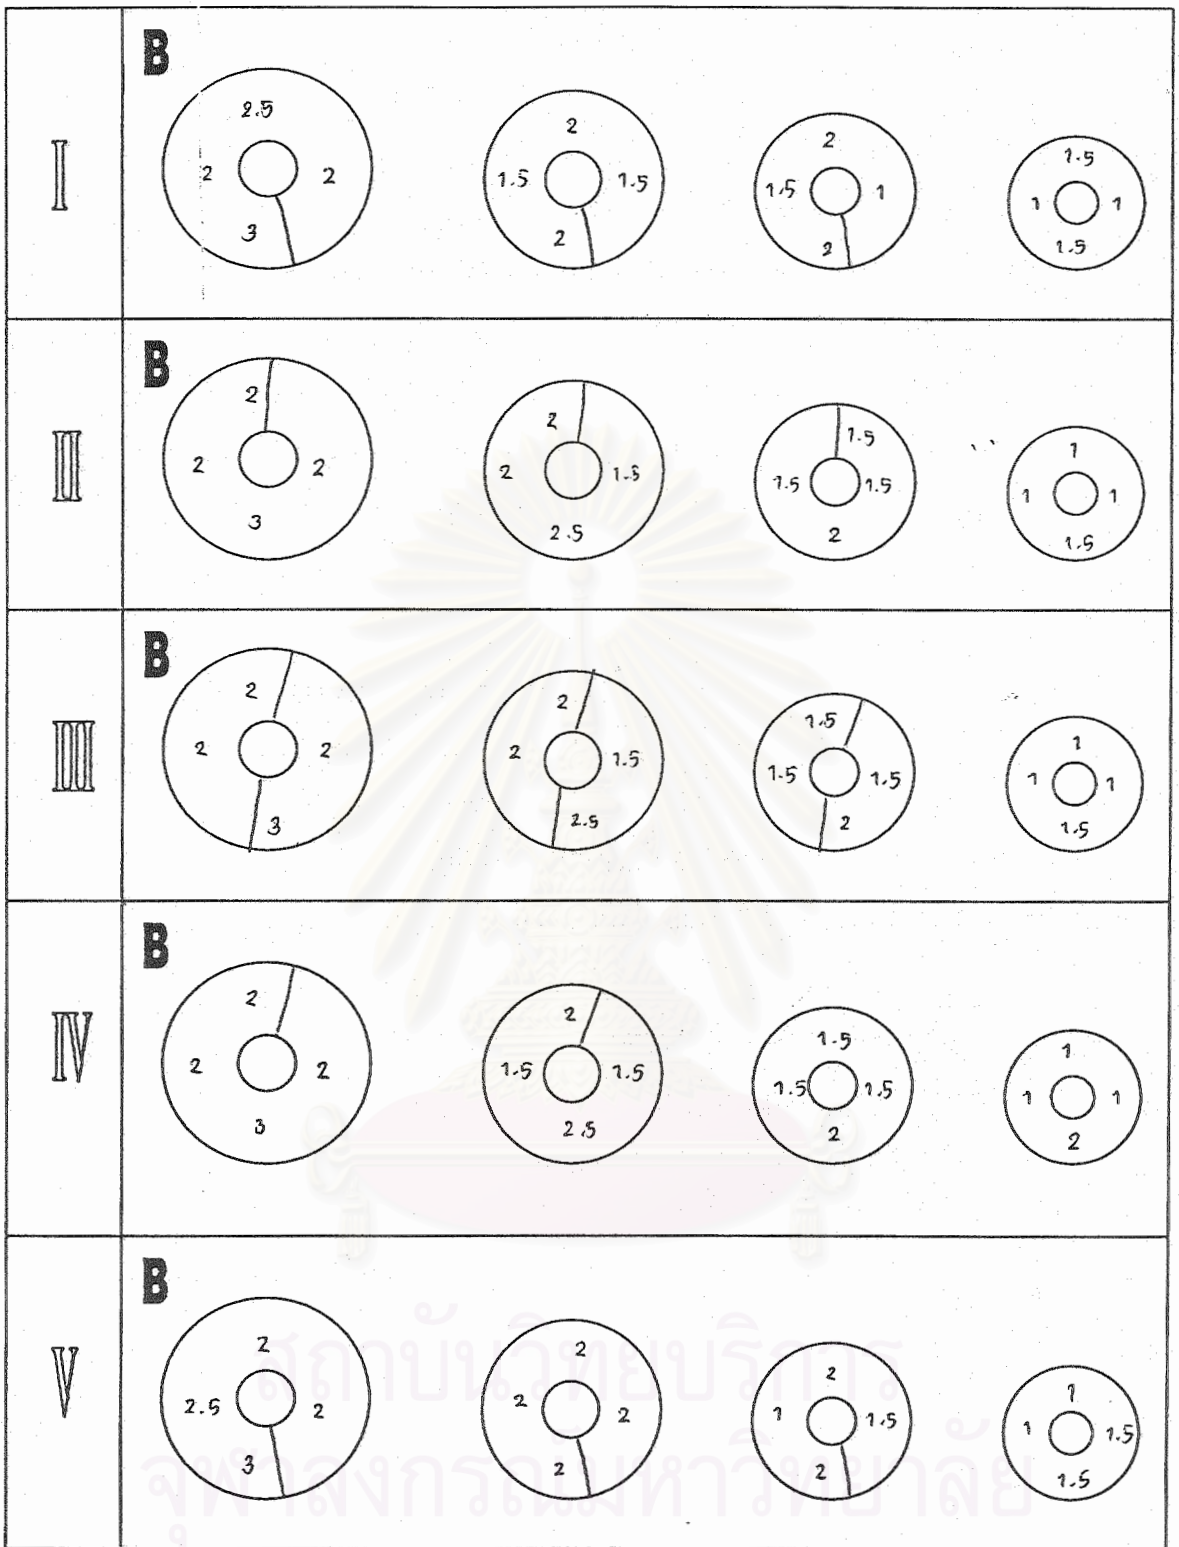
Figure 4 Graphic represented cross sectional of the root at different level in samples of group IV (5 samples); B = Buccal
