CHAPTER 7

TEST

7.1 Instrumental and Operational Preparation

7.2 Testing

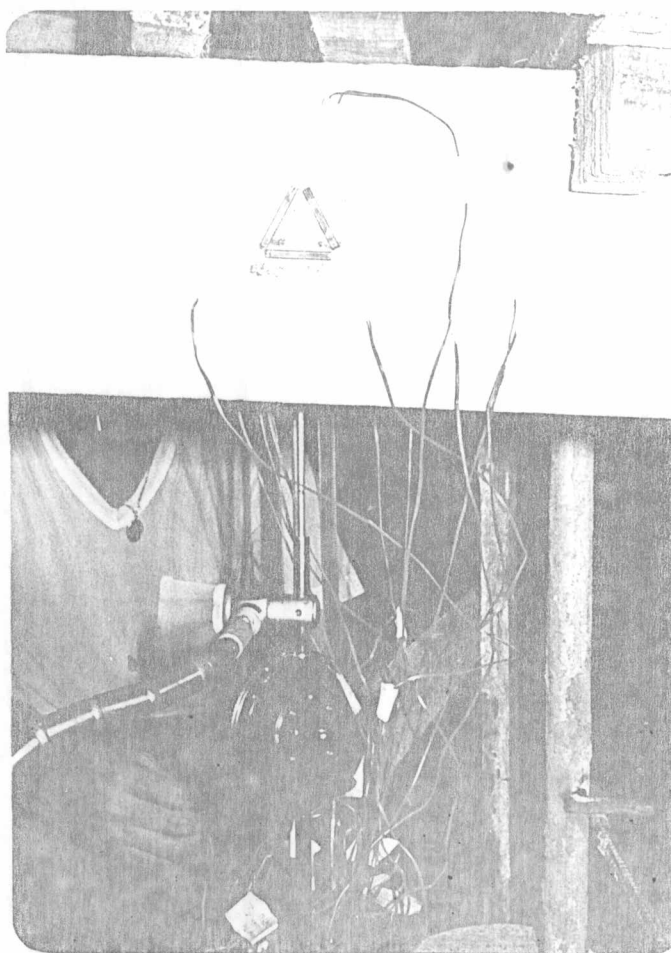
Photograph 7.3 S-beam Model; Gauges Positioned
at Centre-span to Form Rosette.

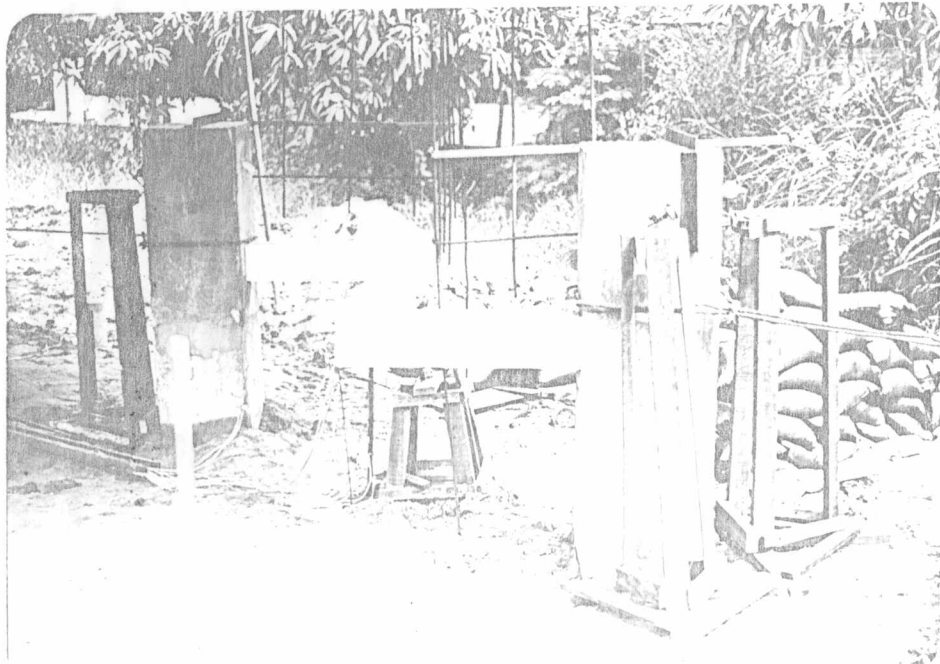
Photograph 7.6 Z-beam Model Prior to Test.

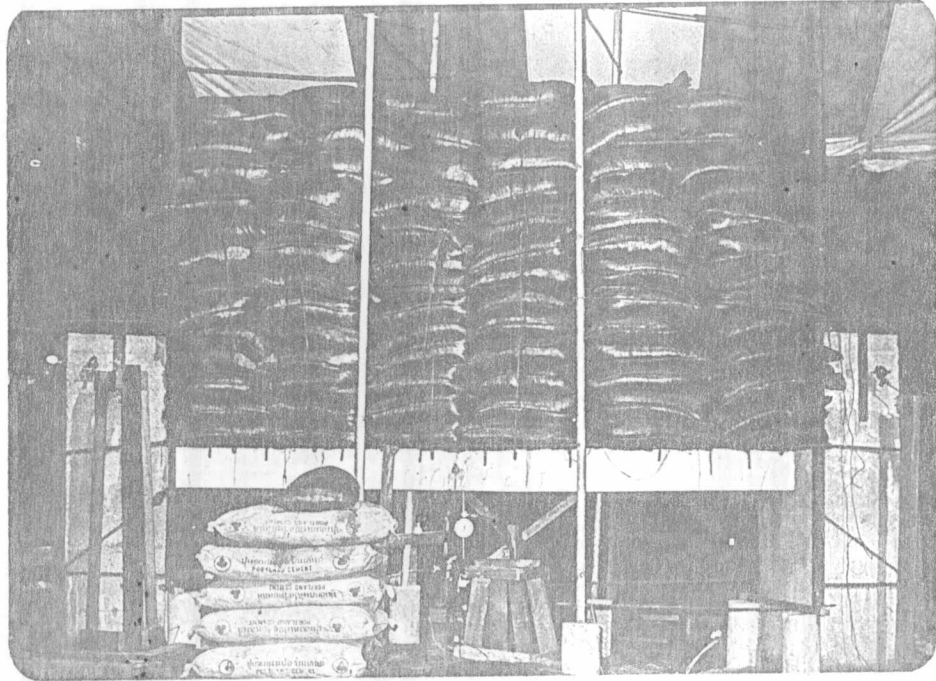
Photograph 7.9 S-beam Model at an Early Stage of Loading.

The test manoeuvred on September 11, 1980 conferred chronological priority on the S-beam model. The beam's concrete attained an age of 28 days at the test date. Imposition of each load increment corresponding to a uniform load intensity of 132 kilogrammes per lineal metre was immediately succeeded by registration of extensometer readings and resistance changes in gauges. Following application of an imposed load of 3,775 kilogrammes, equivalent to an intensity of 1,248 kilogrammes per metre, an incipient crack formed on an upper corner at a location bordering on each support. The corner referred to is incorporated into the intrados of each half-arc. Further application of load increments resulted in extension of this pioneering crack. The extended mark on the upper face of the beam made somewhat a right angle to the beam's longitudinal axis whereas the prolonged trace on the intrados showed a diagonal pattern. This diagonal formation well accords with the foreseeable sense of warping due to combined influence of critical torsion and shear. The fraternal crack emerging on the extrados at a further stage of loading somewhat pursued a vertical mode of development. This vertical formation emits predominance of bending in recognition of contradictory influences of torsion and shear.

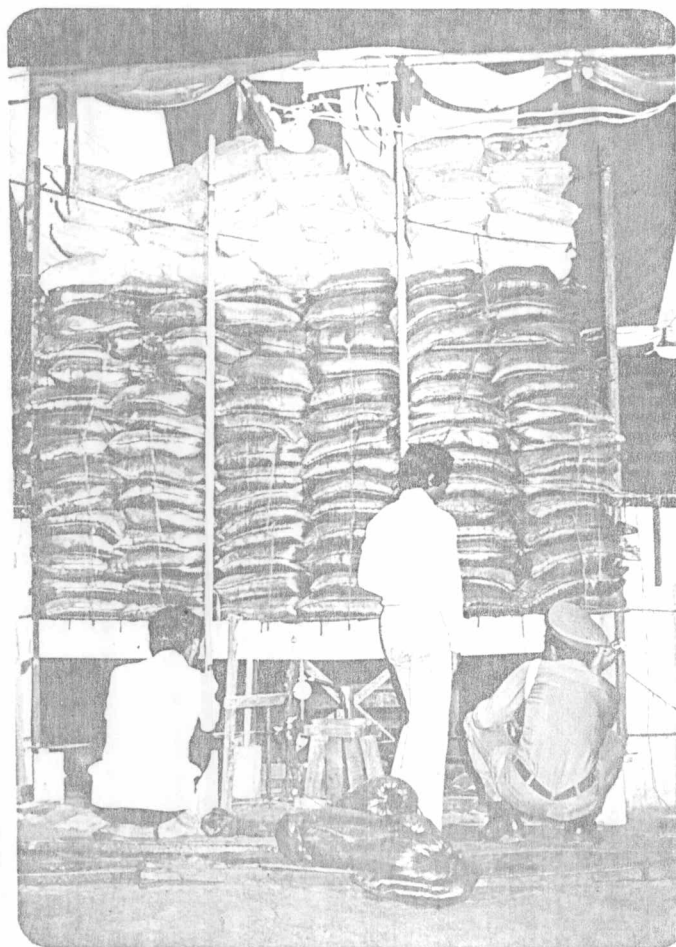
Photograph 7.10 S-beam Model at an Intermediate
Stage of Loading.

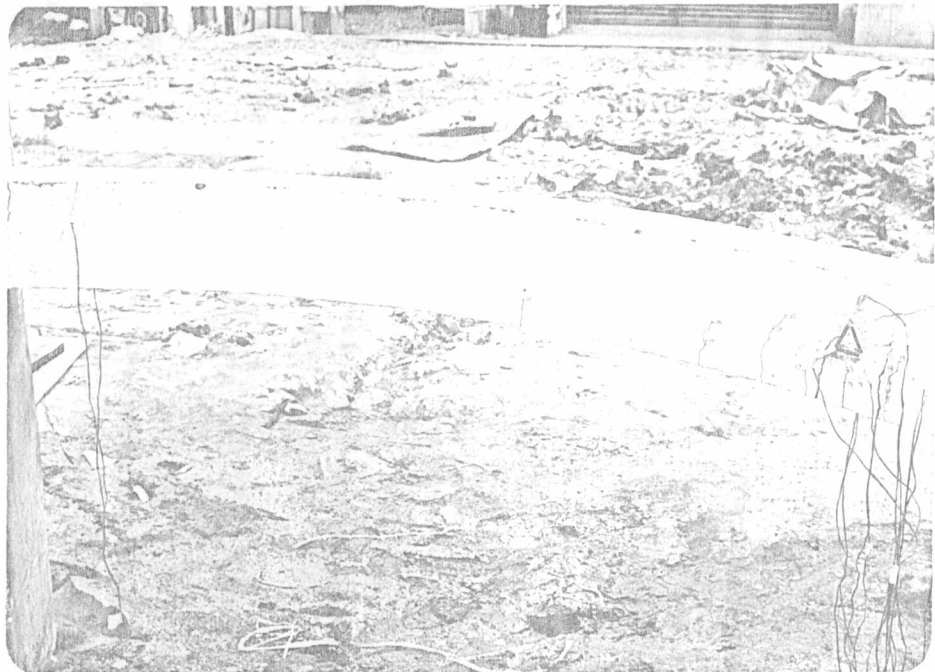
Photograph 7.14 S-beam Model; Crack at Centre-span.

The first crack in proximity to the centre-span on the beam's soffit came to pass at an imposed load of 1,380 kilogrammes per metre. Extension of this crack on each side of the beam assumed a diagonal

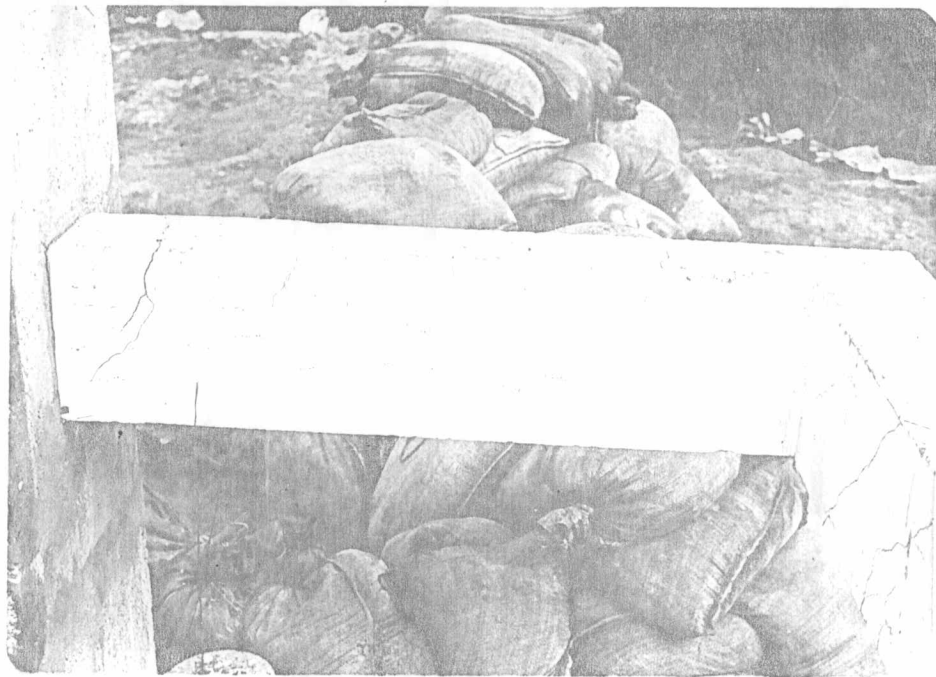
Photograph 7.19 Z-beam Model; Another View of Crack Modes.

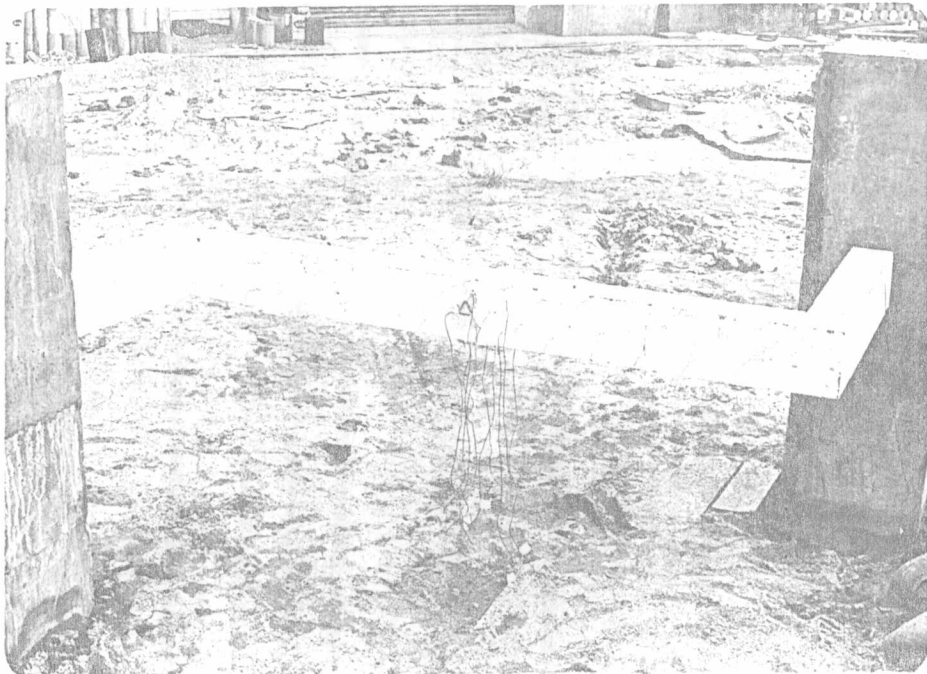
Photograph 7.21 Z-beam Model; Crack Paths on Side of
Transverse Member.
