ALUMINA CORROSION IN DEIONIZED WATER

A Thesis Submitted in Partial Fulfillment of the Requirements  
for the Degree of Master of Engineering Program in Chemical Engineering

Thesis Title	ALUMINA CORROSION IN DEIONIZED WATER
By	Miss Vipada Dokmai
Field of Study	Chemical Engineering
Thesis Advisor	Associate Professor Varong Pavarajarn, Ph.D.

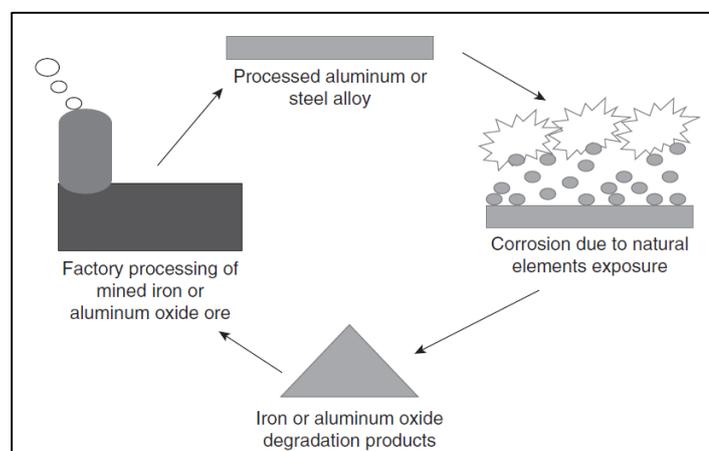
**Figure 2.1** Diagrammatic representation of corrosion cycle in general industries [5].

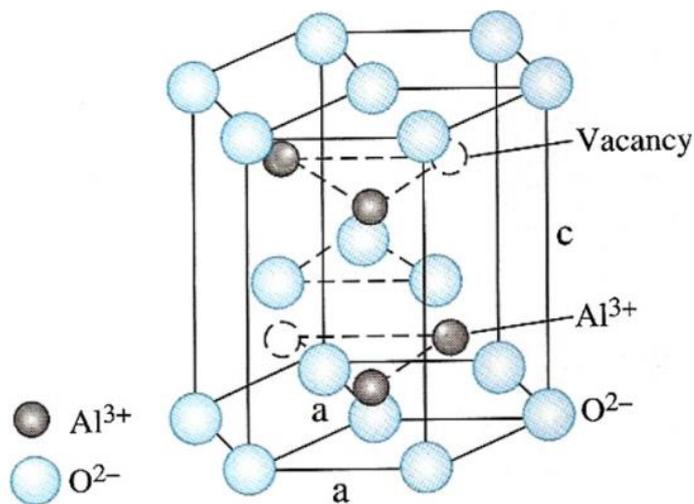
Figure 2.2 A hexagonal close packing of  $\alpha$ - $\text{Al}_2\text{O}_3$  structure [9]

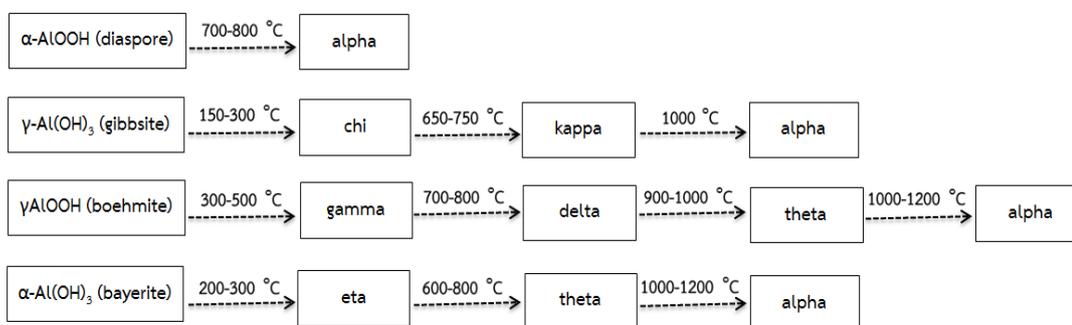
Figure 2.3 Transformation sequences related to metastable to alpha structures [10].

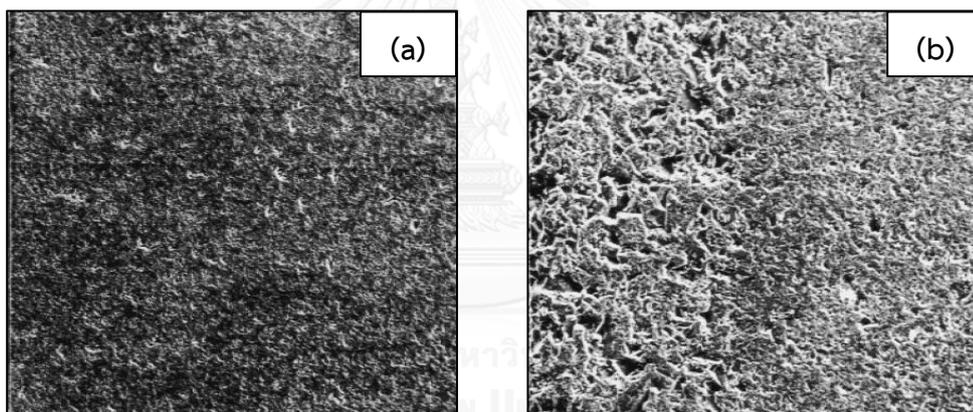
**Figure 2.4** Cross sectional area of alumina ceramic with (a) low impurities content and (b) high impurities content [11].

Generally, crystalline alumina has a good corrosion-resistance and chemically inert. However, there are many studies about the corrosion of alumina ceramic at high temperature, highly basic and acidic solution. For example, Oda et al. reported hydrothermal corrosion in different grade of alumina in water under temperature control at 300°C for 10 days, the result was shown that defect formed on surface caused by reaction and dissolution of impurities ( $\text{SiO}_2$  and  $\text{NaO}_2$ ) at grain-boundary of which cross section is shown in Figure 2.4. Moreover, it also concluded that the corroded layer at high impurities content has more thickness than at low impurities content, therefore, the corrosion of alumina ceramic was significantly involved in the impurity level [11].

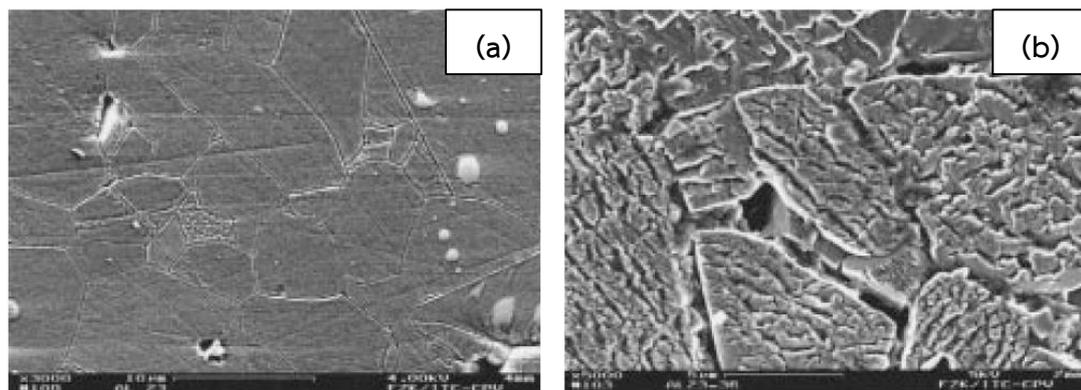
**Figure 2.5** Microstructure of ALC (99.7%  $\text{Al}_2\text{O}_3$ ) (a) before corrosion testing and (b) a corroded layer was formed on surface when exposed to HCl solution [12].

In addition, Figure 2.5 and 2.6 can be summarized that experimental conditions (i.e., corrosive agent, temperature, exposing time and composition at grain boundary) are important factors affecting alumina corrosion as well [12,13].

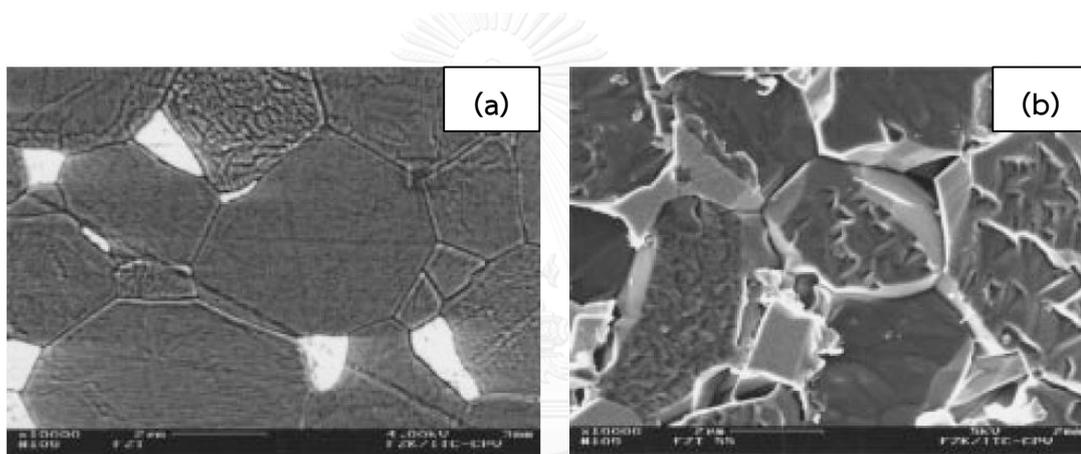
**Figure 2.6** Microstructure of ZTC ( $\text{ZrO}_2+\text{Al}_2\text{O}_3$ ) (a) before corrosion testing and (b) a corroded layer was formed on surface when exposed to  $\text{H}_2\text{SO}_4$  solution [12].

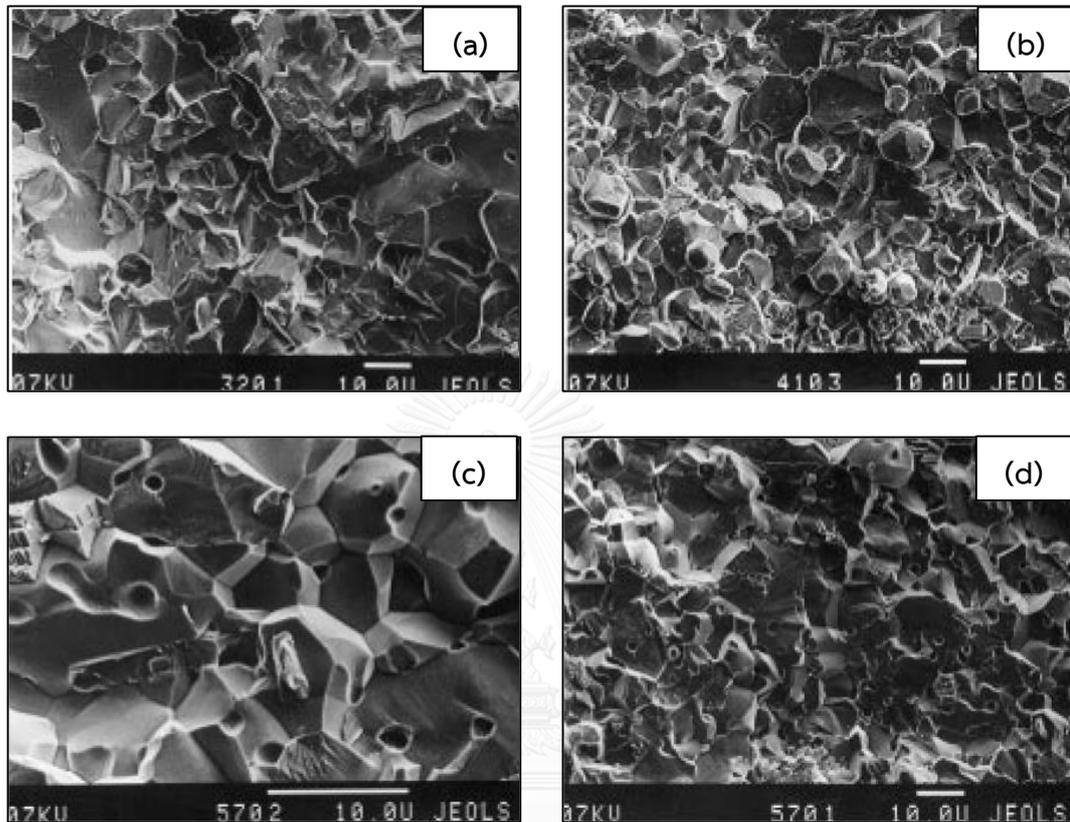
**Figure 2.7** SEM images of alumina after defect was formed on alumina surface tested (a) in air (b) in water and (c,d) in acid at pH = 1 [14].

The result can be concluded that the fracture was found on surface is originated from the interfacial chemical interaction between Mg-O bonding and acid. Additionally, it is directly related to the composition of element and environment conditions, and we can learn that adding Mg-O into alumina can decrease corrosive resistance of alumina ceramics [14].

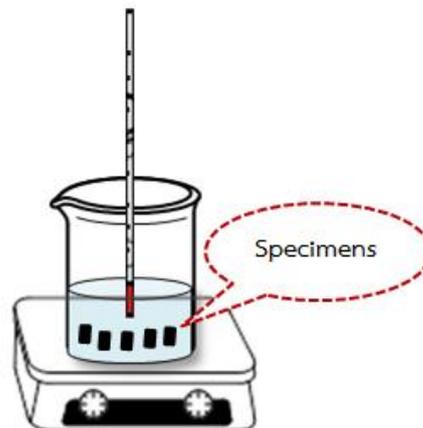
**Figure 3.2** The corrosion tests of alumina ceramics in deionized water.

Some industries have reported that alumina can be corroded in deionized water at low temperature. In this preliminary study, it needs to replicate the corrosion on the specimens to make sure that it is possible to see the defect formed on the surface. Before corrosion testing, specimens are thoroughly washed with isopropyl alcohol (IPA) and distilled water. Then, cleaned specimen is placed into a beaker filled with deionized water. Target temperature is adjusted by heating the system with hot plate as shown in Figure 3.2.

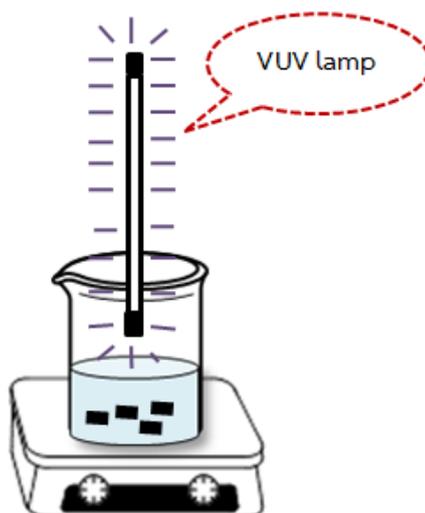
**Figure 3.3** Experimental set-up for the hydroxyl radical testing.

The corrosion test in this part was performed at the temperature of 50 °C and immersion time of 30, 60 and 90 minutes respectively. The specimens were put into deionized water and used the VUV (Vacuum Ultra Violet) lamp as the light source, which has a high potential to generate the hydroxyl radicals. The schematic diagram is shown in Figure 3.3.

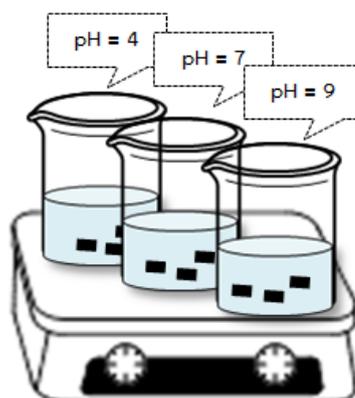
**Figure 3.4** Experimental set-up for studying the effect of pH.

This experiment was conducted in deionized water which various pH in very extreme condition (strong acid and strong alkaline solution). The solution was adjusted by hydrochloric acid (HCl) or sodium hydroxide (NaOH). The pH was set at 4, 7 and 9 in the temperature of 50 °C, the variation period of time at 30, 60 and 90 minutes. The experimental design is shown in Figure 3.4.

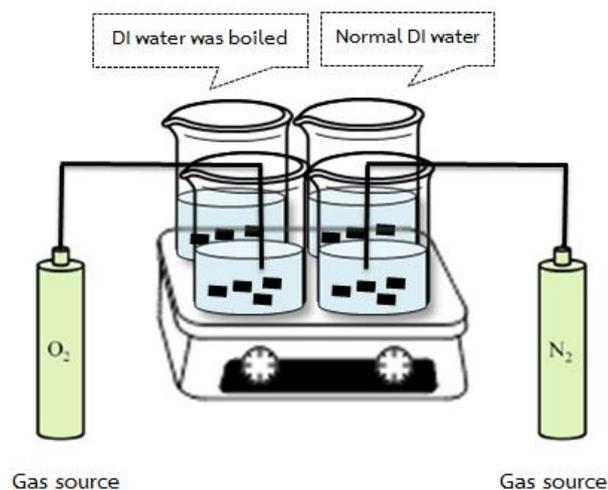
**Figure 3.5** Schematic diagrams for studying the effect of oxygen content in water.

In this experiment, the specimens were put in deionized water that was heated in two conditions; (i) at the temperature of 50°C for 30 and 90 minutes and (ii) at the temperature of 60°C for 15 and 50 minutes. This test was proposed to investigate the effect of oxygen content which may cause the defect. The test in this session has a diagram as shown in Figure 3.5. Oxygen content in deionized water was measured by Oxyguard equipment, and varied by four different kinds of water treatments as follows.

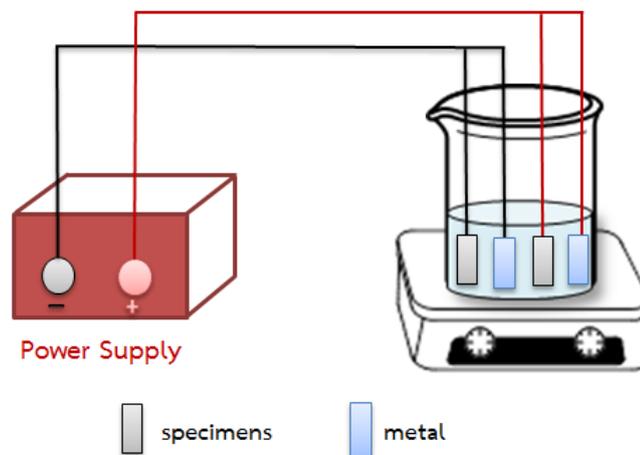
**Figure 3.7** Experimental set-up for the investigation the effect of electron transfer on corrosion of alumina.

In this part, the corrosion was tested to investigate effect of electrons transfer on the formation of defect. The experimental setup is shown in Figure 3.7. In the experiment, two specimens were tested simultaneously. The specimen was attached to one electrode of a DC power supply, while another one of electrode was connected with metal. Together with one specimen was connected to the positive electrode and another was connected to negative electrode, the power supply to

the specimen was varied in the range of 6 to 25 volt. All of specimens were immersed into deionized water in 2 conditions; (i) at the temperature of 50°C for 30 and 60 minutes and (ii) at the temperature of 60°C for 15 and 50 minutes. Additionally, the bottom of beaker was also contained a specimen without connecting with any electrode as a control the experiment.

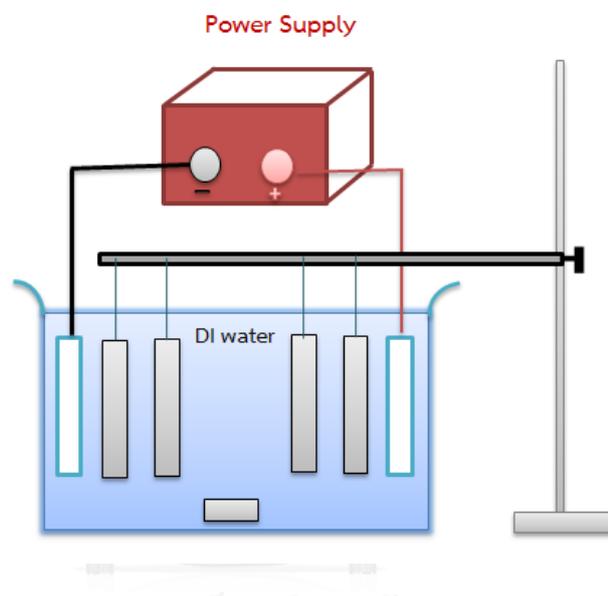
**Figure 3.8** Experimental setup for investigation the effects of the local concentration of  $H^+/OH^-$  in water.

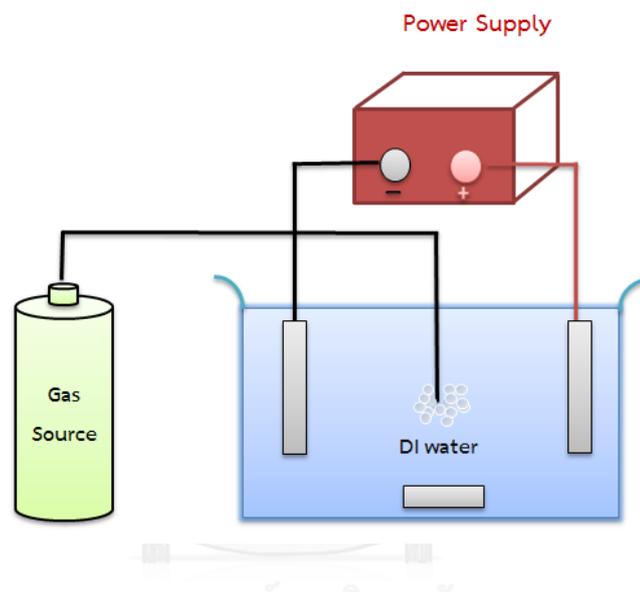
**Figure 3.9** Experimental set-up for investigation of the effect of electron transfer couple with oxygen content.

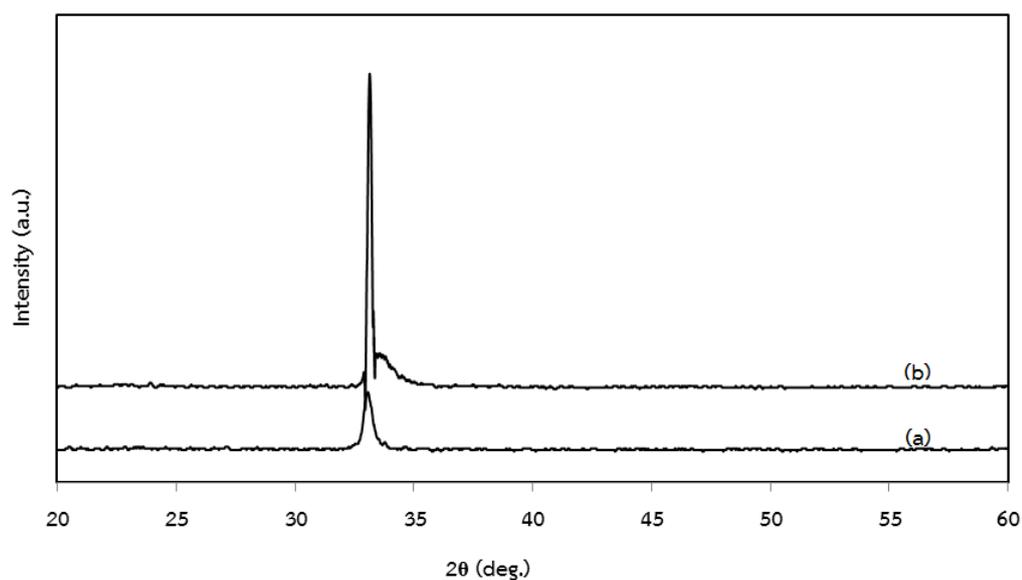
**Figure 4.1** The XRD patterns of alumina-coated coupons on silicon substrate. (a) the pattern of deposited state (b) the pattern after heat treatment

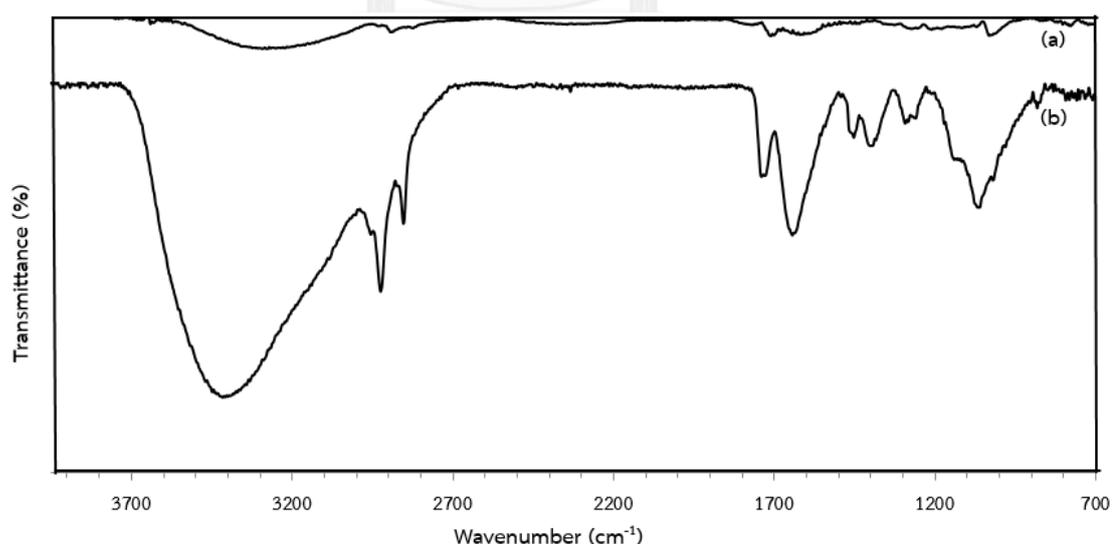
**Figure 4.2** FTIR transmittance spectra of alumina-coated coupons. (a) the alumina-coated coupons grown on Si-substrate (b) the spectra of alumina-coated coupons after the defect formed on the alumina surface.

From the FTIR results, it can be concluded that the corroded layer on the surface is caused by OH- group in DI water. This OH group can be reacting with amorphous alumina, which is hypothesized that it is hydrolysis reaction.

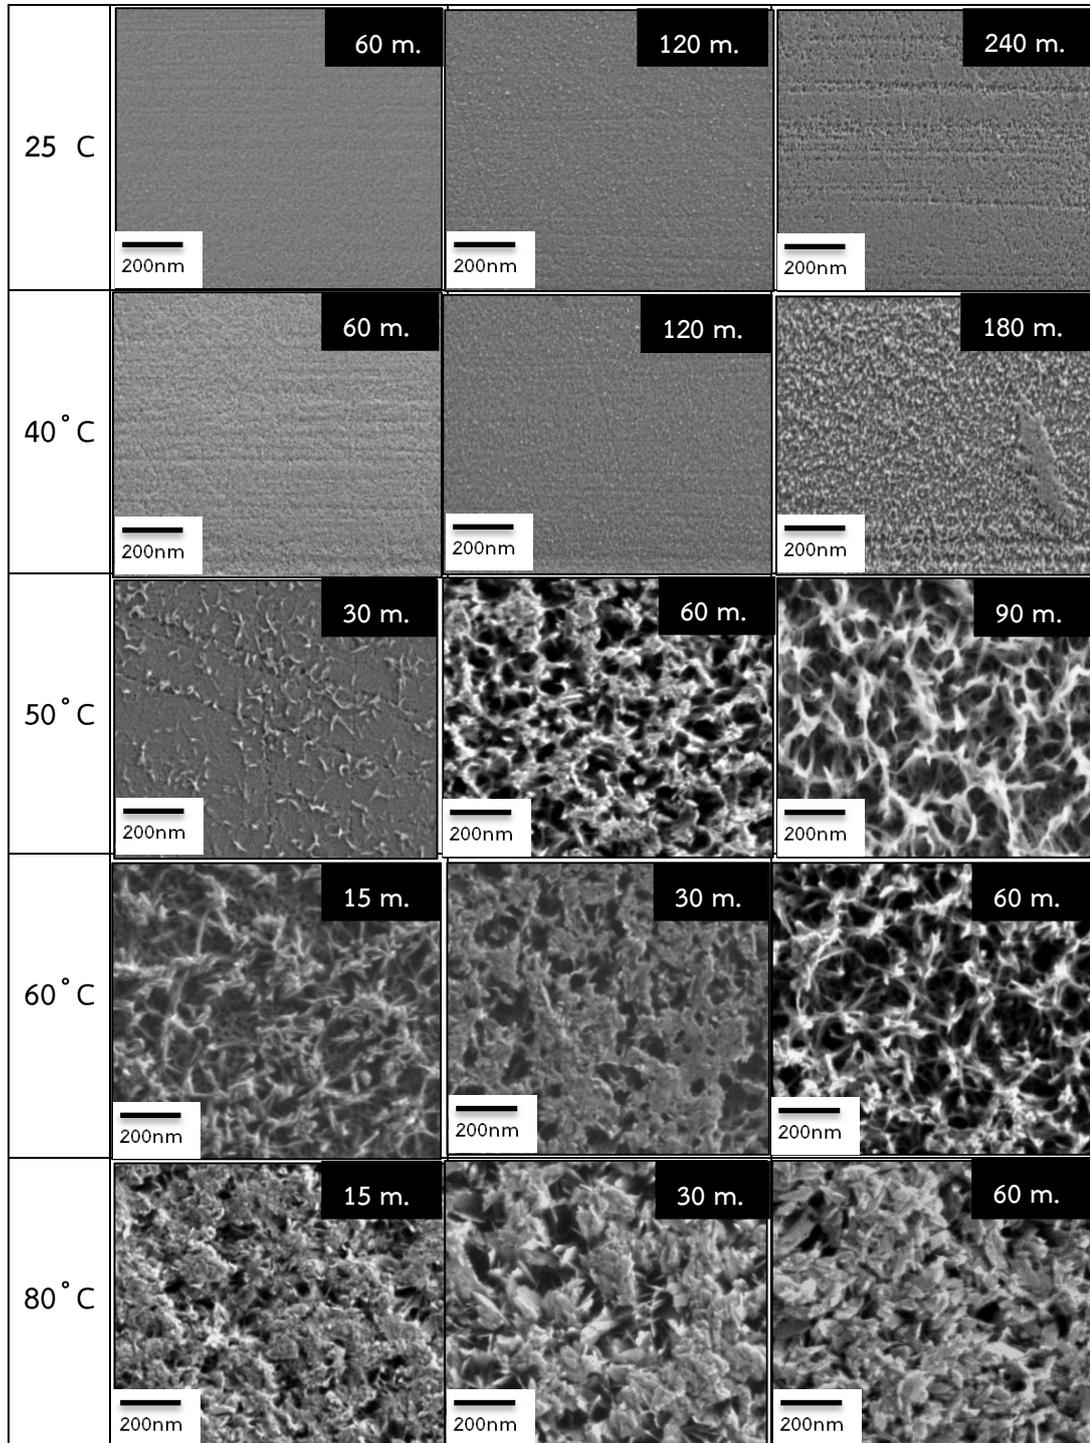
**Table 4.1** SEM results after the corrosion tests.

Each corrosion tests are repeated many times. The results indicated that no defect formed at temperature in the range of 25°C to 45°C although each specimen is immersed in DI water for a long period of time. Moreover, this experiment can be concluded that the temperature at 25°C and 40°C may not be the starting temperatures that cause the corrosion of amorphous alumina. From the SEM results, they can also be concluded that the defect becomes apparent at temperature 50°C, immersion time for 60 minutes (for the immersion time as 30 minutes, the defect is not clearly observed). These defects tend to increase when the immersion time is prolonged. Especially, the severe level of the defect is formed on the surface of specimens at the temperature 60°C to 80°C s although they are immersed in DI water in short period of time.

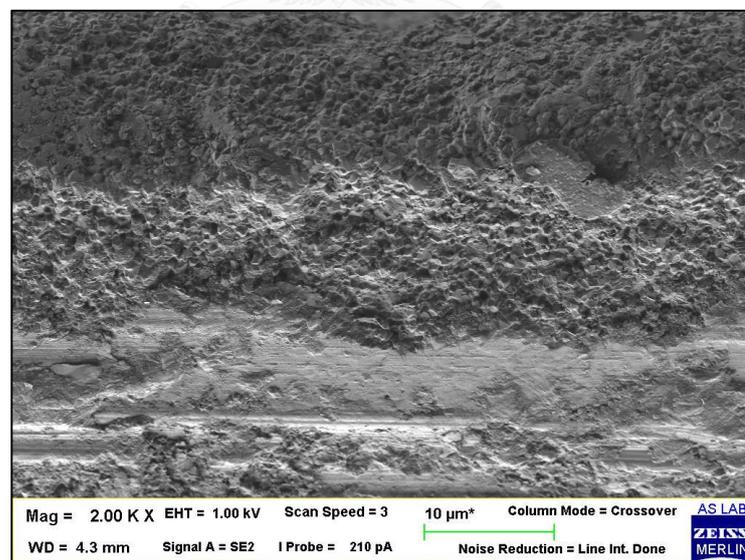
**Figure 4.3** Cross-sectional area of the specimen at 2.00KX magnification.

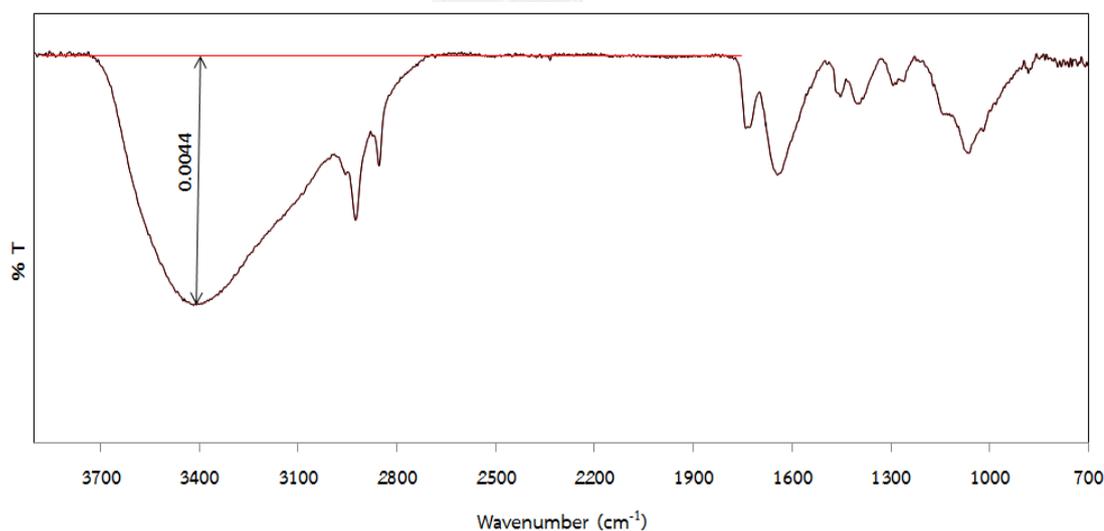
**Figure 4.4** Example of the OH peak height measurement analyzed by ATR-FTIR at the temperature of  $50^{\circ}\text{C}$  for 60 minutes.

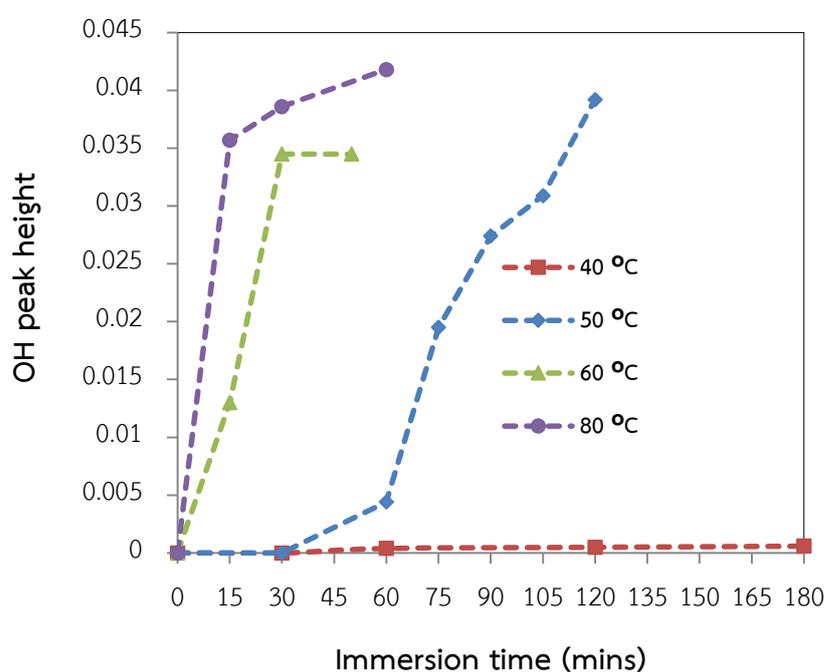
**Figure 4.5** The correlation between the OH peak height and the immersion time in each condition.

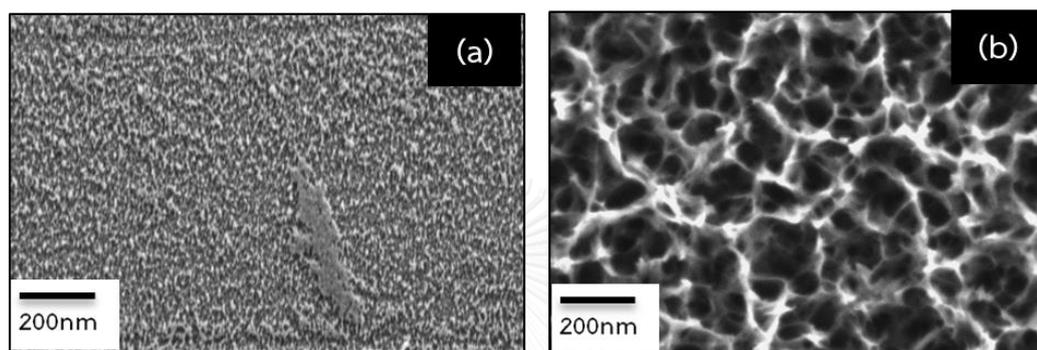
**Figure 4.6** SEM images of the specimens shows the result of the surface corrosion after the specimen is immersed in DI water at  $40^{\circ}\text{C}$  for (a) 180 minutes without irradiation and (b) 150 minutes with VUV irradiation.

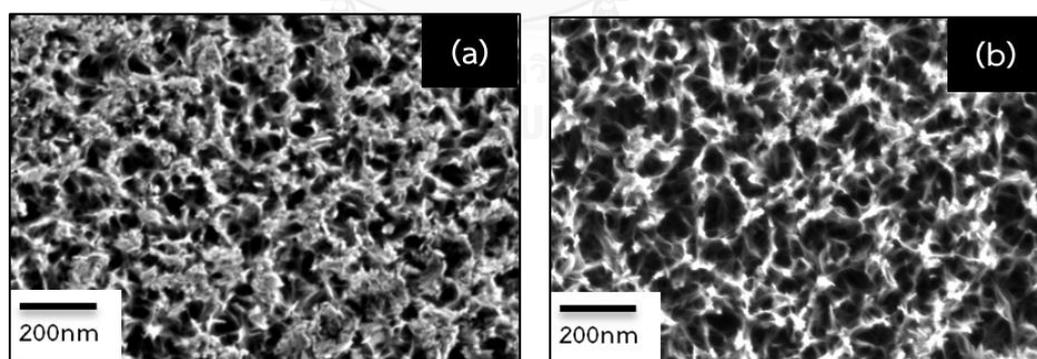
**Figure 4.7** SEM images of the specimens shows the result of the surface corrosion after the specimen is immersed in DI water at  $50^{\circ}\text{C}$  for 60 minutes (a) without irradiation and (b) with VUV irradiation.

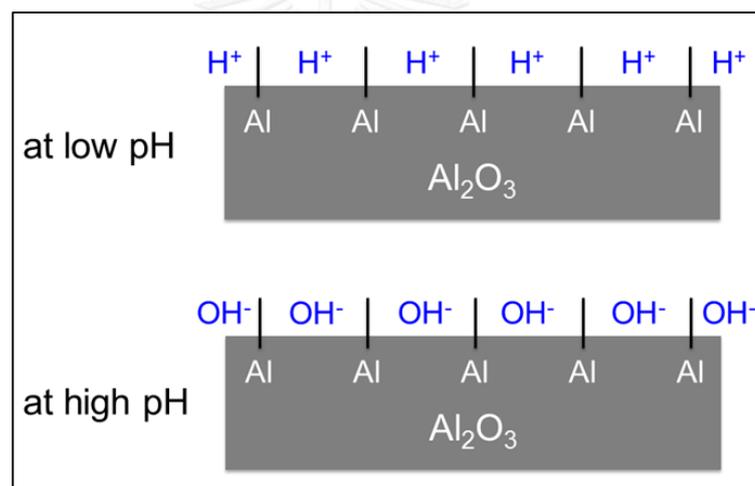
**Figure 4.8** The hypothesis for surface charge of the specimen when immersed in DI water at low and high pH, respectively.

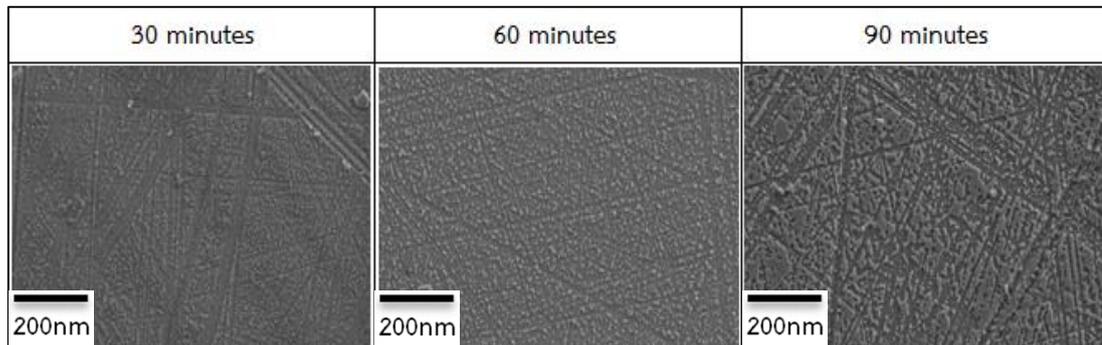
**Figure 4.9** SEM images of the specimens after the specimen is immersed in DI water at pH of 4 with various period of time.

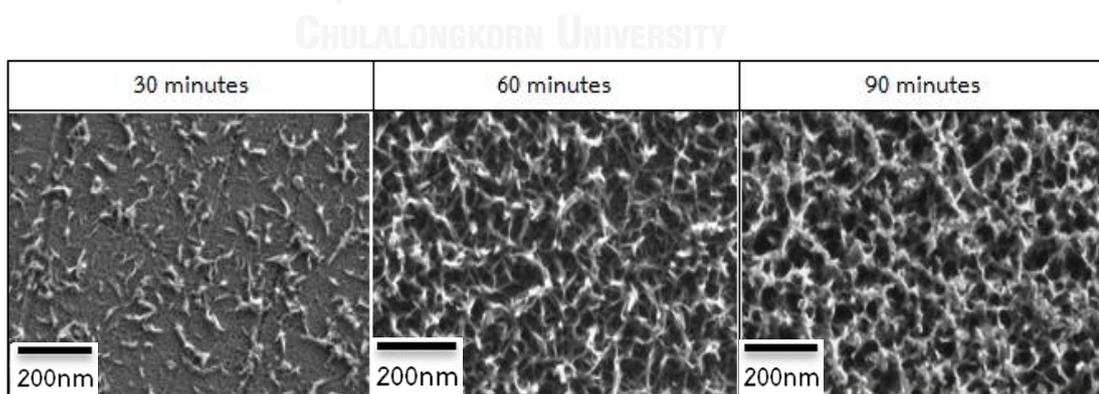
**Figure 4.11** SEM images of the specimens after the specimen is immersed in DI water at pH of 9 with various period of time.

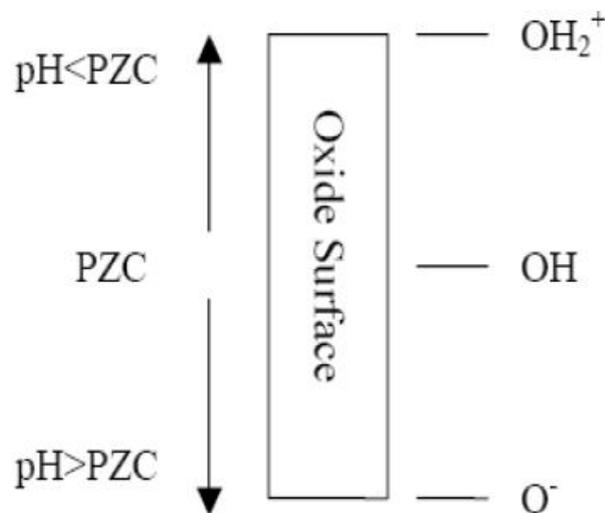
**Figure 4.12** The point of zero charge model for metal oxide. [19].

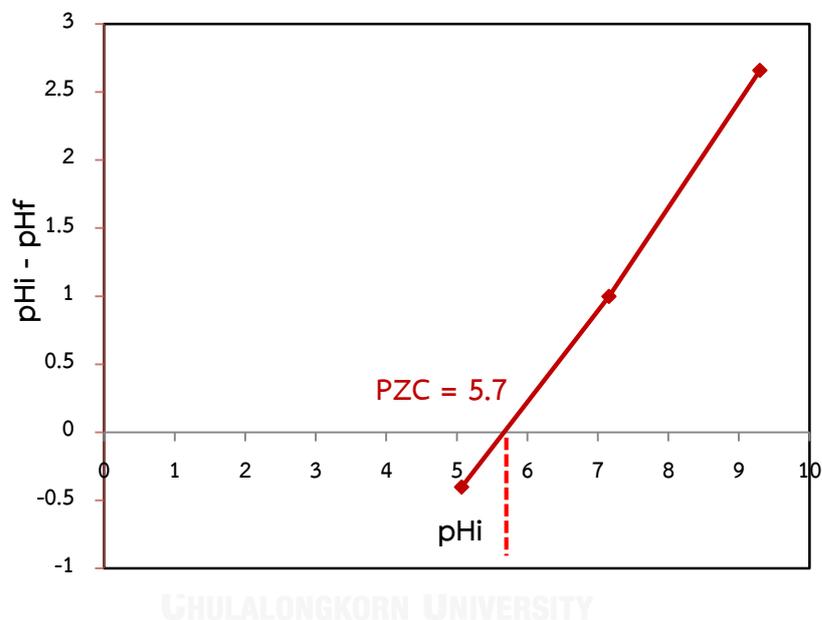
**Figure 4.13** The PZC of amorphous alumina measured by using titration method.

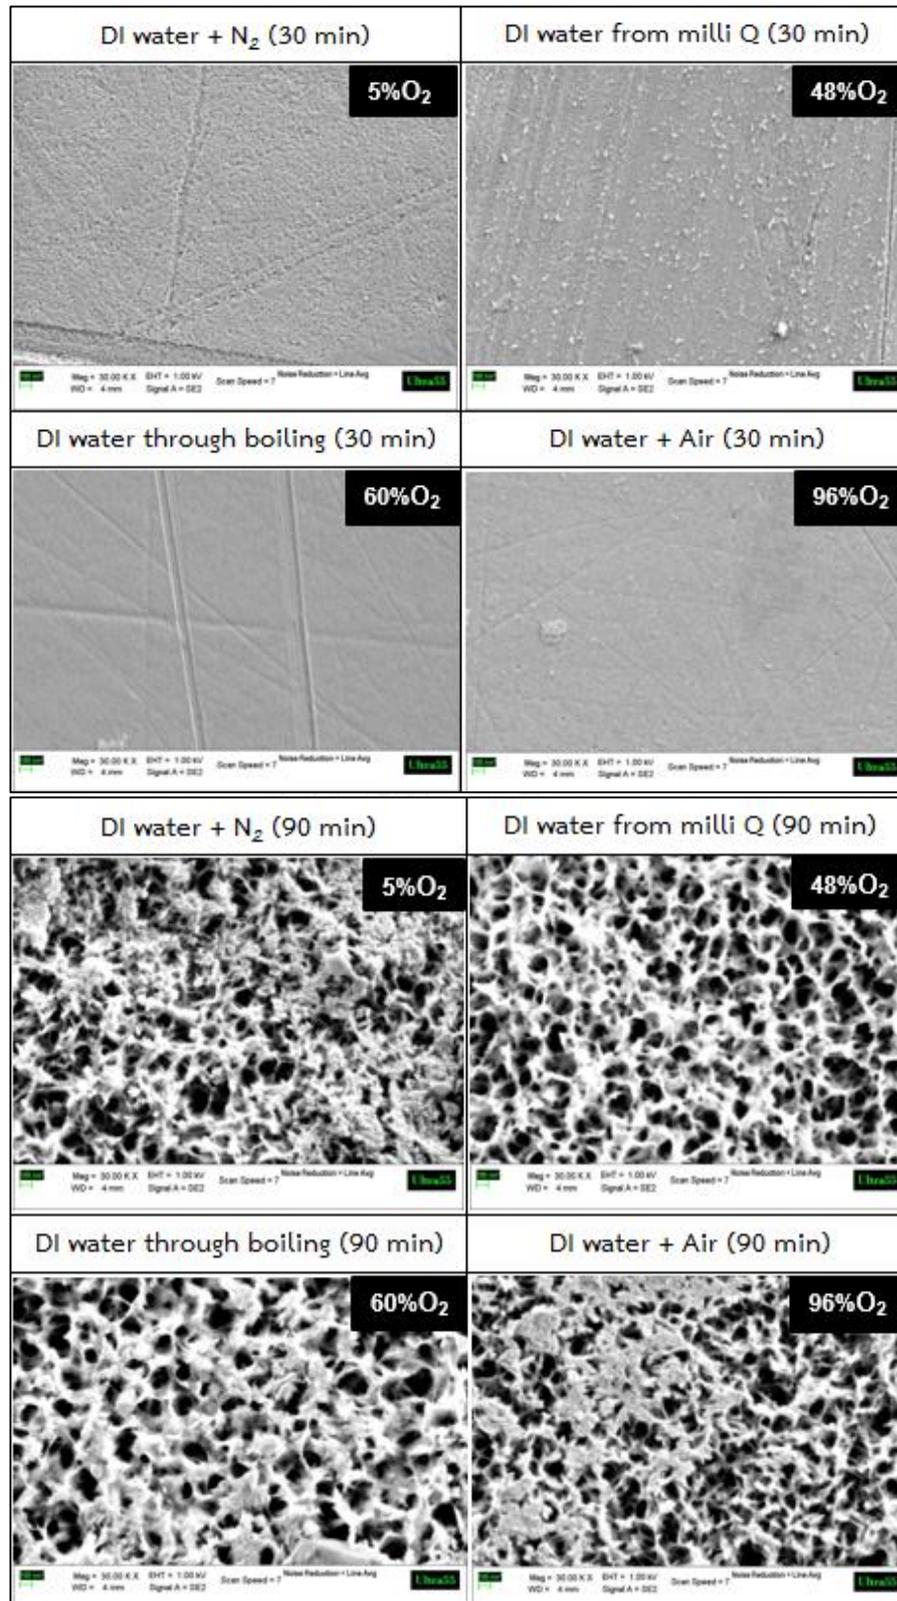
Figure 4.14 SEM micrograph of the specimen after immersed in DI water with various the amount of oxygen and immersion time at the temperature of 50°C.

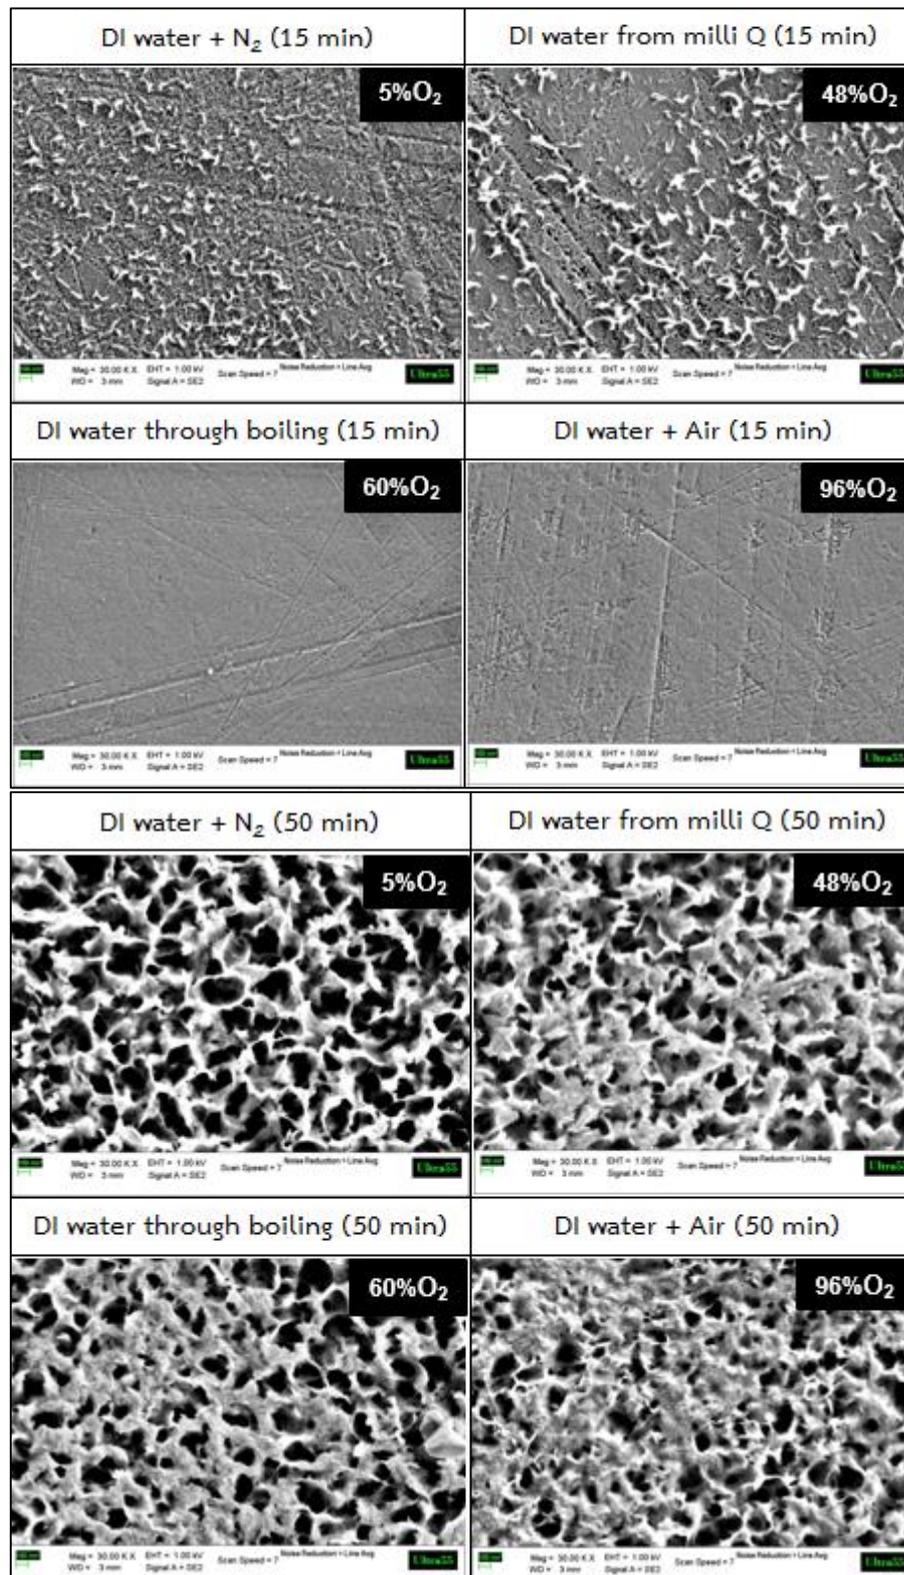
Figure 4.15 SEM micrograph of the specimen after immersed in DI water with various the amount of oxygen and immersion time at the temperature of 60°C.

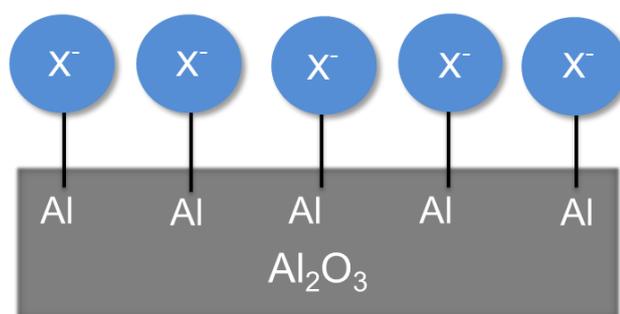
**Figure 4.16** The hypothesis of alumina surface model after added some anions in DI water.

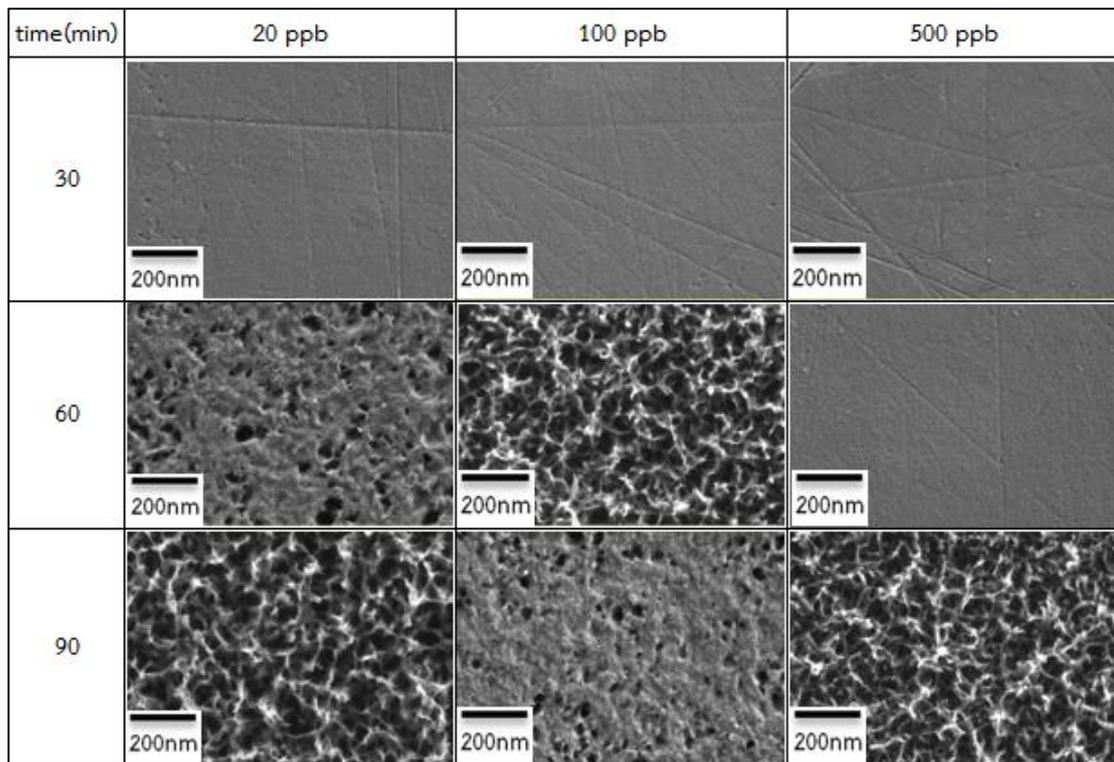
**Figure 4.17** SEM images of specimen after immersing into solution with  $\text{Cl}^-$  in various the concentrations and period of time.

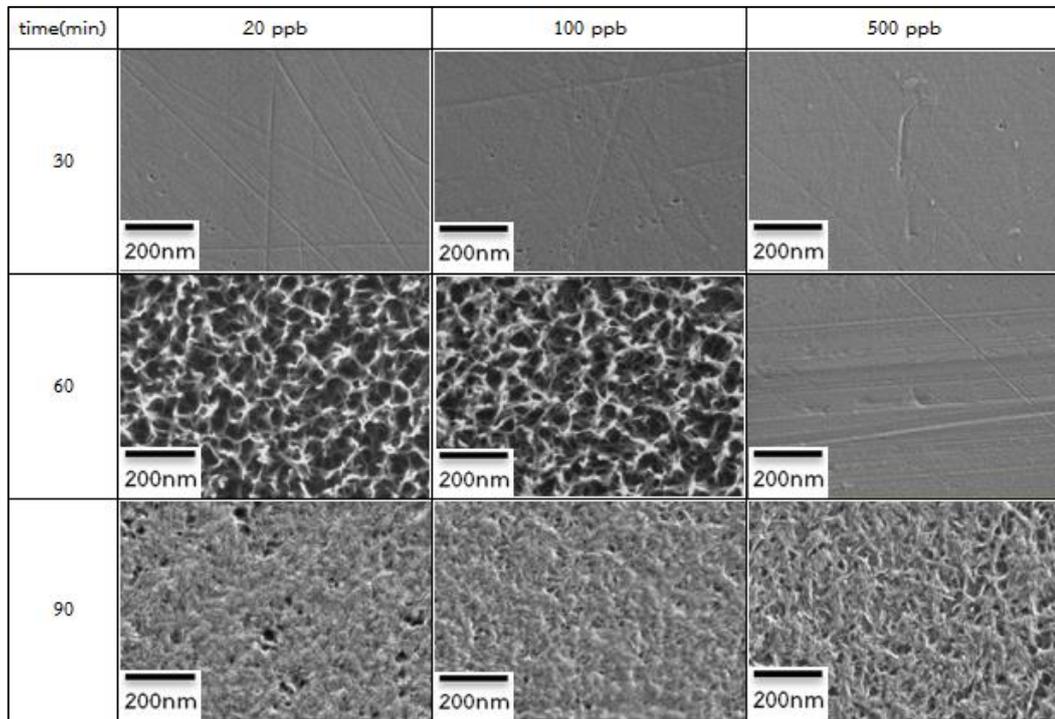
**Figure 4.18** SEM images of specimen after immersing into solution with  $\text{NO}_3^-$  in various the concentrations and period of time.

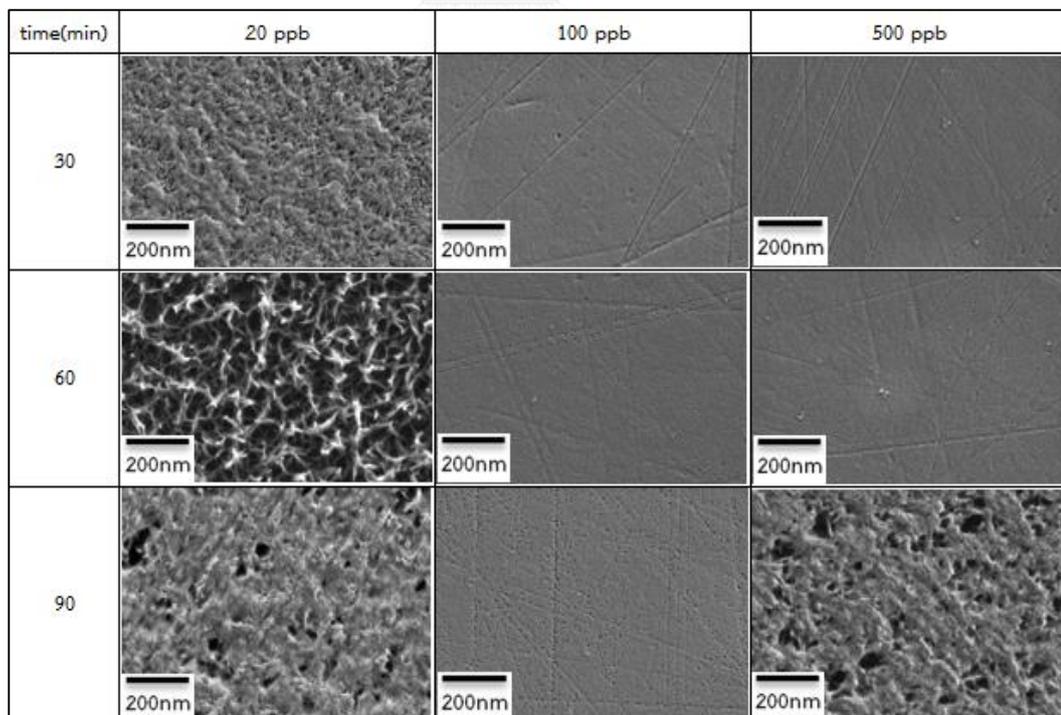
**Figure 4.19** SEM images of specimen after immersing into solution with  $\text{Br}^-$  in various the concentrations and period of time

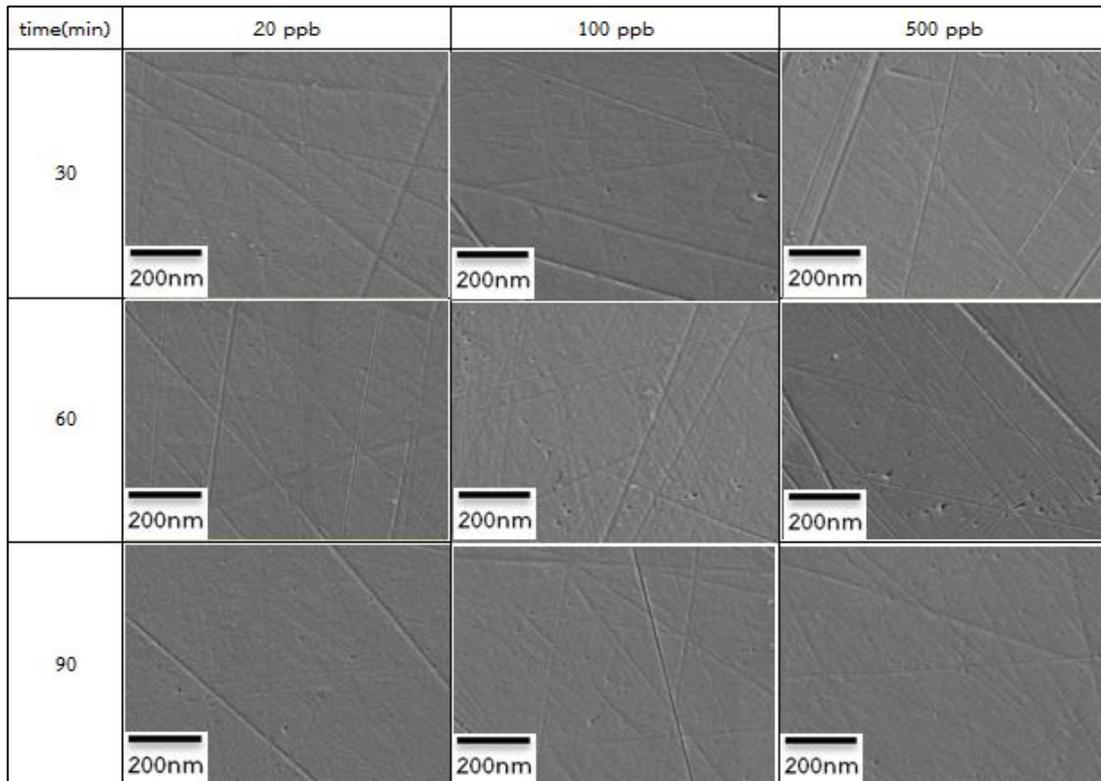
**Figure 4.20** SEM images of specimen after immersing into solution with  $\text{PO}_4^{3-}$  in various the concentrations and period of time.

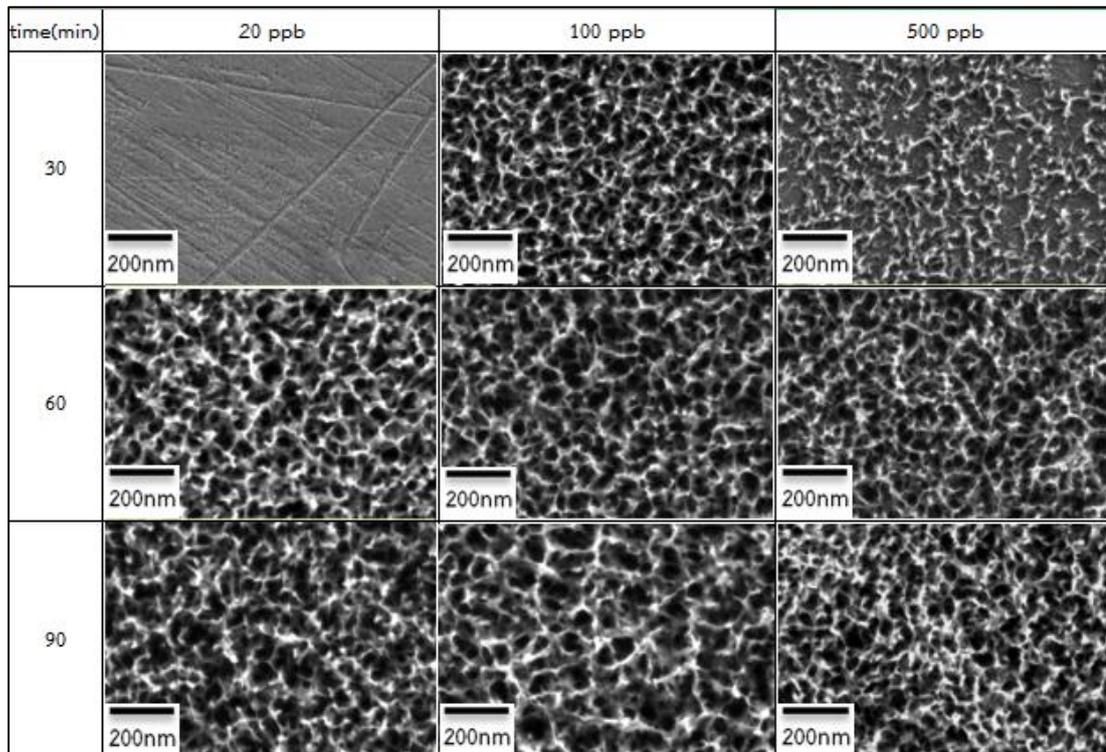
**Figure 4.21** SEM images of specimen after immersing into solution with  $K^+$  at the temperature of  $50^\circ C$  with various concentrations and period of time.

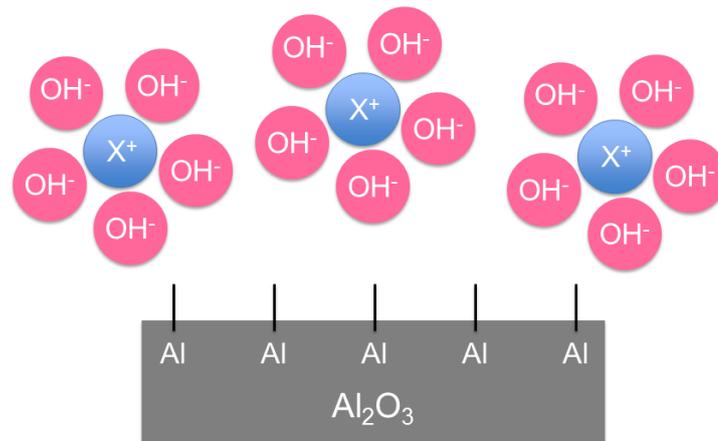
**Figure 4.22** The hypothesis of alumina surface model after added some cations in DI water.
