ALUMINA CORROSION IN DEIONIZED WATER

A Thesis Submitted in Partial Fulfillment of the Requirements  
for the Degree of Master of Engineering Program in Chemical Engineering

Thesis Title	ALUMINA CORROSION IN DEIONIZED WATER
By	Miss Vipada Dokmai
Field of Study	Chemical Engineering
Thesis Advisor	Associate Professor Varong Pavarajarn, Ph.D.

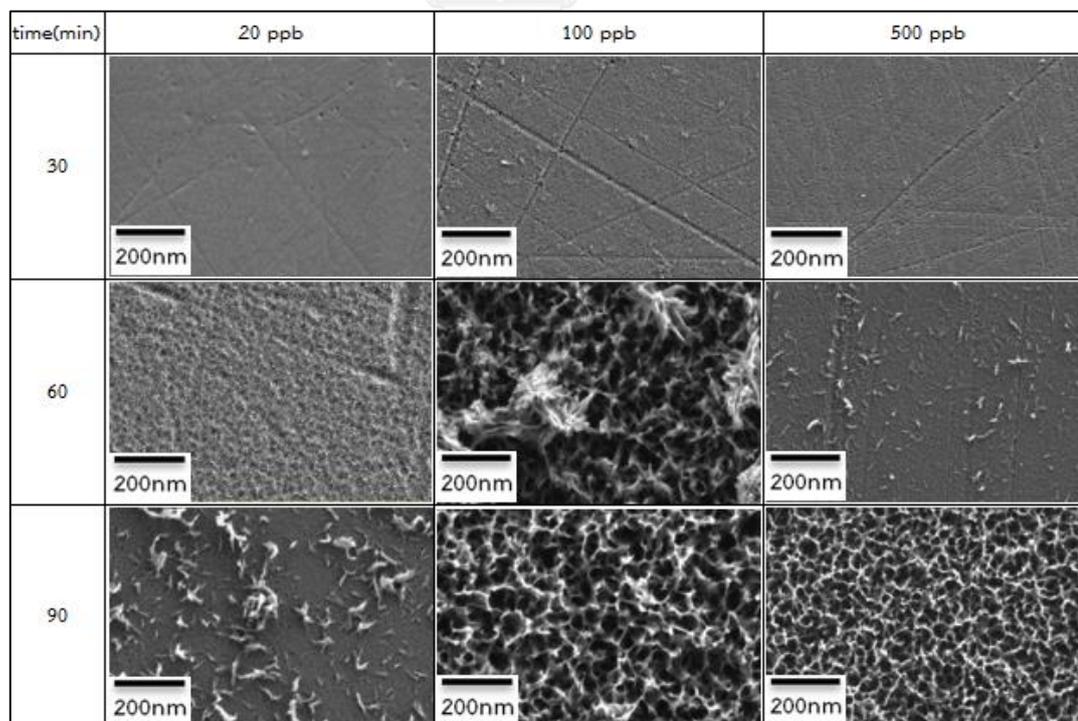
**Figure 4.23** SEM images of specimen after the specimen is immersed in solution mixed with  $Al^{3+}$  ion in various the concentrations and period of time.

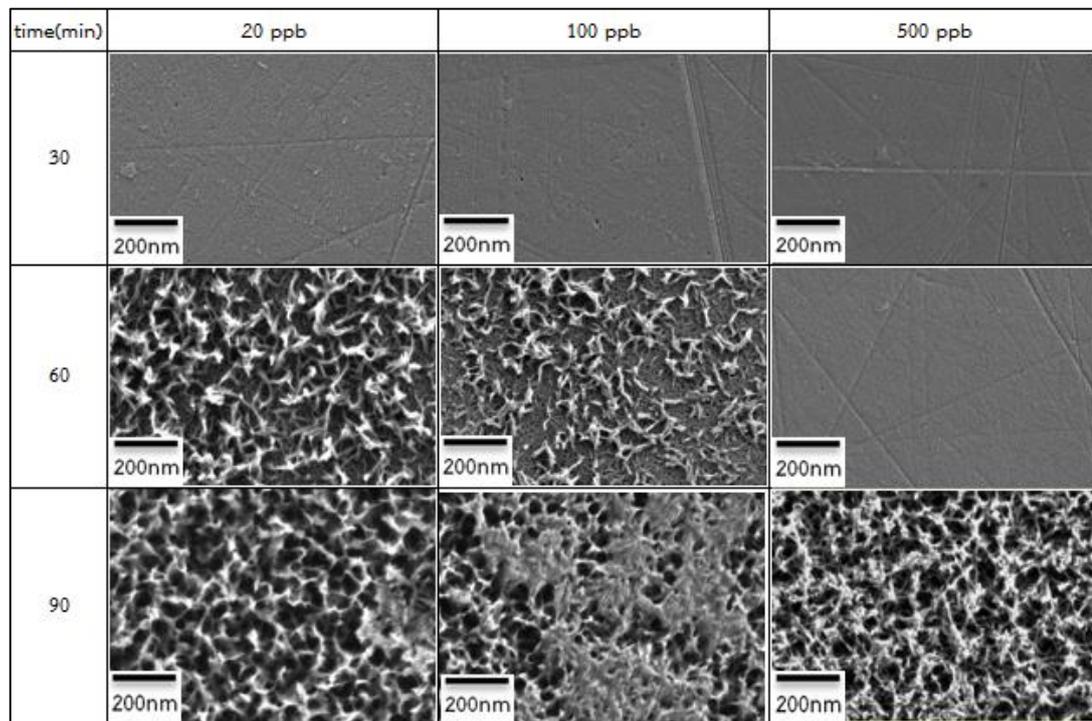
**Figure 4.24** SEM images of specimen after the specimen is immersed in solution mixed with  $Mg^{2+}$  ion in various the concentrations and period of time.

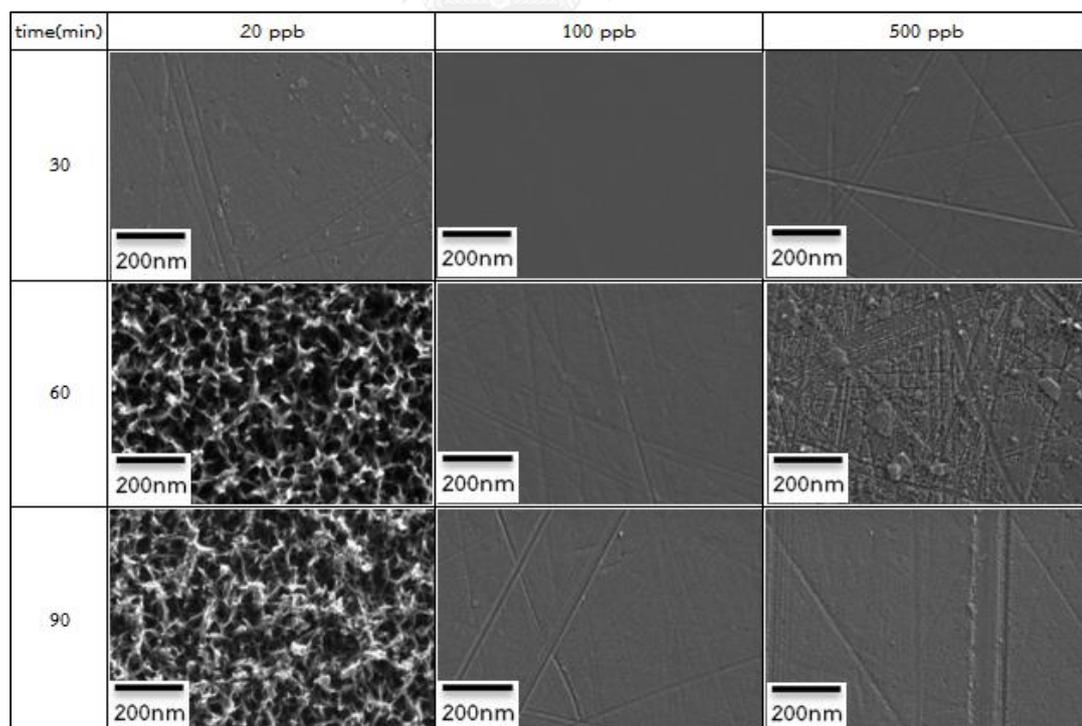
**Figure 4.25** SEM images of specimen after the specimen is immersed in solution mixed with  $Zn^{2+}$  ion in various the concentrations and period of time.

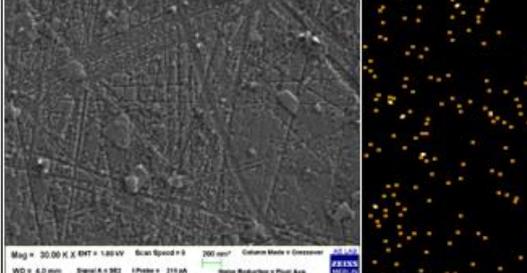
**Figure 4.26** The comparison between SEM images and ToF-SIMS analysis of the specimens after the specimen is immersed in DI water mixed with  $\text{Zn}^{2+}$  ions at various concentrations.

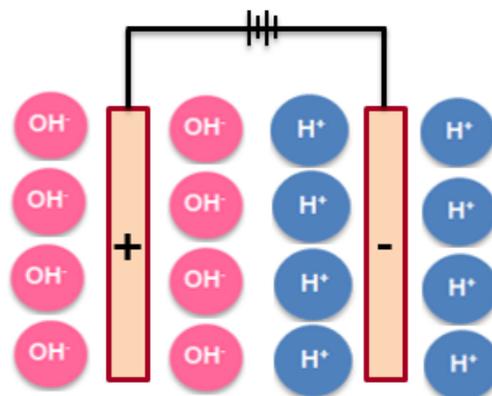
**Figure 4.27** Hypothesis of the specimens when applied potential to the system.

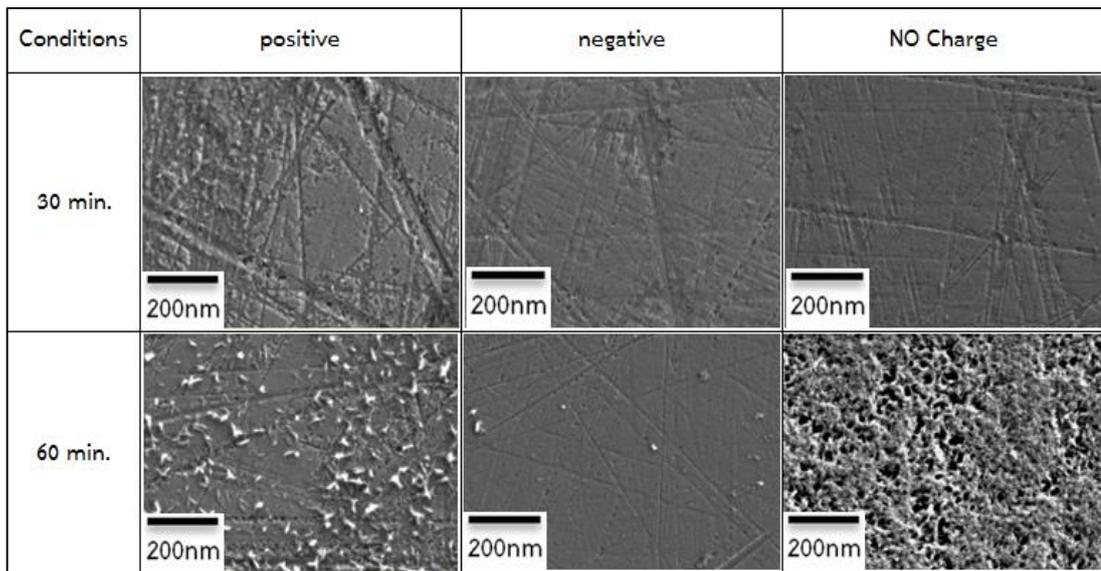
**Figure 4.28** The surface morphology of the alumina at each site of the electrodes after the specimen is immersed in DI water at 50°C with various period of time. The electric potential is applied at 6 V.

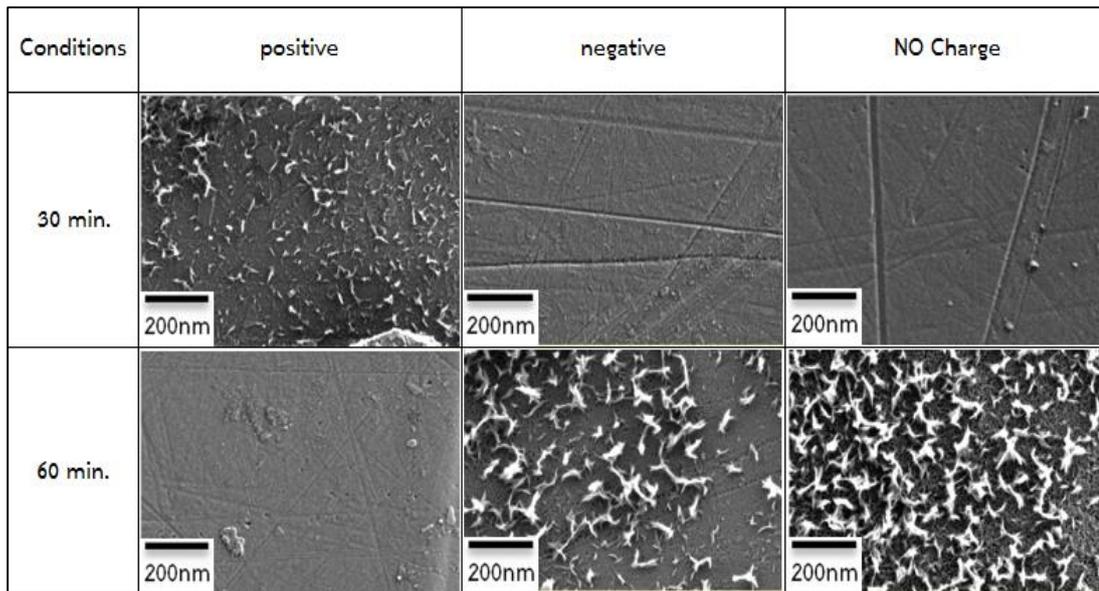
**Figure 4.30** The surface morphology of the alumina at each site of the electrodes after the specimen is immersed in DI water at 50°C with various period of time. The electric potential is applied at 20 V.

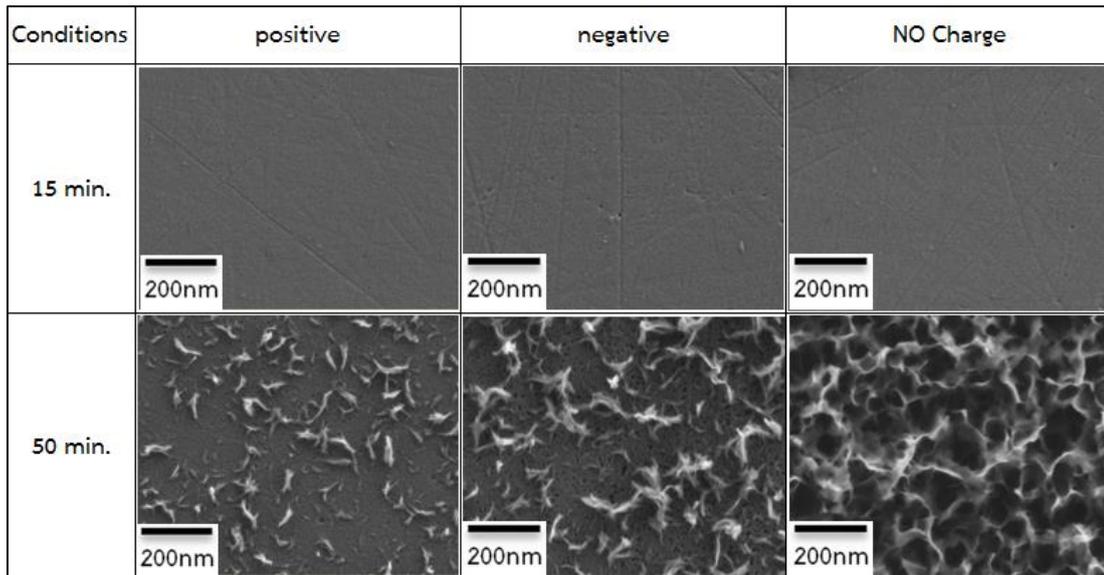
**Figure 4.31** The surface morphology of the alumina at each site of the electrodes after the specimen is immersed in DI water at 50 °C with various period of time. The electric potential is applied at 12 V.

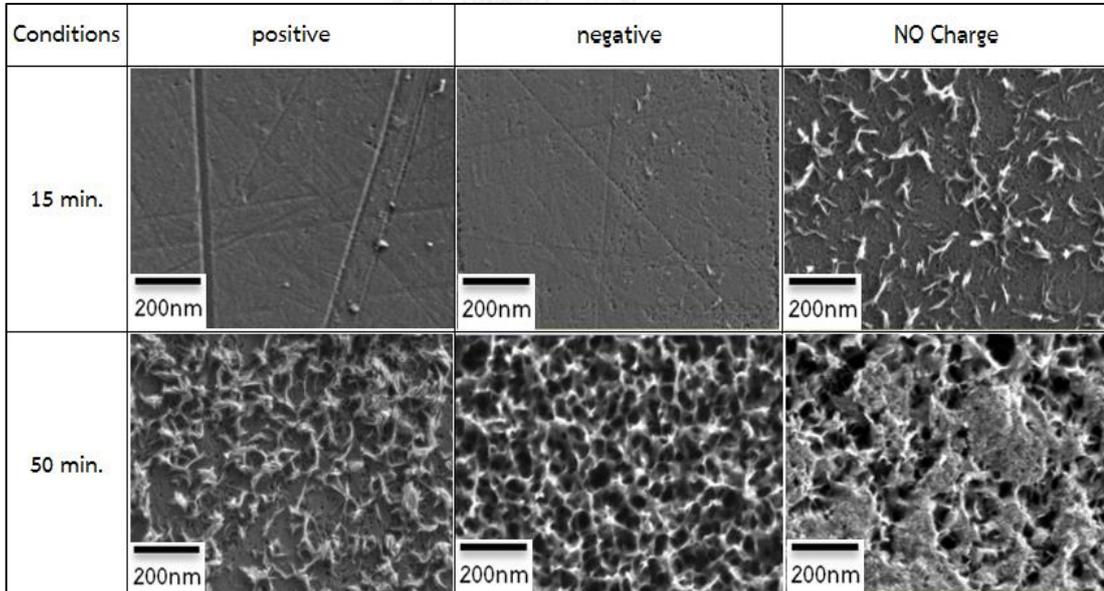
**Figure 4.32** The surface morphology of the alumina at each site of the electrodes after the specimen is immersed in DI water at 50 °C with various period of time. The electric potential is applied at 15 V.

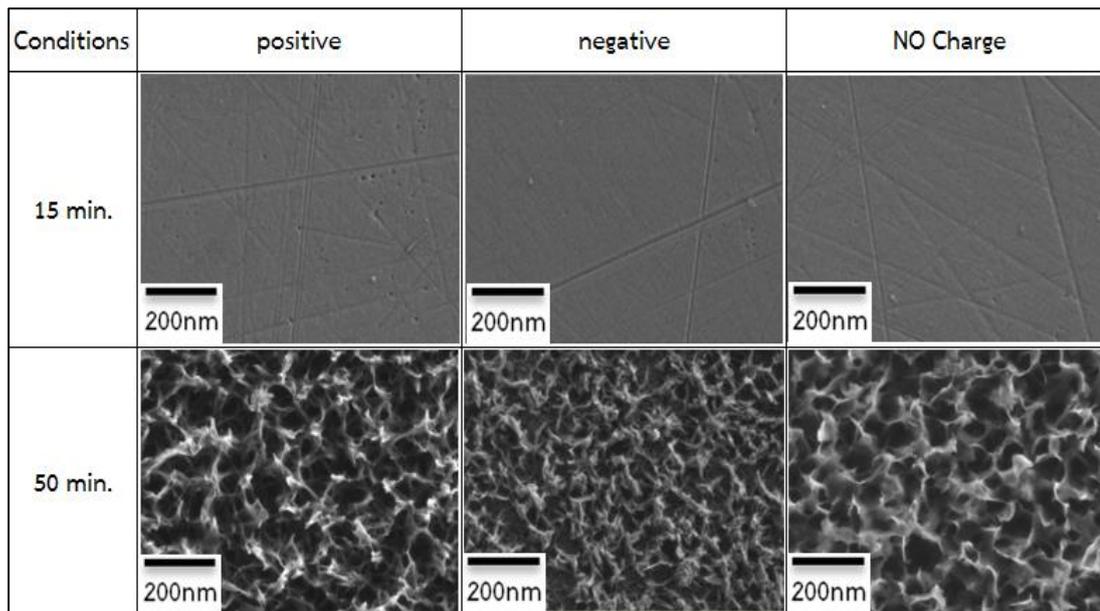
**Figure 4.33** The surface morphology of the alumina at each site of the electrodes after the specimen is immersed in DI water at 50 °C with various period of time. The electric potential is applied at 20 V.

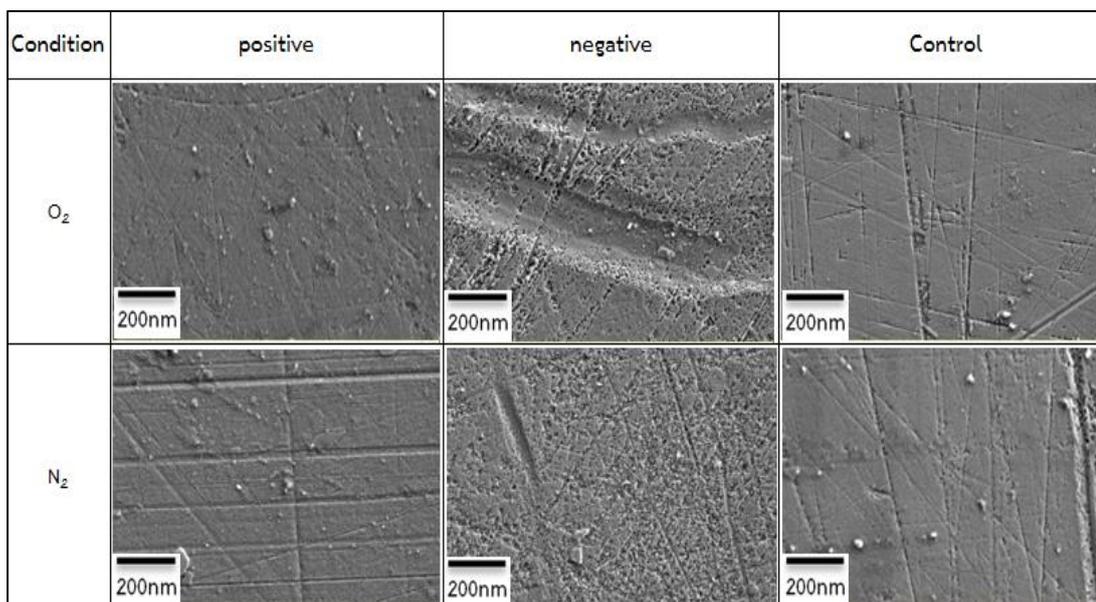
**Figure 4.34** The microstructure of the alumina surface when connected to each site of the electrodes and continuously bubbled O<sub>2</sub> and N<sub>2</sub> into DI water at 50° C for 30 minutes. The applied electric potential is 3 V.

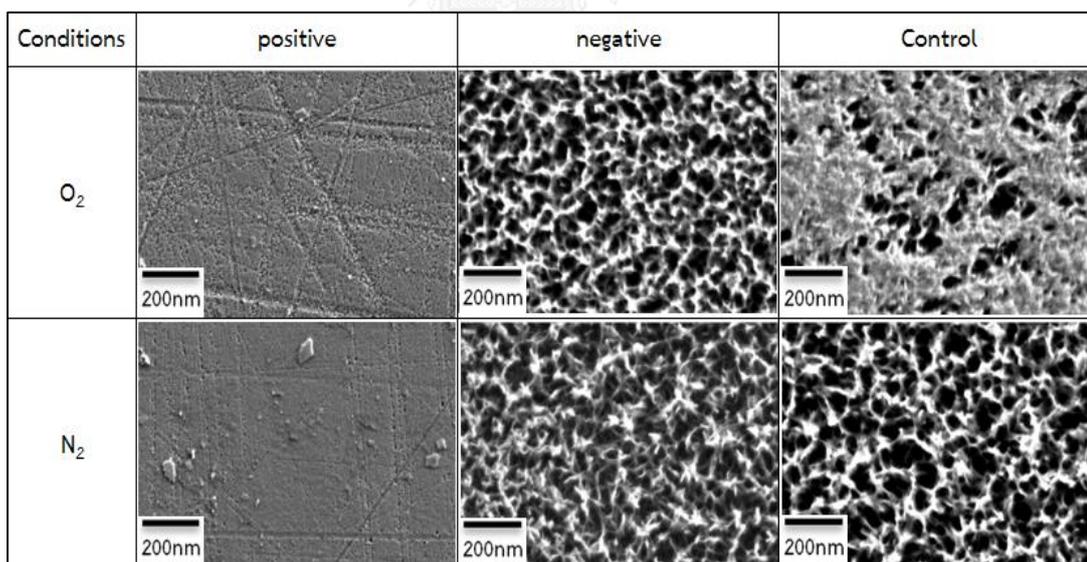
**Figure 4.35** The microstructure of the alumina surface when connected to each site of the electrodes and continuously bubbled O<sub>2</sub> and N<sub>2</sub> into DI water at 50° C for 60 minutes. The applied electric potential is 3 V.

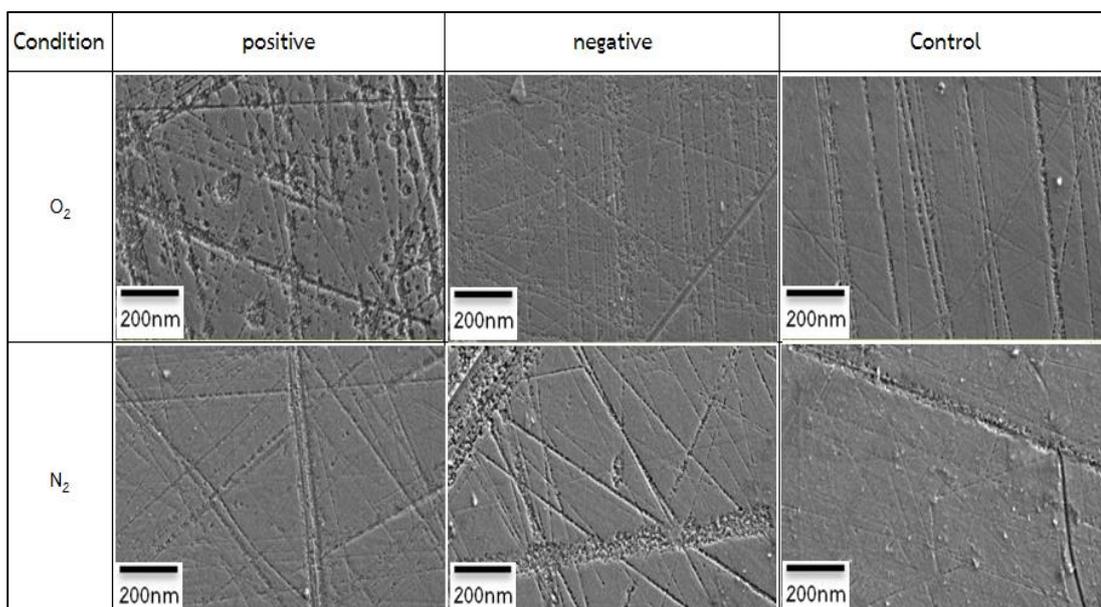
**Figure 4.36** The microstructure of the alumina surface when connected to each site of the electrodes and continuously bubbled O<sub>2</sub> and N<sub>2</sub> into DI water at 50° C for 30 minutes. The applied electric potential is 6 V.

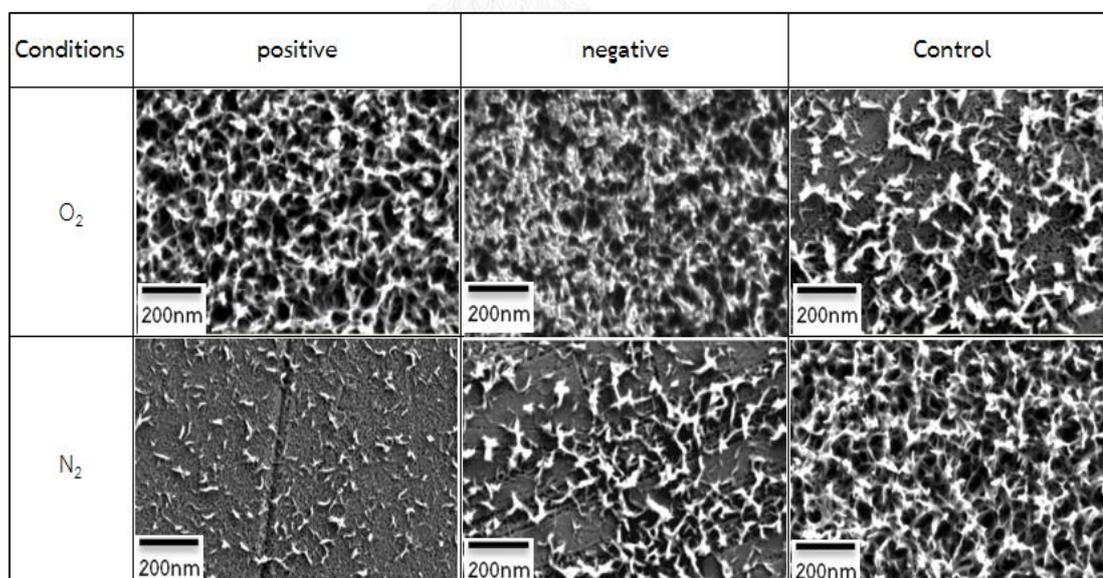
**Figure 4.37** The microstructure of the alumina surface when connected to each site of the electrodes and continuously bubbled O<sub>2</sub> and N<sub>2</sub> into DI water at 50° C for 60 minutes. The applied electric potential is 6 V.

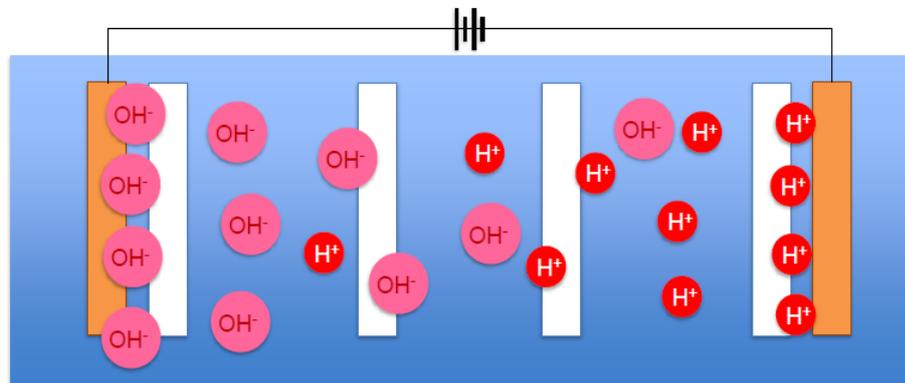
**Figure 4.38** The hypothesis for studying the effect of  $OH^-/H^+$  concentration.

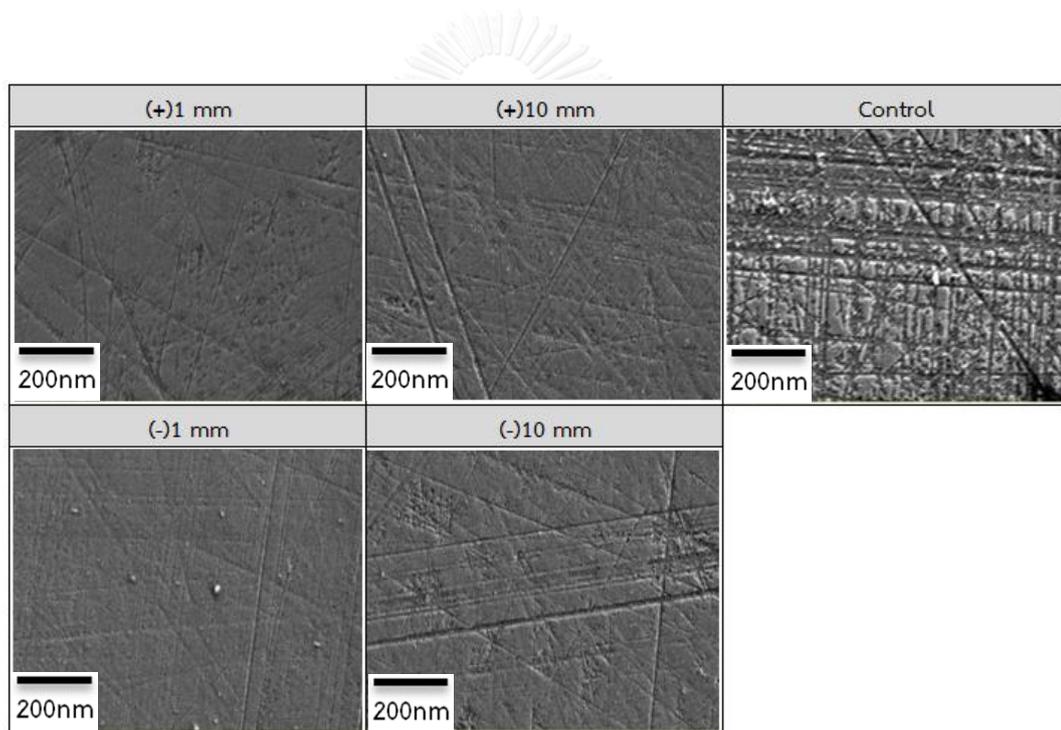
**Figure 4.39** The SEM images of the alumina layer after the specimens are immersed in DI water between the two electrodes at the temperature of 50°C for 30 minutes and applied electric potential 3 V.

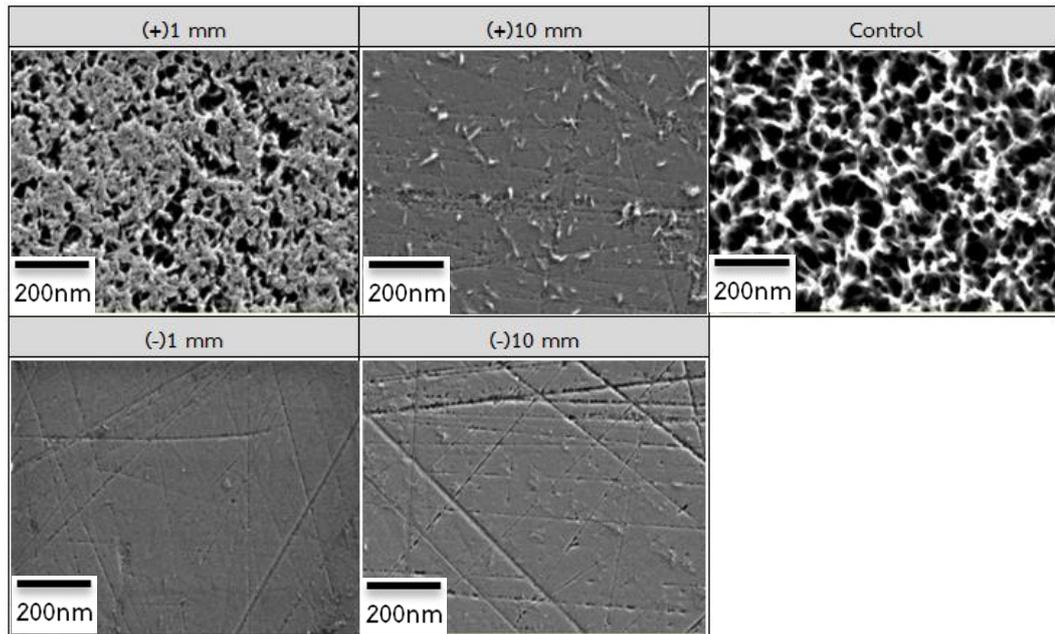
**Figure 4.40** The SEM images of the alumina layer after the specimens are immersed in DI water between the two electrodes at the temperature of 50°C for 60 minutes and applied electric potential 3 V.

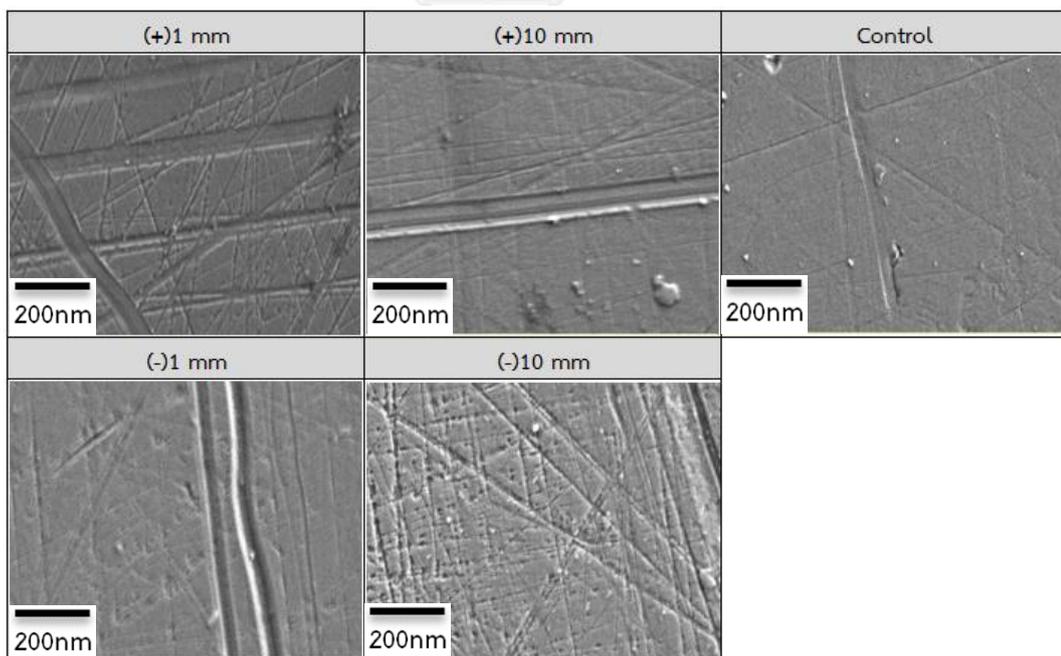
**Figure 4.41** The SEM images of the alumina layer after the specimens are immersed in DI water between the two electrodes at the temperature of 50°C for 30 minutes and applied electric potential 6 V.

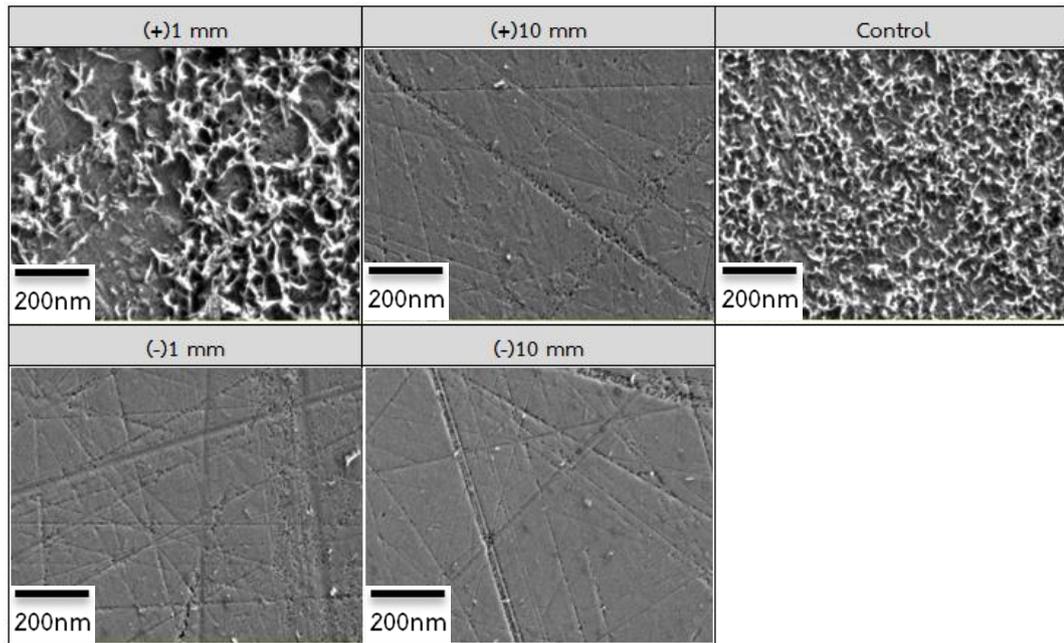
**Figure 4.42** The SEM images of the alumina layer after the specimens are immersed in DI water between the two electrodes at the temperature of 50°C for 60 minutes and applied electric potential 6 V.

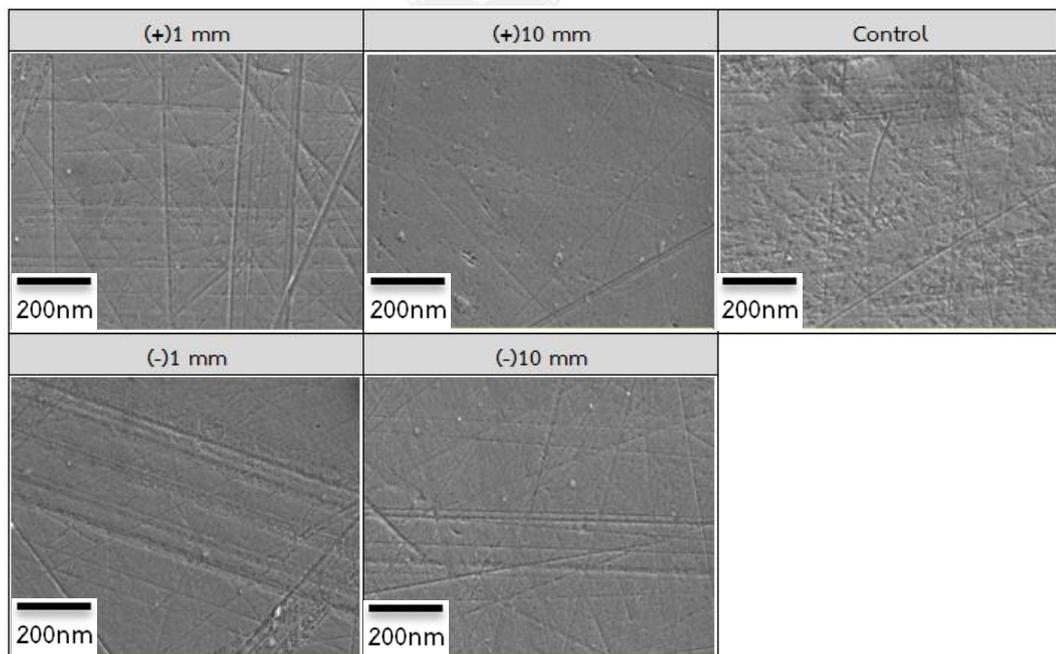
**Figure 4.43** The SEM images of the alumina layer after the specimens are immersed in DI water between the two electrodes at the temperature of 50°C for 30 minutes and applied electric potential 12 V.

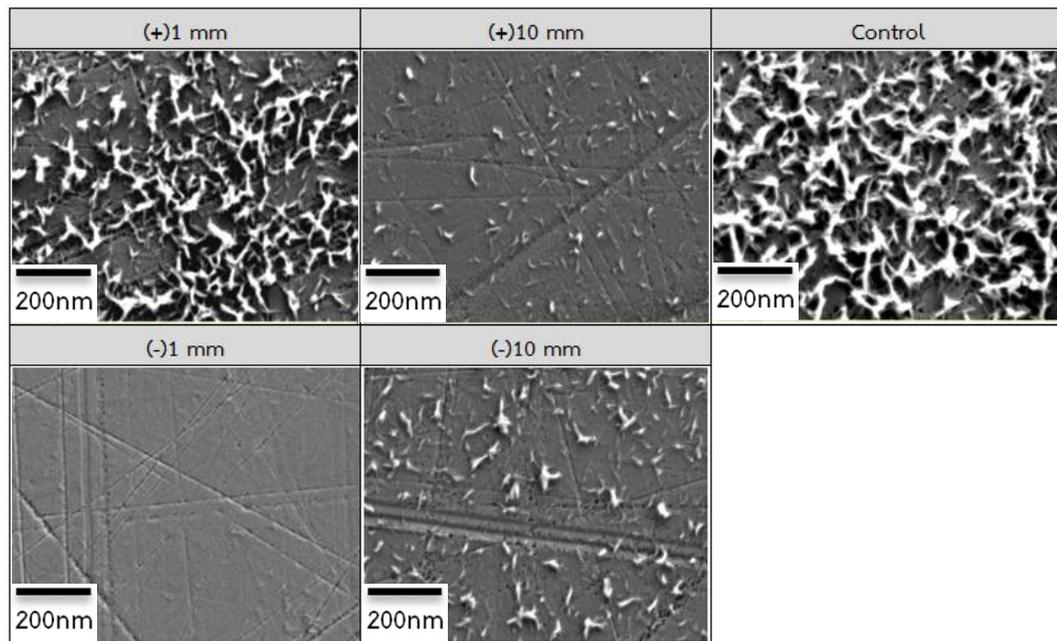
**Figure 4.44** The SEM images of the alumina layer after the specimens are immersed in DI water between the two electrodes at the temperature of 50°C for 60 minutes and applied electric potential 12 V.

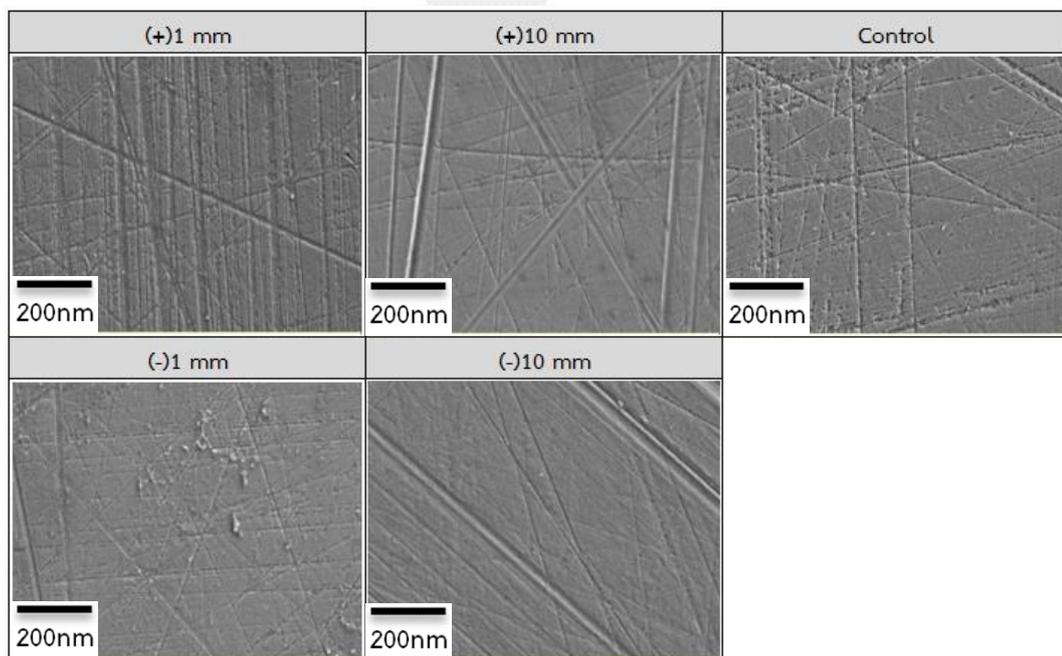
**Figure 4.45** The SEM images of the alumina layer after the specimens are immersed in DI water between the two electrodes at the temperature of 50°C for 30 minutes and applied electric potential 15 V.

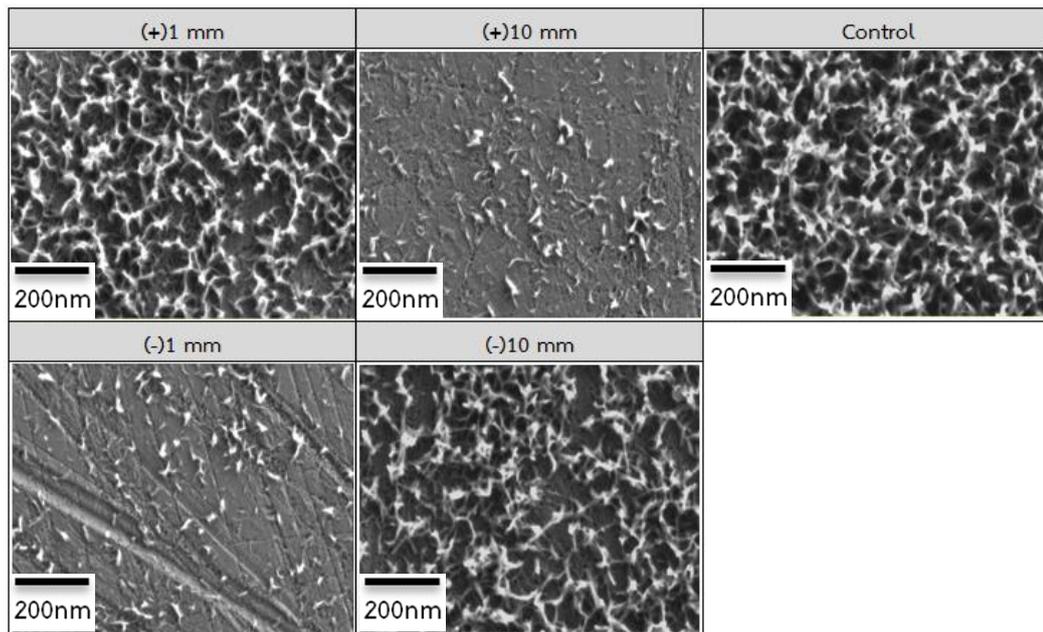
**Figure 4.46** The SEM images of the alumina layer after the specimens are immersed in DI water between the two electrodes at the temperature of 50°C for 60 minutes and applied electric potential 15 V.

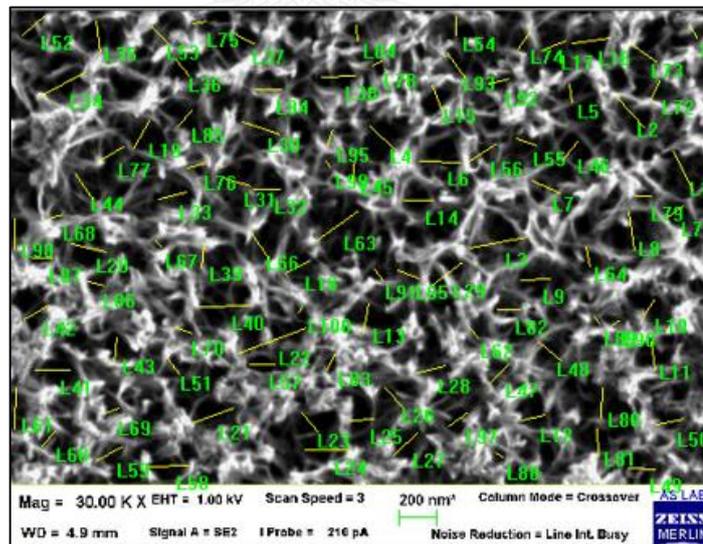
**Figure B.1** Example of measuring average particle size of the specimen after corrosion testing at 60 °C for 60 minutes.

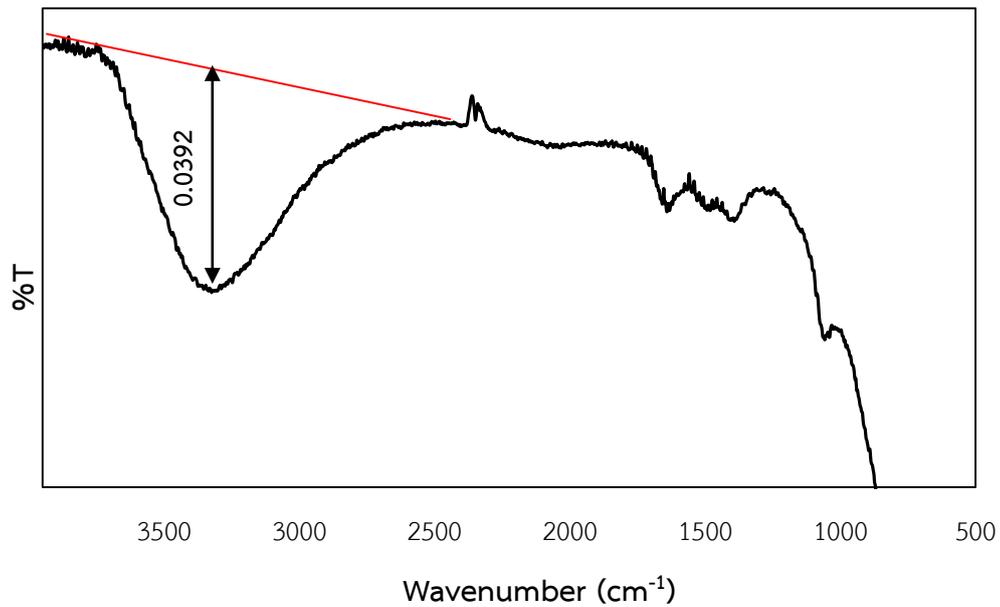
**Figure B.2** High of OH<sup>-</sup> peak after immersing the specimen into DI water at 50 °C for 120 minutes.
