A DEVELOPMENT OF KNOWLEDGE-BASED MODELS FOR CHECKING
DESIGN ERRORS IN BUILDING CONSTRUCTION PROJECTS IN CAMBODIA

A Thesis Submitted in Partial Fulfillment of the Requirements
for the Degree of Master of Engineering Program in Civil Engineering

Department of Civil Engineering

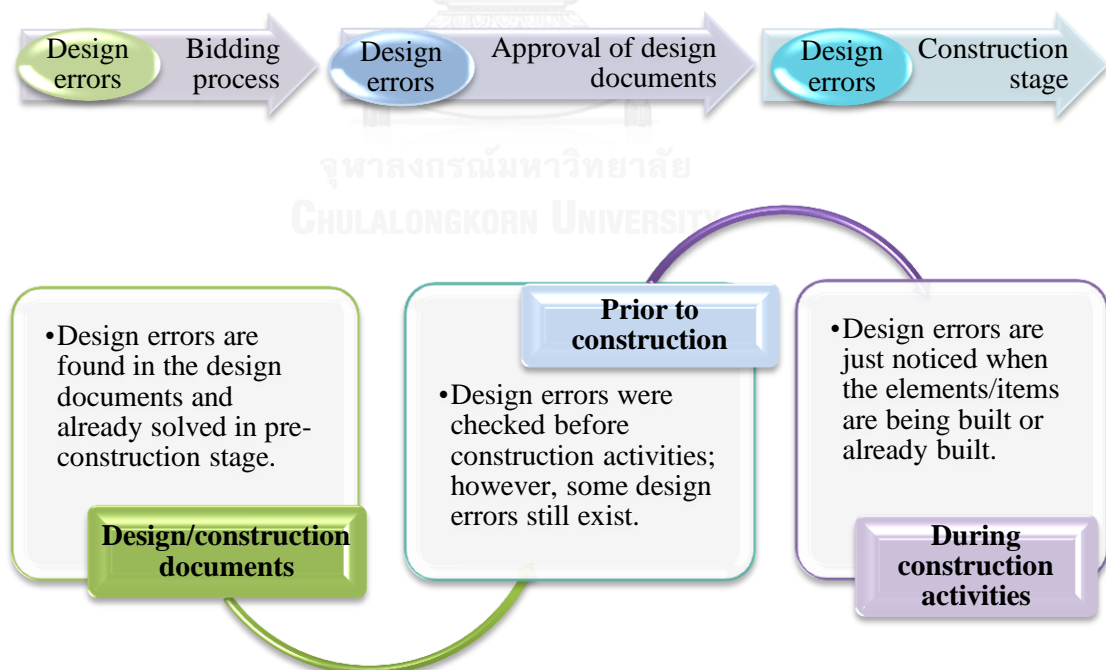
Figure 2.1 Stage of design errors

This research covers the problems of design errors that the experts have experienced so far after the design/construction documents are approved until the construction stage. The design errors which are found in the bidding process until the approval of the design/construction documents are not counted in this study.

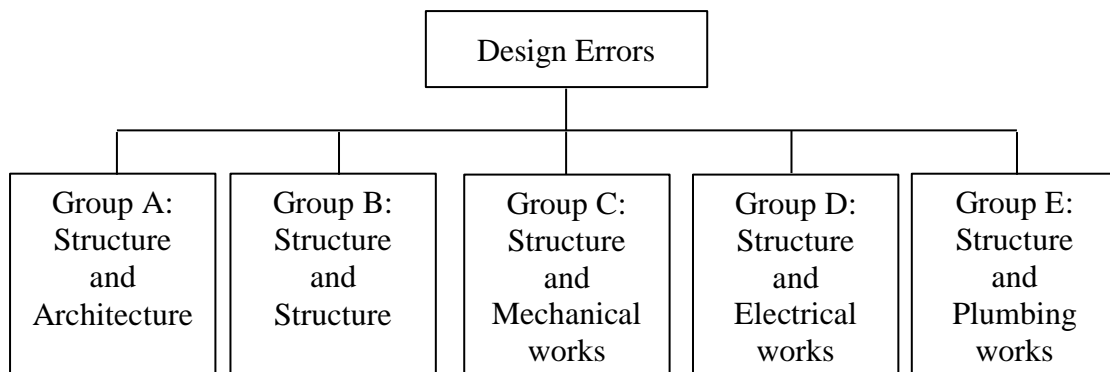
Figure 2.3 Design errors between structure and other building components (Austin et al., 1999)

The following figure presents the design errors between structure and other building components such as structure, architecture, and MEP systems to be studied.

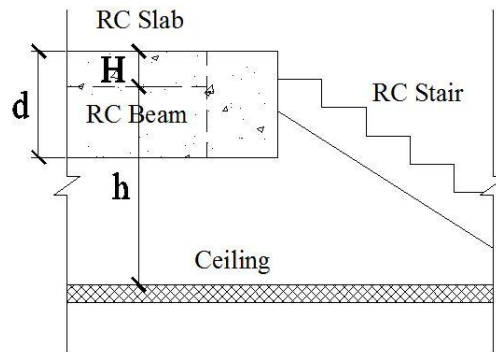
Ex 2 [1, 5] The case was quite similar as in the example 1. Because the slab was **precast concrete**, the **slab thickness** was not quite related. However, the **depth of beam in the top riser of stair** was deeper than the **depth of ceiling**. Therefore, the ceiling works had to be modified.
