CHAPTER 4

EXPERIMENTAL RESULTS AND DISCUSSION

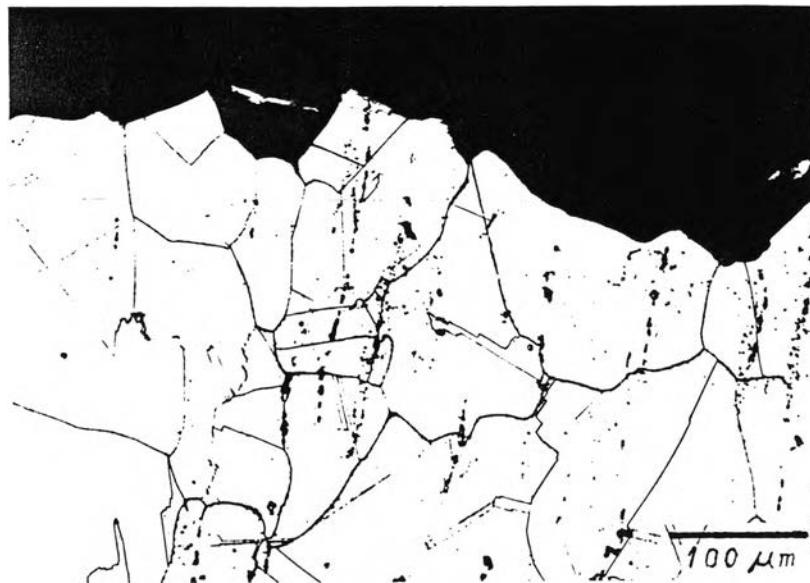
Few features of deformation in grains or slip bands were observed occurring near fracture surface, as shown in Figure 4.9. Fracture profile line confirmed that the dominant propagation of main crack was along grain boundaries, as shown in Figure 4.10. For unfractured crept specimens which were carried out at stress $R = 740$ MPa. and temperature $T = 650^{\circ}\text{C}$ for 1 hour-transient creep and 25 hours-steady state creep, no changes in microstructure were observed due to very low deformation (low stain), as shown in Figure 4.11.

Figure 4.10 As Fracture Profile Line at Fracture Surface 50 X

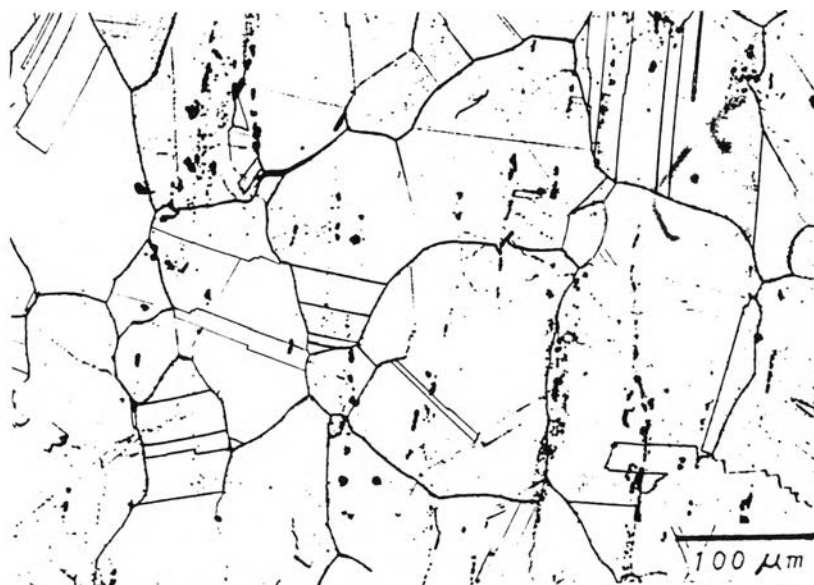
Figure 4.11 As Low Deformation Microstructure of Primary Creep Stage 50 X

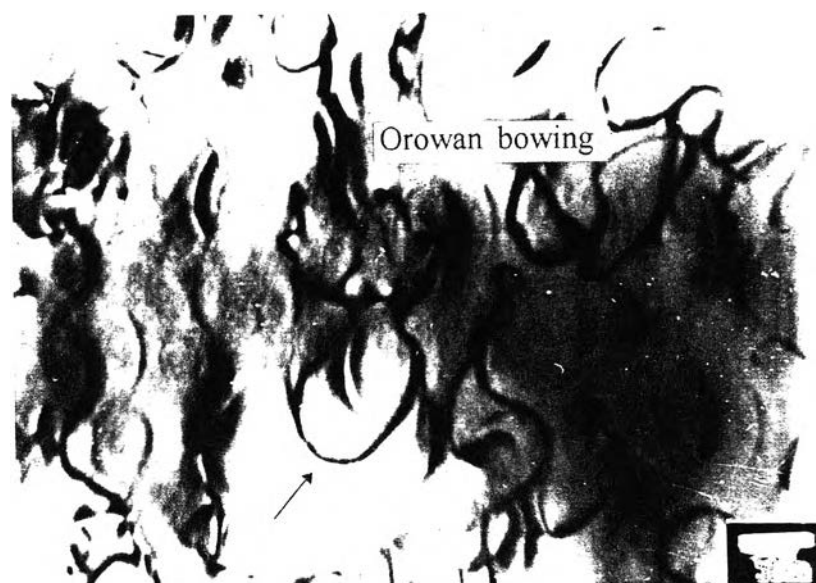
In primary or transient creep stage, the specimen was cut after 1 hr. test. The ununiform distribution of dispersed gliding dislocations was observed in each of the individual grain, Figure 4.12. These dislocations concentrated partially in some regims of the matrix and hereby generated dense dislocation networks formation. The major mechanism concerning with the movement of dislocation passing the precipitates was Orowan bowing mechanism where presented in the regims among individual wide slip bands, Figure 4.13. Very low amount of dislocation loops as a result of Orowan bowing were also observed in the location around the particle-matrix interface, Figure 4.14. The another mechanism of deformation i.e., dislocations shearing the gamma prime particles causing narrow stacking faults formation inside of

Figure 4.14 As Dislocation Movements passed Gamma Prime of primary Creep Stage in TEM

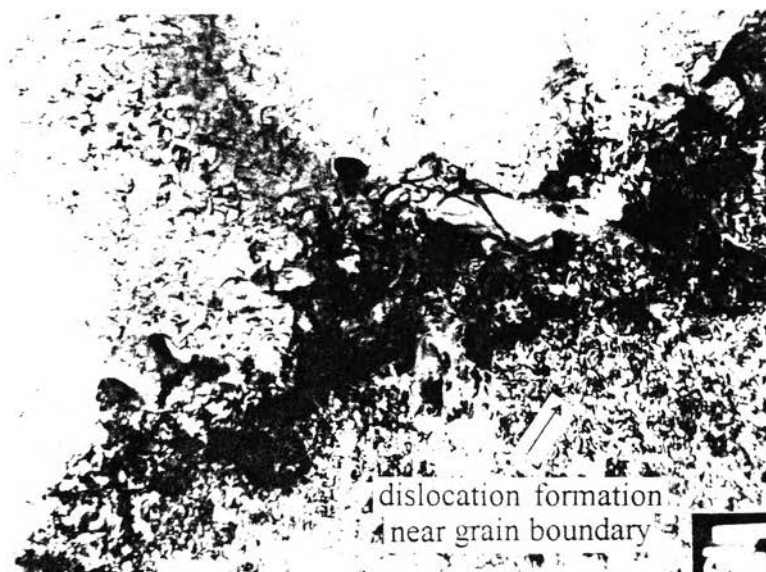
In secondary creep stage, the specimen was cut after 25 hrs. test. The dominant deformation mechanism was Orowan bowing. The dislocation networks were formed more dense and homogeneously distributed than in primary creep stage, Figure 4.16. The density of dislocation was also greater in the areas near grain boundaries due to dislocation pile up, Figure 4.17.

Figure 4.17 As Dislocation piled-up at Grain Boundary of Secondary Creep Stage Substructure in TEM

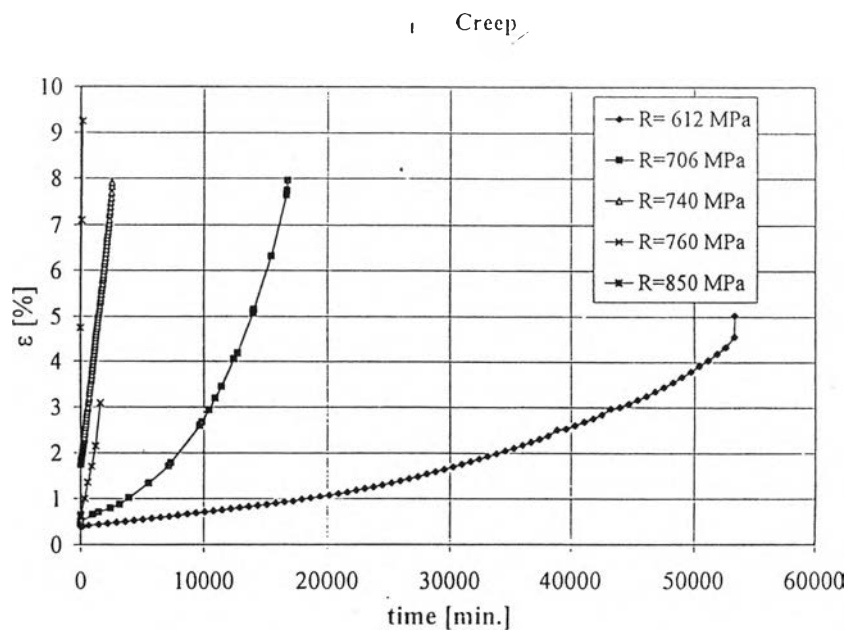
higher than the yield strength $R = 680$ MPa. (obtained from tensile test at elevated temperature $T = 650^{\circ}\text{C}$). The only one creep test carrying out at stress level $R = 612$ MPa which was below the obtained yield stress value. The results showed that creep fracture lifetimes inversely varied with stress levels. The lowest stress at $R = 612$ MPa produced the longest lifetime. On the other hand, the highest stress at $R = 850$ MPa gave the shortest lifetime, as shown in Figure 4.19 and Table 4.2. This phenomenon is in agreement on many previous works on creep of materials [3,5,6,7,16,17,18].

Diagram 4.1 Diagram of Strain-Time of Creep Tests

In creep curves of creep stress levels at 612 and 740 MPa the strain increased from origin point and reached the end point of steady state creep stage, Diagram 4.1. The creep development exhibited by running point deviate from linearity and obtained highly increasing in slope indicating for tertiary creep stage. This would occur by result of increasing in stress concentration due to change in the cross-section area, namely localized necking. Furthermore, the increase in creep strain resulted partly from the development of intergranular cavities as shown in Figure 4.19. Subsequently the initiation of crack would occur from an agglomeration of cavities along grain boundaries with the expense of decreasing in the intervoid spacing. Therefore voids can link up together leading to intergranular creep failure. However, from the another

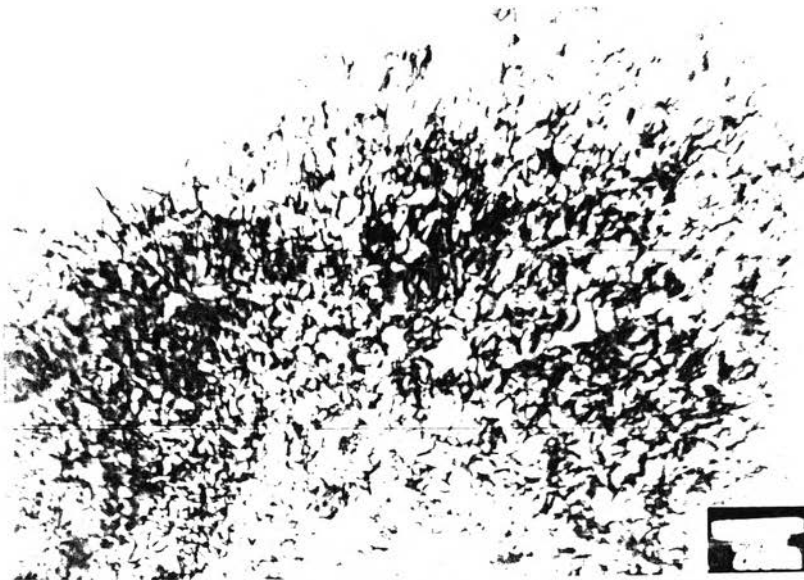
In tertiary creep stage, the specimen were analysed after fracture. The main observed dislocation mechanism was also Orowan bowing which was similar to secondary creep stage, Figure 4.18. The dislocation formation was networks distribution which was more dense and homogeneously than those of secondary creep stage. However, the existing of the shearing mechanism in TEM microstructure in secondary and tertiary creep stages was difficult to investigate difinitely or unclear. Thus in tertiary creep stage before, very dense dislocation networks formation as a result of dislocation pile up mechanism might provide work hardening and thus affected to reduction in ductility.

Figure 4.18 As Dense Dislocation Substructure of Tertiary Creep Stage in TEM

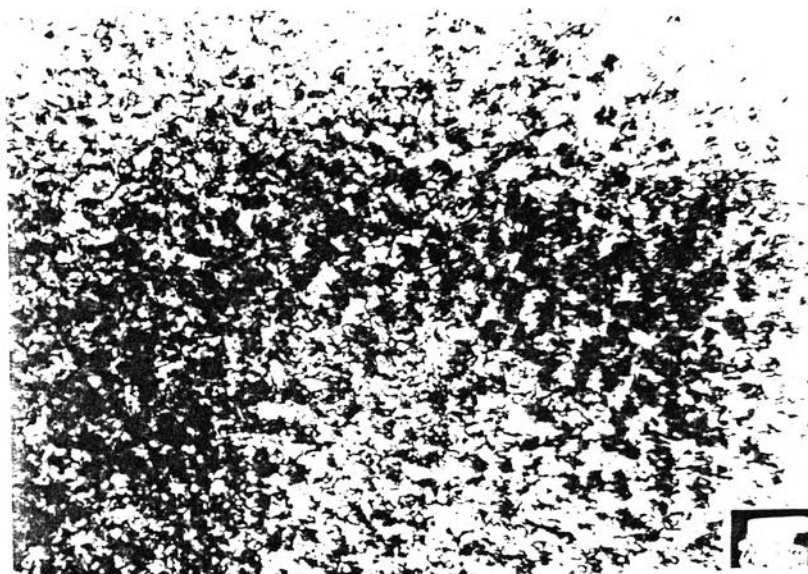
Figure 4.20 As Dislocation Substructure of ICC Test with 1 hr Hold Time in TEM

The investigation on dislocation/precipitates interaction was performed on the isothermal cyclic creep tested specimens after rupture. The main aim was to investigate the effect of varying holding times introducing onto cyclic stress waveform. This holding time affected to dislocation development. The result of isothermal cyclic creep test with 10 hrs. holding time was revealed that the final microstructure after fracture consisted of very dense dislocation networks in matrix due to high deformation. The principal strengthening mechanism involving dislocation movements via precipitates was still Orowan bowing, as shown in Figure 4.20. Substructure characteristics were similar to those of crept specimen as mentioned in substructure analysis of creep tests section.

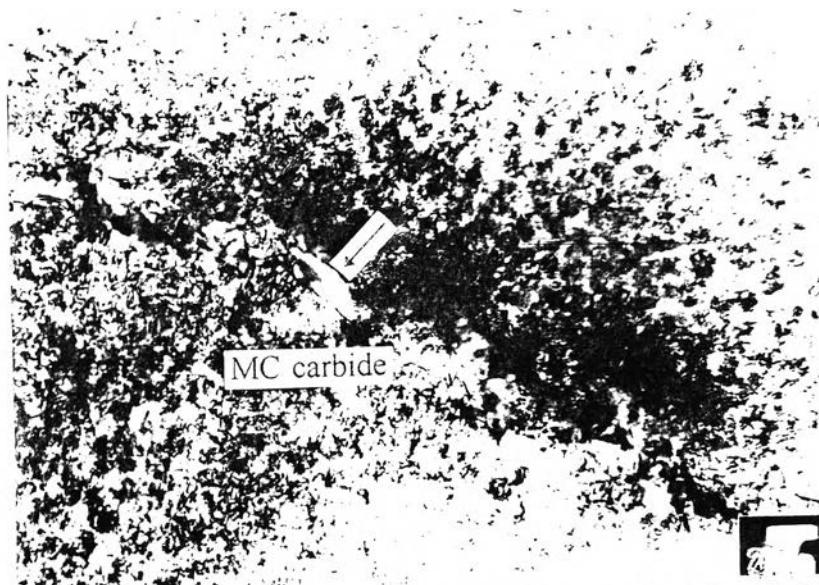
Figure 4.22 As Dense Dislocation Networks of ICC Test with 10 hrs Hold Time in TEM

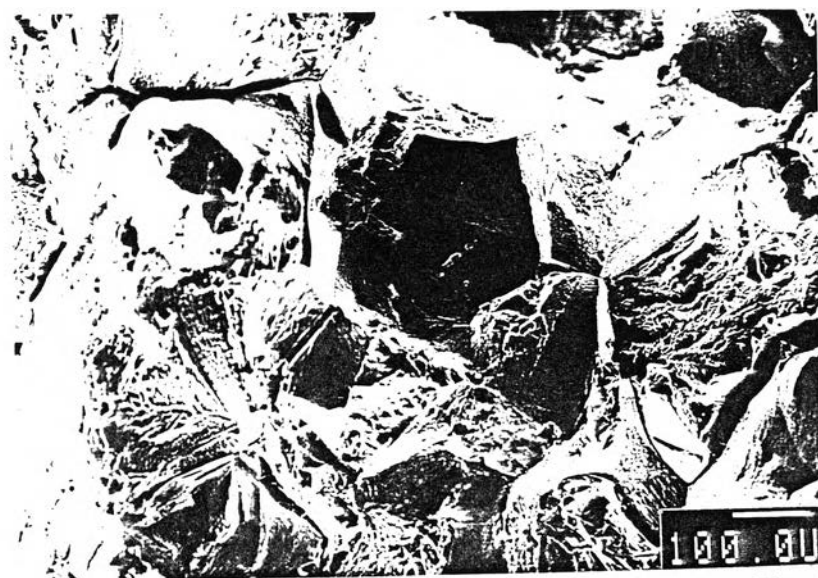
Figure 4.29 As Fracture Initiated Intergranularly from Fatigue Test in SEM

initiated intergranularly and then propagated primarily transgranularly, as illustrated in Figures 4.29 and 4.30. This fatigue fracture process might be the combination effects between increased stress concentration and strain rate at the crack tip.
