ARCHITECTURAL JOINERY DESIGN TO PREVENT WATER LEAKAGE IN A PRECAST
CONCRETE DETACHED HOUSE

A Thesis Submitted in Partial Fulfillment of the Requirements
for the Degree of Master of Architecture in Architectural Design

FACULTY OF ARCHITECTURE

Chulalongkorn University

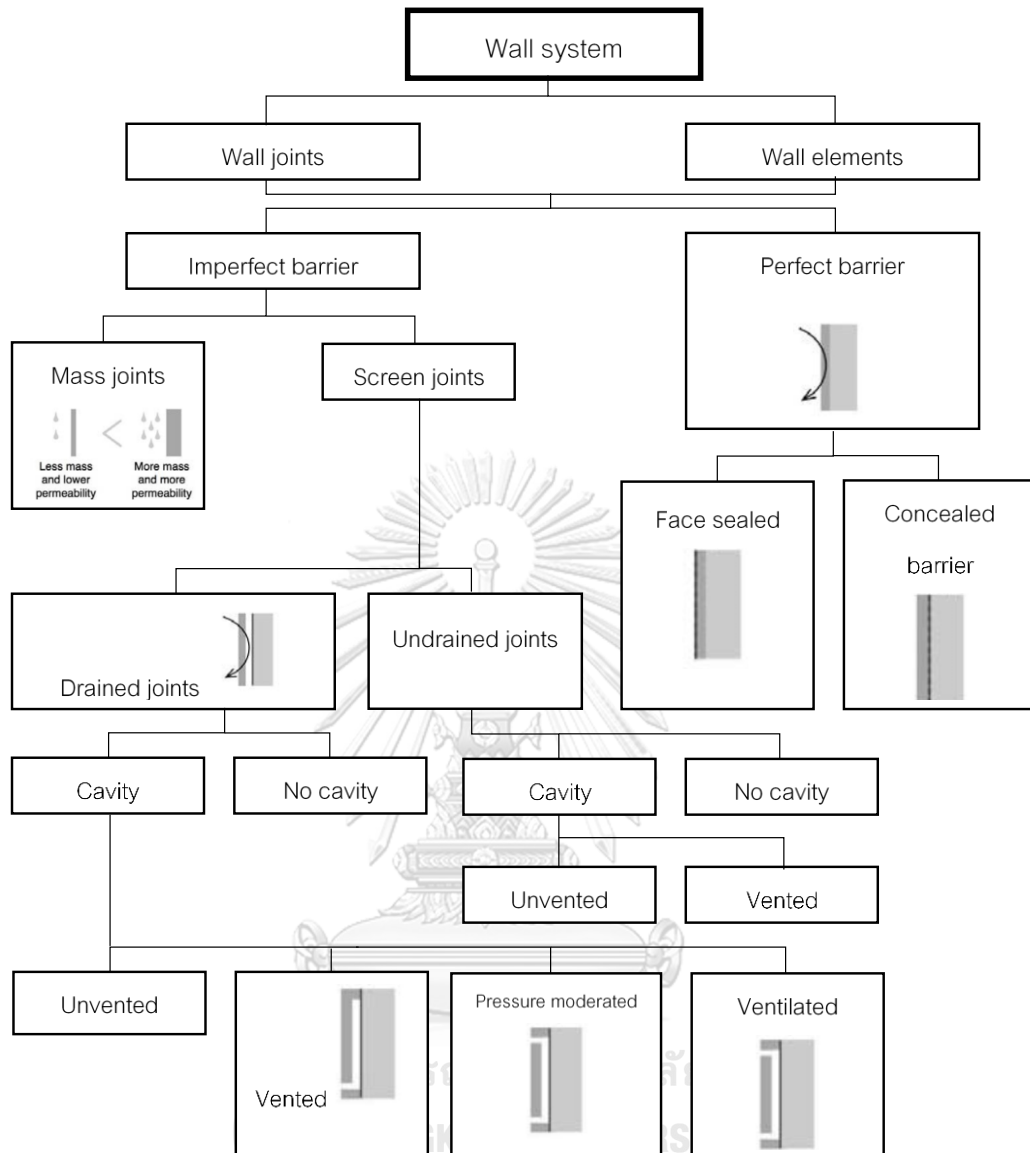
Figure 2 Diagram of categorization of wall system by rain control strategy. (Straube, 2010)

According to Straube (2010), rainwater that deposited on the wall can be drained (rain bounced off from the surface or surface drainage), stored (absorbed or attached by surface tension), and transmitted (water penetration or infiltration). The diagram below is based on the actual wall behavior to the rain control strategy. The wall system is made up of both wall joints and wall panels (element). The two broad categories are perfect barriers and imperfect barriers. A perfect barrier is a wall that is wholly sealed or a wall that is solid with no gap or opening. A perfect barrier can be a seal that is on the external face (a face seal) or a seal that is concealed in between the walls. This approach relies on the assumed perfection of the single plane of material and its ability to completely resist water penetration. In theory, the precast concrete panels are a perfect barrier, but the connection at the joints is an imperfect barrier. The research on joinery is more related to the imperfect barrier category. A mass joint is a type of joint that absorbs water into the joint material. Therefore, in mass joints, the efficiency of water prevention depends on the mass of the material, as it does in grouted joints. Screen joints form a layer of protective devices that shield against rainwater. The two types of screen joints are drained joints and undrained joints. (Deposited water is drained when it comes through a screen but is removed by gravity.) The undrained joint performs like a perfect barrier in which a layer of material shields the concrete panels from rain. On the other hand, the drain joint had a layer of protective shield but allowed the water to penetrate the inner layer. The cavity is an open or filled space that helps gravitational drainage, airflow, and act as a capillary break. Vented design allows some degree of air to enter, whereas ventilated design allows a large amount of air to help dry the water vapor in the cavity. Pressure-moderated is a system that moderates pressure differences within the screen system. When the perfect moderation of pressure occurs, the general condition of pressure equalization is achieved. (Straube, 2010, 2016b) (Figure 2).

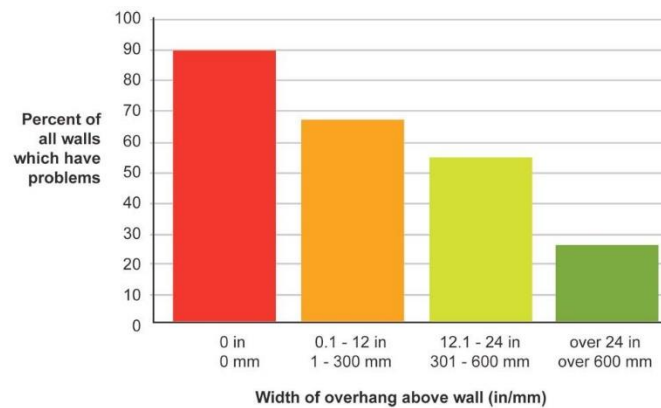
Figure 6 The study of wall problem percentage vs. the width of the overhang above the wall.

The water deflection element protects the building wall surface from direct rainwater. The mechanism deflects some water away from the building. The house walls have long exposure to rain, especially the wind-driven rain. The walls have an extreme exposure during annual rainy seasons, monsoons, and tropical cyclones. The amount of water deposited on the wall can be diminished using water deflection elements and building positioning. It is the first line of defense for the house in order to reduce water leakage problems. The study of wall problem in relation to the overhang length in "Rain Control in Buildings" article from the Building Science Digest journal (Straube, 2007 #38) show that the length of overhang can reduce the wall problem in the wall surface. A survey from British Columbia of a wood frame building shows that the width of a building's overhang is linked with the damage caused by rain. Overhang width is studied in order to understand wall problems caused by exposure to rainwater.

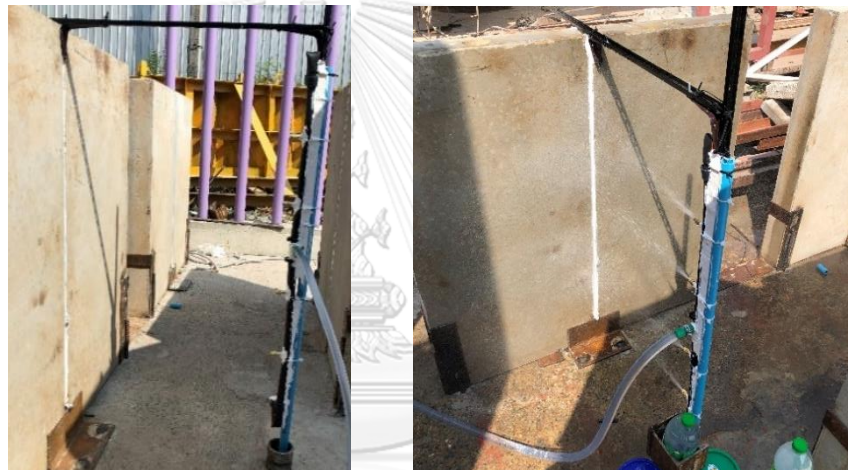
Figure 12 The equipment used in the water spray test and the installation before and during the test.

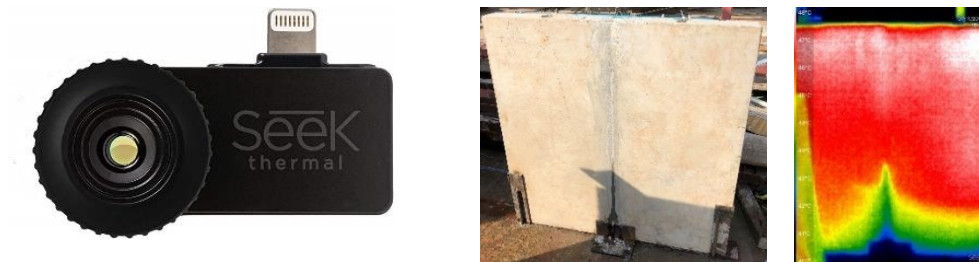
Figure 14 The Seek thermal Compact equipment and the example of the collected thermal image.

The device for thermal image collection is a thermography camera called "Seek thermal Compact" (Figure 14). This device is an all-purpose thermal imaging camera that connects to an iOS device and captures temperature in the form of a visual image. The thermal image will show a clearer temperature difference on the tested surface and identify the location of water penetration.

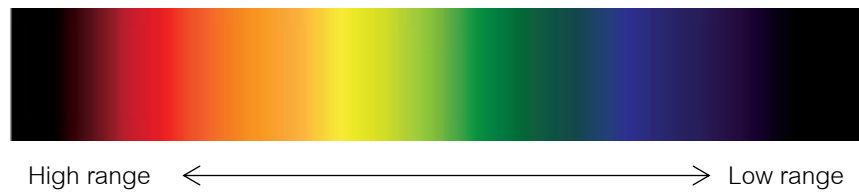
Figure 16 The spectrum of color shown in the collected thermal image that represents the difference in surface temperature.

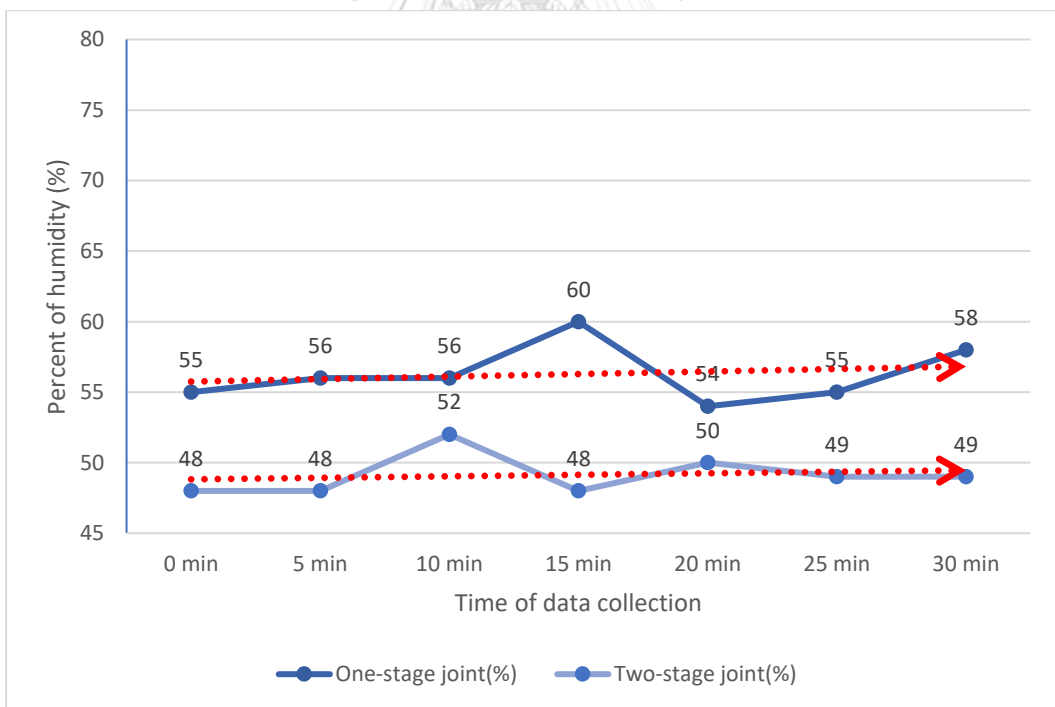
Figure 18 Change in rel. humidity (%) of the three joints without scarf detail on a surface test.

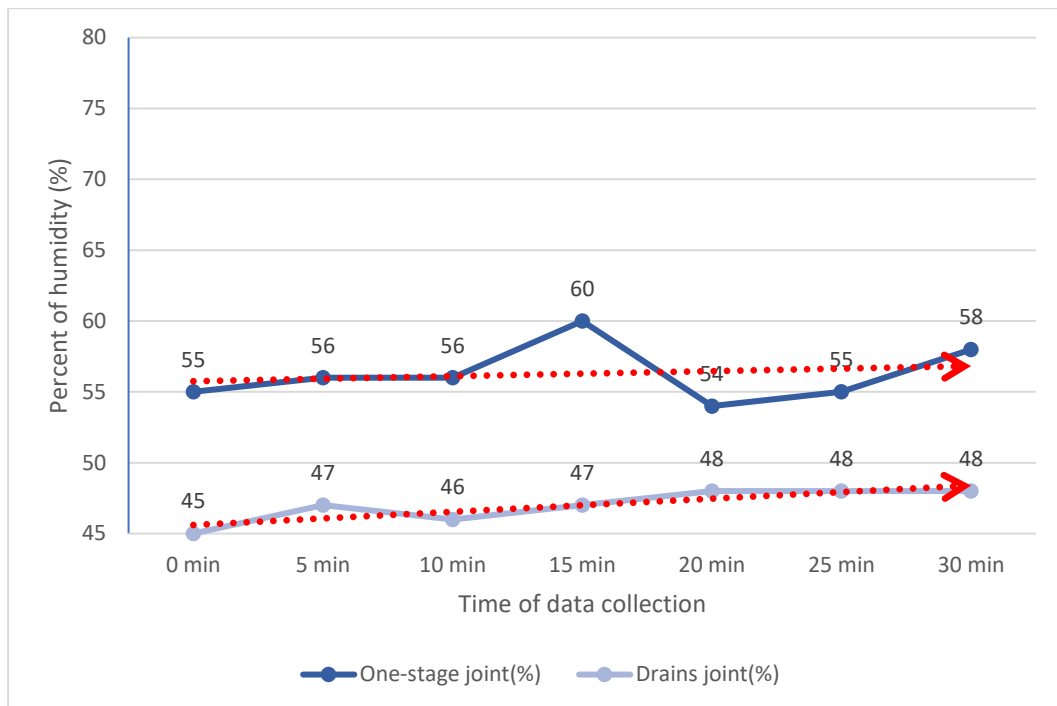
Figure 22 Change in rel. humidity (%) of the three joints without scarf detail on a surface test.

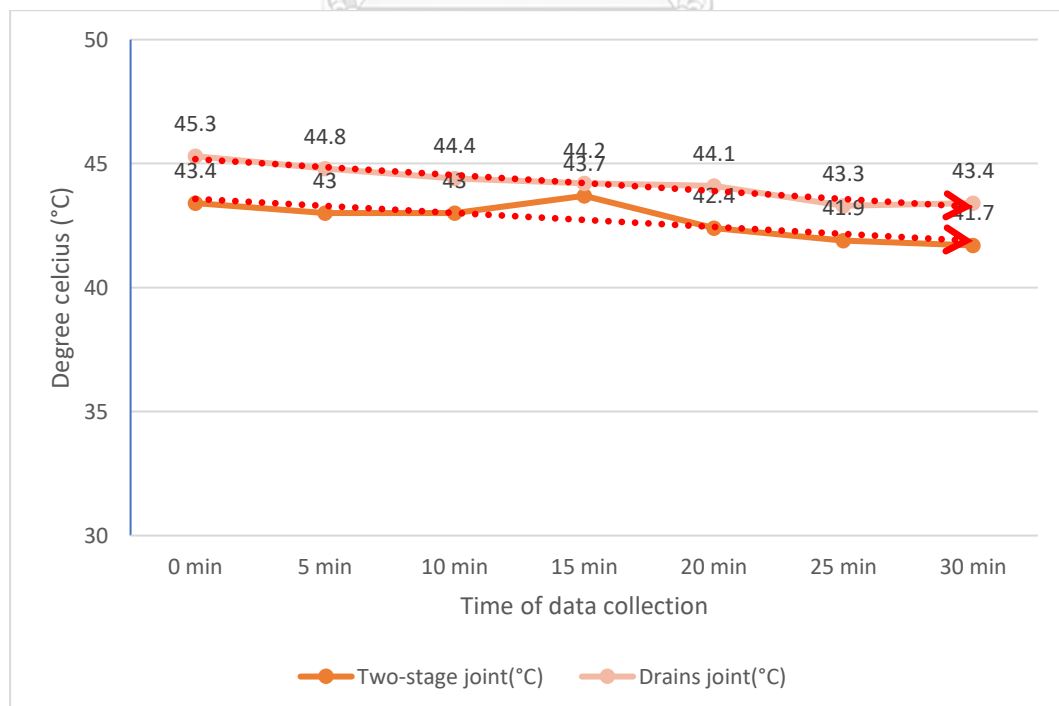
Figure 25 Change in temperature (°C) of the three joints without scarf detail on a surface test.

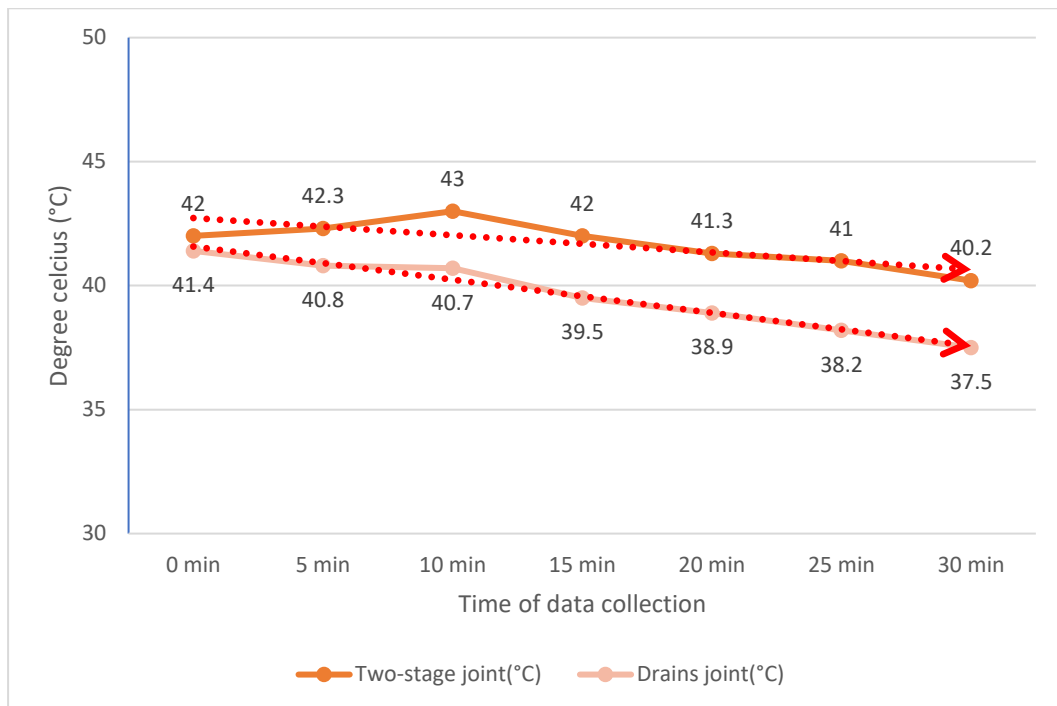
Figure 27 Change in temperature ($^{\circ}\text{C}$) of the three joints without scarf detail on a spray test.

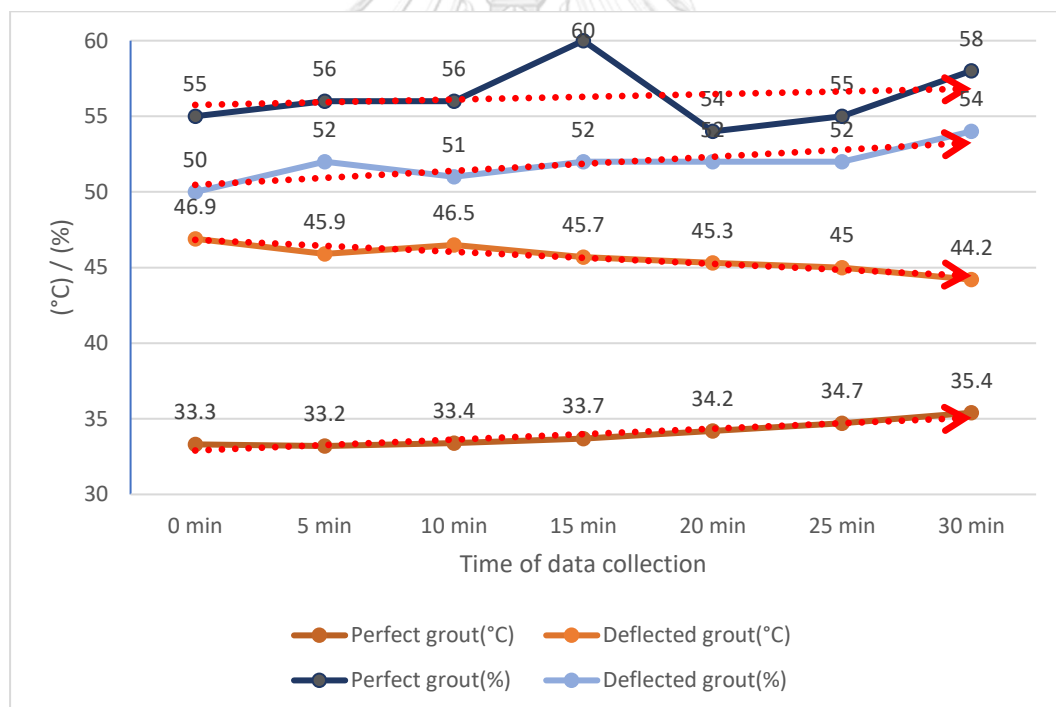
Figure 29 Change in temperature ($^{\circ}\text{C}$) and rel. humidity (%) of the perfect one-stage joint compared with the defected one-stage joints from a surface tests.

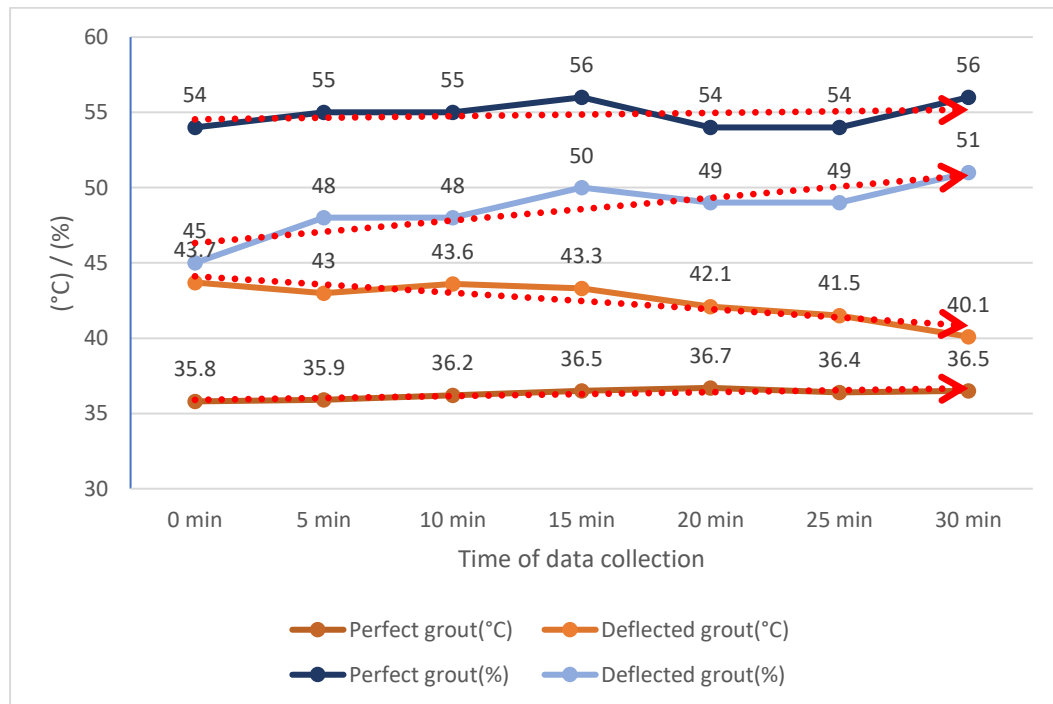
Figure 30 Change in temperature (°C) and rel. humidity (%) of the perfect one-stage joint compared with the defected one-stage joints from a spray tests.

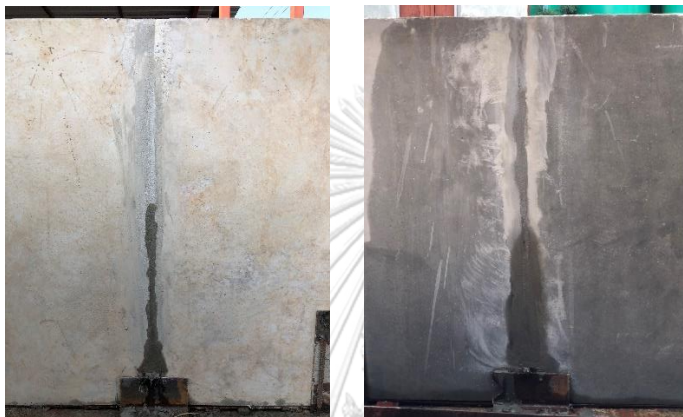
Figure 31 The image was taken from the interior side (left) and the exterior side of the one-stage test module (right).

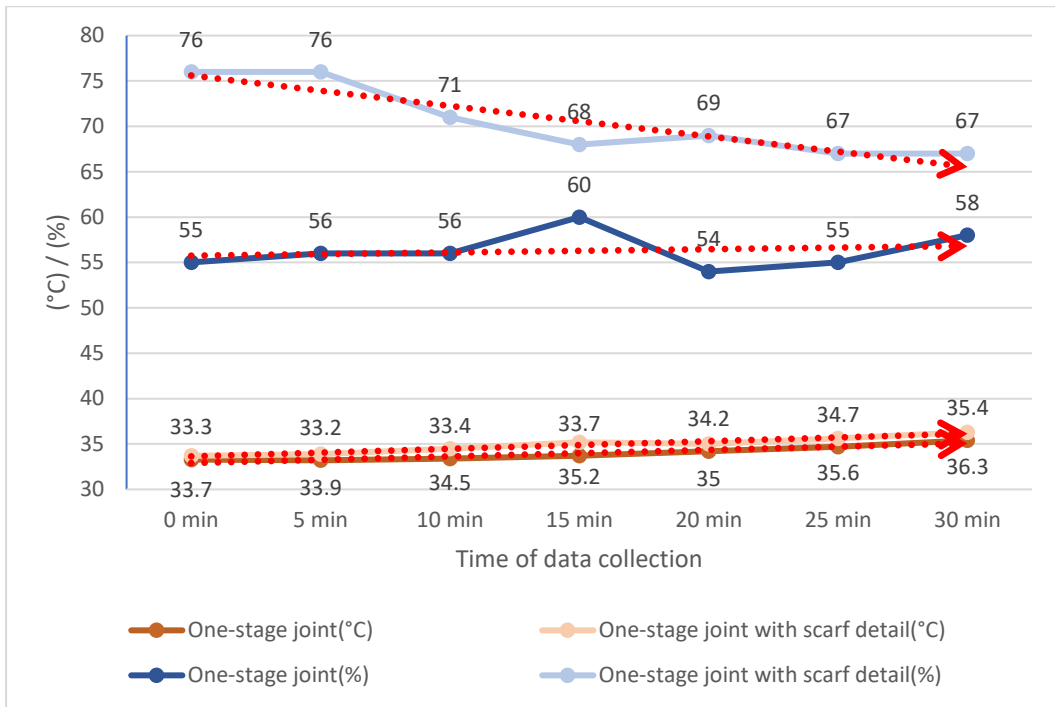
Figure 32 Change in temperature (°C) and rel. humidity (%) of the one-stage joint compared with the one-stage joint with scarf details on a surface test.

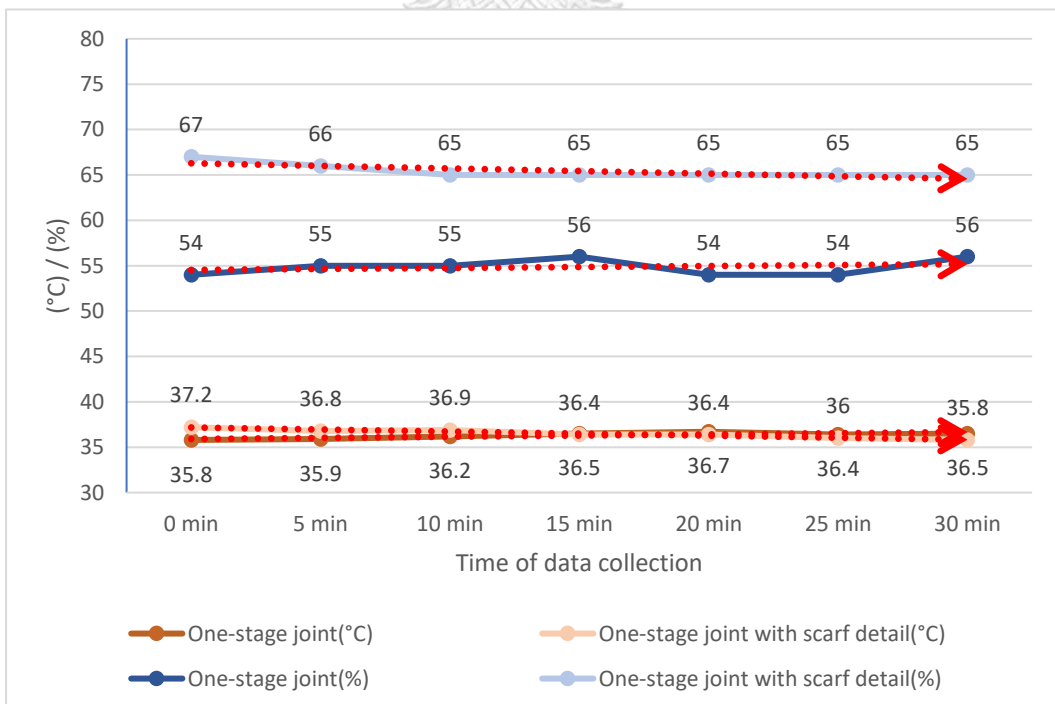
Figure 33 Change in temperature (°C) and rel. humidity (%) of the one-stage joint compared with the one-stage joints with scarf detail on a spray test.

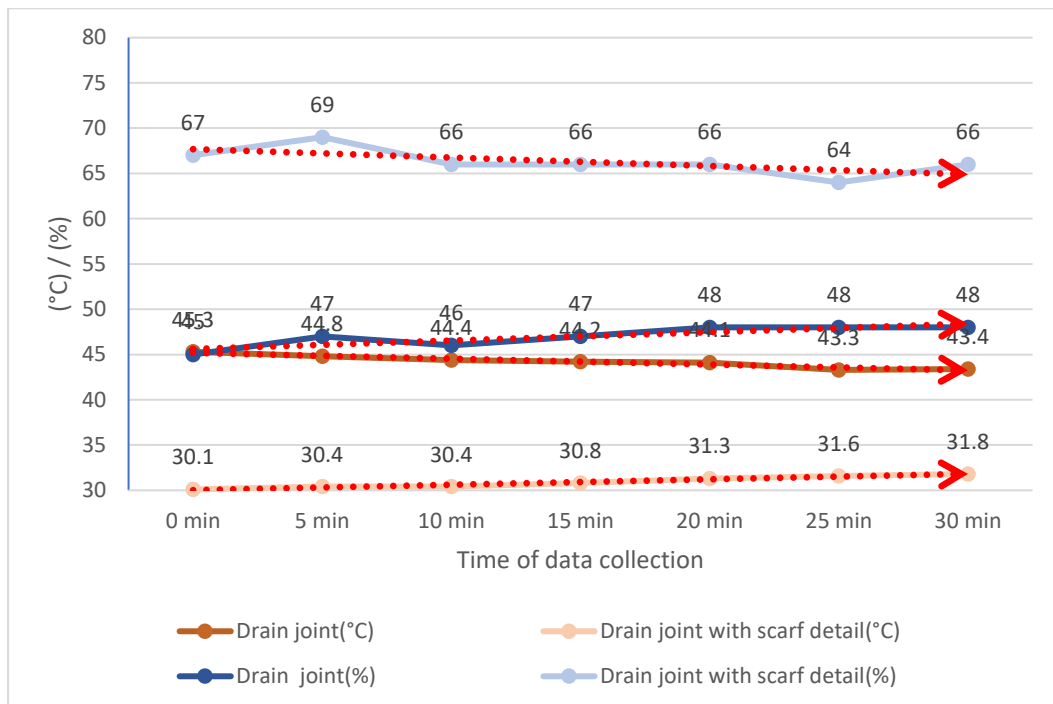
Figure 36 Change in temperature ($^{\circ}\text{C}$) and rel. humidity (%) of the drain joint compared with the drain joints with scarf detail from a surface test.

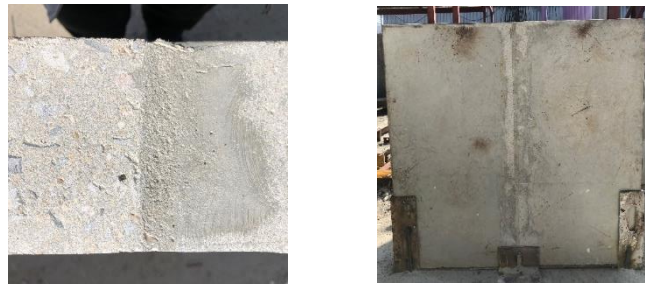
Figure 38 The top view image (left) and front view image (right) of a one-stage joint.

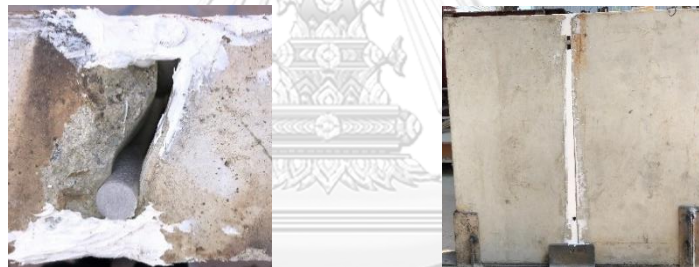
Figure 39 The top view image (left) and front view image (right) of a scarfs drains joint.

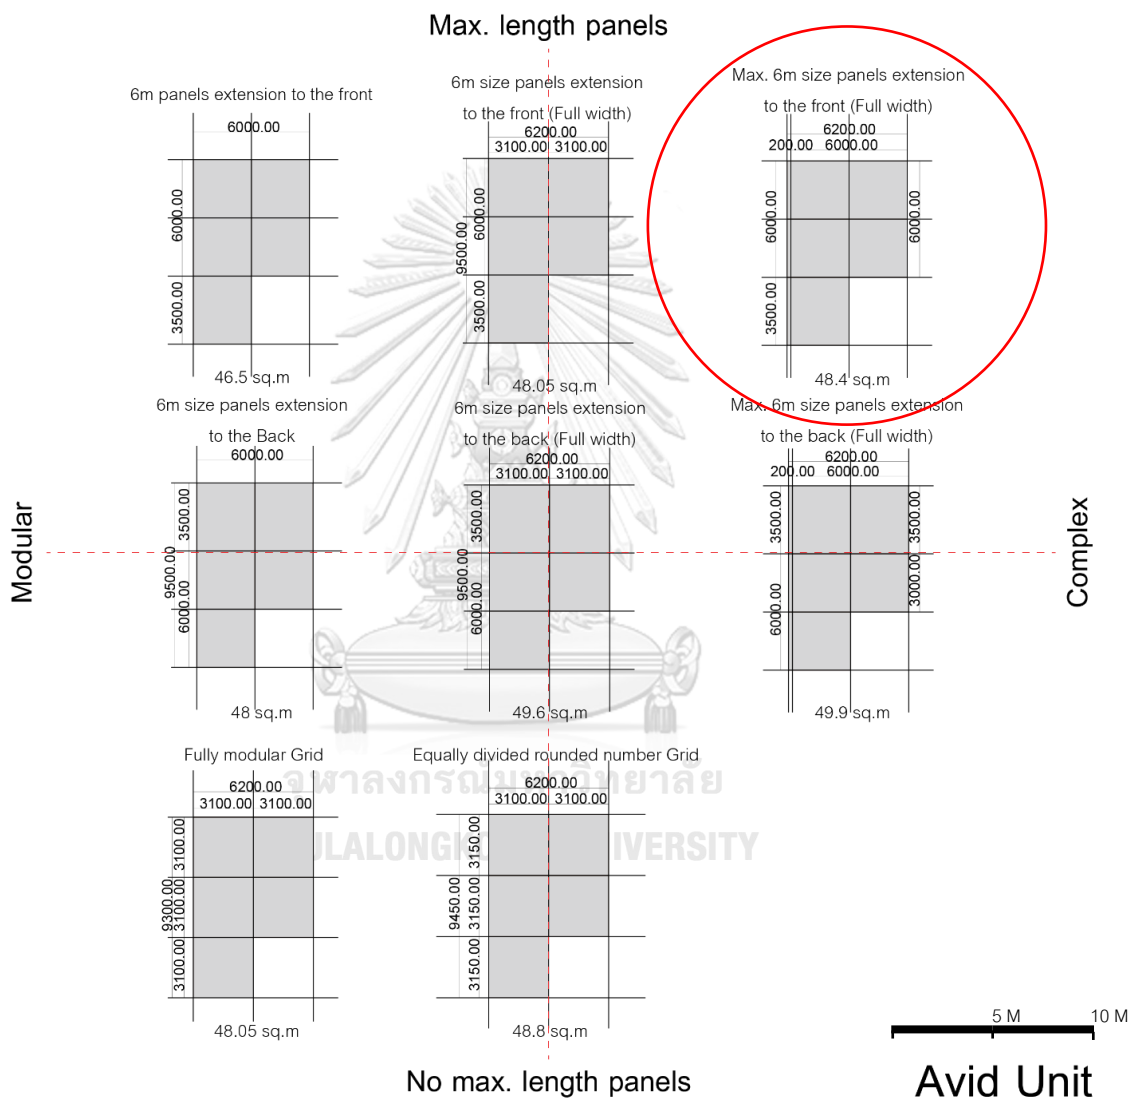
Figure 50 Design schemes for Avid unit grid planning.

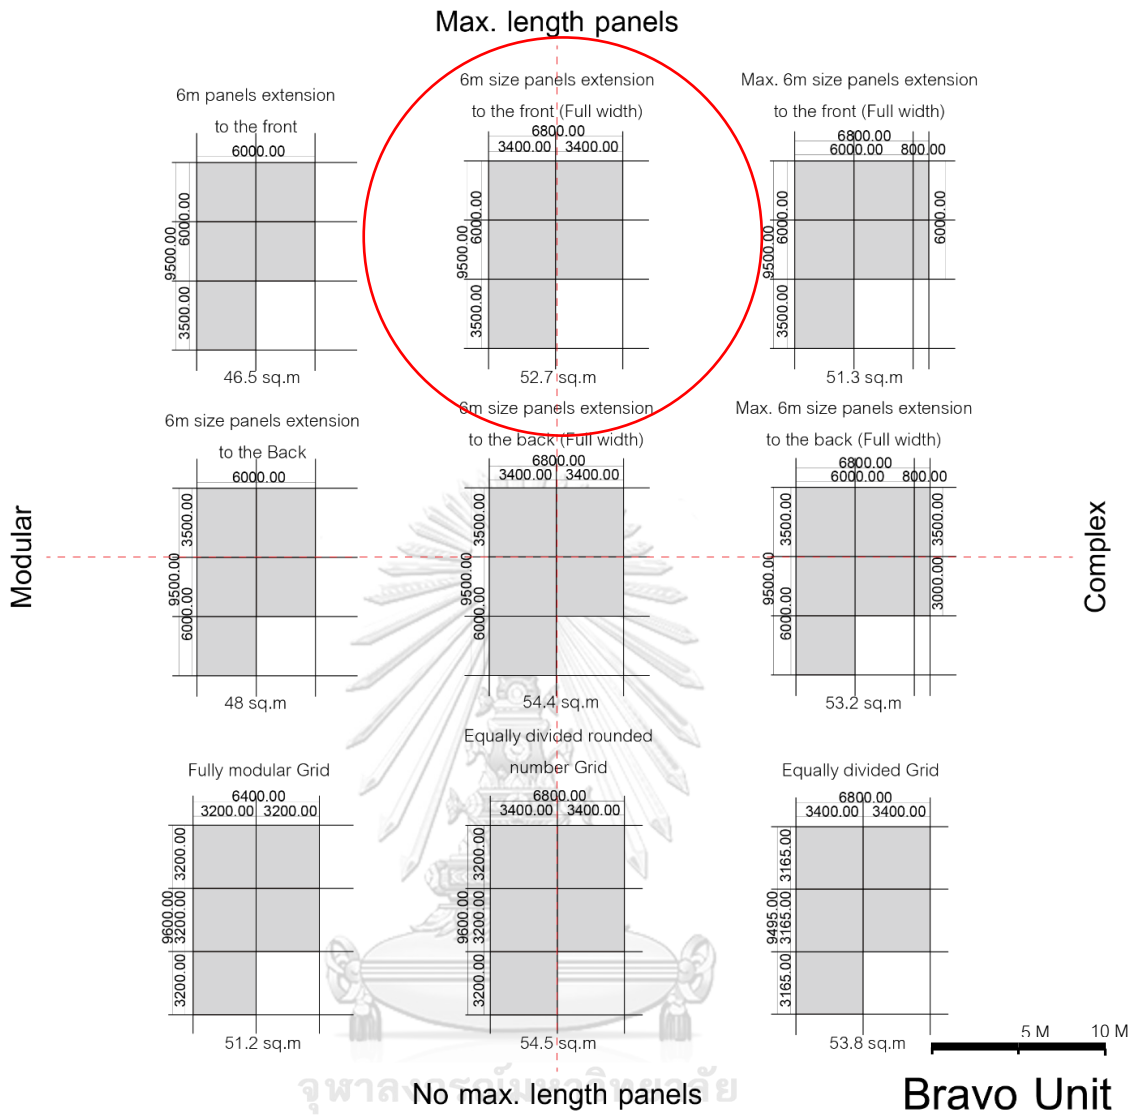
Figure 52 Design schemes for Bravo unit grid planning.

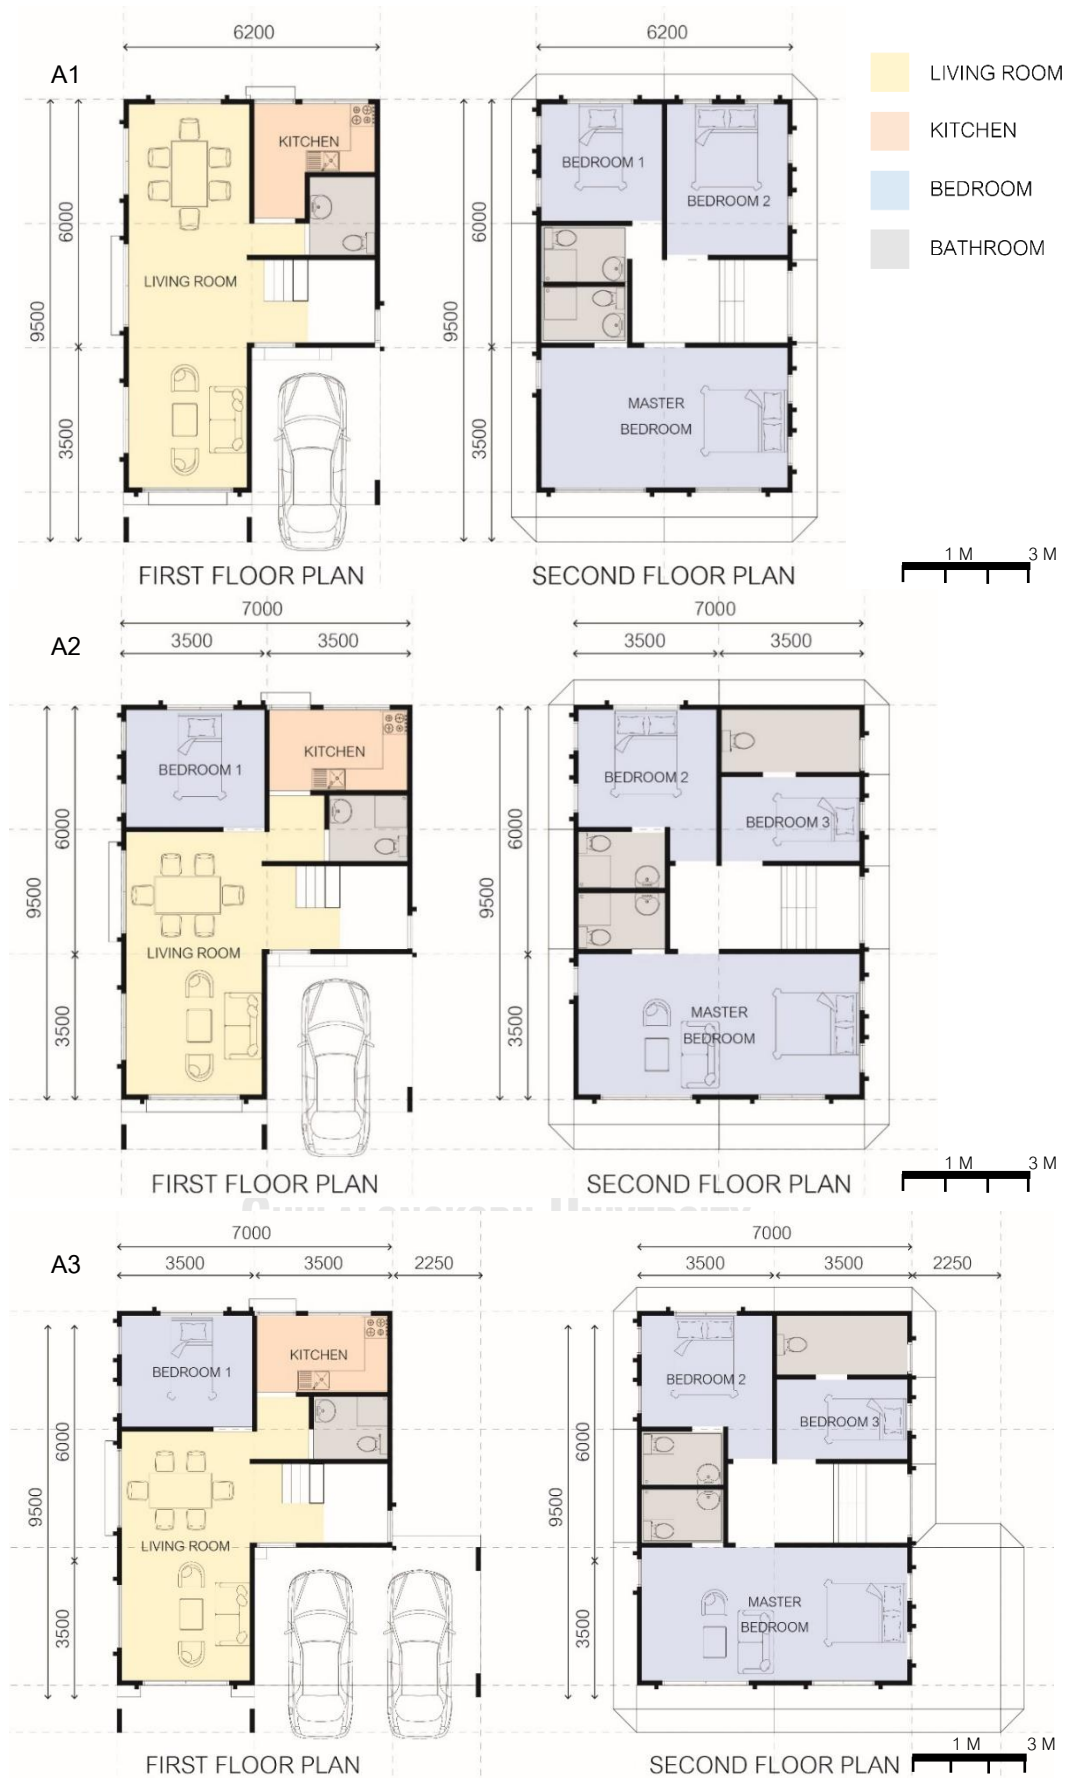
Figure 64 Space planning for the proposed design of the A1, A2, and A3 unit.
