SHORELINE CHANGE AFTER THE 26 DECEMBER 2004 TSUNAMI BETWEEN  
LAEM PAKARANG-KHAO LAK AREA, CHANGWAT PHANG-NGA, THAILAND

A Thesis Submitted in Partial Fulfillment of the Requirements  
for the Degree of Master of Science Program in Earth Sciences

Department of Geology

Chulalongkorn University

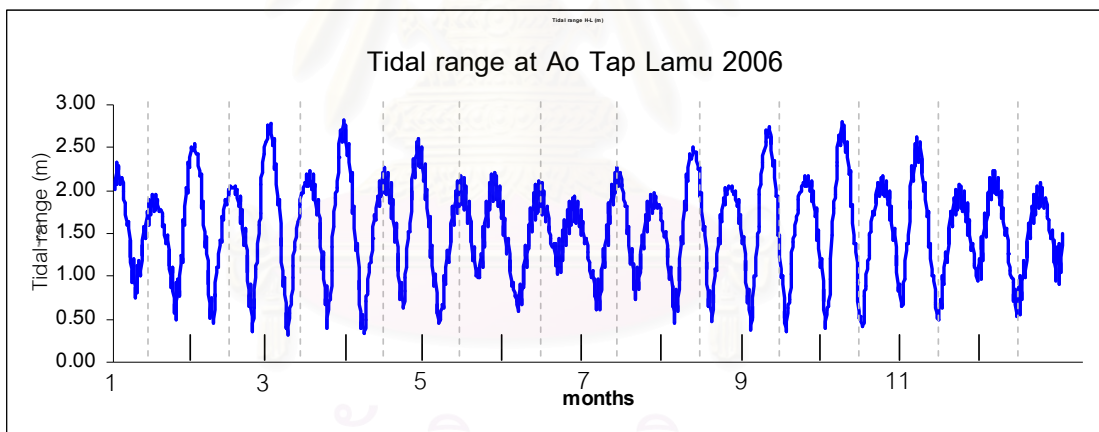
Figure 2.7 Tidal range at Ao Tap Lamu 2006

Tides are the cyclic rising and falling of Earth's ocean surface caused by the tidal forces of the Moon and the Sun acting on the Earth. Tides cause changes in the depth of the sea and produce oscillating currents known as tidal streams, making prediction of tides important for coastal navigation. The strip of seashore that is submerged at high tide and exposed at low tide, the intertidal zone, is an important ecological product of ocean tides. The characteristic of tides in this study area is semidiurnal tide, two times of high tide and low tide in one day, with average 1.55 meters in tidal range calculated from tides table of Ao Tap Lamu ,Phang-nga province in 2006 (Figure 2.7).

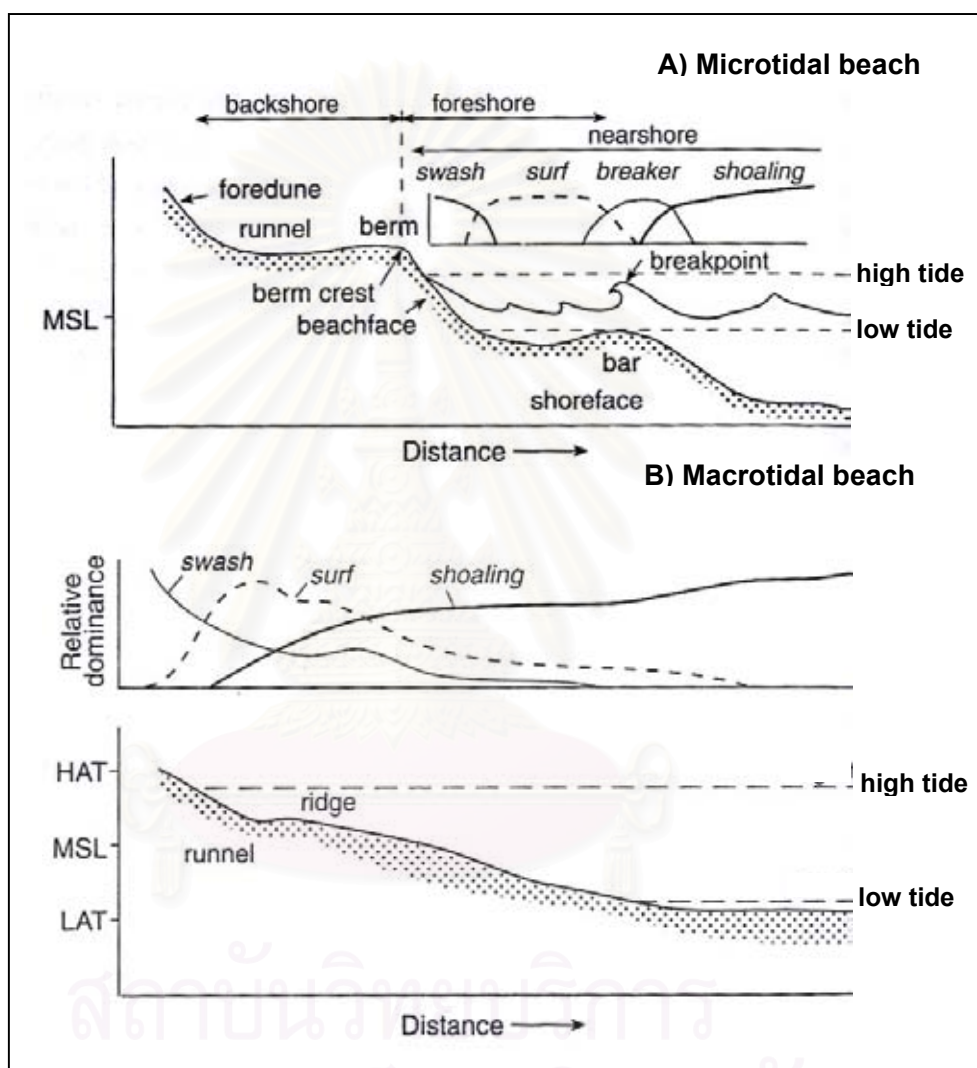
Figure 2.8 Beach morphology. A) profile of a microtidal wave-dominated beach. B) typical morphology of a mega-or macrotidal beach. Generalised distribution of the relative dominance of swash, surf, and shoaling activity is shown averaged over time across the beach.(modified from Woodroffe, 2002)

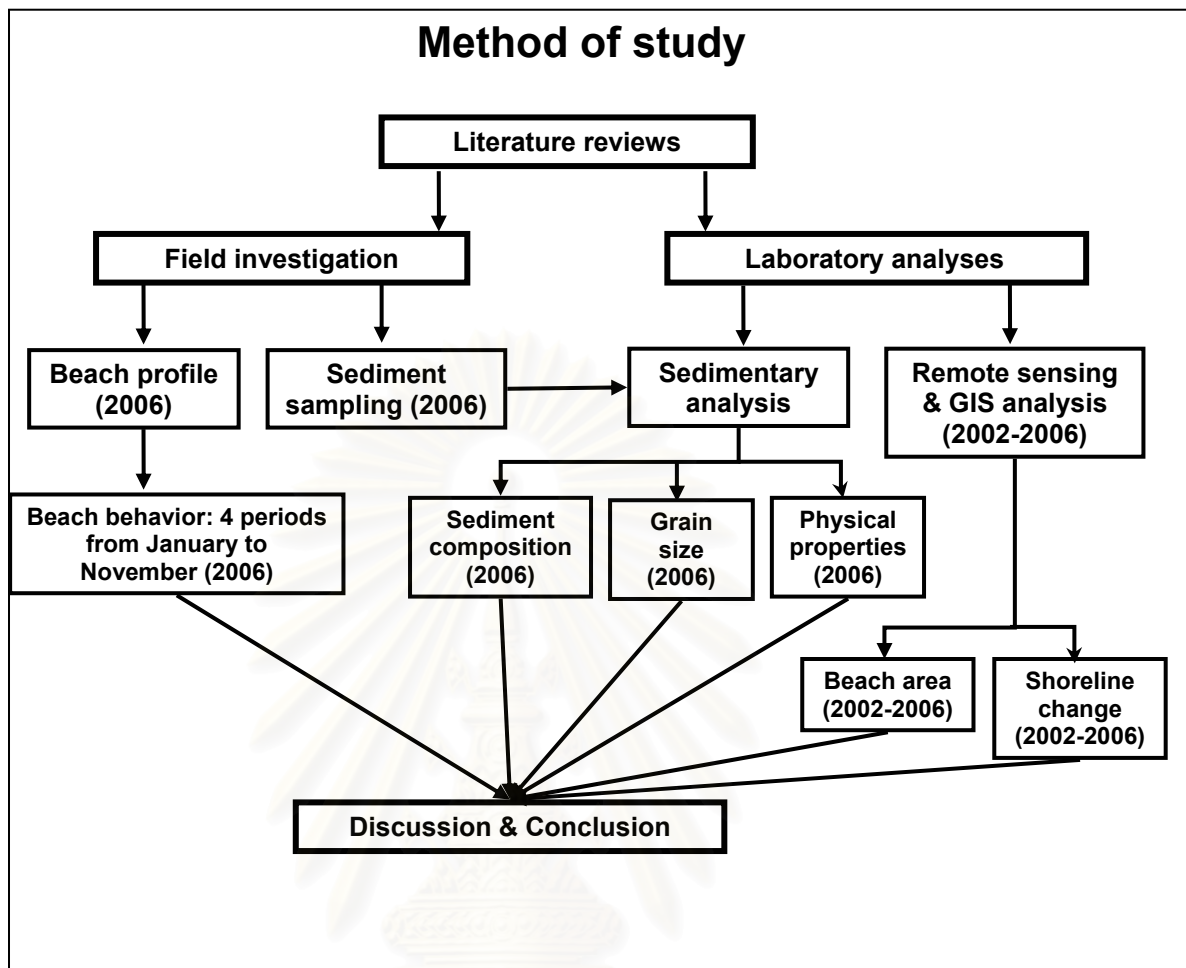
Figure 3.1 Flow chart showing methodology of this research.

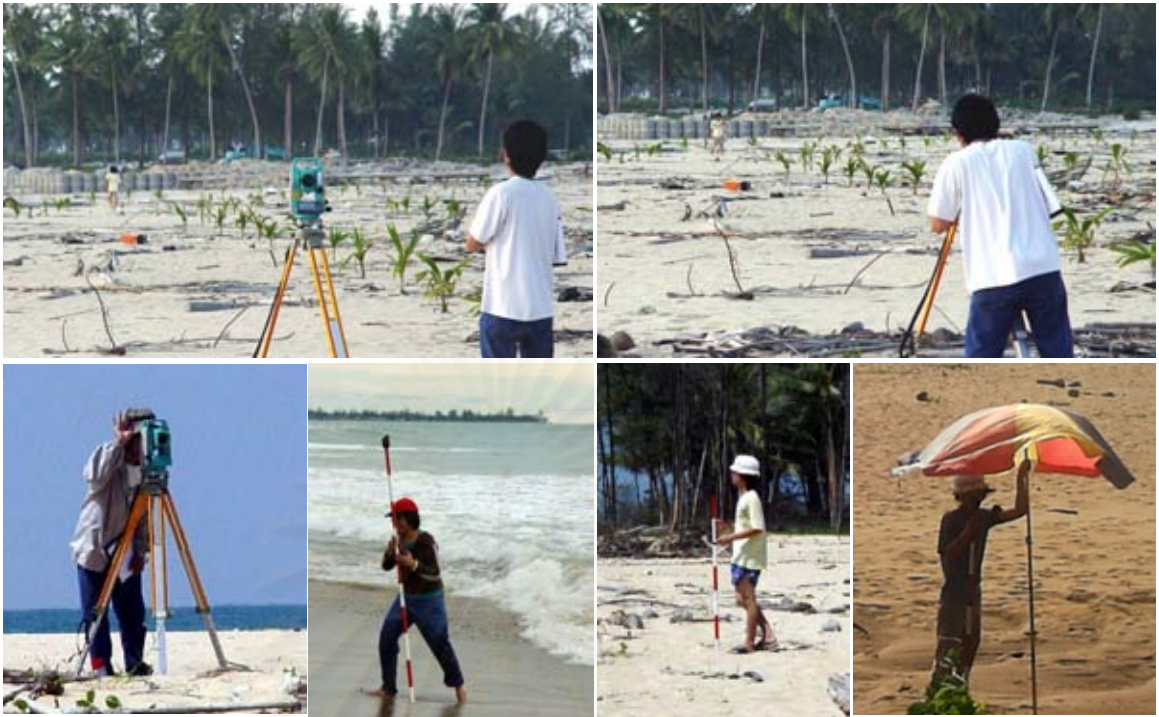
Figure 3.5 Photographs showing measurement of beach profile and inlet/outlet cross-section in the study area.

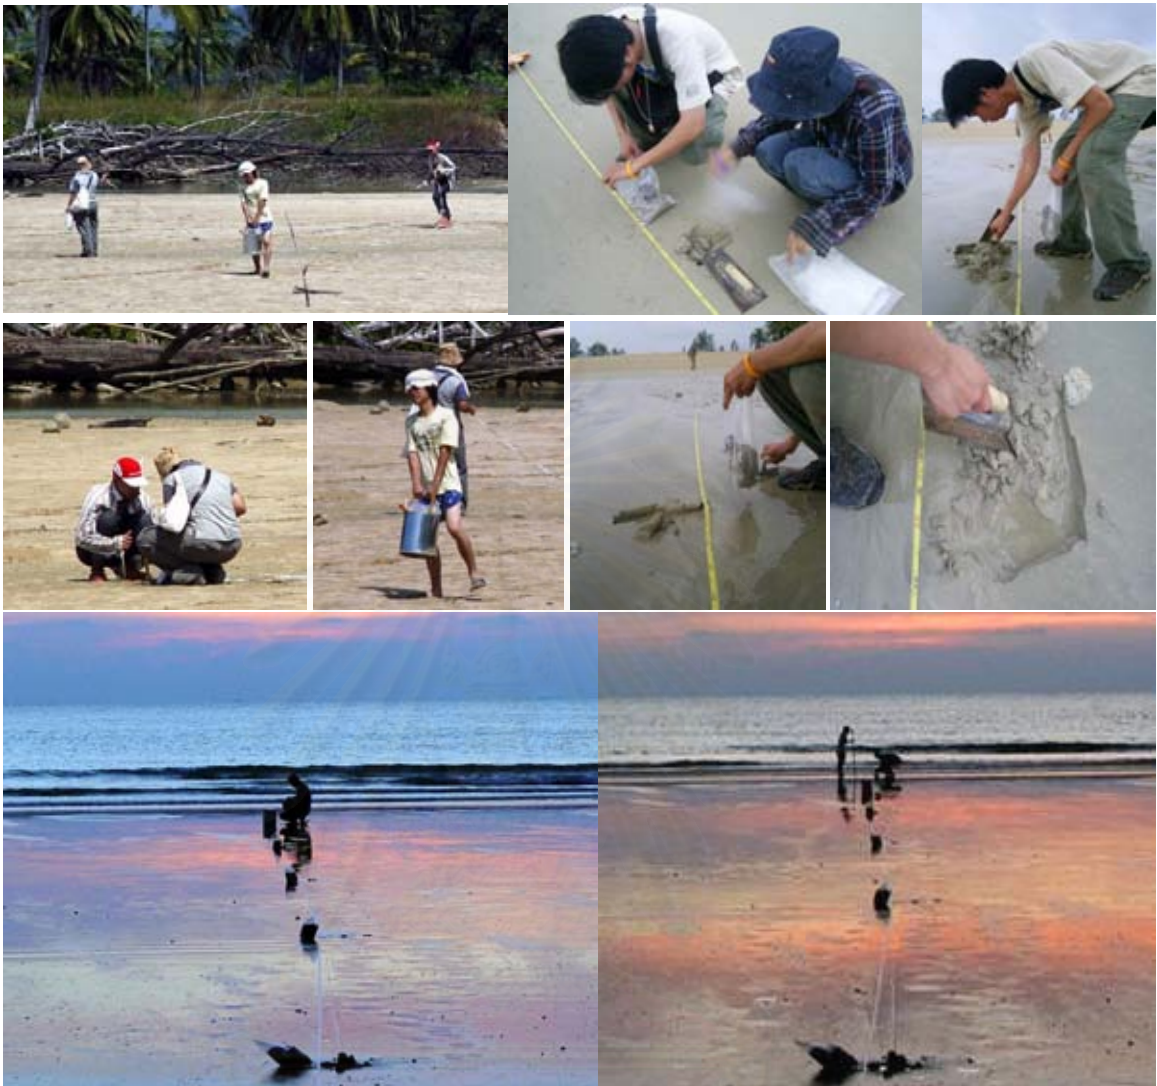
Figure 3.6 Photographs show surficial beach sediment sampling from backshore to foreshore in swash zone at low tide time.

The coastal zone is composed of many dynamic morphologic features that frequently change their forms and sediment distribution. Although a beach can display a large range of sizes and shapes, each beach is expected to characterize by particular texture and composition representing the available sediments. Textural trends alongshore and cross-shore are indicative of the depositional energy and the stability or instability of the foreshore and nearshore zones (Larson et al, 1997). Surface sediments provide information about the energy of the environment as well as the long-term processes and movement of materials, such as sediment transport pathways. In this research, surface grab samples were collected (typically several hundred grams of beach sand) every 20 meters interval from reference point along each beach profile, including the crest of the foredune ridge, at the dune toe, at mid-beach, and within the swash zone at low tide (figure 3.6).

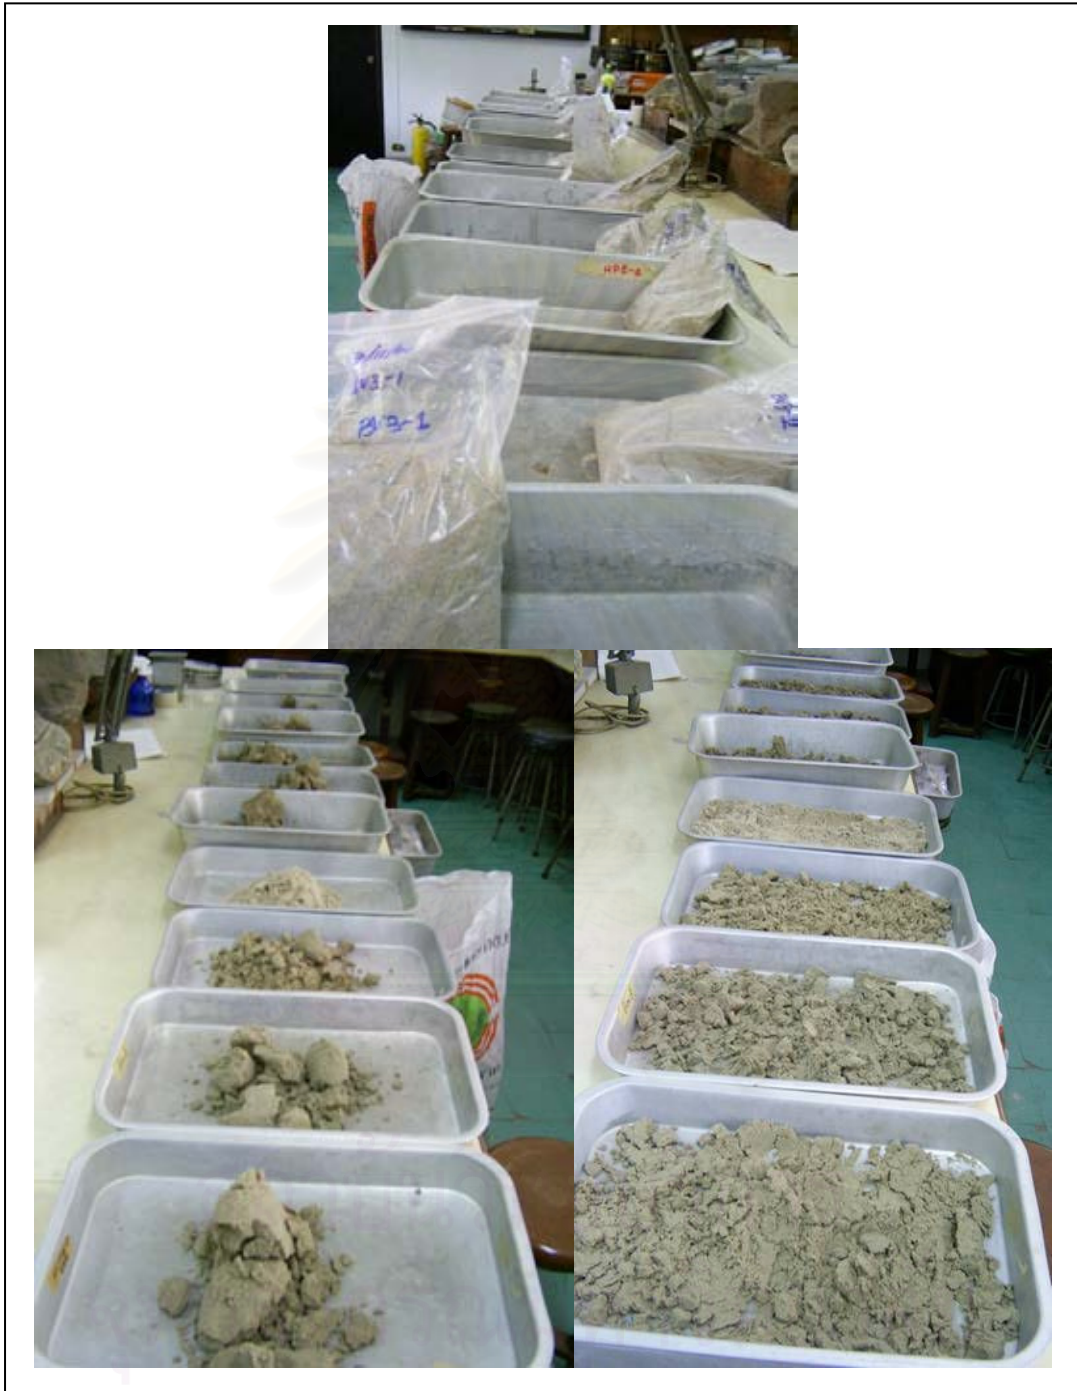
Figure 3.8 Photographs show preparing of samples before dry in oven and sieve in dry sieve mesh.

- Dry samples in oven at temperature 80° C about 5-6 hours for release water in samples which make grain of sediments sticking together.
- Mix sediments and then split the sample 2 times (4 piles).
- Weight a pile of sample which was spitted typically several hundred grams depend on grain size such as 500 gram for coarse grain, 200 gram for medium grain, and 100 gram is fine to fine grain.
- Prepare sieve meshes at equivalent sieve mesh no. 5, 10, 18, 35, 60,120 and 230 (A.S.T.M.) or in  $\phi$  (phi) scale at -2.00, -1.00, 0.00, 1.00, 2.00, 3.00, and 4.00 respectively.
- Fill sample into sieve meshes which were prepared and put sieve meshes on sieve shaker.
- About 10 minutes later, contain beakers which prepared for each sieve mesh, with sieved samples by divide samples in each sieve mesh into each beaker.
- Weight samples in each beaker and note in weight table.

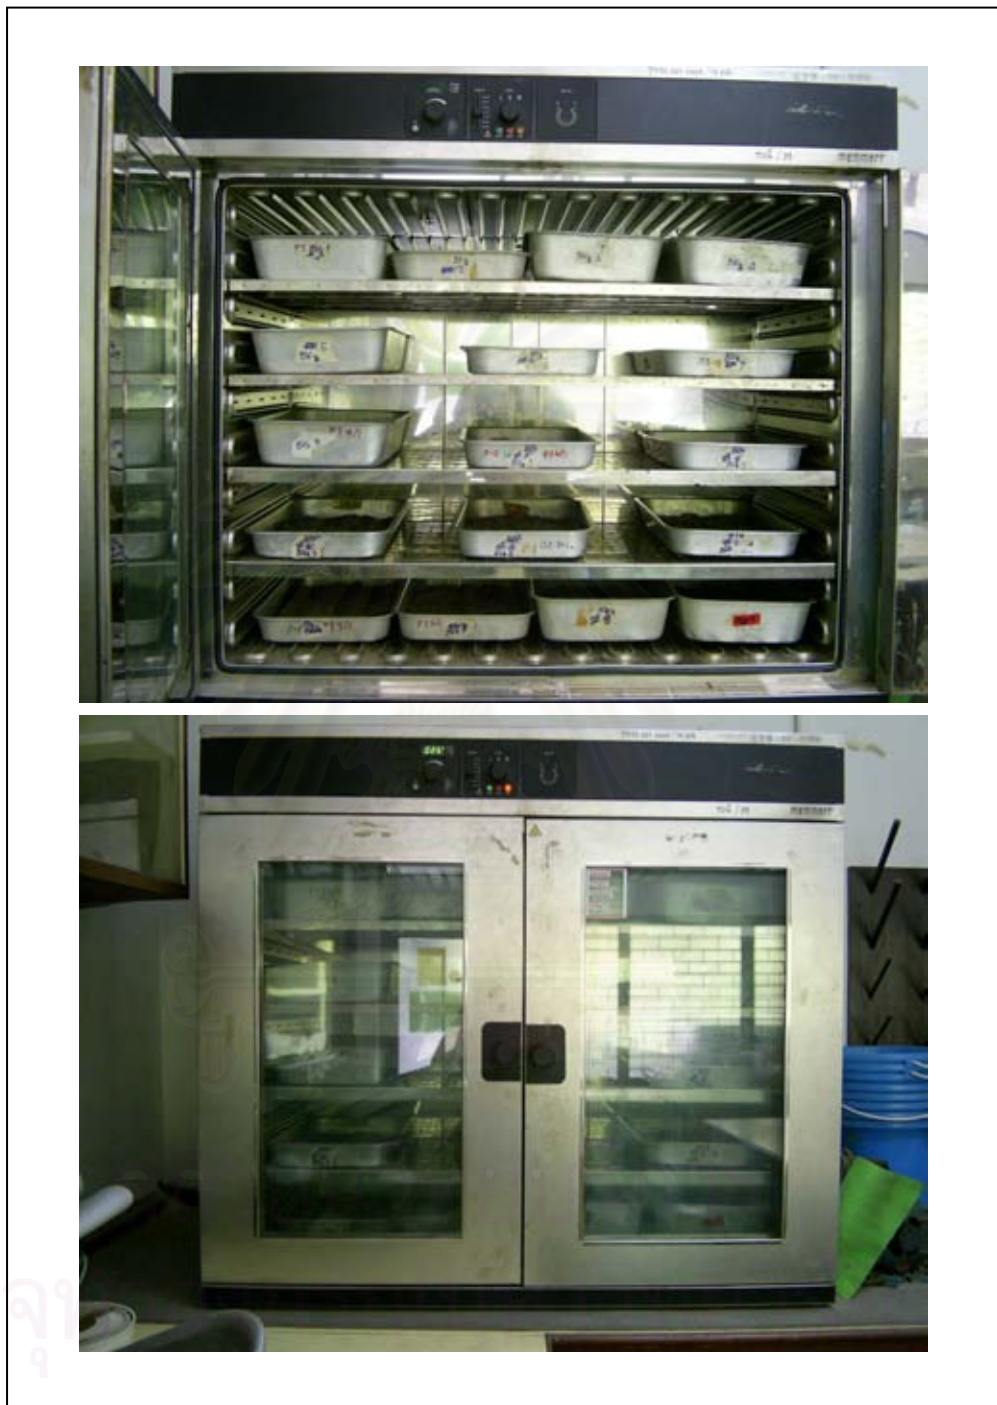
Figure 3.9 Photographs show drying samples in oven at temperature 80° C about 5-6 hours for release water in samples.

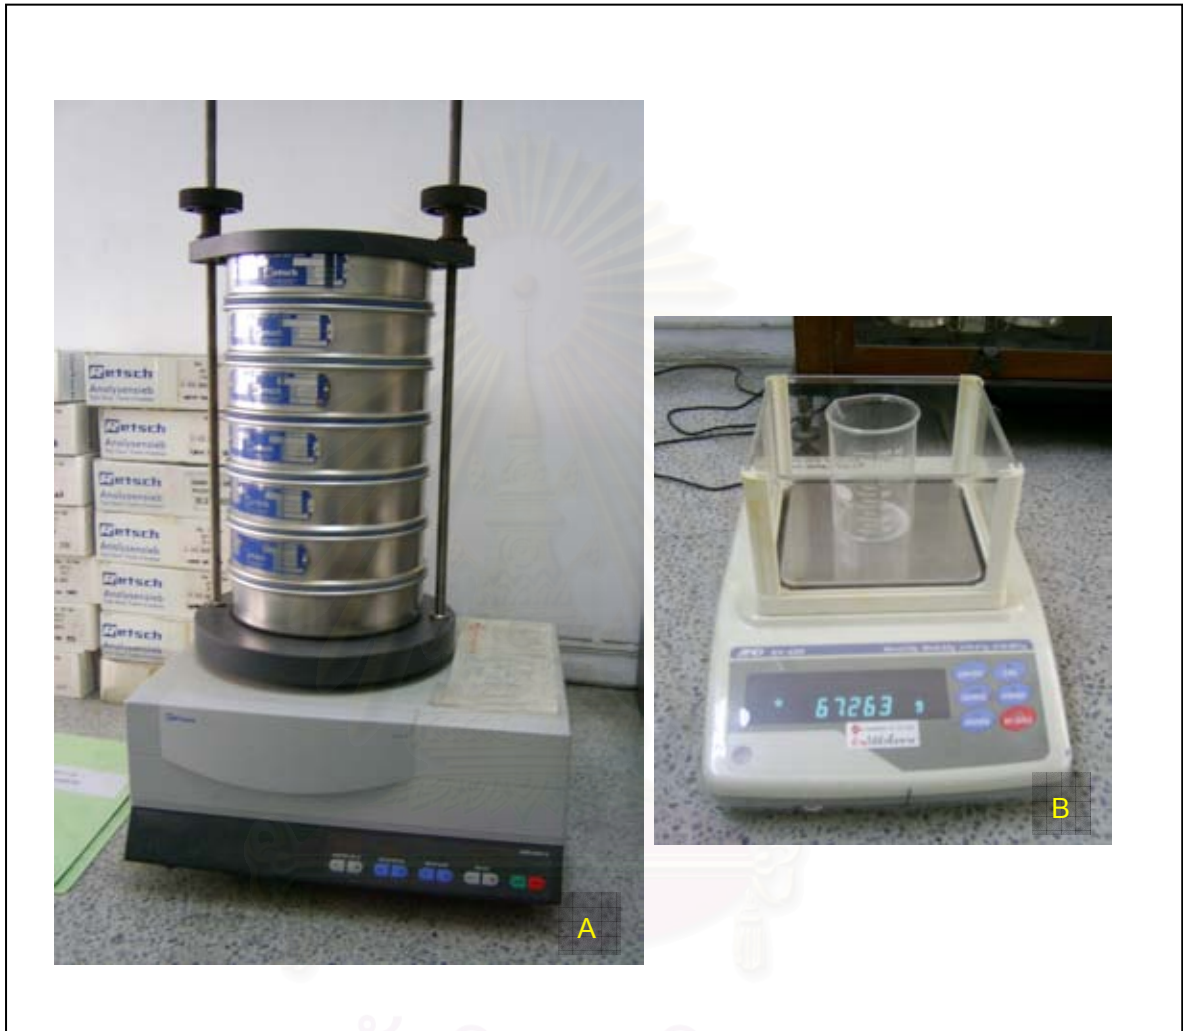
Figure 3.10 Photographs show sieve mesh and sieve shaker (picture A) and also weight measurement used in this study (picture B).

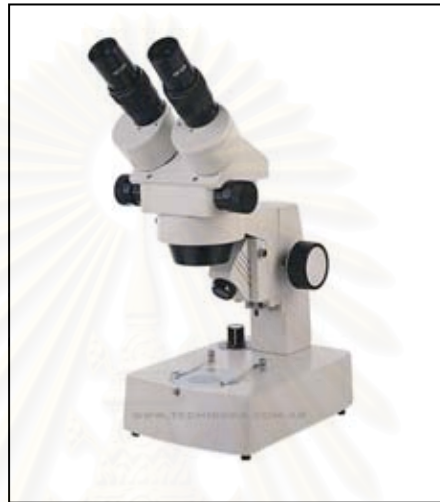
Figure 3.13 Photograph show binocular microscope.

**3.2.3.1.2 Analysis in sediment compositions** The compositions of sediment was classified using binocular microscope (Figure 3.13) and the percentage was estimated also in binocular comparing to the standard chart of sediment's percentage composition (Figure 3.14).

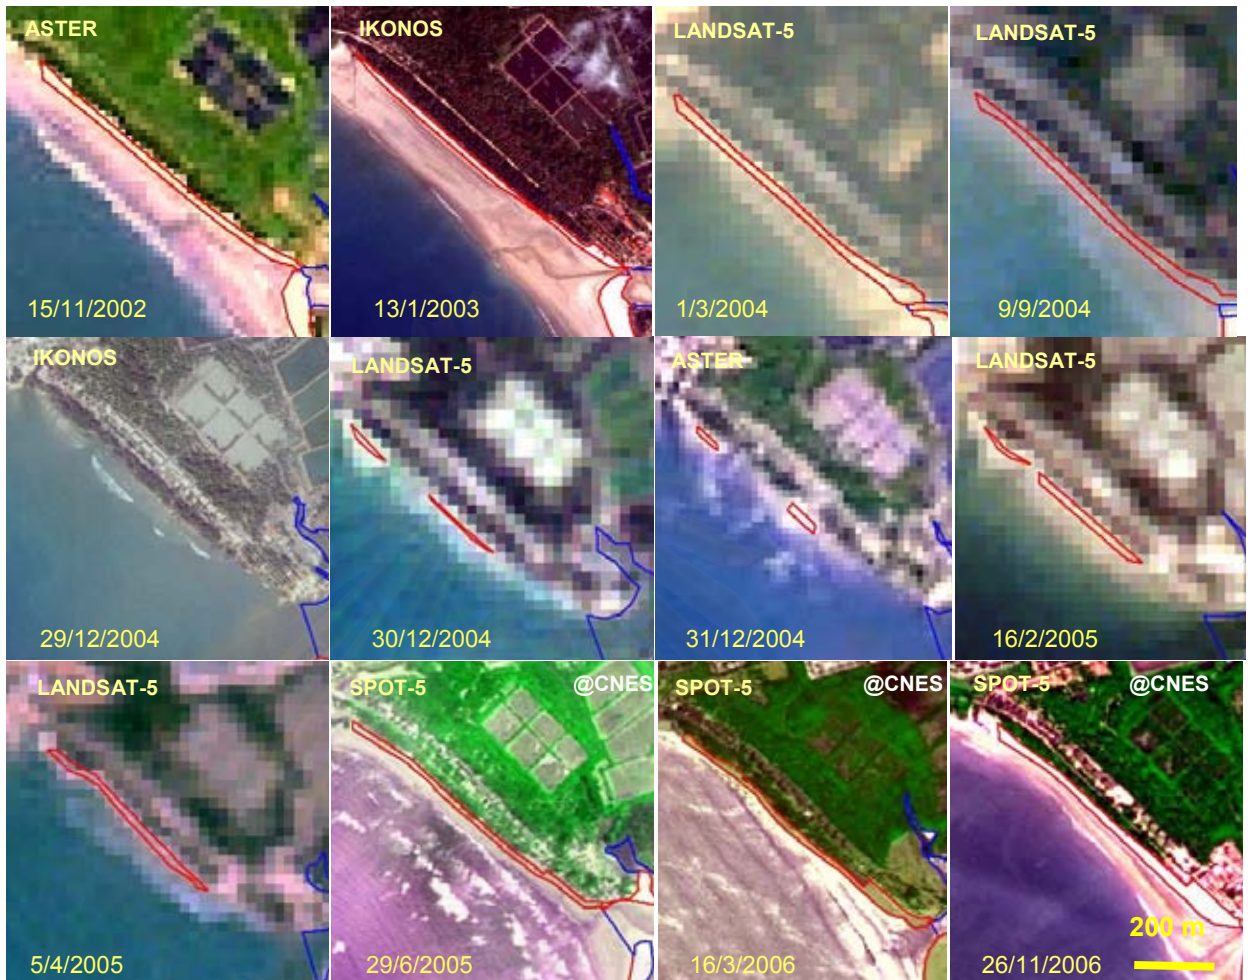
Figure 4.14 Series of satellite images showing beach area change at area A before and after the 2004 tsunami event. Red polygon in each image indicated beach area from mean high tide shoreline.

The result of the beach area change from 2002-2006 (Figure 4.14 and Table 4.5) showed that the beach area change before the 2004 tsunami event tended to increase spatially from 16,401 m<sup>2</sup> in November 2002 to 19,030 m<sup>2</sup> in September 2004. However, beach area was decreased to 11,141 m<sup>2</sup> in January 2003. Three days after the 2004 tsunami attacked, beach area was disappeared about 19,030.53 m<sup>2</sup> and beach shape was also deformed. It was eroded and split into two beaches from the erosion of the 2004 tsunami (Figure 4.14 picture 30/12/2004). However, after beach area was eroded by the 2004 tsunami, the recovery process showed an optimistic signal by keep increasing in beach area. Split beach areas continued to merge together into continuous beach again in April 2005, from the satellite image data evidence (Figure 4.14 picture 30/12/2004 to 5/04/2005). Beach area continued to increase from 0 m<sup>2</sup> in December 2004 to 23,109 m<sup>2</sup> in November 2006. It exceeds beach area before tsunami attacked (Figure 4.15). In conclusion, beach area within area A is completely recovered.

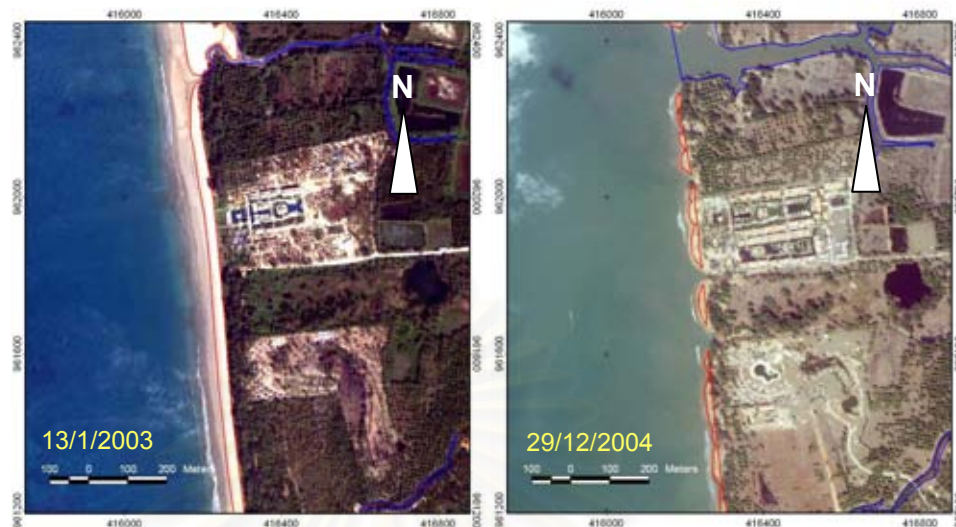
Figure 4.19 Comparing IKONOS satellite images taken before and after tsunami show eroded beach area at area C which split into several parts from the erosion of tsunami and shape of beach is change into half-circle shape similar to the cusped beach morphology. Red polygon indicated beach area in each period.

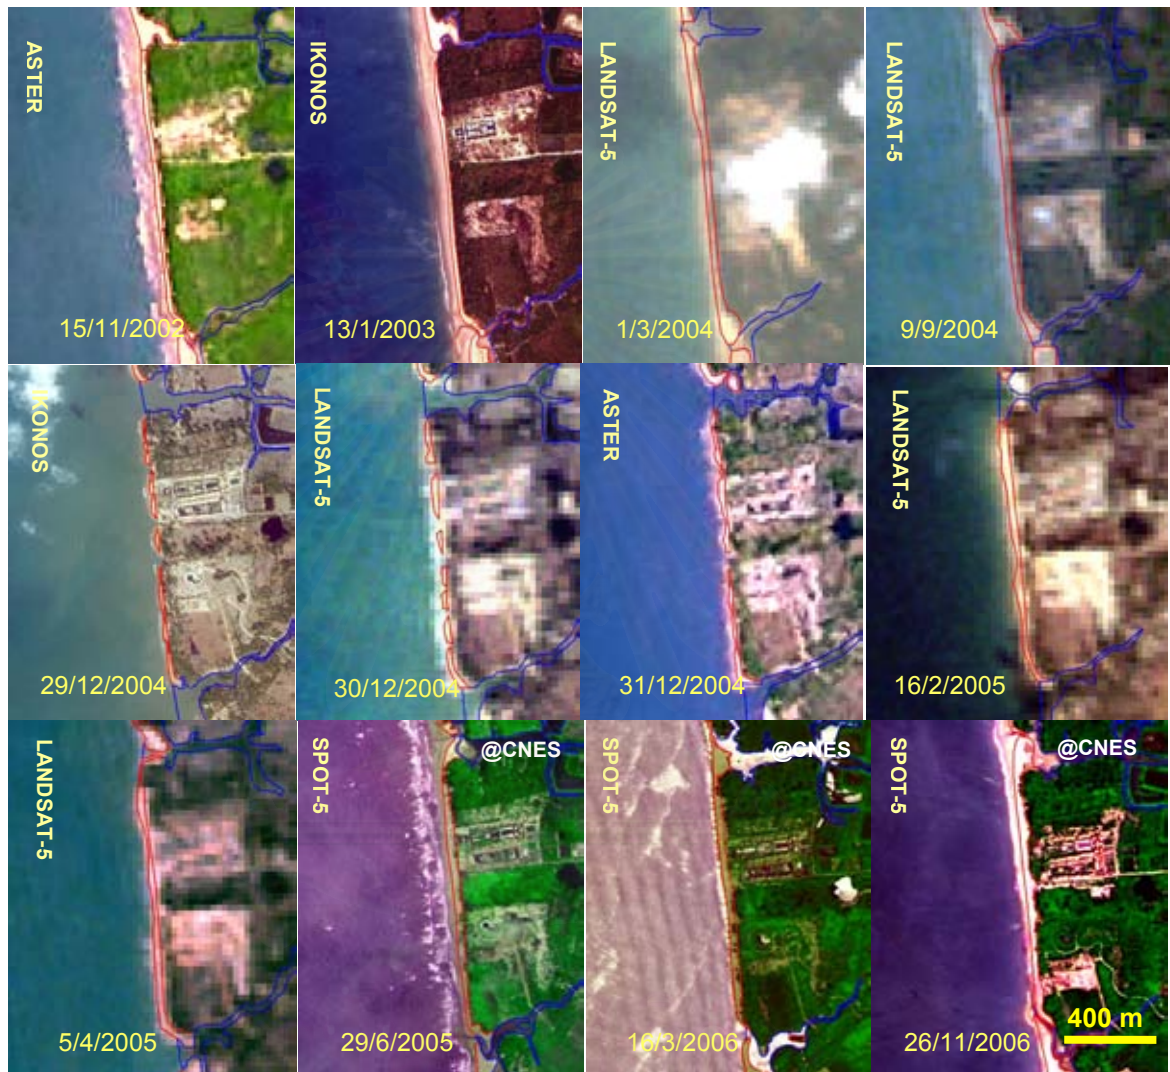
Figure 4.20 Series of satellite images used for calculating beach area change at area C. Red polygon indicated beach area which shows rapid return of beach sediment within two years (January 2005-November 2006).

Beach area changed before the 2004 tsunami from Area C (Figure 4.20, Figure 4.21 and Table 4.7) exhibited equilibrium with area normally changed from 36,155 to 55,405 m<sup>2</sup>. Average of area was about 46,235 m<sup>2</sup> with the change of about  $\pm 10,000$  m<sup>2</sup> during 2002-2004. Three days after the 2004 tsunami attacked, beach area was disappeared about 33,024.28 m<sup>2</sup> and beach shape was also changed. Beach face was eroded away and split into several parts by the erosion of tsunami. Shape of beach was became half-circle as cusped beach morphology (Figure 4.19) and also sediments at mouth of inlet/outlet channel were completely eroded. However, after eroded of beach area from the 2004 tsunami, the recovery process showed an optimistic signal by keep increasing in beach area. Beach cusped-like shape was merged together again by new sediment deposited in February 2005 (Figure 4.20 picture 29/09/2004 to 16/02/2005). Beach area continued to increase from 15,579.23m<sup>2</sup> in December 2004 to 51,701.62 m<sup>2</sup> in November 2006. However, beach area seemed to stable since June 2005 (Table 4.7). Average beach area from June 2005 to November 2006 was

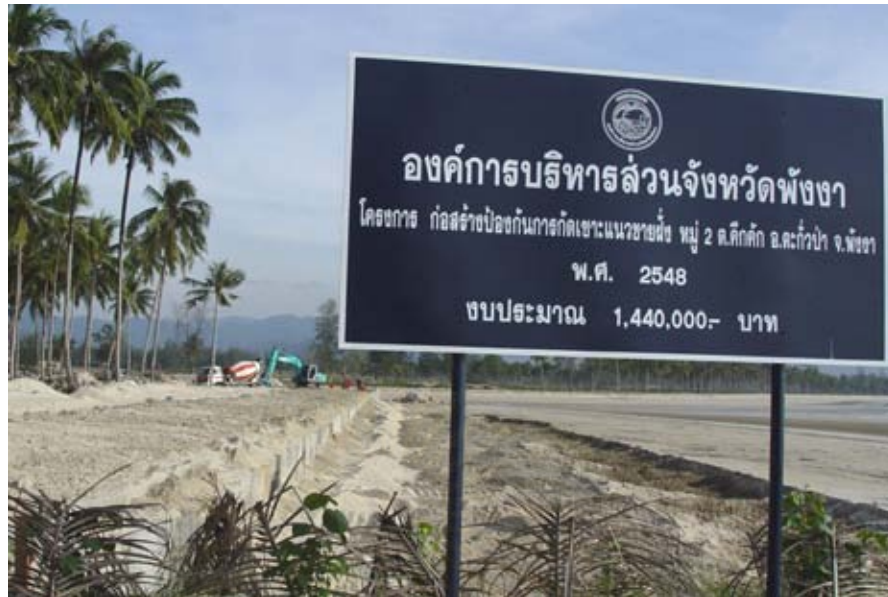
Figure 4.44 Photograph showing new sea wall was built in early 2005 in the north side of inlet/outlet channel at Blue Village Pakarang Resort area.

Eroded shoreline at Blue Village Pakarang Resort area was almost recovered after one year of the 2004 tsunami event as mentioned in result of remote sensing and GIS analysis. However, human activity is one of several factors that induce rate of recovery. Sea wall was built by local government to protect erosion of shoreline from wave in the north side of channel (Figures 4.44 to Figure 4.46).

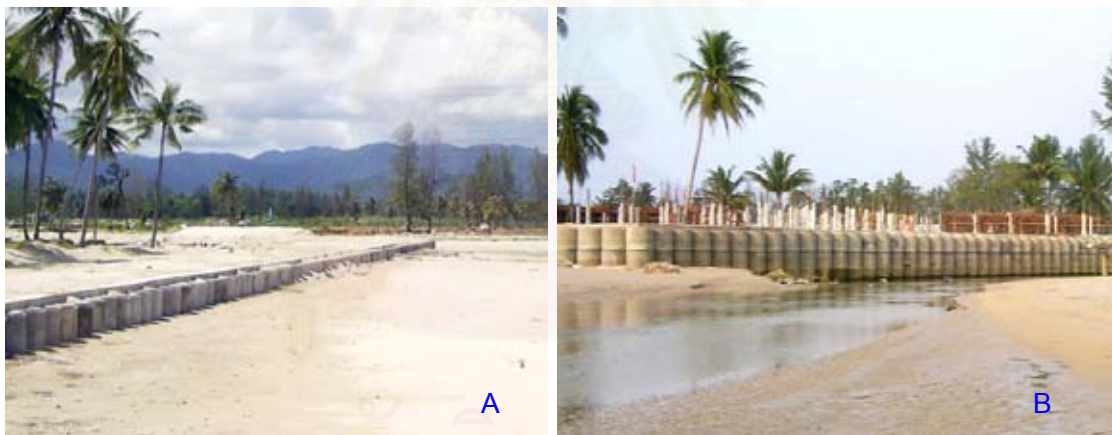
Figure 4.45 Photographs showing new sea wall was constructed parallel to the shoreline (A) and sea wall along the tidal channel (B).

From field observation in period of January to November 2006, new deposition of sand after the 2004 tsunami was clearly observed. New sediment was deposited in front of the sea wall approximately 1.5 meters in vertical thickness. Moreover, new tidal channel tended to expand in north-south direction parallel to the shoreline (Figure 4.47).

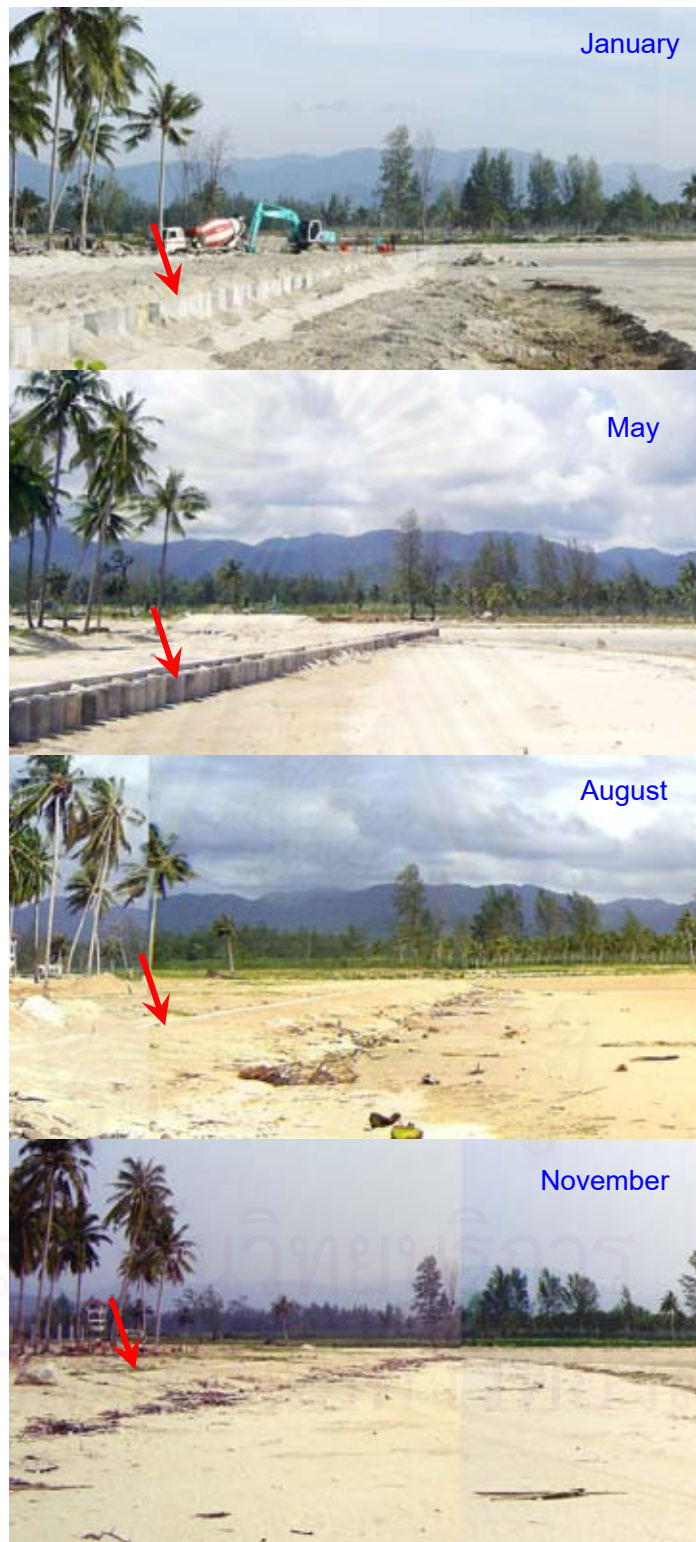
Figure 4.46 Comparing photographs of inlet/outlet mouth (looking south) at Blue Village Pakarang Resort showing deposition of sand in front of new sea wall. Deposition was clearly observed at concrete pipe (red arrow).

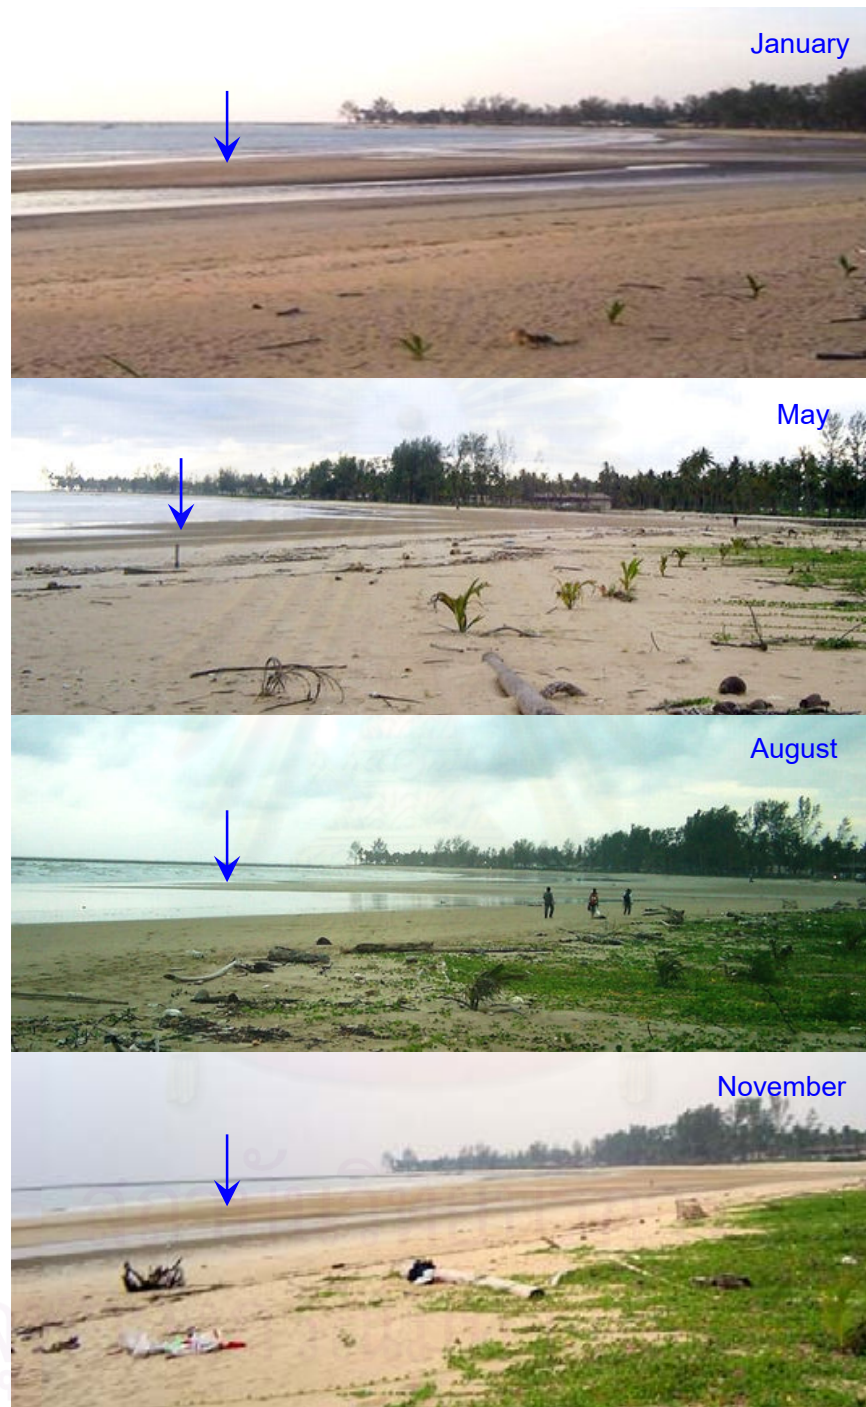
Figure 4.47 Photographs showing tidal delta emerged (as arrows indicated) at low tide time in 2006 that expanded its size in north-south direction parallel to the shoreline (looking north).

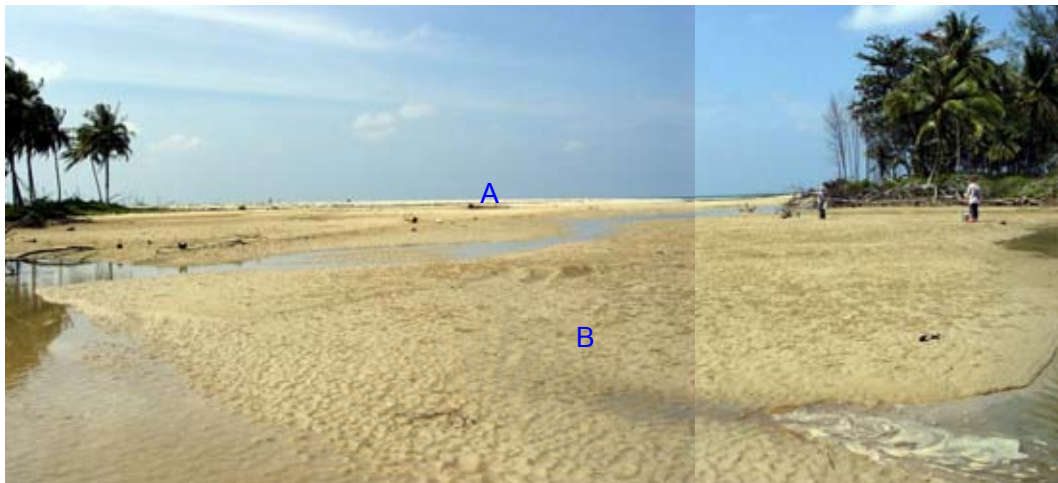
Figure 4.62 Photograph showing new sediment deposits at mouth of tidal channel. A is location where new beach sediment returned, and B shows new flood-tidal delta and washover deposits behind new beach ridge (looking west).

Eroded shoreline at Sofitel Magic Lagoon Resort area was almost recovered after one year of the 2004 tsunami event. New sediment deposit was filled up in the eroded area at the mouth of inlet/outlet channel (Figures 4.62 and Figure 4.63). Accretion of sediment at mouth of inlet/outlet channel also found in this area (Figure 4.64), in January tidal delta was accumulated under low tide, then in June, August, and November tidal delta emerged and expanded itself in to the sea. Moreover, slope of foreshore was also changed which responded to the season change (Figure 4.65).

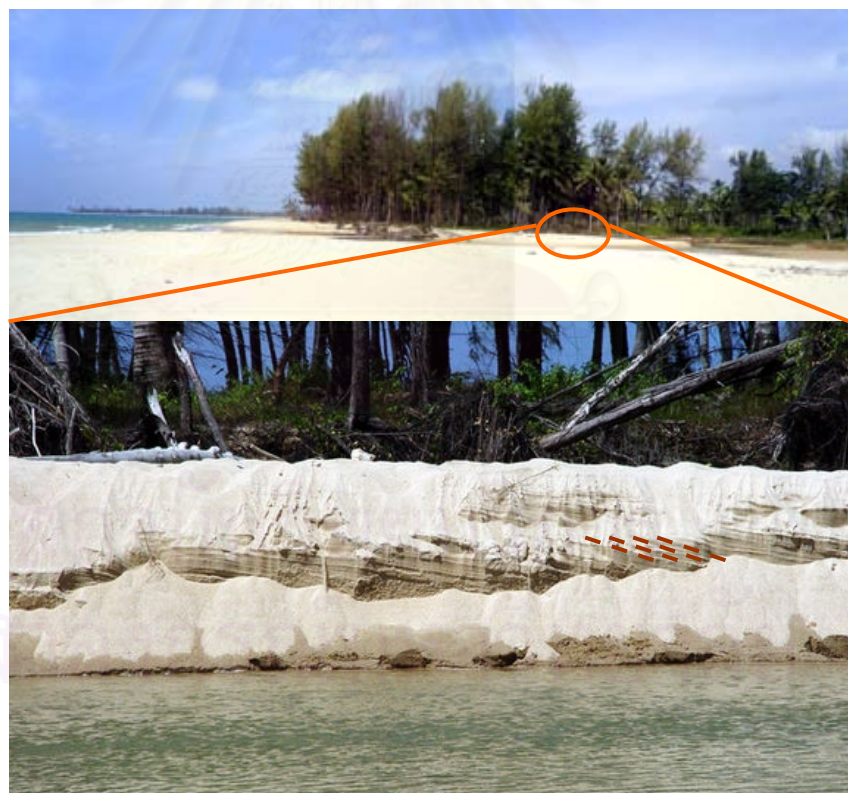
Figure 4.63 Photograph showing new backshore sediment indicate inclination of layer in landward direction (looking north) deposited where eroded channel back occurred.

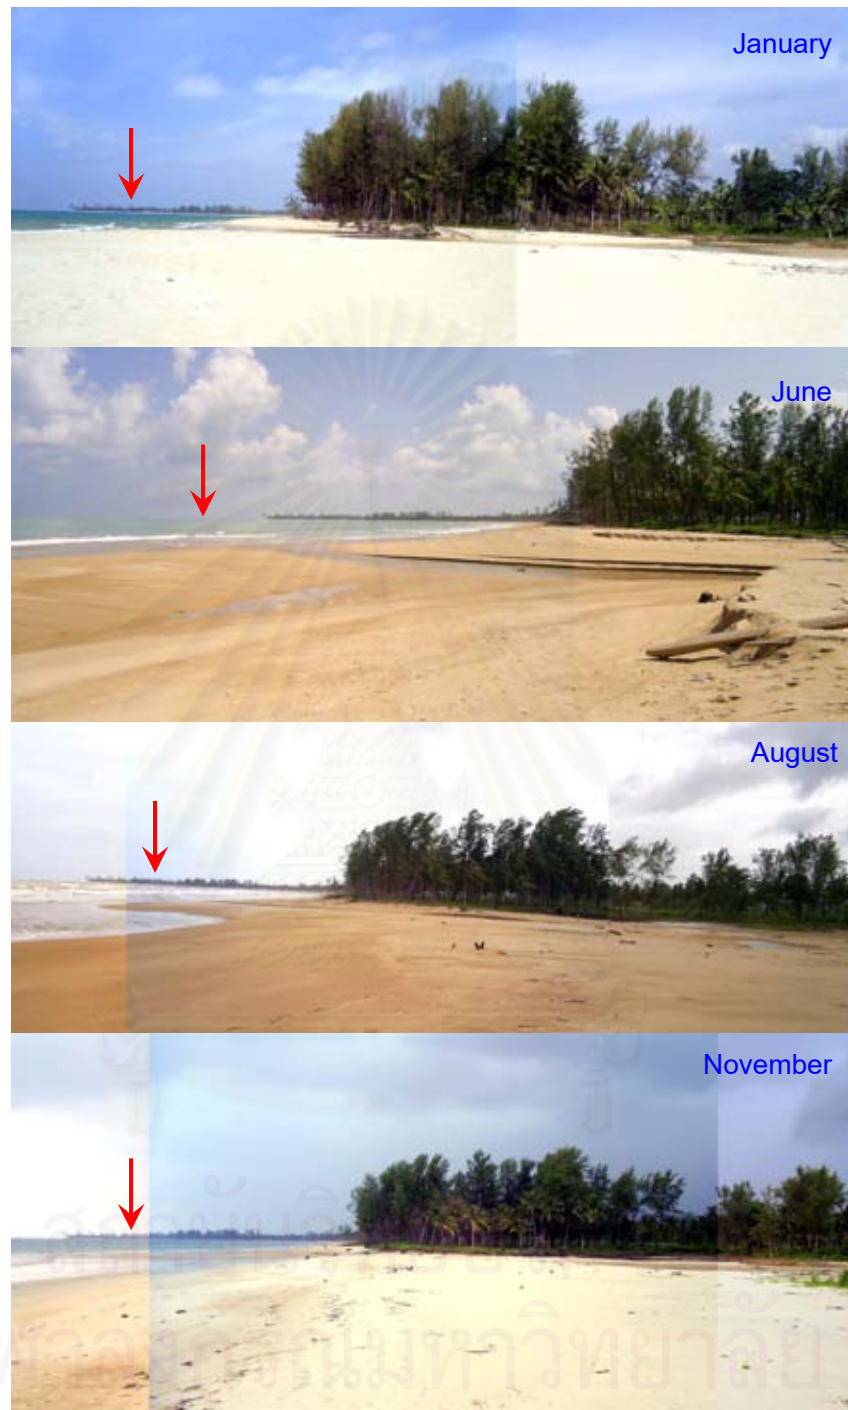
Figure 4.64 Series of photographs at inlet/outlet channel mouth taken in 2006 at Sofitel Magic Lagoon Resort showing accretion of sediment at mouth of channel (looking north). Red arrows indicate expand of tidal delta in seaward direction.

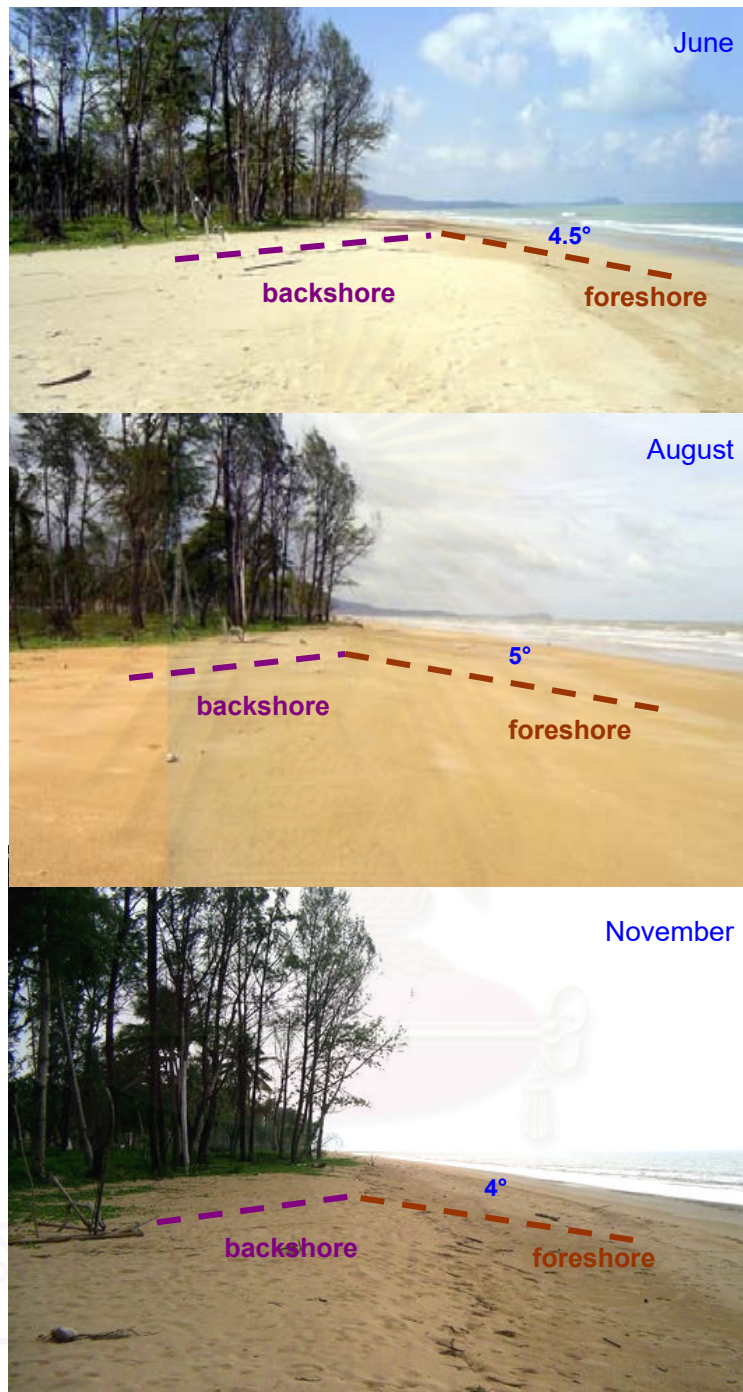
Figure 4.65 Series of photographs of backshore and foreshore slope at Sofitel Magic Lagoon Resort area taken in different seasons of 2006 showing slope of foreshore became steeper during June to August in rainy season and decreased angle after end of rainy season in November (looking south).

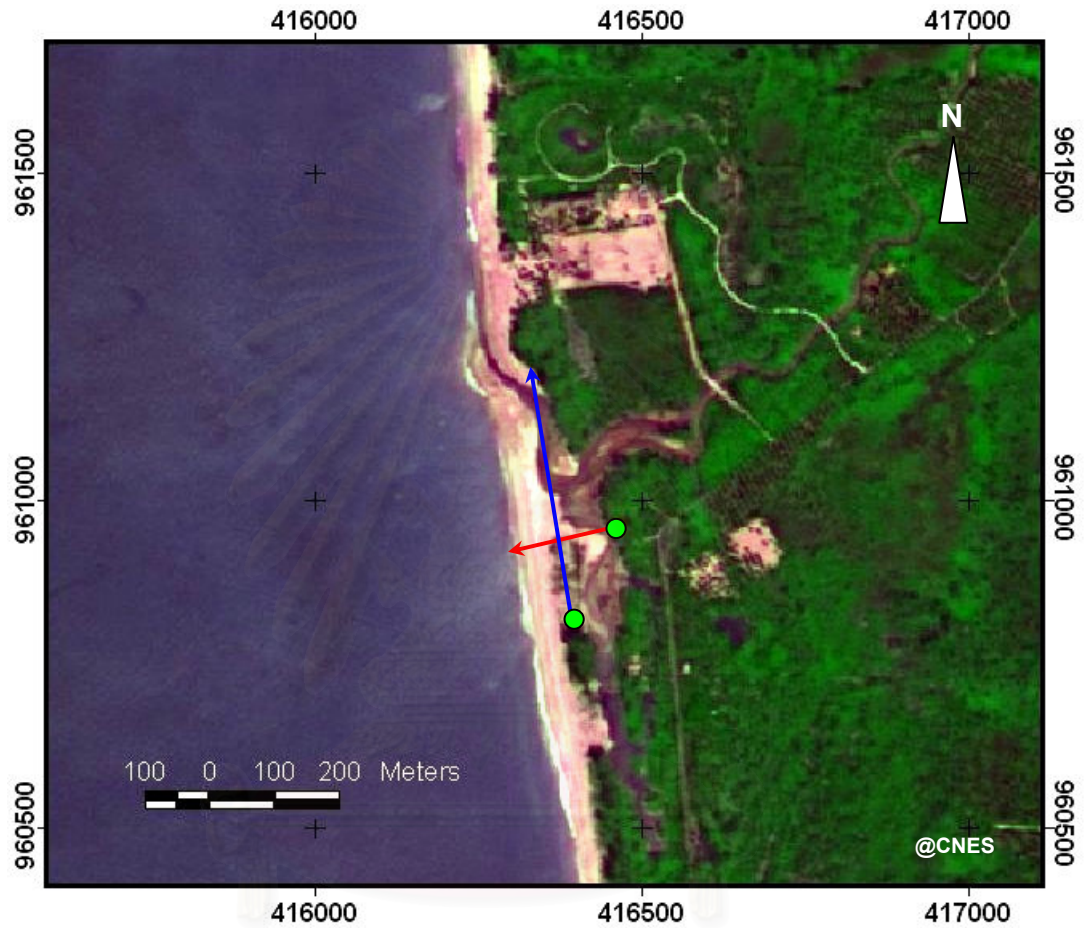
Figure 4.66 Beach profiling lines both perpendicular and parallel to the shoreline at Klong Khuek Khak. Green dot is a reference point. Red line is east-west beach profile and blue line is south-north inlet/outlet cross-section. Background image is from SPOT-5 satellite taken two year after the 2004 tsunami.
