SHORELINE CHANGE AFTER THE 26 DECEMBER 2004 TSUNAMI BETWEEN  
LAEM PAKARANG-KHAO LAK AREA, CHANGWAT PHANG-NGA, THAILAND

A Thesis Submitted in Partial Fulfillment of the Requirements  
for the Degree of Master of Science Program in Earth Sciences

Department of Geology

Chulalongkorn University

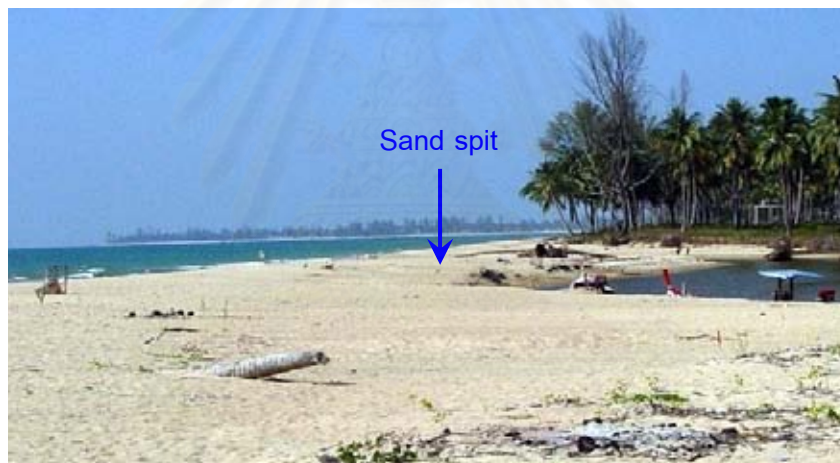
Figure 4.77 Photograph showing new sand spit at mouth of inlet/outlet channel at Klong Khuek Khak area (looking north). Height of sand spit from water level in channel at high tide time is approximately 3 meters.

Eroded shoreline at Klong Khuek Khak area was almost recovered after one year of the 2004 tsunami event. New sediment deposit was filled up in the eroded area at the mouth of inlet/outlet channel. New sand spit was found at the mouth of inlet/outlet channel in January 2007 which approximately high 3 meters above the present mean sea level (Figure 4.77). Sand spit was accumulated in northward direction response to the longshore current in this area. In November sand spit was growth exceeds the mouth of inlet/outlet channel and extends itself into the sea (Figure 4.79 C). After that, from field observation in March 2007, sand spit closed the mouth of inlet/outlet channel led channel meandered to find new drainage outlet. The middle part of sand spit which close to the main channel was destroyed by erosion of meandering

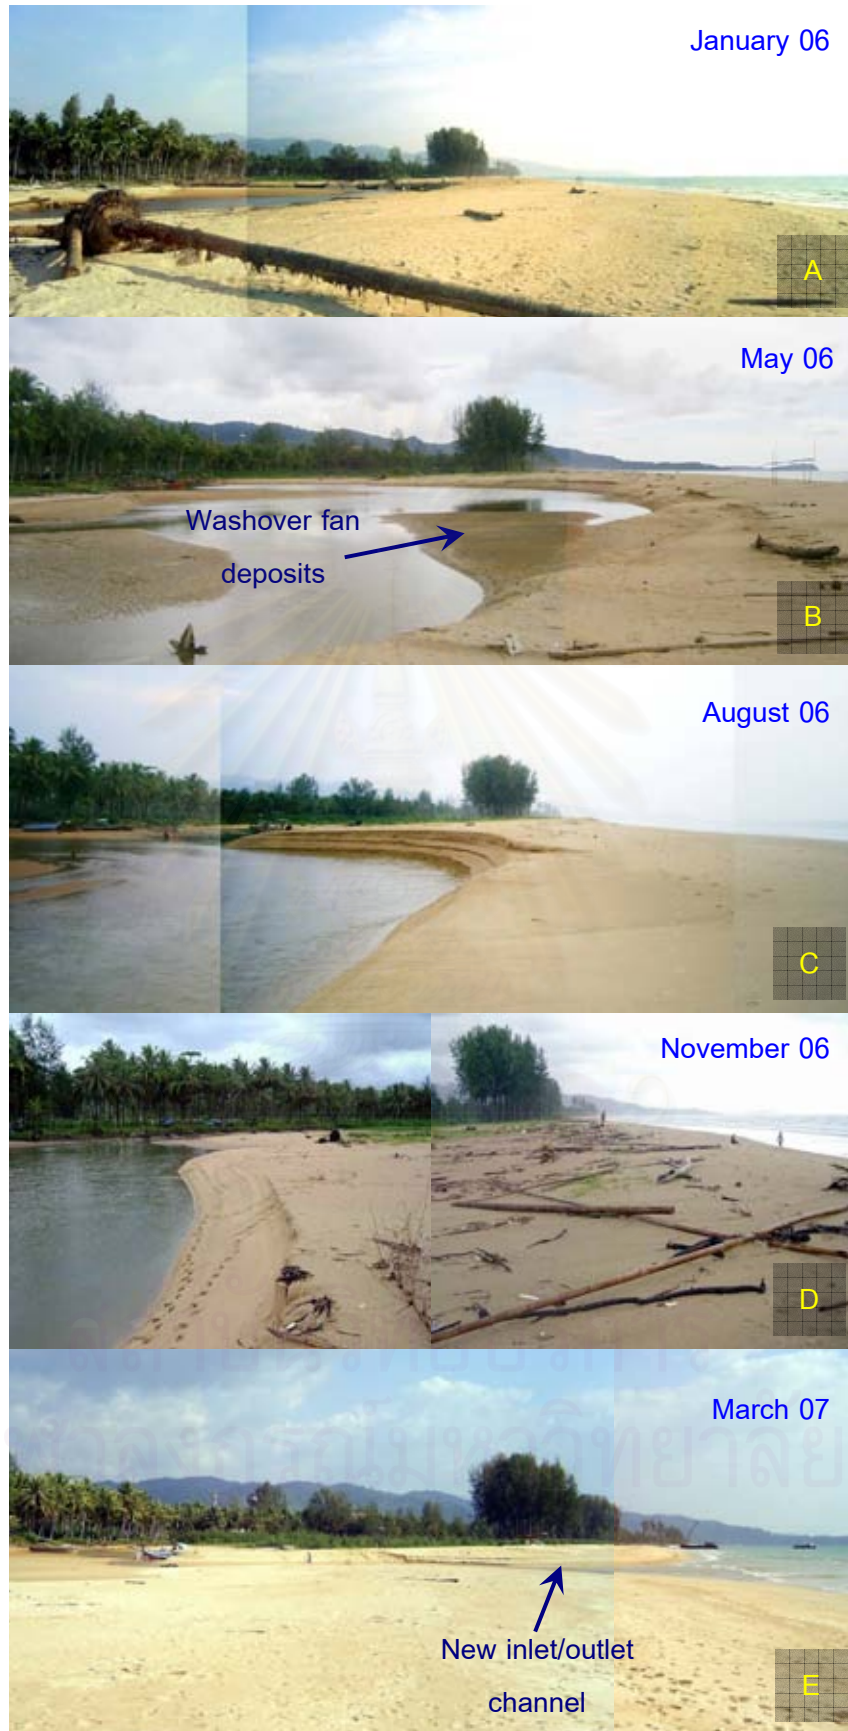
Figure 4.78 Series of photographs taken from January 2006 to March 2007 showing the change in shape of sand spit (looking south).

stream behind sand spit (Figure 4.78 C) and new outlet was opened at the middle part of sand spit (Figure 4.78 E).

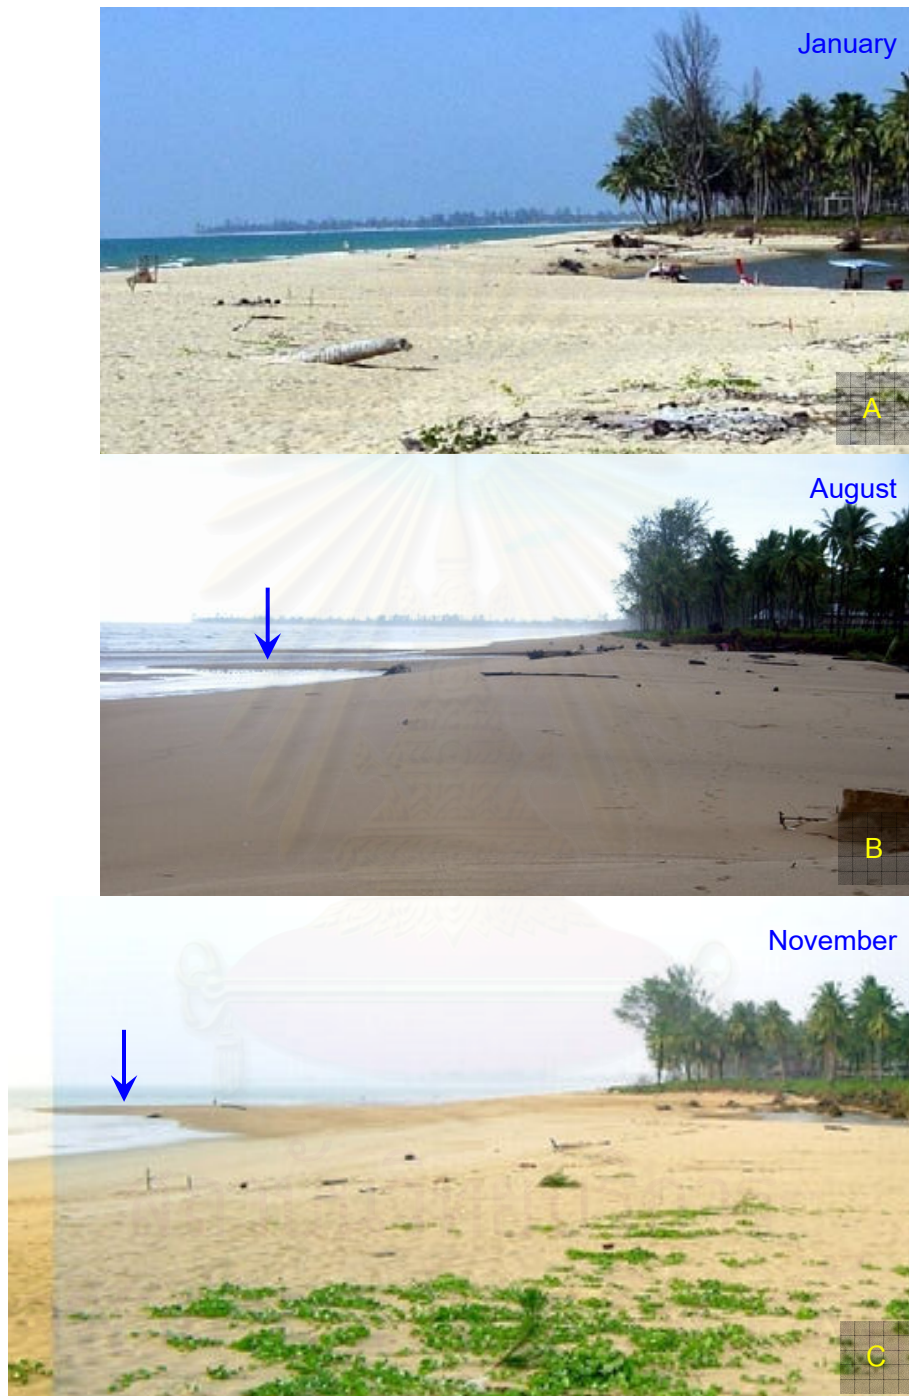
Figure 4.79 Series of photographs of inlet/outlet channel mouth at Klong Khuek Khak area taken in different seasons of 2006 showing accretion of sediment at mouth of channel as arrow indicated (looking north).

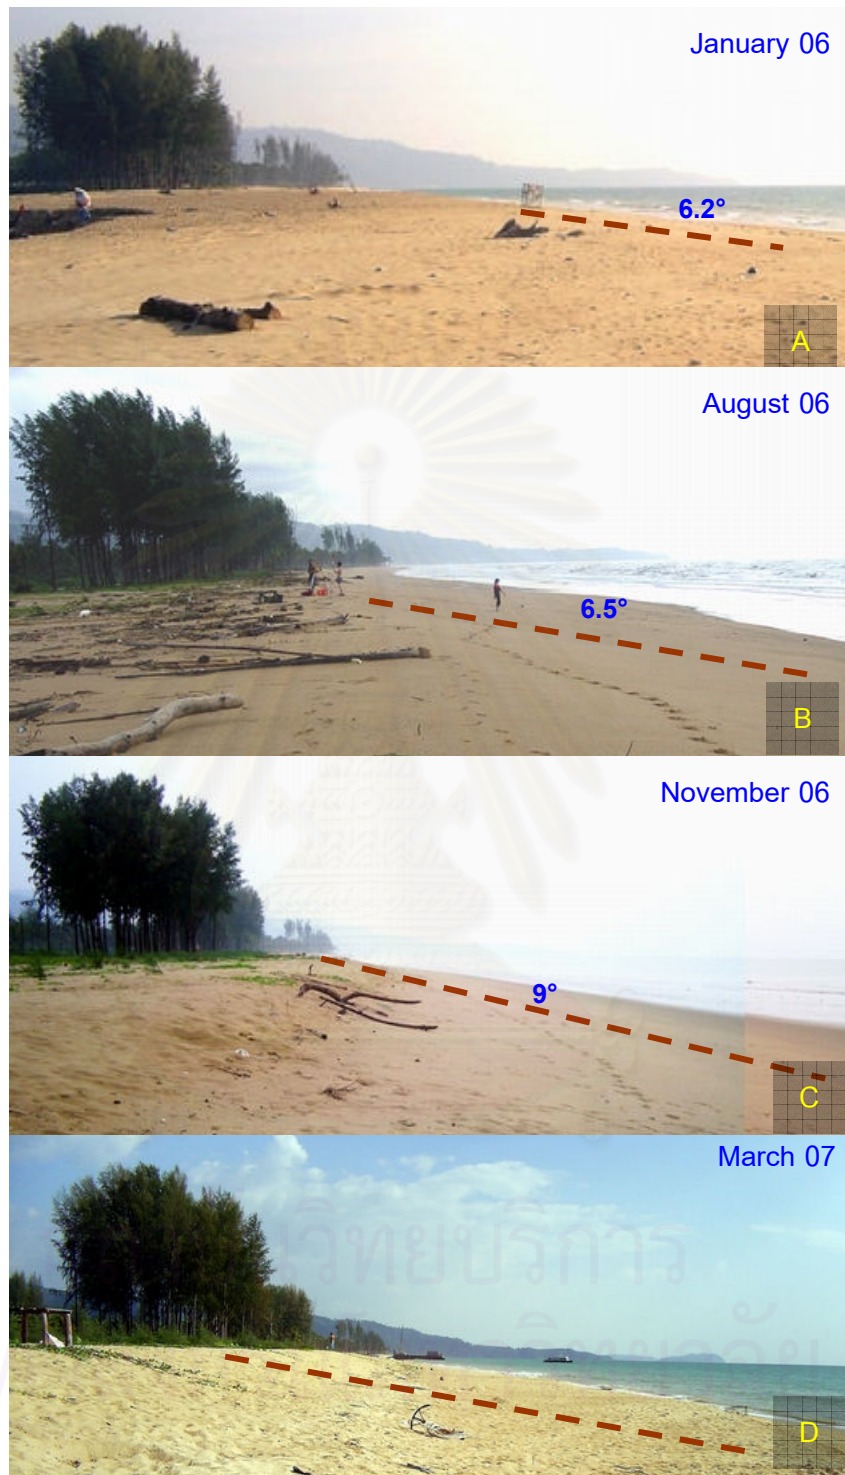
Figure 4.80 Series of photographs of foreshore slope at Klong Khuek Khak area comparing in different seasons since January 2006 to March 2007 showing steep slope in August to November 2006, and gentle slope in January 2006 and March 2007(looking south).

Slope of foreshore also changes response to the annual seasonal changes (Figure 4.80). In January 2006, foreshore slope was gently (Figure 4.80 A), then steeper in August (Figure 4.80 B), and much steeper in November (Figure 4.80 C). Finally, in March 2007 slope of foreshore was decreased and turned to gentle again (Figure 4.80 D). Evidence of high energy of wave in monsoon season was also observed. In May, washover fan and slump of sand spit was found behind sand spit (Figure 4.81).

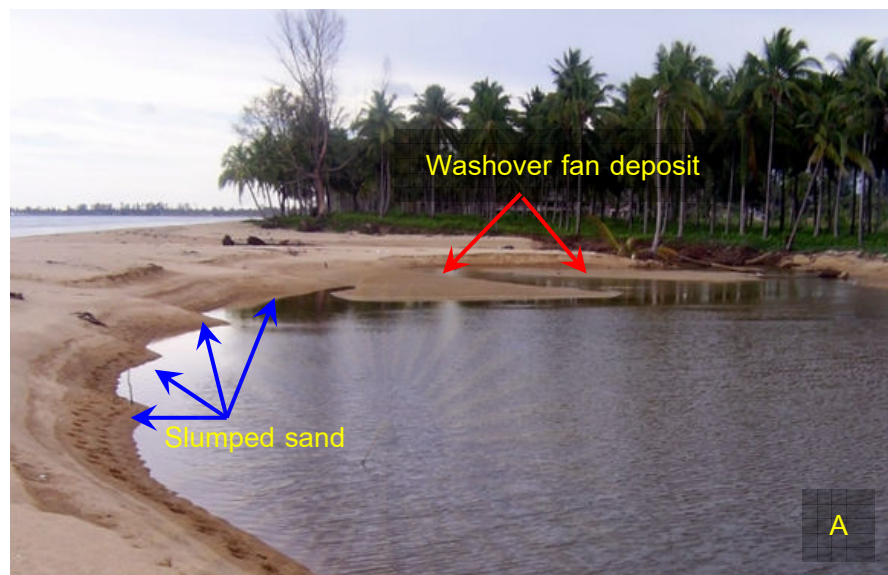
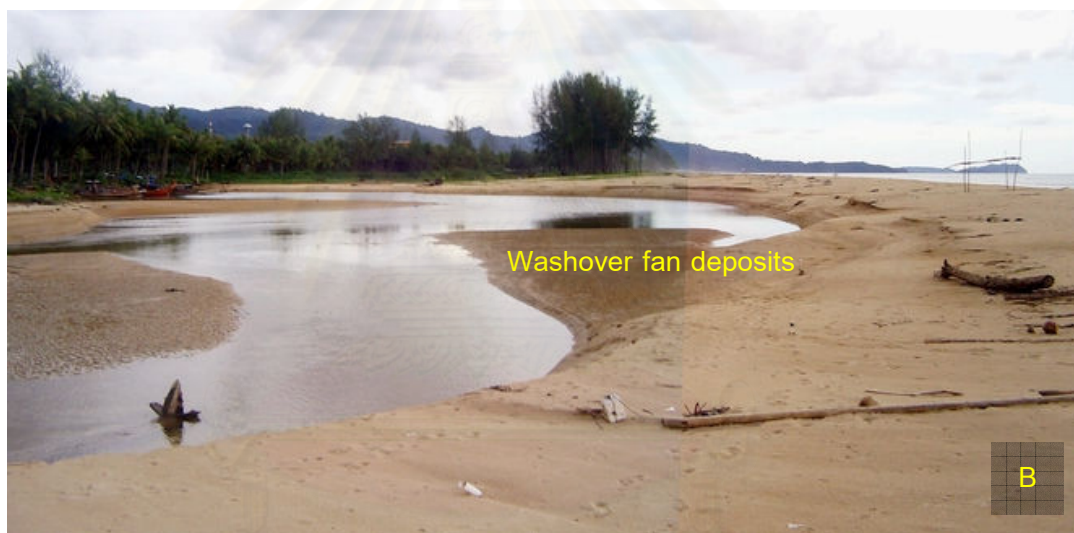
Figure 4.81 Photographs showing washover sand deposits and slump of sand behind sand spit has left by seasonal storm surge (picture A looking north, picture B looking south).

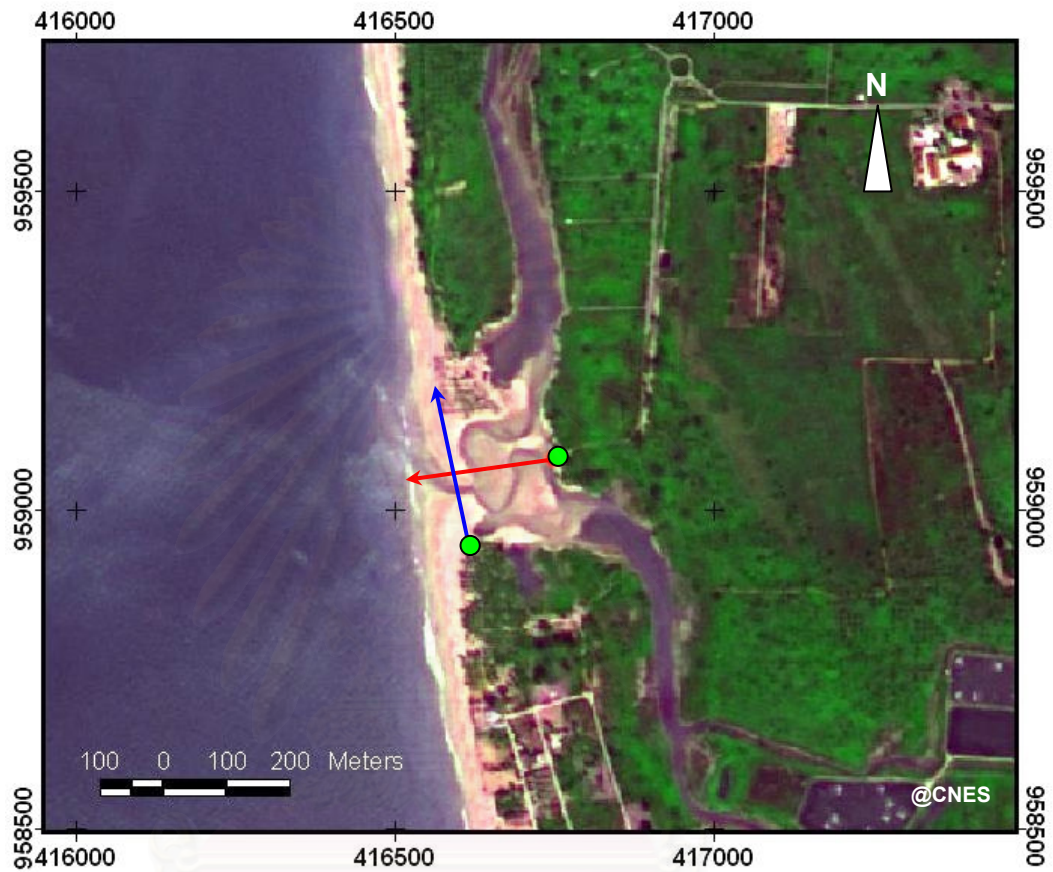
Figure 4.83 Profiling position at Ban Bang Niang. Green dot is a reference point.

Red line is east-west beach profile and blue line is south-north inlet/outlet cross-section. Background image is from SPOT-5 satellite taken two year after the 2004 tsunami.

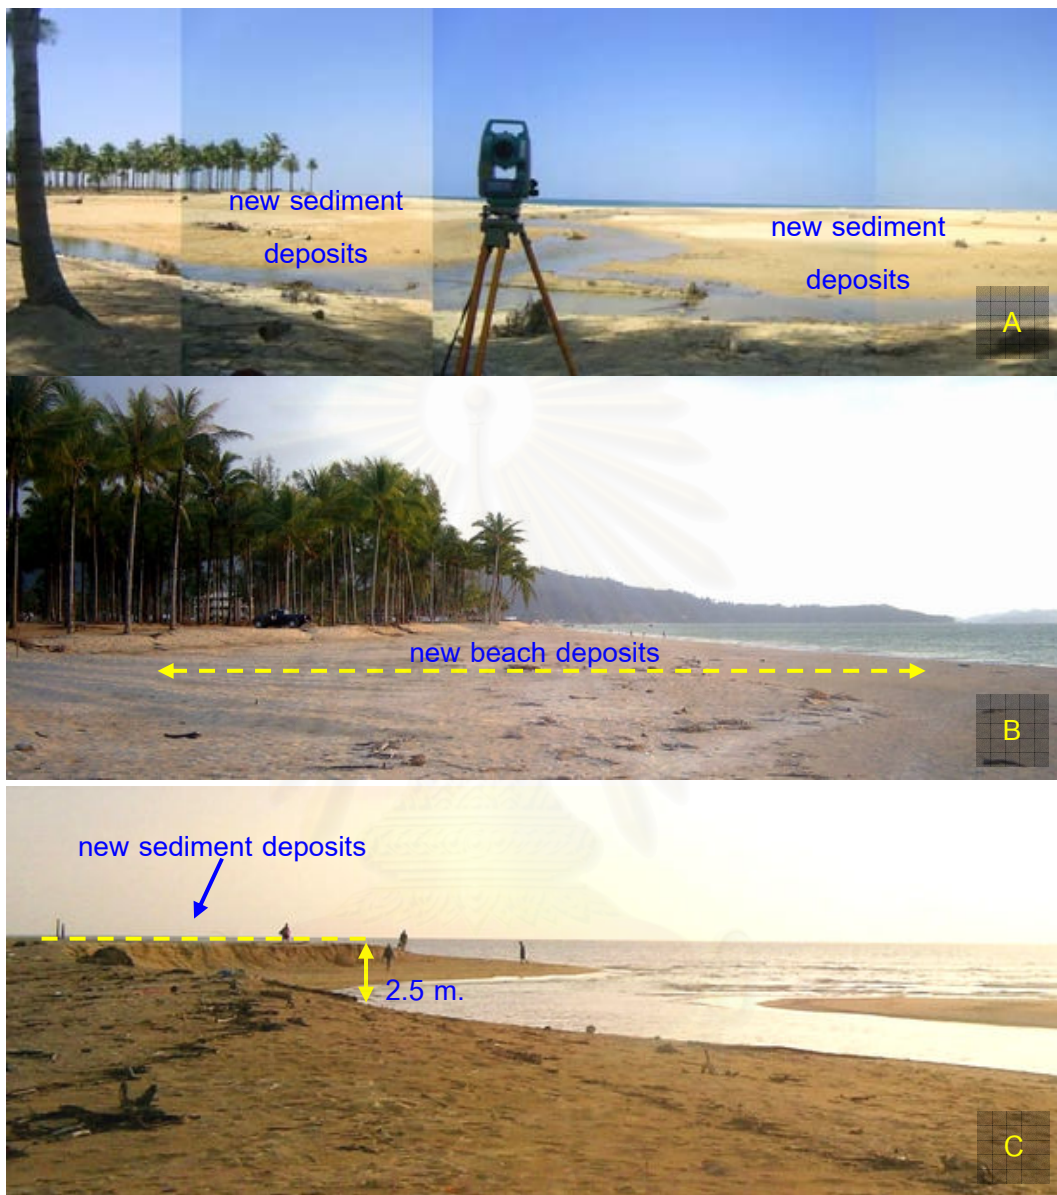
Figure 4.99 Photographs showing new sediment filled up in the eroded area of Ban Bang Niang in February 2006. Picture A shows sediment deposit at mouth of inlet/outlet channel (looks west), picture B shows new beach deposits in the south side of inlet/outlet channel (looking south) and picture C shows new sediments deposit near inlet/outlet channel, height of deposition is 2.5 from ground surface.

Eroded shoreline at Ban Bang Niang area was almost recovered after one year of the 2004 tsunami event. New sediment deposit was filled up in the eroded area which height approximately 2.5 meters from ground surface (Figure 4.99 C). Stream cut outcrop near the mouth of inlet/outlet channel in February 2006 also shows development of shoreline that indicating successions of backshore and foreshore layer (Figure 4.100). Instability of mouth channel area was recorded from field investigation since February to November 2006 as mentioned in inlet/outlet cross-section which shows erosion and deposition of channel bank at mouth of inlet/outlet area (Figure 4.101). In February, tidal channel became small and slightly meandered (Figure 4.101 A). Then, in May, channel had changed outlet to the left of previous one due to erosion of stream cut outcrop near inlet/outlet (Figure 4.101 B). Sediment deposit at the mouth of inlet/outlet channel was accumulated higher than high tide water level leading water cannot drain out to the sea (Figure 4.101 B). Three months later, in August, (Figure 4.101 C), tidal channel eroded sand barrier and new outlet opened on the right of previous one with more meandered channel shape. Finally, in November, (Figure 4.101 D) new sediment deposit occurred again near inlet/outlet mouth at the same place that stream cut outcrop was observed. Channel shape was wider, bigger and meandered into the entire area.

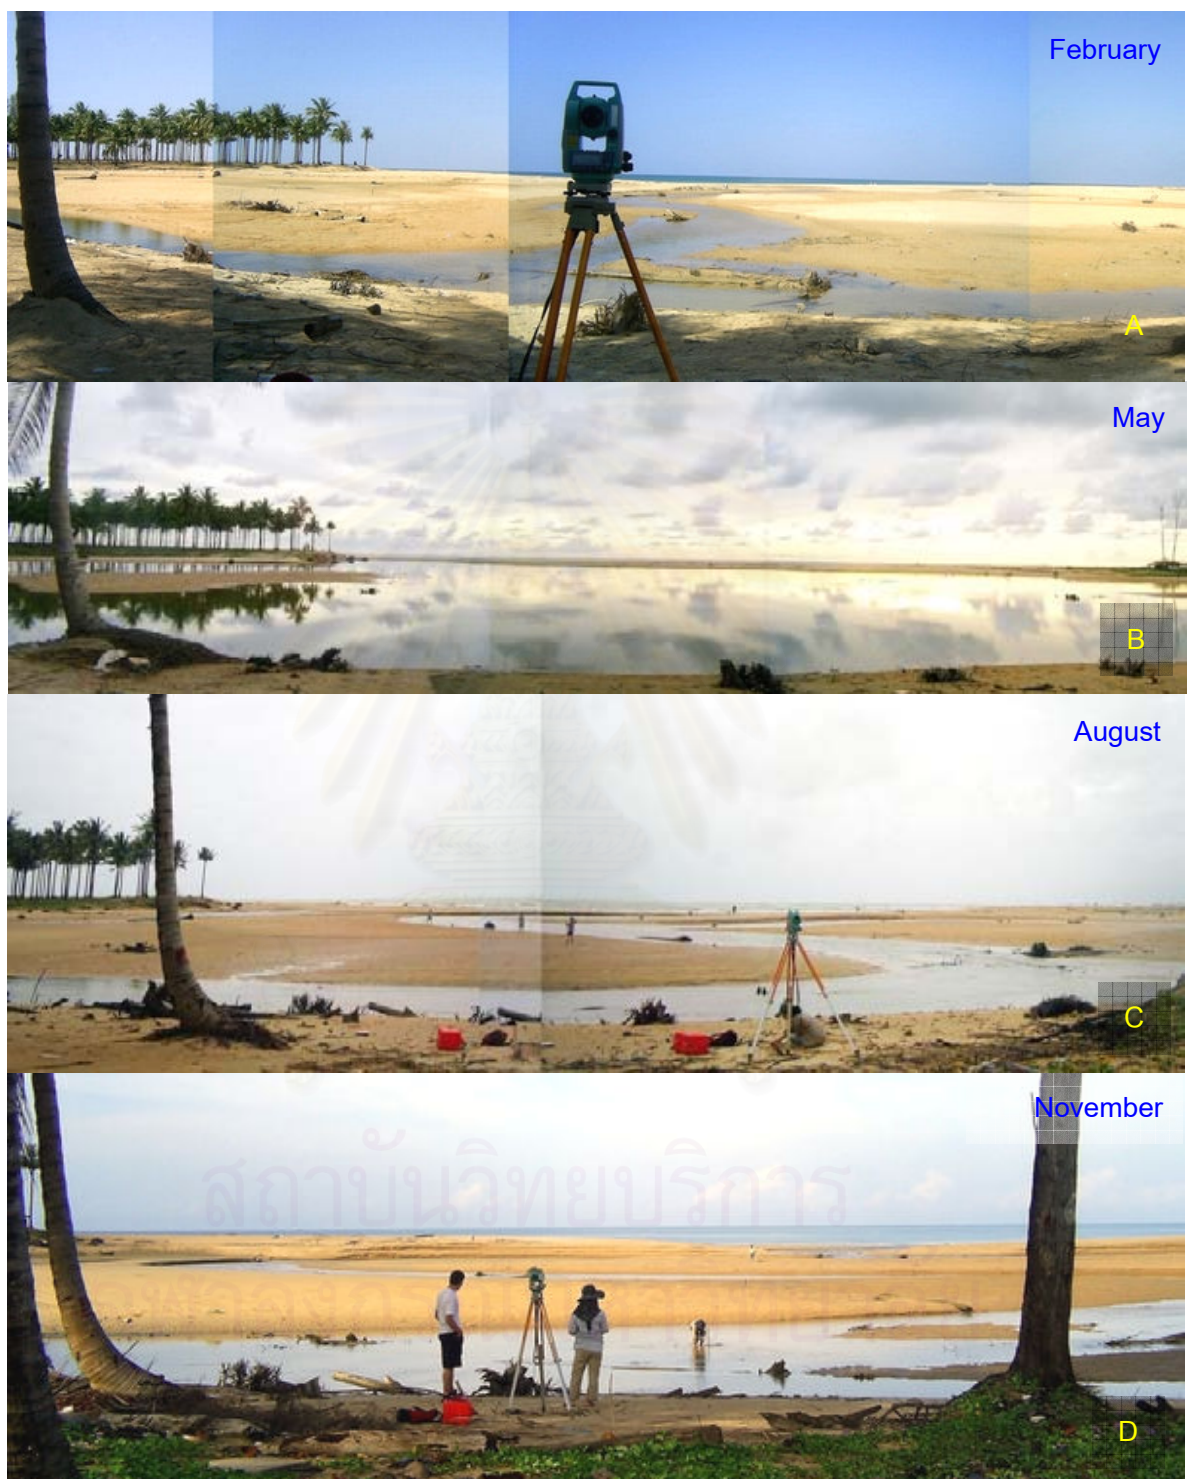
Figure 4.101 Photographs showing a small meandering stream that was clearly observed at Ban Bang Niang from February to November 2006 (looking west).

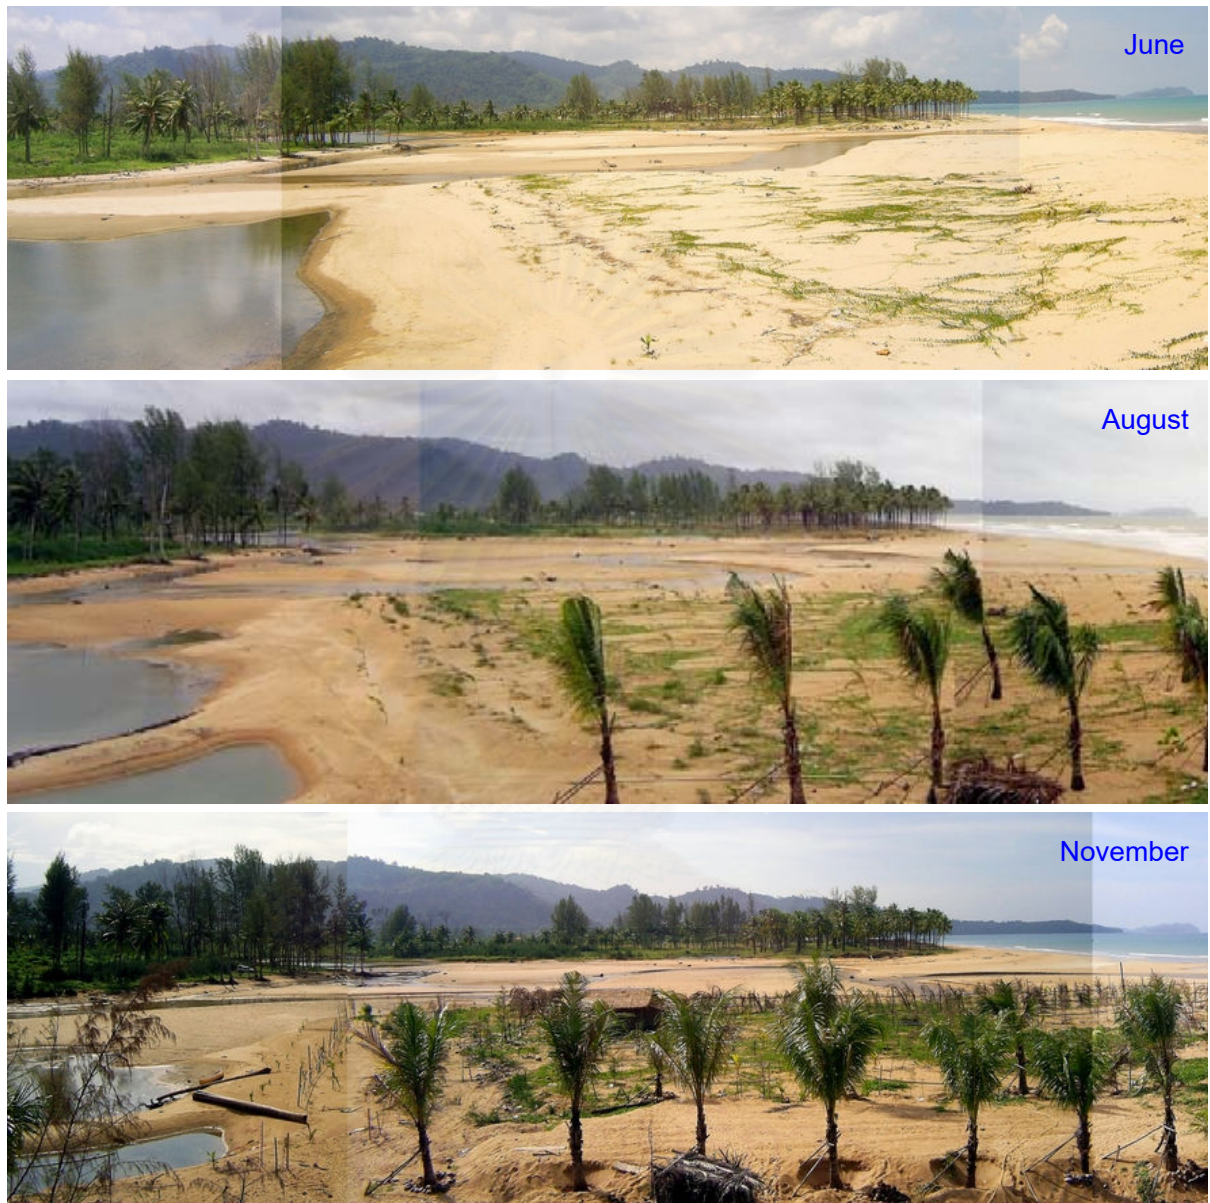
Figure 4.102 Photographs showing inlet/outlet channel at Ban Bang Niang area showing meandering stream inside tidal channel and also land use change from June to November 2006 (looking south).
