สรุปผลการทดสอบดินและรูปทัศนภูมิจุลศาสตร์

ท่าอากาศยานสาทรกรุงเทพ ฯ

แผนภูมิของการออกแบบความหนา

รูปแบบของการสำรวจรอยแตกนิเวศนาการจราจร

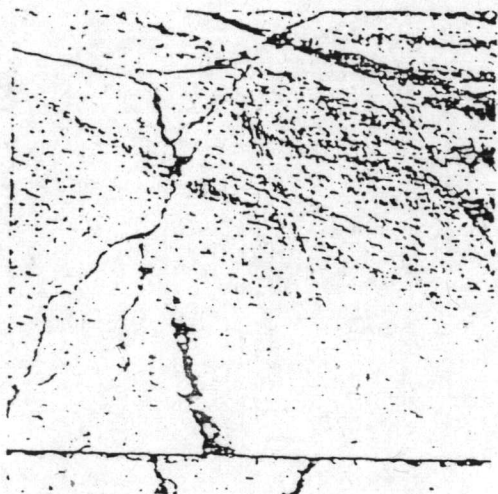
(i) Longitudinal, Transverse, and Diagonal Cracks These cracks are defined with reference to their orientation in the slab. Examples of such cracks are shown in Figure 1A, 1B and 1C.

C. DIAGONAL CRACK

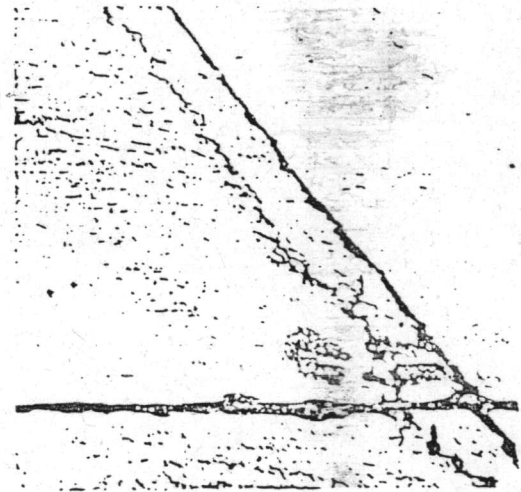
(iii) Joint Spalling Joint spalling is the occurrence of raveling or cracking along the joints, generally ranging from 2 to 6 in. in width. Typical spalling along the longitudinal joint, transverse joint, and at the corner of a slab is shown in Figures 2D, 3A and 3B, respectively.

D. LONGITUDINAL JOINT SPALL

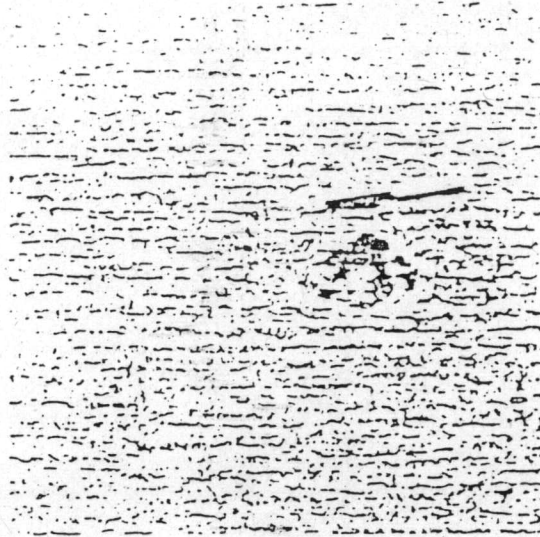
(vii) Pop-outs Pop-outs (Figure 4A) are small spalls occurring in the interior portion of the slab and are usually caused by defective coarse aggregates.

A. POP OUT
