THE LONGEVITY OF CERAMIC VENEERS: CLINICAL EVALUATION OF MECHANICAL,
BIOLOGICAL, AND ESTHETIC PERFORMANCES OF CERAMIC VENEERS UP TO 7-YEARS
RETROSPECTIVE STUDY

A Thesis Submitted in Partial Fulfillment of the Requirements
for the Degree of Master of Science Program in Esthetic Restorative and Implant
Dentistry

Faculty of Dentistry
Chulalongkorn University
Academic Year 2017

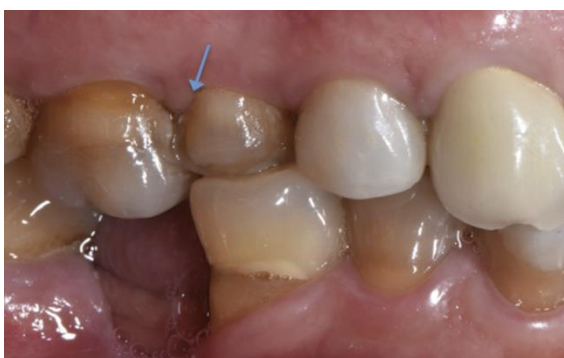
Figure 3: Debonding of veneer restoration at 6 years recall on second maxillary premolar tooth

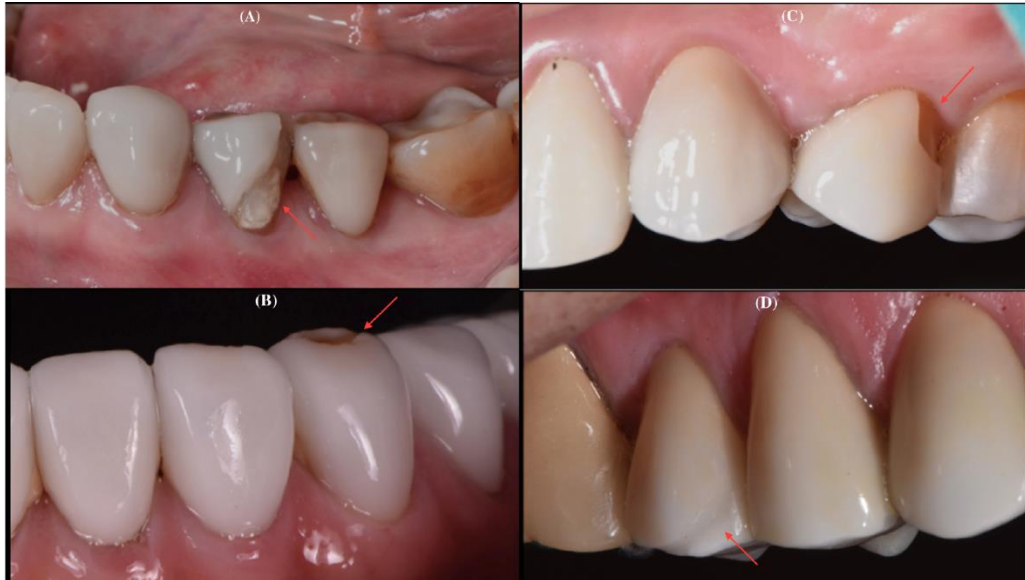
Figure 4: Ceramic Veneer Fracture

A: Irreparable fracture of ceramic veneer at 5 years recall on right mandibular premolar tooth

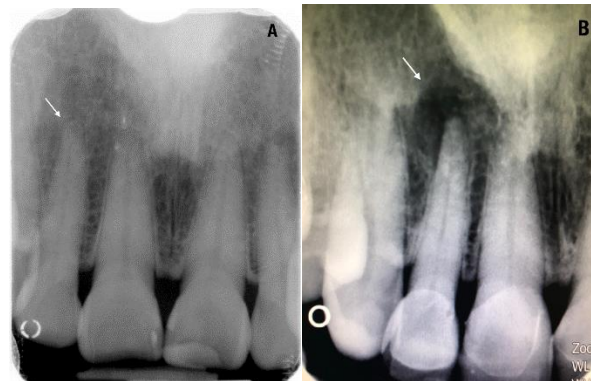
Figure 7: Periapical lesion on lateral central incisor (12).

A: Periapical film of lateral incisor before placed veneer restoration in 2012.

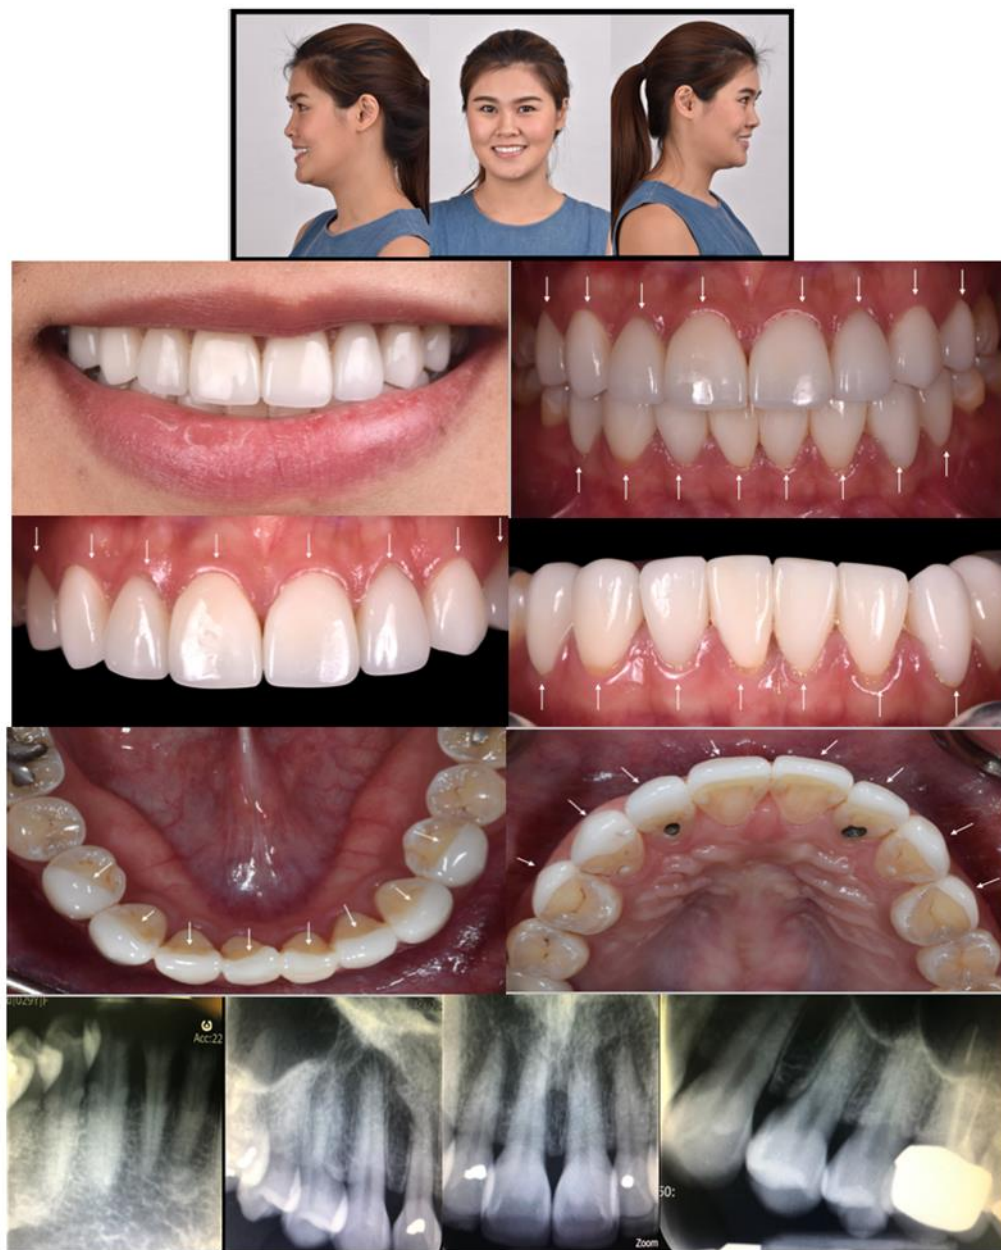
Ceramic veneer restorations on teeth number 14,13,12,11,21,22,23,24,34,33,32,31,41, 42, 43, 44 were placed in 2009. The esthetic evaluation resulted in excellent color matching all teeth. The mechanical evaluation, all teeth resulted in no debonding.

Marginal adaptation of all veneer restorations rated as score 0. Marginal discoloration of all veneer restorations rated as score 0. All veneer restorations were intact with teeth and fully retained. The biological evaluation, right maxillary canine (13) and left maxillary central incisor (21) showed moderate gingival, rated as score 2 (Moderate inflammation: moderate glazing, redness, edema, and hypertrophy. Bleeding on probing). Others showed no gingival inflammation. All veneer restorations had no history of postoperative hypersensitivity, rated as score 0. Gingival recession was found on right mandibular canine (43), left mandibular canine (31), left mandibular lateral incisor (32), right maxillary lateral incisor (12), rated as score 1. Caries rated as score 0 of all veneer restorations. Radiographic examination showed no significant finding, rated as score 0.

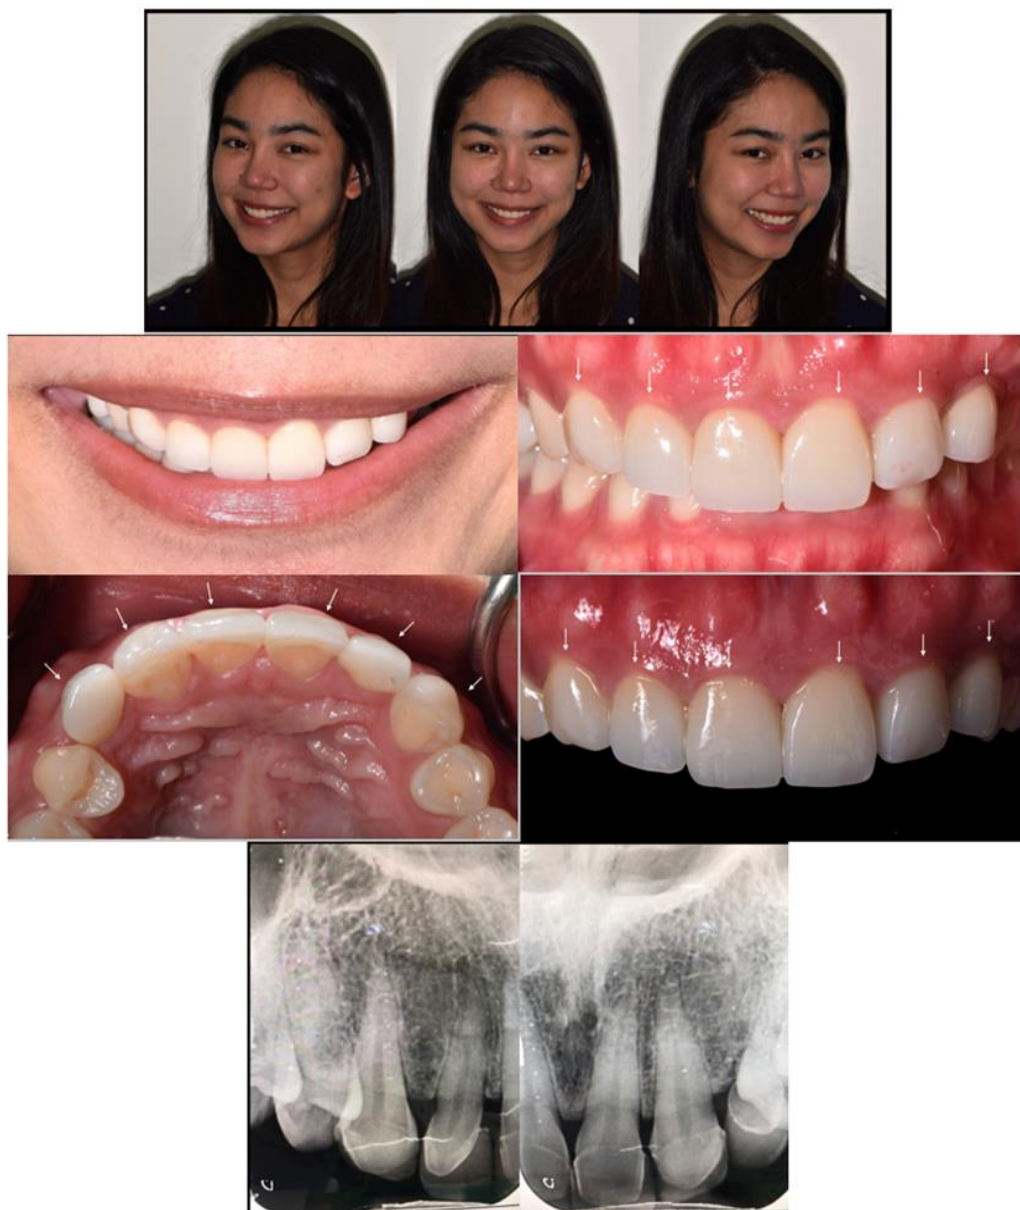
Ceramic veneer restorations on teeth number 13,12,11,21,22,23 were placed in 2009.

restorations rated as score 0. Marginal discoloration of right maxillary lateral incisor (12) at palatal area rated as score 1. (Visual evidence of marginal discoloration from slightly staining, which can be polished away). All veneer restorations were intact with teeth and fully retained, rated as score 0. The biological evaluation, all veneer restorations showed healthy gingival, rated as score 0. Veneer restorations had no history of postoperative hypersensitivity and no gingival recession. Caries rated as score 0 of all veneer restorations. Radiographic examination showed no significant finding, rated as score 0.

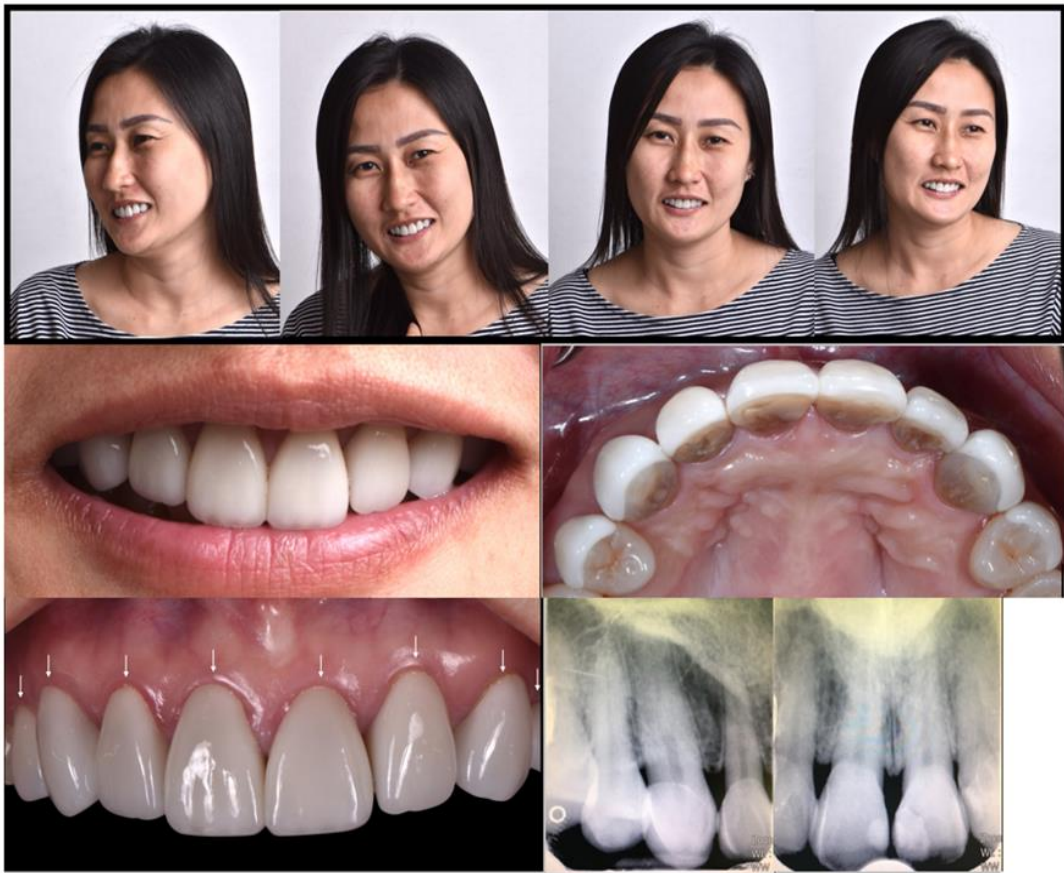
Ceramic veneer restorations on teeth number 14,13,12,11,21, 22,23,24 were placed in 2010. The esthetic evaluation resulted in excellent color matching all teeth. The mechanical evaluation, all teeth resulted in no debonding. Marginal adaptation at midpalatal area of left central incisor (21) rated as score 1. (Slightly discontinuity detectable from explorer with clinical acceptable). Marginal discoloration of left central incisor (21) at palatal area rated as score 1. (Visual evidence of marginal discoloration from slightly staining, which can be polished away). All veneer

restorations were intact with teeth and fully retained. The biological evaluation, all veneer restorations showed no gingival inflammation, no postoperative hypersensitivity and caries rated as score 0. Gingival recession rated as score 1 on left maxillary canine (23) (Visual evidence of gingival recession \leq 1 mm.). Radiographic examination showed no significant finding, rated as score 0.

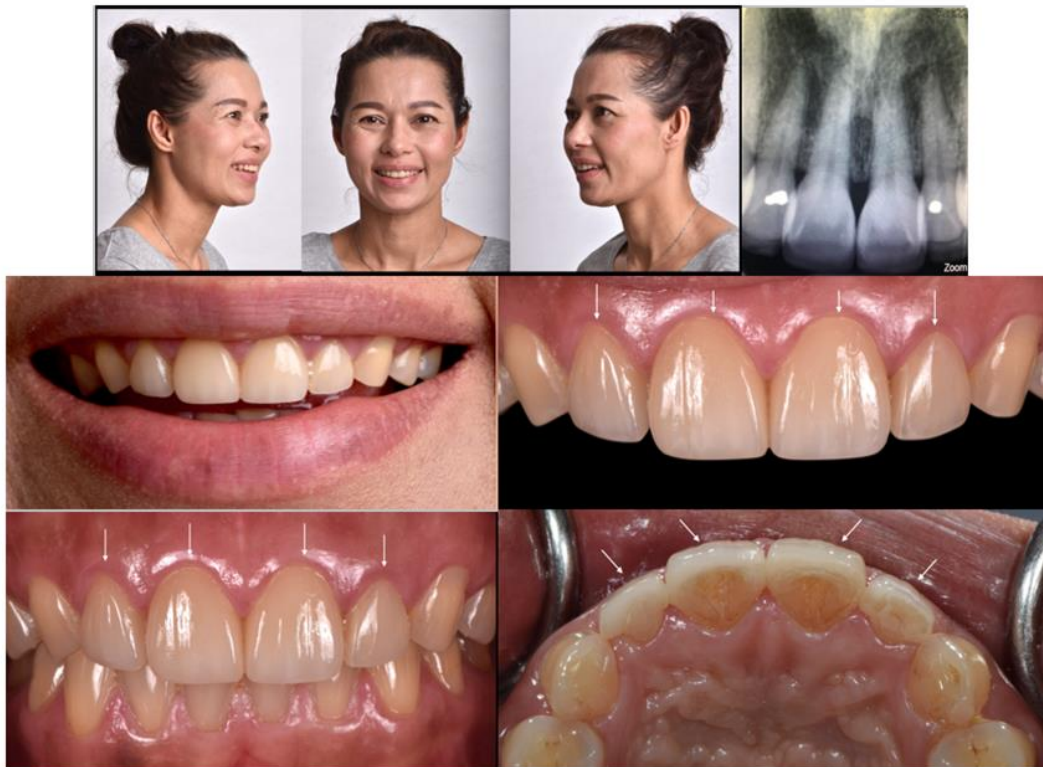
Ceramic veneer restorations on teeth number 12,11,21,22 were placed in 2010. The esthetic evaluation resulted in excellent color matching all teeth. The mechanical evaluation, all teeth resulted in no debonding. Marginal adaptation at midpalatal area of right central incisor (11) rated as score 1. (Slightly discontinuity detectable from explorer with clinical acceptable). Marginal discoloration of right central incisor (11) at palatal area rated as score 1. (Visual evidence of marginal discoloration from slightly staining, which can be polished away). All veneer restorations were intact with teeth and fully retained. The biological evaluation, veneer restorations of left lateral incisor

(22) and right central incisor (11) showed no gingival inflammation. However, left maxillary central incisor (21) and right lateral incisor (12) showed moderate gingival inflammation, rated as score 2. Postoperative hypersensitivity, gingival recession and caries rated as score 0 of all veneer restorations. Radiographic examination showed no significant finding, rated as score 0.

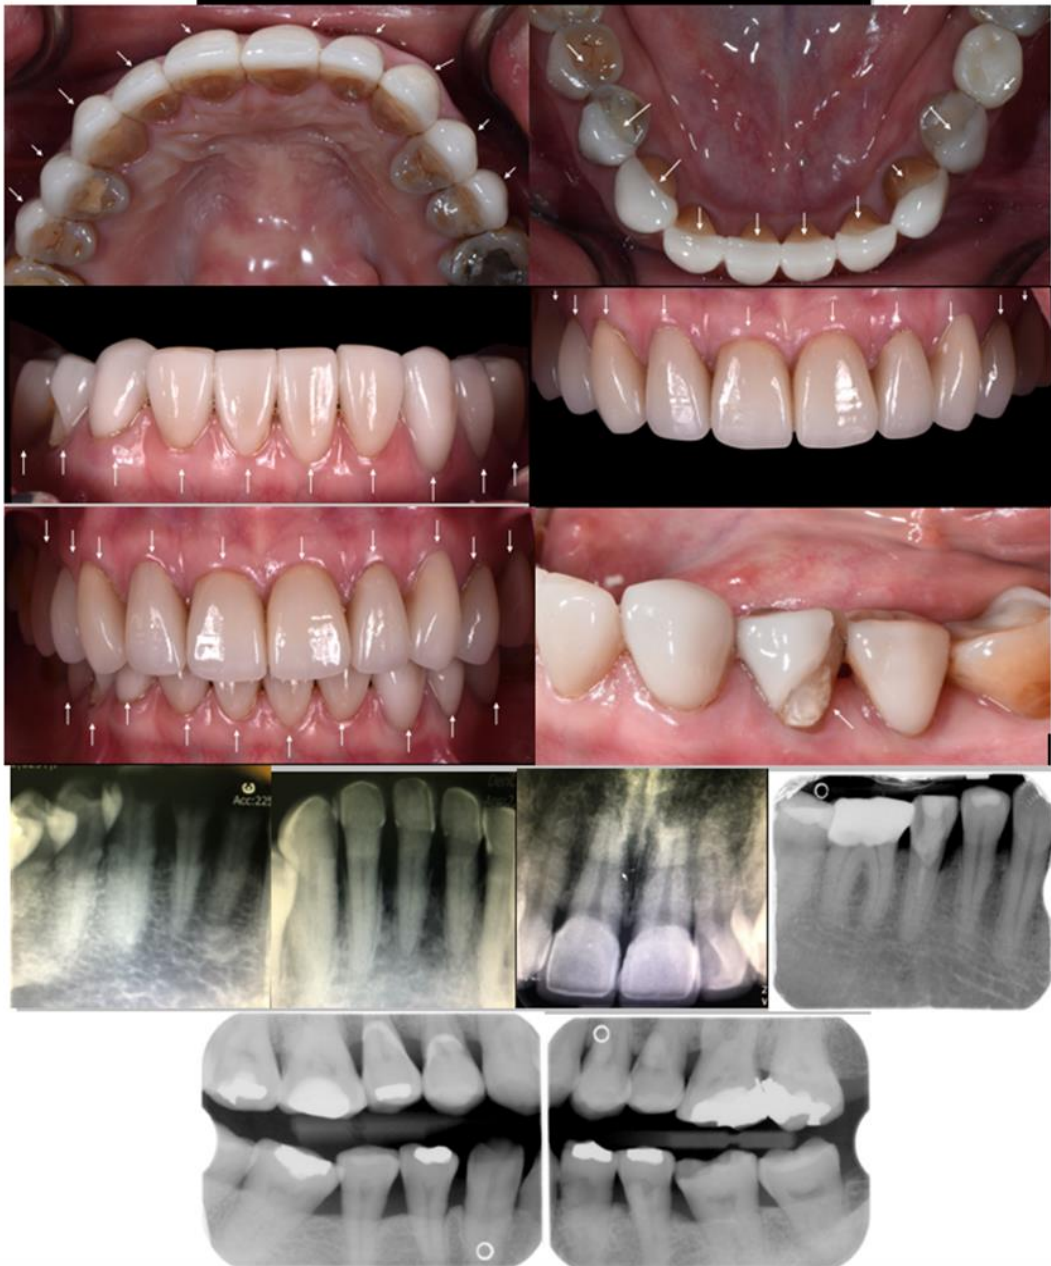
Ceramic veneer restorations on teeth number 15,14,13,12,11,21,22,23,24,25 were placed in 2010. and teeth number 35,34,33,32,3,41,42,43,44,45 were placed in 2011.

The esthetic evaluation resulted in excellent color matching all teeth. The mechanical evaluation, all teeth resulted in no debonding. Marginal adaptation of all veneer restorations rated as score 0. Marginal discoloration of all veneer restorations rated as score 0. Most veneer restorations were intact with teeth and fully retained. While right mandibular first premolar (44) showed fracture of veneer restoration at cervical area, rated as score 2. The biological evaluation, all veneer restorations no gingival inflammation, rated as score 0. All veneer restorations had no history of postoperative hypersensitivity. Gingival recession on right maxillary first premolar (14) was mild gingival recession less than 1 mm., rated as score 1. Caries rated as score 0 of all veneer restorations. Radiographic examination showed no significant finding, rated as score 0.

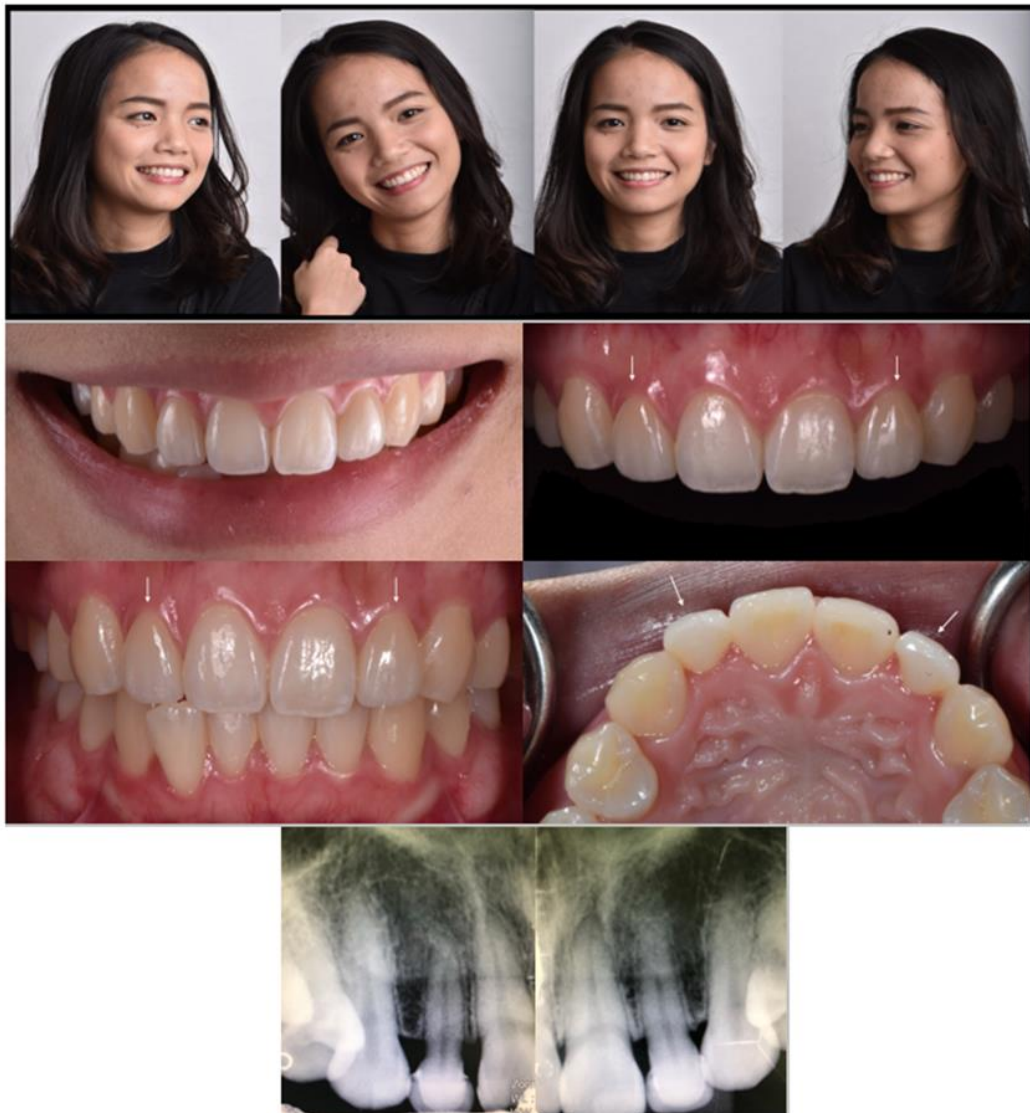
Ceramic veneer restorations on teeth number 14,24,25 were placed in 2010. The esthetic evaluation resulted in excellent color matching all teeth. The mechanical evaluation, one veneer restoration showed debonding at left maxillary second premolar tooth (25). Marginal adaptation, all veneer restorations, which still intact with teeth, rated as score 0. Marginal discoloration rated as score 0 for all veneer

restorations. Both left and right Maxillary first premolar were intact with teeth and fully retained. The biological evaluation, veneer restorations of right maxillary first premolar (24) showed moderate gingival inflammation, rated as score 2. Postoperative hypersensitivity, gingival recession and caries rated as score 0 of all veneer restorations. Radiographic examination showed no significant finding, rated as score 0.

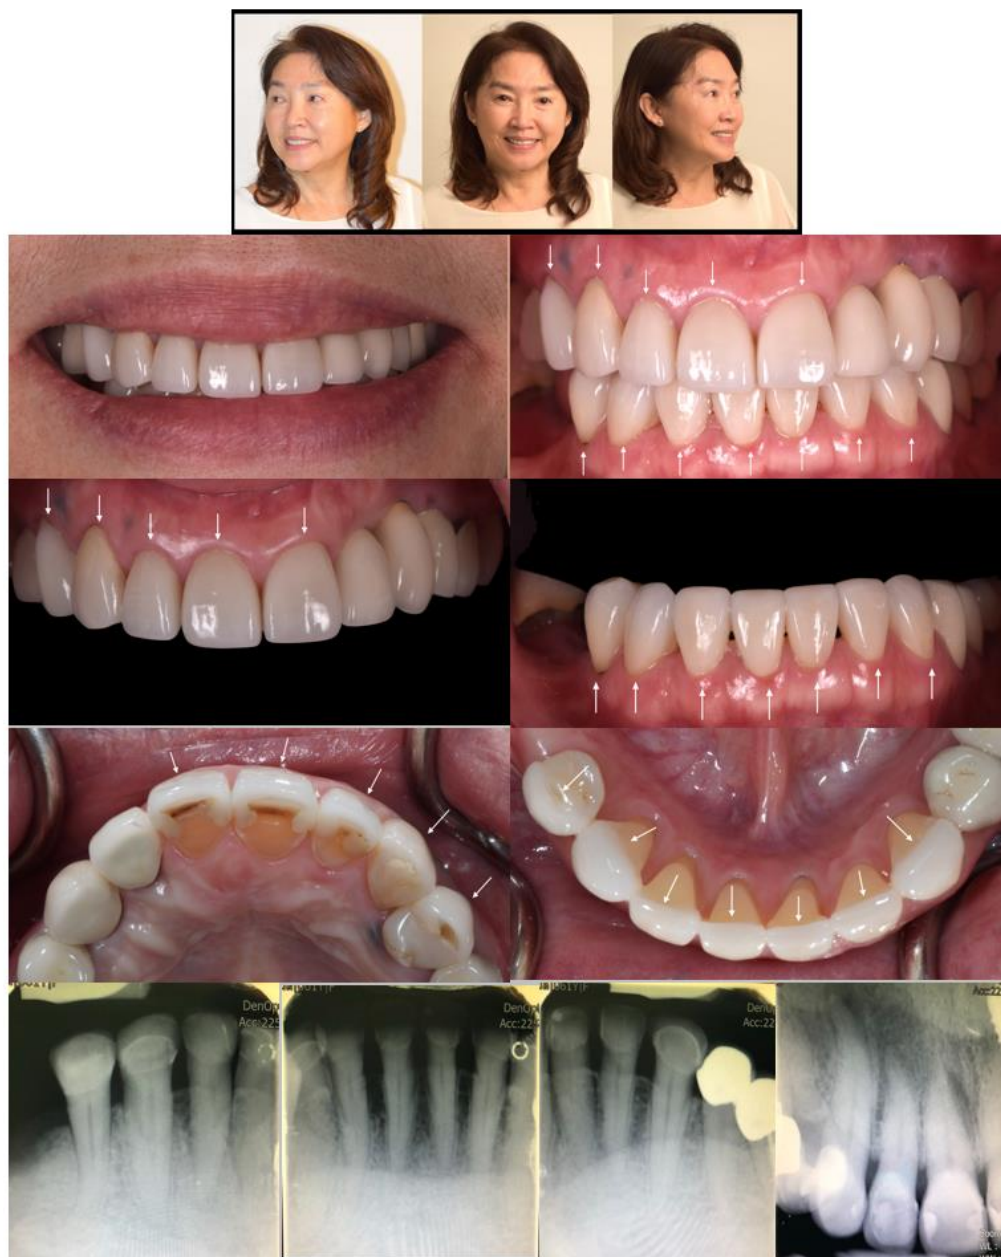
Ceramic veneer restorations on teeth number 14,13,12,11,33,32,31,41,42,43,44 were placed in 2010. The esthetic evaluation resulted in excellent color matching all teeth.

most veneer restorations rated as score 0. While, mesiobuccal margin of left mandibular central incisor (31) rated as score 1. Marginal discoloration of all veneer restorations rated as score 0. All veneer restorations were intact with teeth and fully retained, rated as score 0. The biological evaluation, right maxillary canine (13), left mandibular canine (33) and right mandibular first premolar (44) showed moderate inflammation with bleeding on probing, rates as score 2. All veneer restorations had no history of postoperative hypersensitivity. Gingival recession on right maxillary canine (13) was mild gingival recession, rated as score 1. Caries rated as score 0 of all veneer restorations. Radiographic examination showed no significant finding, rated as score 0.

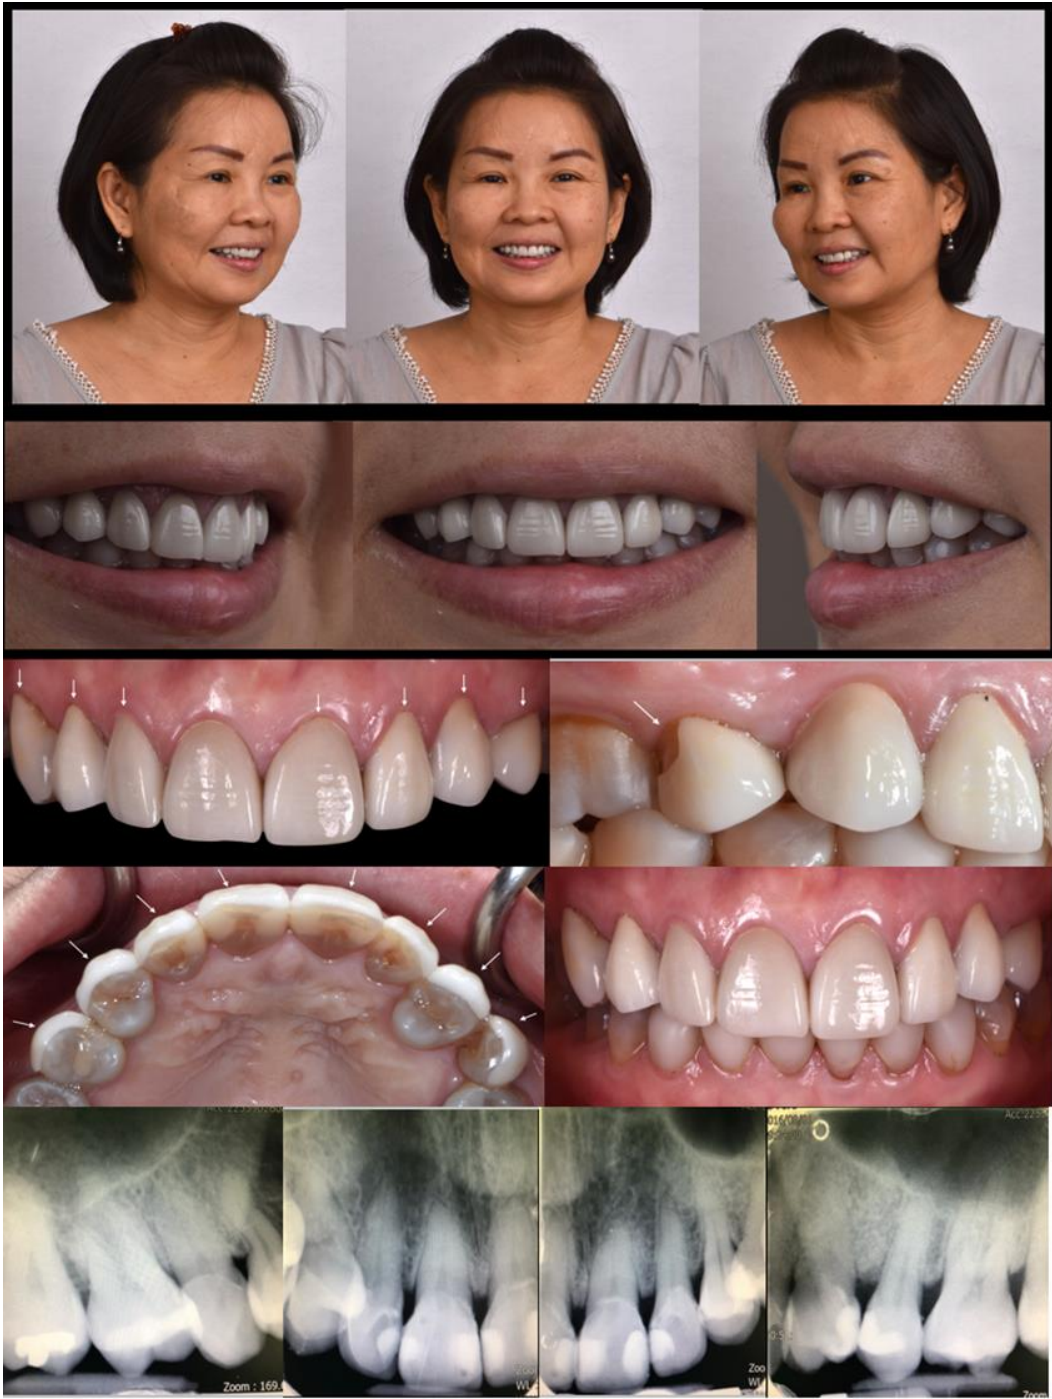
Ceramic veneer restorations on teeth number 15,14,12,11,21,22,24,25 were placed in 2011. The esthetic evaluation resulted in excellent color matching all teeth. The

mechanical evaluation, all teeth resulted in no debonding. Marginal adaptation rated as score 0 all teeth. (No visual evidence of marginal discoloration on the margin.) Marginal discoloration rated as score 0 all teeth. One veneer restoration on left second premolar showed fracture at cervical area rated as score 2 (The restoration is deep crack line/moderate to severe chipping. Replacement is required.). The biological evaluation, left lateral incisor (22) and left maxillary premolar (24) showed moderate gingival inflammation with bleeding on probing rated as score 2. While, others showed no gingival inflammation. No postoperative hypersensitivity and caries rated as score 0. Gingival recession rated as score 1 on left maxillary second premolar (25). (Visual evidence of gingival recession \leq 1 mm.) Radiographic examination showed no significant finding, rated as score 0.

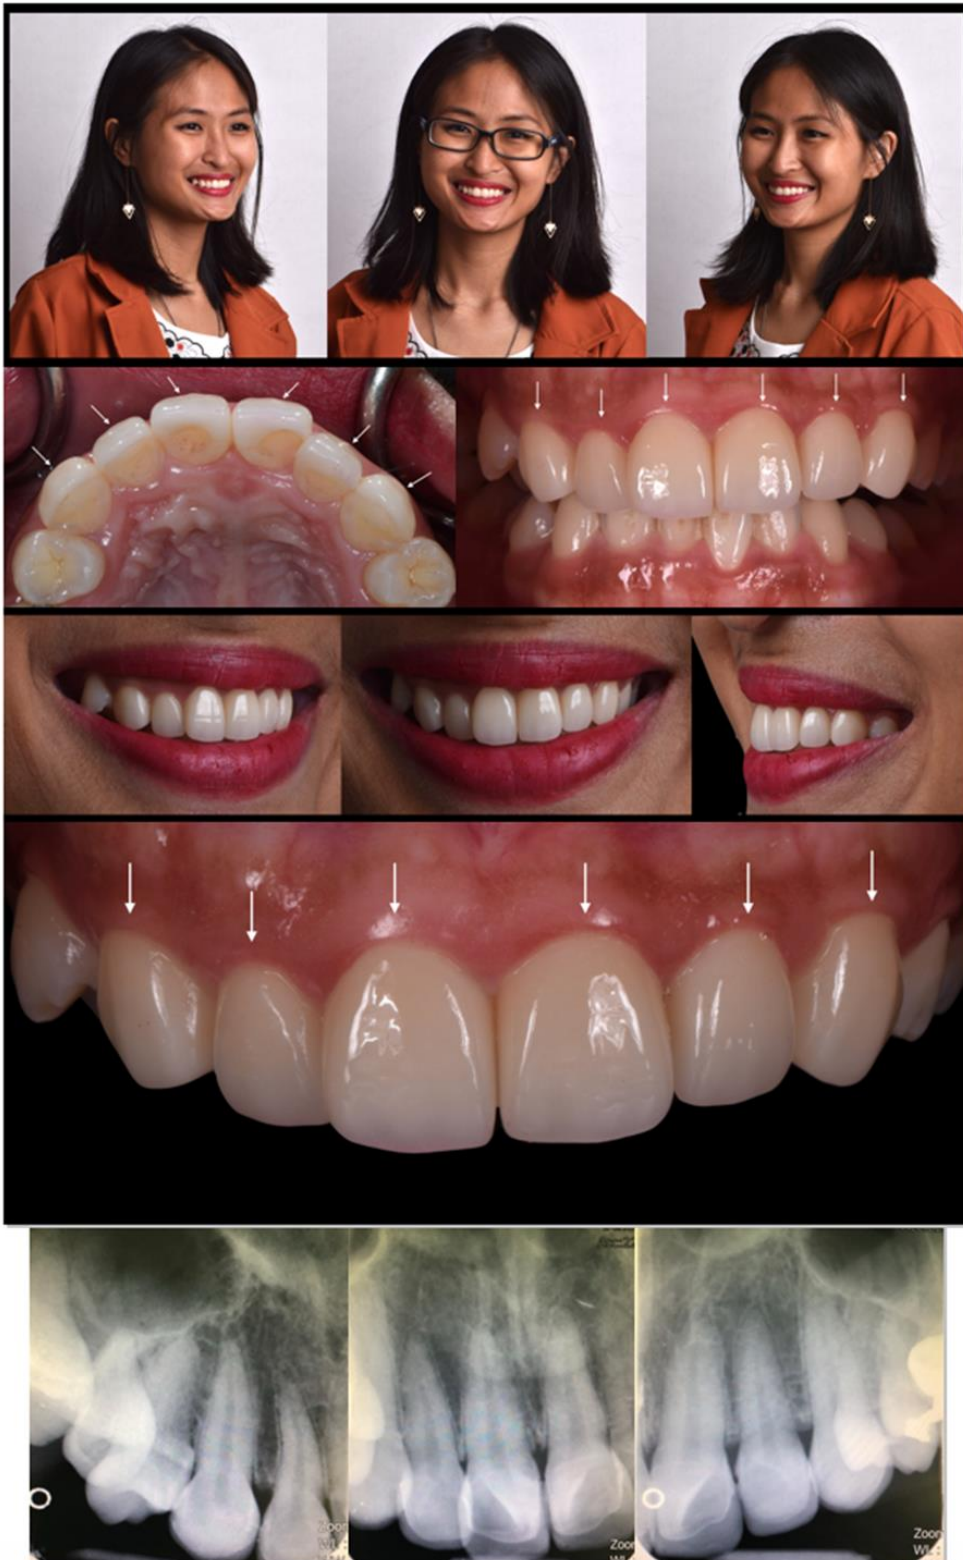
Ceramic veneer restorations on teeth number 13,12,11,21,22,23 were placed in 2011.

The esthetic evaluation resulted in excellent color matching all teeth. The mechanical evaluation, all teeth resulted in no debonding. Marginal adaptation of most veneer restorations rated as score 0. While, midpalatal margin of left maxillary canine (23) rated as score1. Marginal discoloration of left maxillary canine (23) rated as score1. All veneer restorations were intact with teeth and fully retained, rated as score 0. The biological evaluation showed gingival inflammation rated as score 0 on left maxillary canine (23). Left maxillary lateral incisor (22) and left maxillary central incisor (21) showed mild gingival inflammation, rated as score1. All veneer restorations had no history of postoperative hypersensitivity. Gingival recession and caries rated as score 0 of all veneer restorations. Radiographic examination showed no significant finding, rated as score 0.

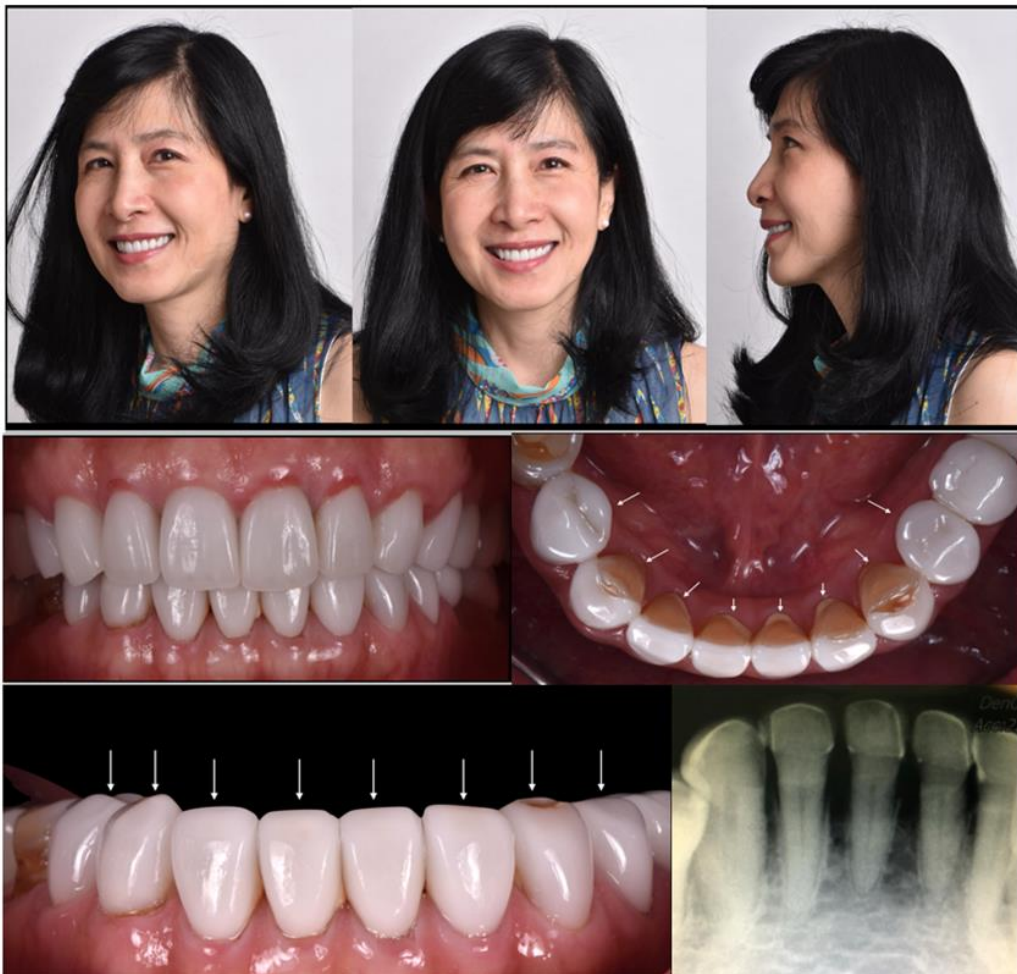
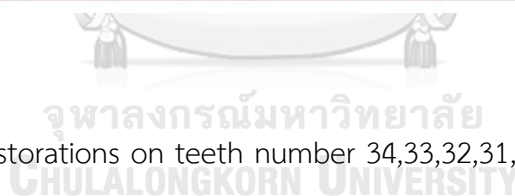
Ceramic veneer restorations on teeth number 34,33,32,31,41,42,43,44 were placed in 2011. The esthetic evaluation resulted in excellent color matching all teeth. The mechanical evaluation, all teeth resulted in no debonding. Marginal adaptation at midbuccal area of left mandibular canine (33) and right mandibular lateral incisor (42) rated as score 1. Also, midpalatal area of left mandibular lateral incisor (32) and right mandibular lateral incisor (42) rated as score 1. (Slightly discontinuity detectable from

explorer with clinical acceptable). Marginal discoloration of left mandibular canine (33) left mandibular lateral incisor (32) right mandibular lateral incisor (42) at palatal area rated as score 1. (Visual evidence of marginal discoloration from slightly staining, which can be polished away). Most veneer restorations were intact with teeth and fully retained, rated as score 0. One veneer restoration showed mild fracture of veneer at incisal third of left mandibular canine (33), rated as score 1. The biological evaluation, left mandibular lateral incisor (32) and right mandibular central incisor (41) showed mild gingival inflammation, rated as score 1. Gingival recession found on left mandibular canine (33) and right mandibular first premolar (44), rated as score 1. Postoperative hypersensitivity, gingival recession and caries rated as score 0 of all veneer restorations. Radiographic examination showed no significant finding, rated as score 0.

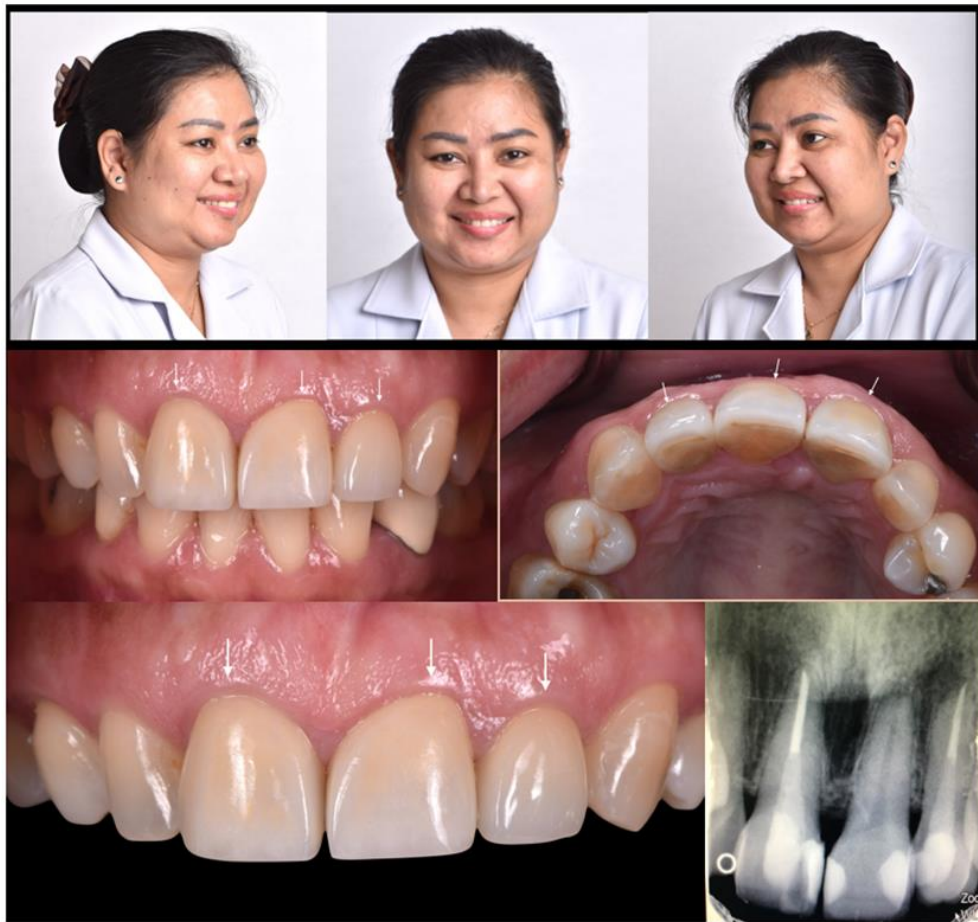
Ceramic veneer restorations on teeth number 12,11,21,22 were placed in 2011. The esthetic evaluation resulted in excellent color matching all teeth. The mechanical evaluation, all teeth resulted in no debonding. Marginal adaptation and marginal discoloration of most veneer restorations rated as score 0. Right maxillary lateral incisor had history of fracture. The new veneer restoration was replaced. The biological evaluation showed no gingival inflammation rated as score 0. All veneer restorations had no history of postoperative hypersensitivity. Gingival recession and caries rated as

score 0 of all veneer restorations. Radiographic examination showed no significant finding, rated as score 0.

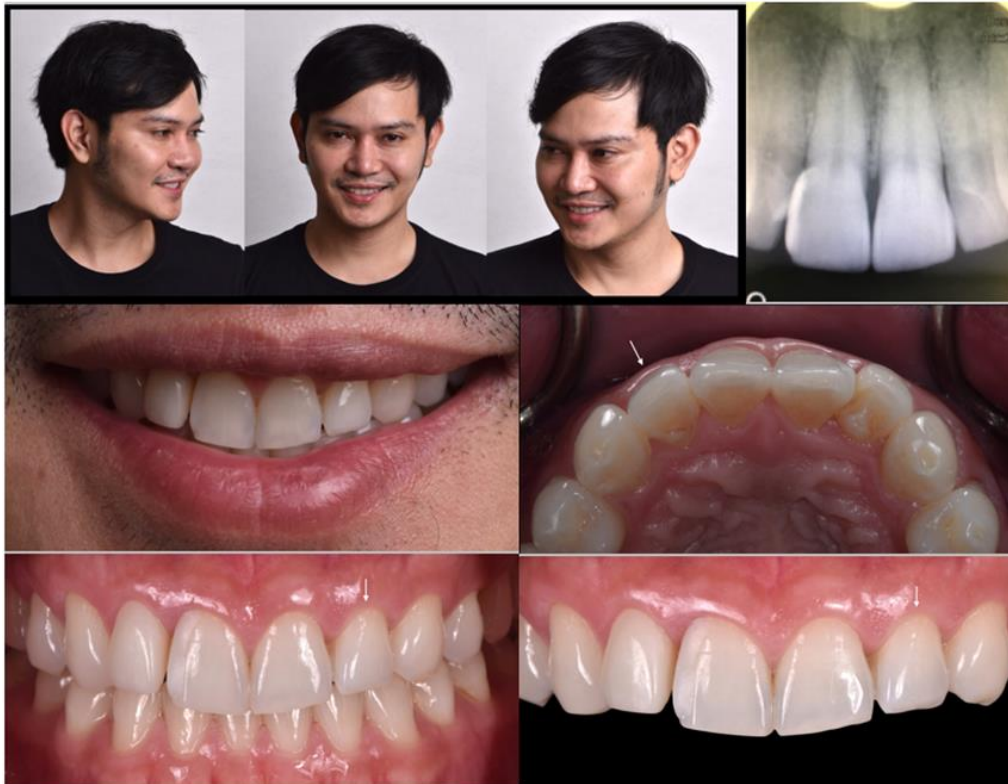
Ceramic veneer restorations on right lateral incisor (12) were placed in 2011. The esthetic evaluation resulted in excellent color matching all teeth. The mechanical evaluation, right lateral incisor (12) resulted in no debonding. Marginal adaptation and marginal discoloration of veneer restoration rated as score 0. Veneer restoration was intact with teeth and fully retained. The biological evaluation, veneer restoration showed no gingival inflammation, rated as score 0. Postoperative hypersensitivity, gingival recession and caries rated as score 0. Radiographic examination showed no significant finding, rated as score 0.

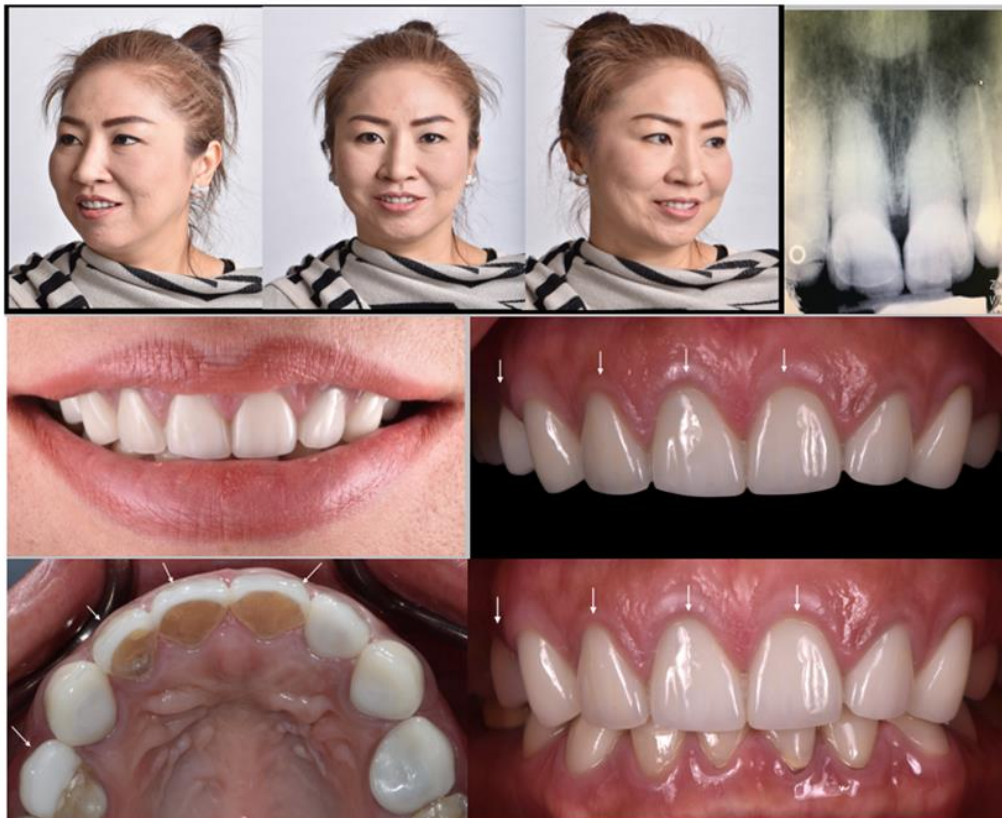
Ceramic veneer restorations on teeth number 14,12,11,21 were placed in 2012. The esthetic evaluation resulted in excellent color matching all teeth. The mechanical evaluation, all teeth resulted in no debonding. Marginal adaptation and marginal discoloration rated as score 0 all veneer restorations. All veneer restorations were intact with teeth and fully retained. The biological evaluation, most veneer restorations showed no gingival inflammation. In contrast, right lateral incisor (12) showed moderate gingival inflammation, rated as score 2 (Moderate inflammation: moderate glazing,

Radiographic examination showed no significant finding, rated as score 0.

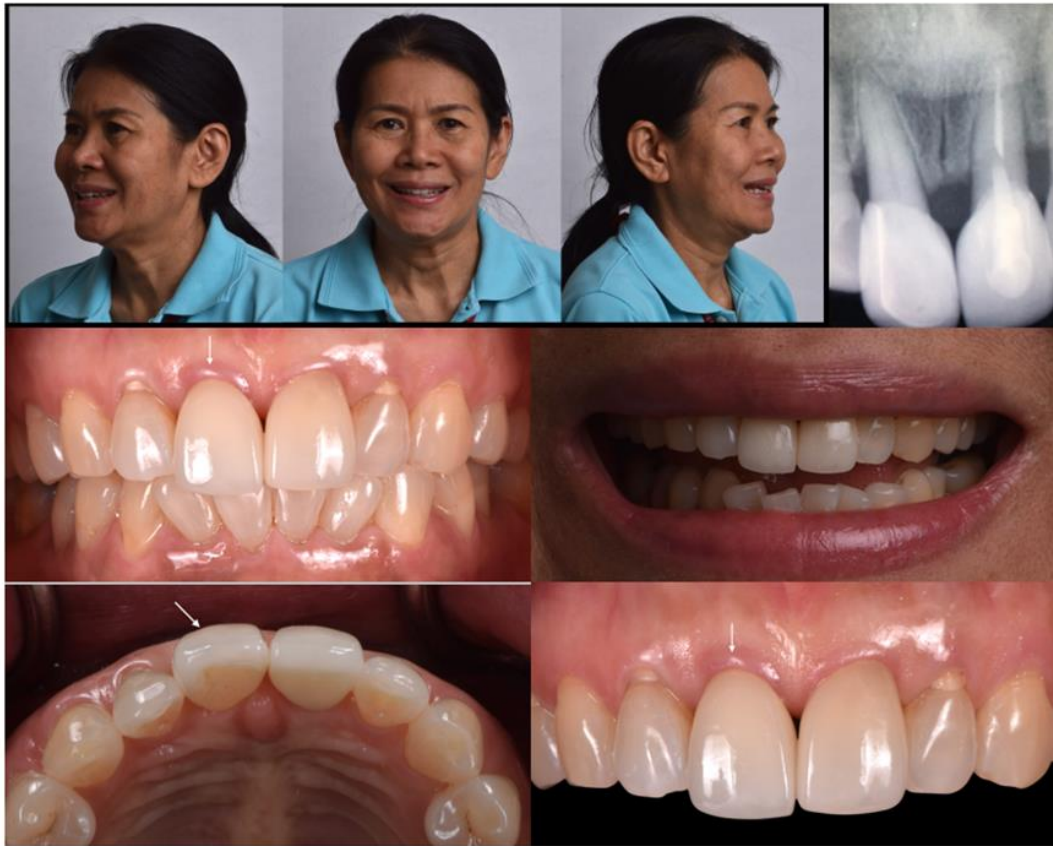
Ceramic veneer restoration on right maxillary central incisor (11) was placed in 2012.

The esthetic evaluation resulted in excellent color matching. The mechanical evaluation, right maxillary central incisor (11) resulted in no debonding. Marginal adaptation and marginal discoloration rated as score 0. Veneer restoration was intact with teeth and fully retained, rated as score 0. The biological evaluation showed no gingival inflammation rated as score 0. Veneer restoration had no history of postoperative hypersensitivity. Gingival recession and caries rated as score 0.

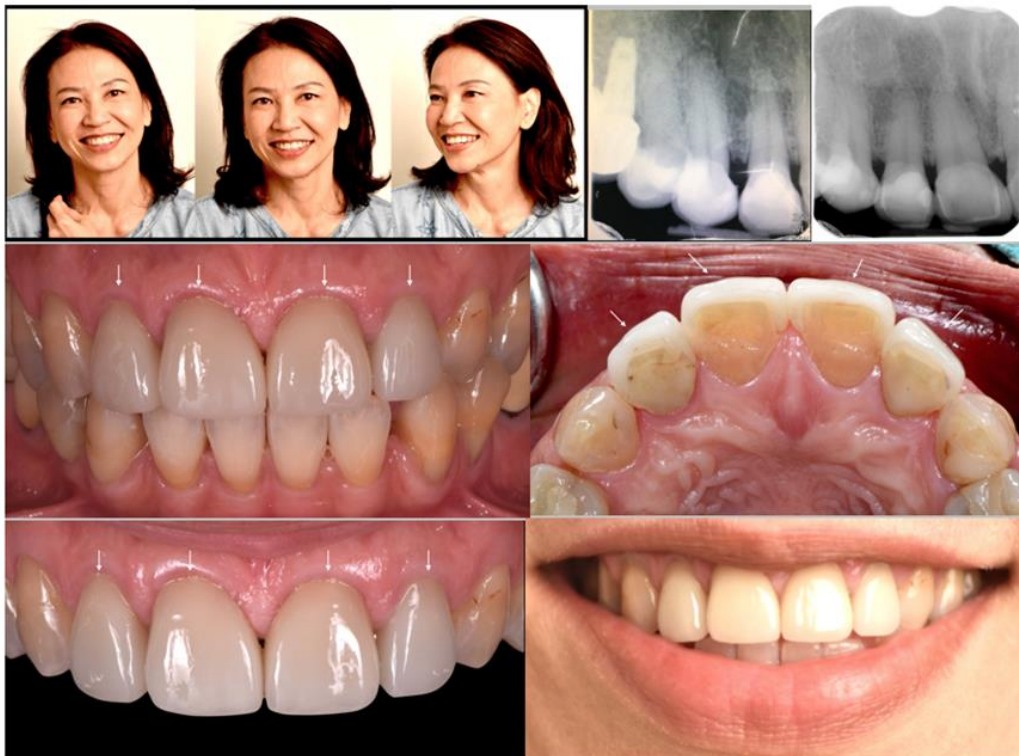
Ceramic veneer restorations on teeth number 12,11,21,22 were placed in 2012. The esthetic evaluation resulted in excellent color matching all teeth. The mechanical evaluation, all teeth resulted in no debonding. Marginal adaptation at midpalatal area of left lateral incisor (22) rated as score 1. (Slightly discontinuity detectable from explorer with clinical acceptable). Marginal discoloration of left lateral incisor (22) at palatal area rated as score 1. (Visual evidence of marginal discoloration from slightly staining, which can be polished away). All veneer restorations were intact with teeth and fully retained. The biological evaluation, veneer restorations showed no gingival

inflammation. However, right maxillary central incisor (11) showed moderate gingival inflammation, rated as score 2. Postoperative hypersensitivity, gingival recession and caries rated as score 0 of all veneer restorations. Radiographic examination showed no significant finding, rated as score 0.
