THE LONGEVITY OF CERAMIC VENEERS: CLINICAL EVALUATION OF MECHANICAL,
BIOLOGICAL, AND ESTHETIC PERFORMANCES OF CERAMIC VENEERS UP TO 7-YEARS
RETROSPECTIVE STUDY

A Thesis Submitted in Partial Fulfillment of the Requirements
for the Degree of Master of Science Program in Esthetic Restorative and Implant
Dentistry

Faculty of Dentistry
Chulalongkorn University
Academic Year 2017

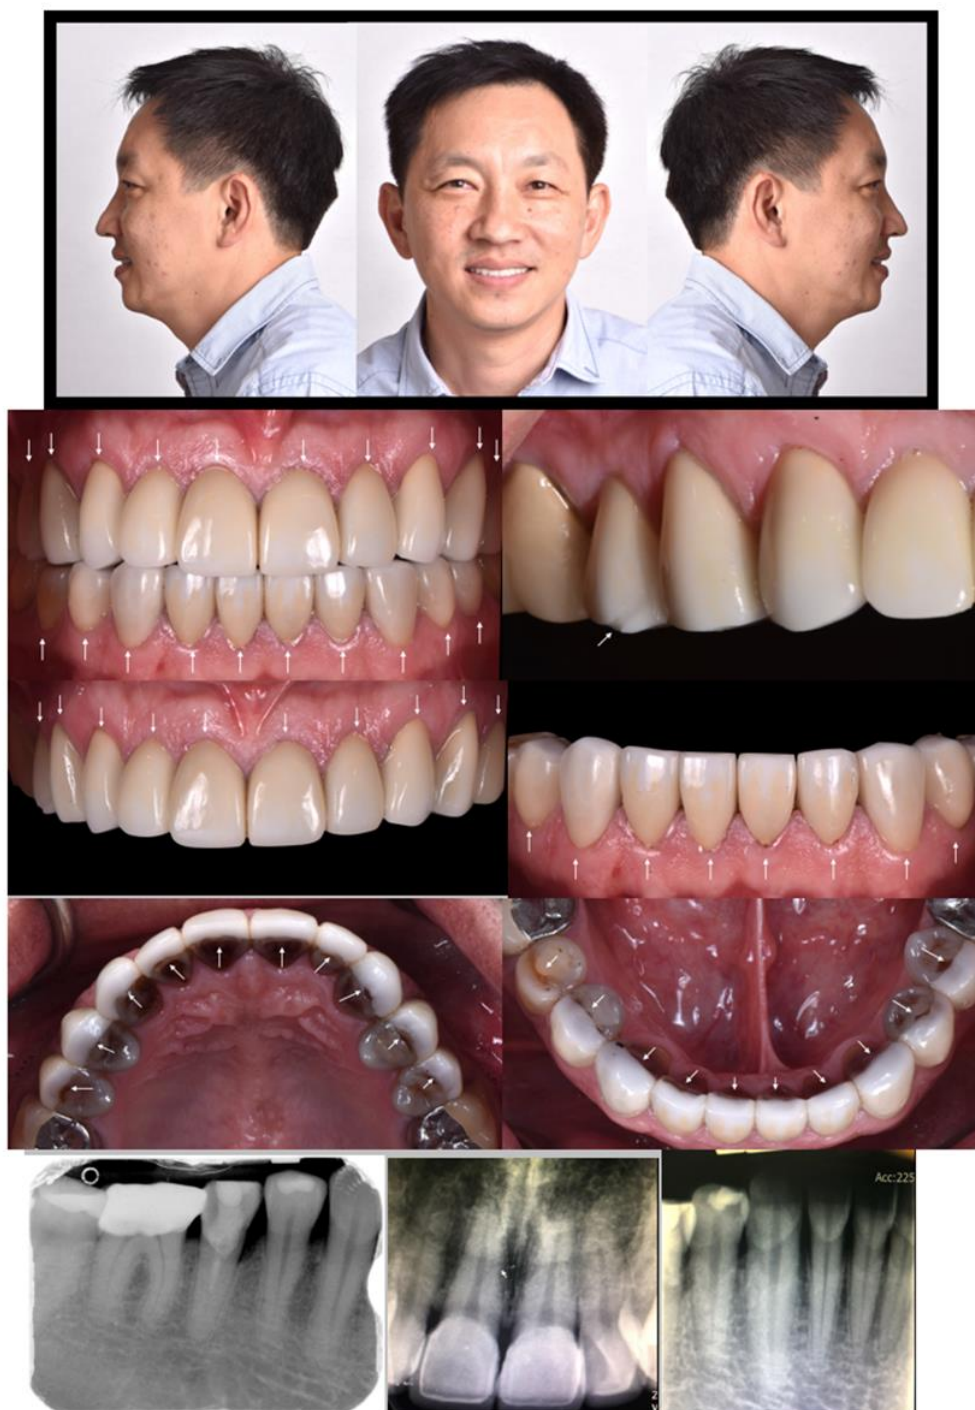
Ceramic veneer restorations on teeth number 15,14,13,12,11,21,22,23,24,25, 35,34,33,32,31,41,42,43 ,44,45 were placed in 2012. The esthetic evaluation resulted in excellent color matching all teeth. The mechanical evaluation, all teeth resulted in no

debonding. Marginal adaptation of all veneer restorations rated as score 0. Marginal discoloration of all veneer restorations rated as score 0. Most veneer restorations were intact with teeth and fully retained. While right maxillary second premolar (15) showed mild chipping of veneer restoration at incisal one-third, rated as score 1 (The restoration is intact with craze line and /or minor chipping of restoration (1/4 of restoration). This fracture can repair or polishing.) The biological evaluation, right maxillary first premolar (14) showed mild gingival inflammation, rated as score 1 (Mild inflammation: slight change in color and little change in texture.). Also, left maxillary lateral incisor (22) showed moderate inflammation, rated as score 2 (Moderate inflammation: moderate glazing, redness, edema, and hypertrophy. Bleeding on probing). Others showed no gingival inflammation. All veneer restorations had history of postoperative hypersensitivity, and later disappeared, rated as score 1 (Present symptom of postoperative sensitivity after veneer fixation.). Gingival recession and caries rated as score 0 of all veneer restorations. Radiographic examination showed no significant finding, rated as score 0.

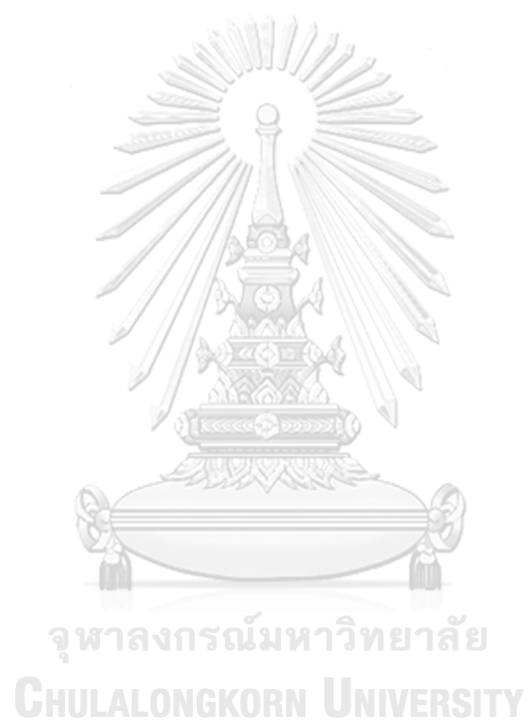
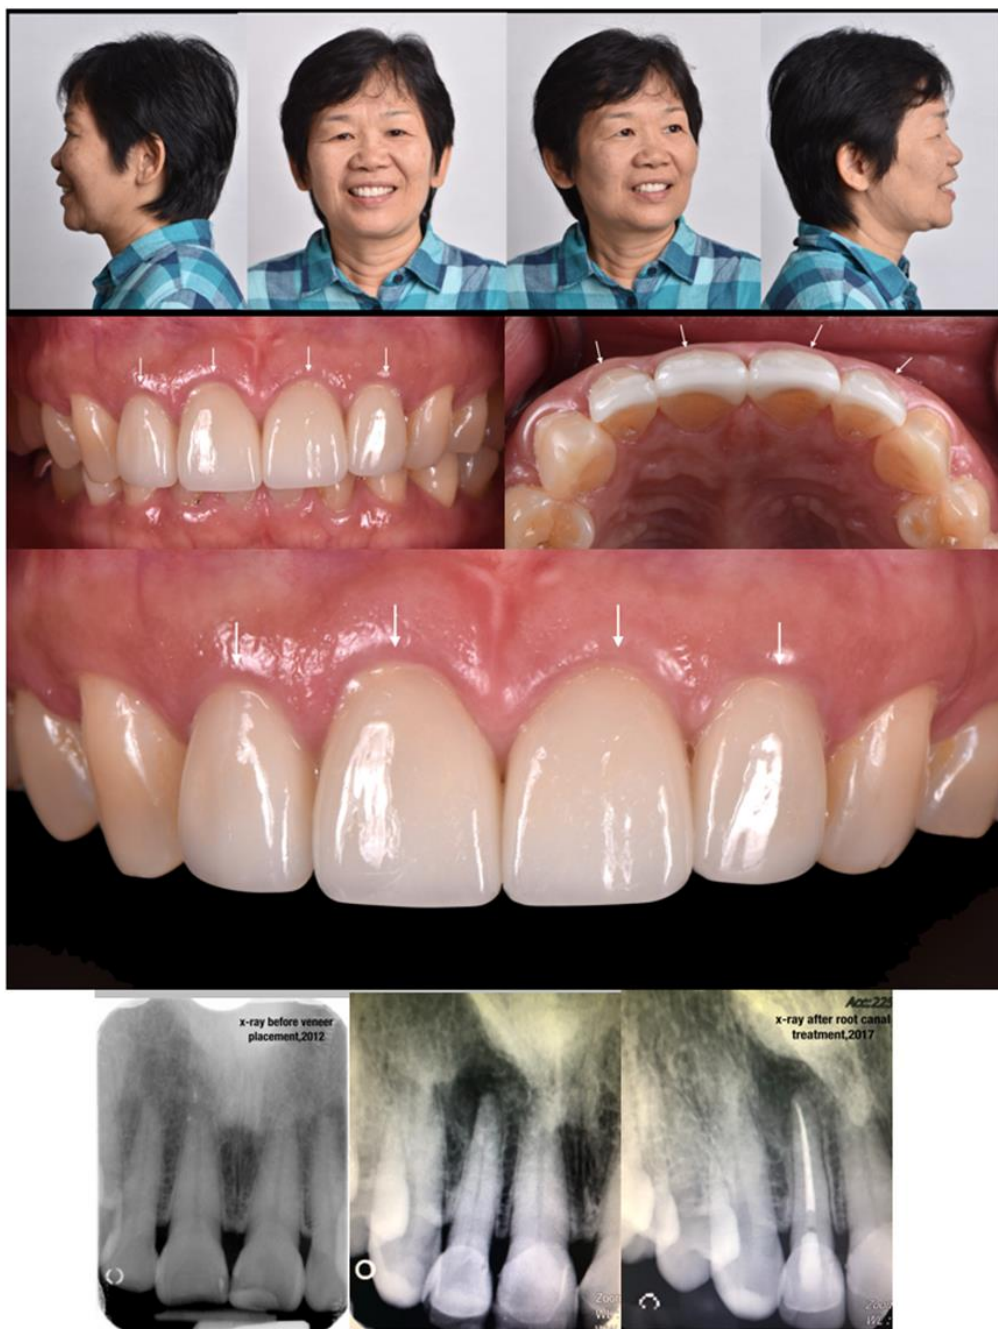
Ceramic veneer restorations on teeth number 12,11,21,22 were placed in 2012.

The esthetic evaluation resulted in excellent color matching all teeth. The mechanical evaluation, all teeth resulted in no debonding. Marginal adaptation and marginal discoloration of most veneer restorations rated as score 0. All veneer restorations were

intact with teeth and fully retained, rated as score 0. The biological evaluation showed no gingival inflammation rated as score 0. All veneer restorations had no history of postoperative hypersensitivity. Gingival recession and caries rated as score 0 of all veneer restorations. One patient had irreversible pulpitis in one tooth (lateral incisor, #12) after veneer placement, rated as score 1. Radiographic photography before veneer placement had no sign of periapical lesion. The lesion was treated with root canal treatment and palatal filling with resin composite, which did not involve with veneer restoration.

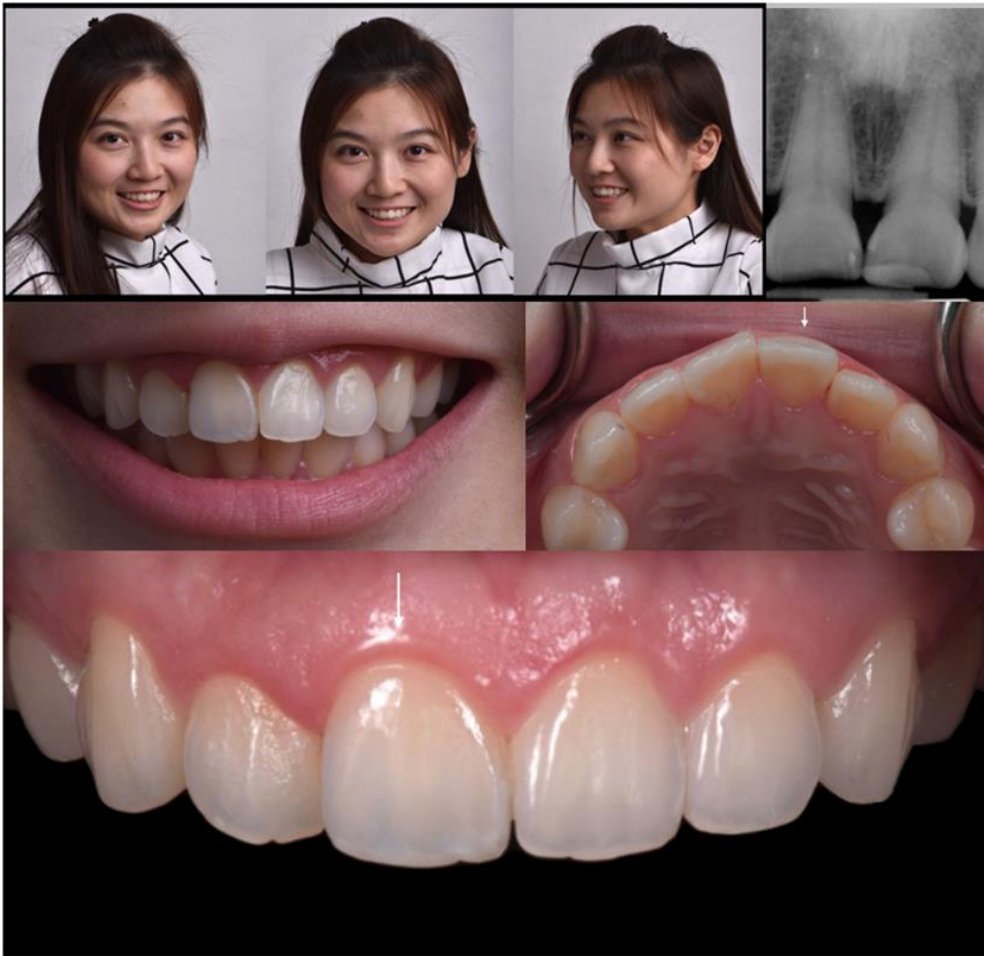
Ceramic veneer restoration on right maxillary central incisor (11) was placed in 2012.

The esthetic evaluation resulted in excellent color matching. The mechanical evaluation, right maxillary central incisor (11) resulted in no debonding. Marginal adaptation and marginal discoloration rated as score 0. Veneer restoration was intact with teeth and fully retained, rated as score 0. The biological evaluation showed no gingival inflammation rated as score 0. Veneer restoration had no history of

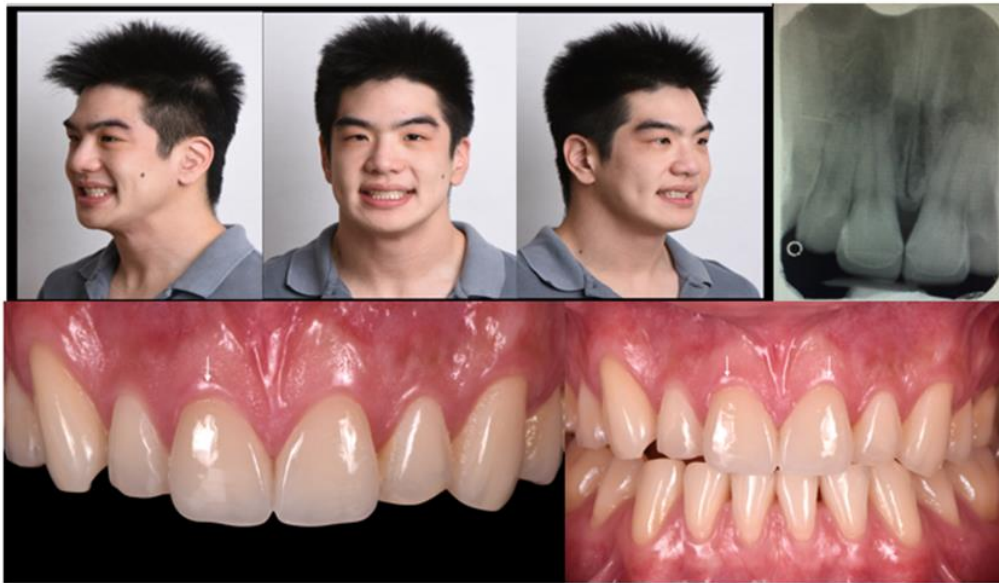
Ceramic veneer restorations on right and left maxillary central incisor (11,21) was placed in 2012. The esthetic evaluation resulted in excellent color matching. The mechanical evaluation, right and left maxillary central incisor (11,21) resulted in no debonding. Marginal adaptation and marginal discoloration rated as score 0. Veneer restorations were intact with teeth and fully retained, rated as score 0. The biological evaluation showed no gingival inflammation rated as score 0. Veneer restorations had no history of postoperative hypersensitivity. Gingival recession and caries rated as score 0. Radiographic examination showed no significant finding, rated as score 0.

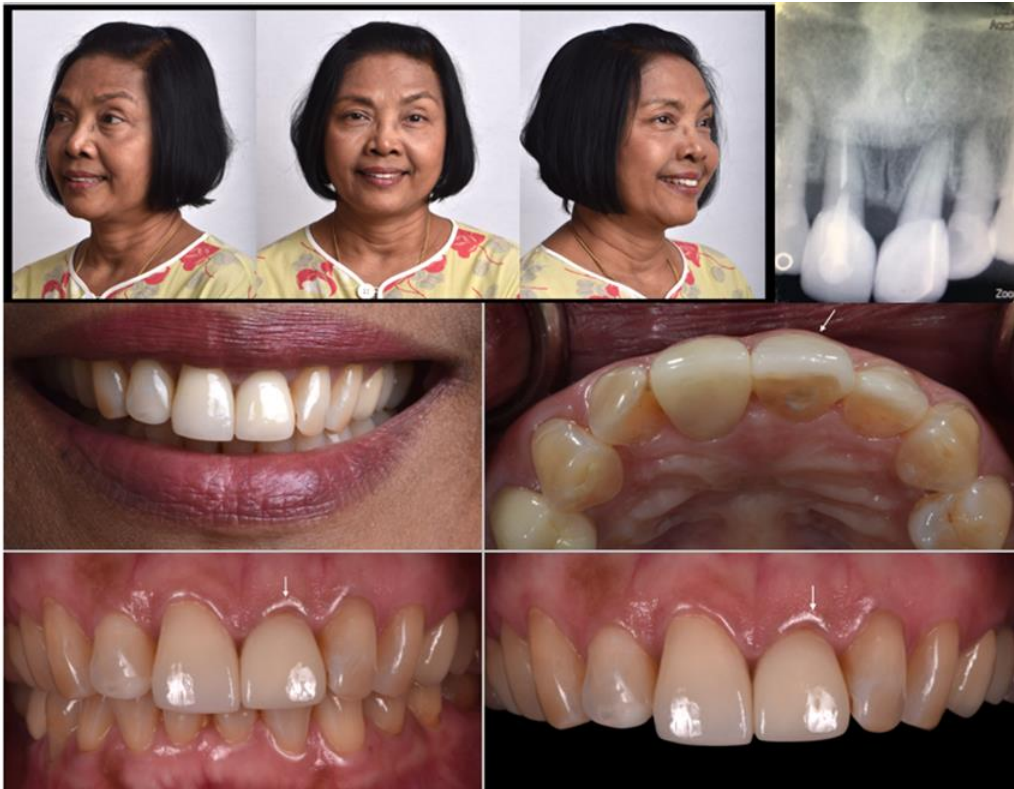
Ceramic veneer restoration on left maxillary central incisor (21) was placed in 2012.

The esthetic evaluation resulted in excellent color matching. The mechanical evaluation, left maxillary central incisor (21) resulted in no debonding. Marginal adaptation and marginal discoloration rated as score 0. Veneer restoration was intact with teeth and fully retained, rated as score 0. The biological evaluation showed no gingival inflammation rated as score 0. Veneer restoration had no history of

Radiographic examination showed no significant finding, rated as score 0.

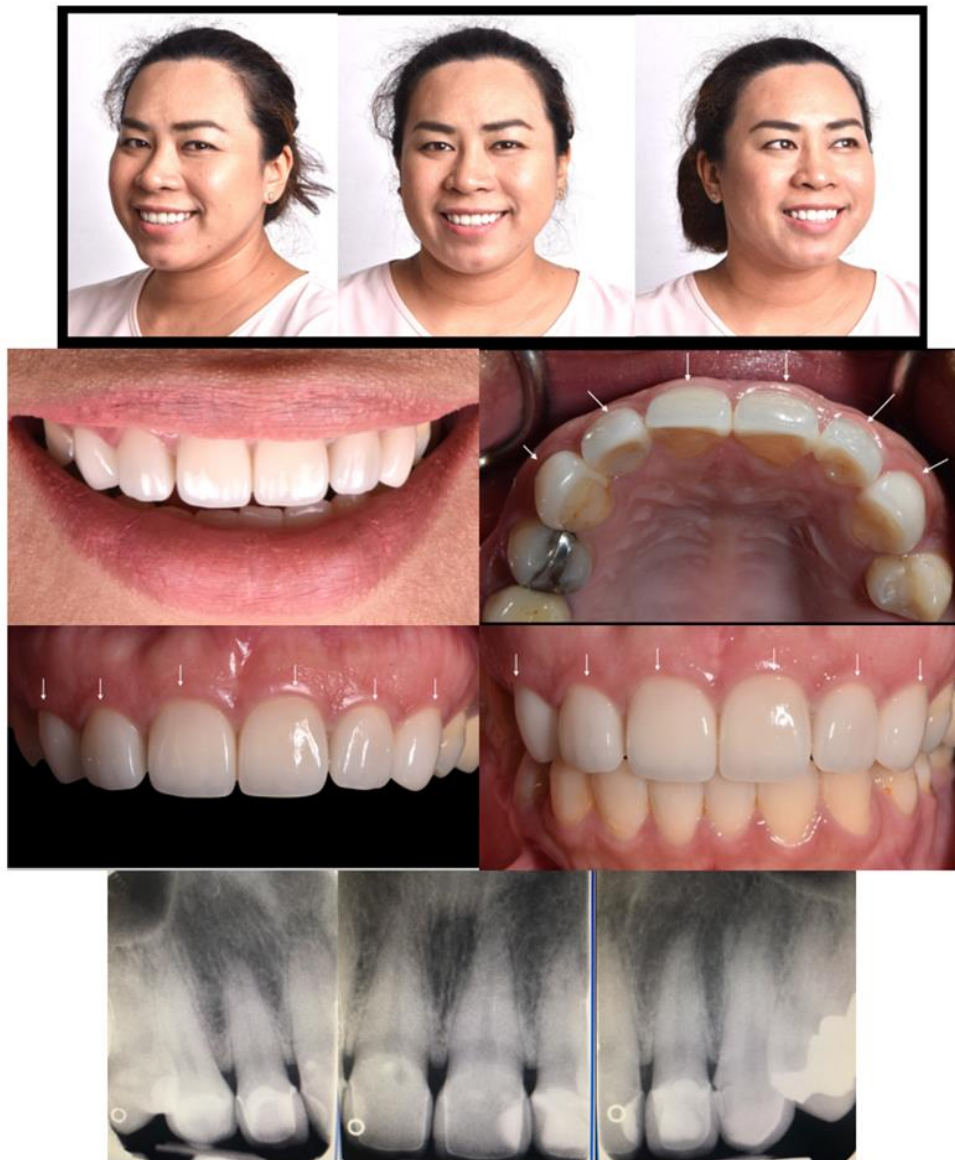
Ceramic veneer restorations on teeth number 13,12,11,21,22,23 were placed in 2012.

The esthetic evaluation resulted in excellent color matching all teeth. The mechanical evaluation, all teeth resulted in no debonding. Marginal adaptation and marginal discoloration of all veneer restorations rated as score 0. All veneer restorations were intact with teeth and fully retained, rated as score 0. The biological evaluation showed

no gingival inflammation, rated as score 0. All veneer restorations had no history of postoperative hypersensitivity. Gingival recession and caries rated as score 0 of all veneer restorations. Radiographic examination showed no significant finding, rated as score 0.

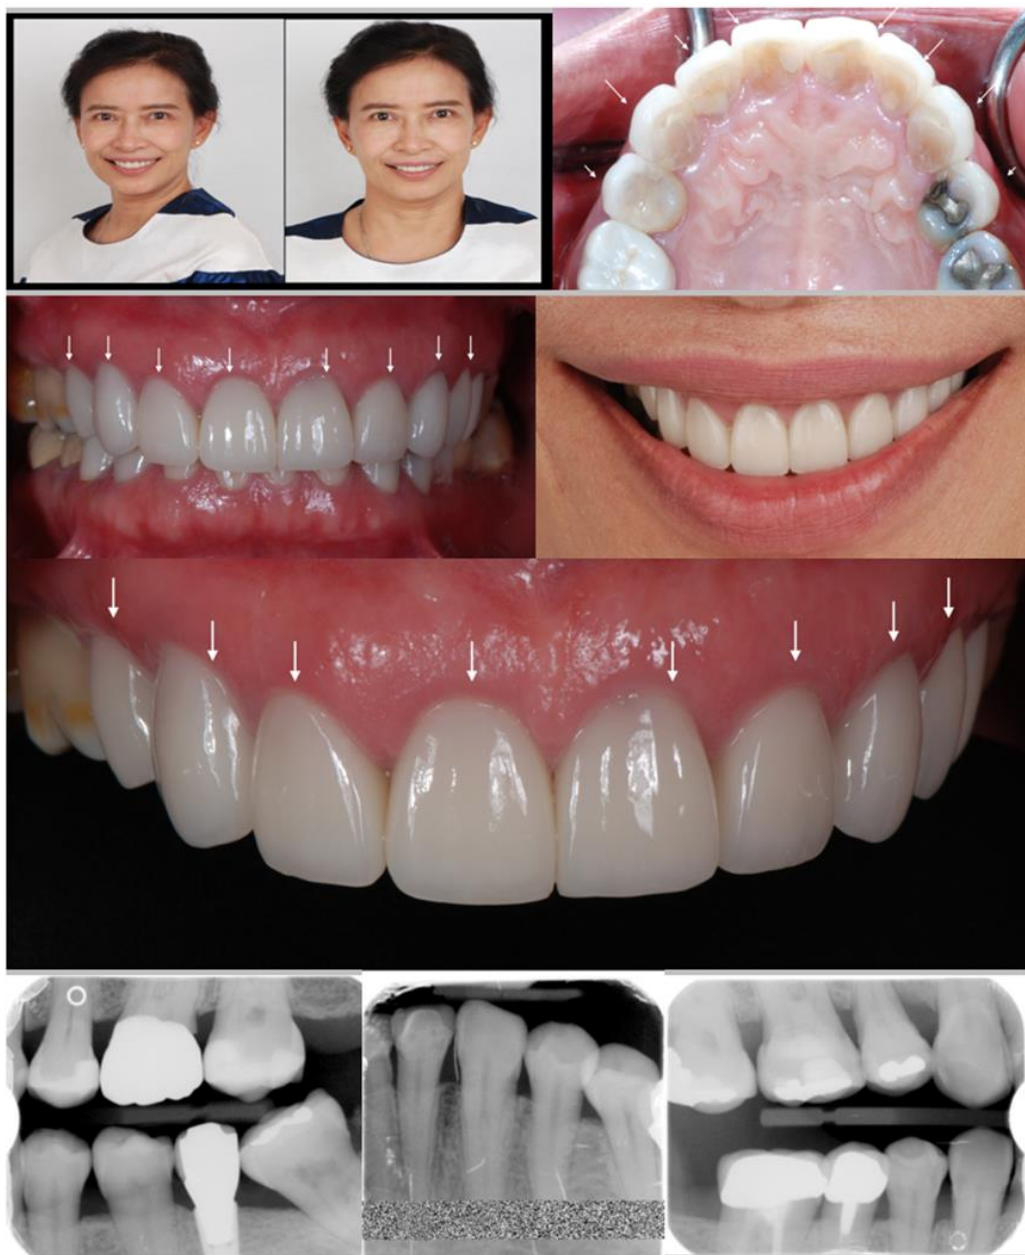
Ceramic veneer restorations on teeth number 14,13,12,11,21,22,23,24 were placed in 2012. The esthetic evaluation resulted in excellent color matching all teeth. The mechanical evaluation, all teeth resulted in no debonding. Marginal adaptation of most

veneer restorations rated as score 0. Marginal discoloration of all veneer restorations rated as score 0. All veneer restorations were intact with teeth and fully retained, rated as score 0. The biological evaluation, all veneer restorations showed healthy gingival, rated as score 0. veneer restorations had no history of postoperative hypersensitivity and no gingival recession. Caries rated as score 0 of all veneer restorations. Radiographic examination showed no significant finding, rated as score 0.
