INFLUENCES OF GEOLOGIC CONDITIONS AND
ANTHROPOGENIC ACTIVITIES ON CHANGES
OF GEOMORPHOLOGY AND SEDIMENT LOAD
CHARACTERISTICS OF THE PING
AND CHAO PHRAYA RIVERS

A Dissertation Submitted in Partial Fulfillment of the Requirements
for the Degree of Doctor of Philosophy in Geology
Department of Geology
Faculty of Science
Chulalongkorn University
Academic Year 2018
Copyright of Chulalongkorn University

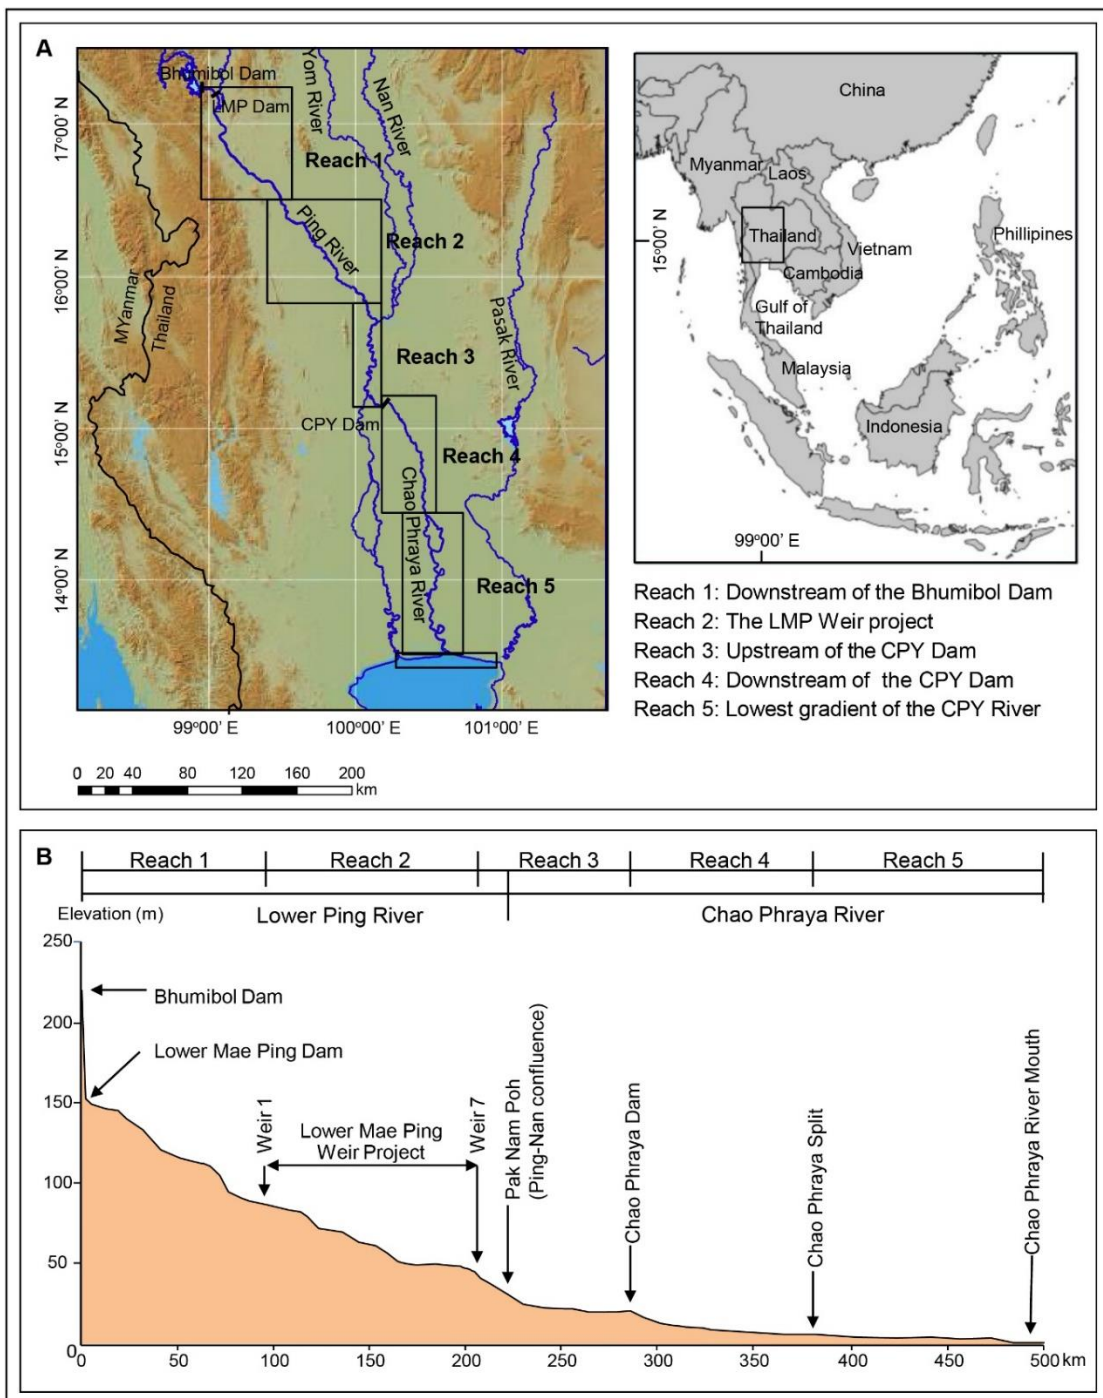
Figure 2.1 (A) Location map showing studied reaches (1-5) of the Lower Ping and Chao Phraya Rivers downstream from the Lower Mae Ping Dam to the Chao Phraya River mouth and the coastal area around its delta in the Gulf of Thailand. (B) Longitudinal profile of the Lower Ping River downstream of the Bhumibol Dam and the Chao Phraya River.

et al., 2006; Liebault et al., 2002; Nicoll and Hichin, 2010). However, in order to examine the cause and effect of the Ping and Chao Phraya Rivers problem thoroughly and effectively, the study area is bounded to cover a vast area from the upstream reaches of the river where the excessive sediment has been trapped continue to the downstream reaches where the severe erosion takes place. Hence, the most effective way to study these changes in river dynamic over a vast area and within a long period is using satellite imageries to track the river geomorphology and landform through time (Khan and Islam, 2003; Kummu et al., 2008; Li and Damen, 2010; Nasreen and Aminul, 2003). Therefore, the study area is set up to cover the Lower Ping River downstream of the Bhumibol Dam and continues to the end of the Chao Phraya River when entering the Gulf of Thailand for a stretch of around 1,000 km. In addition, the coastal area surrounding the Chao Phraya Delta was also examined (Figure 2.1A).

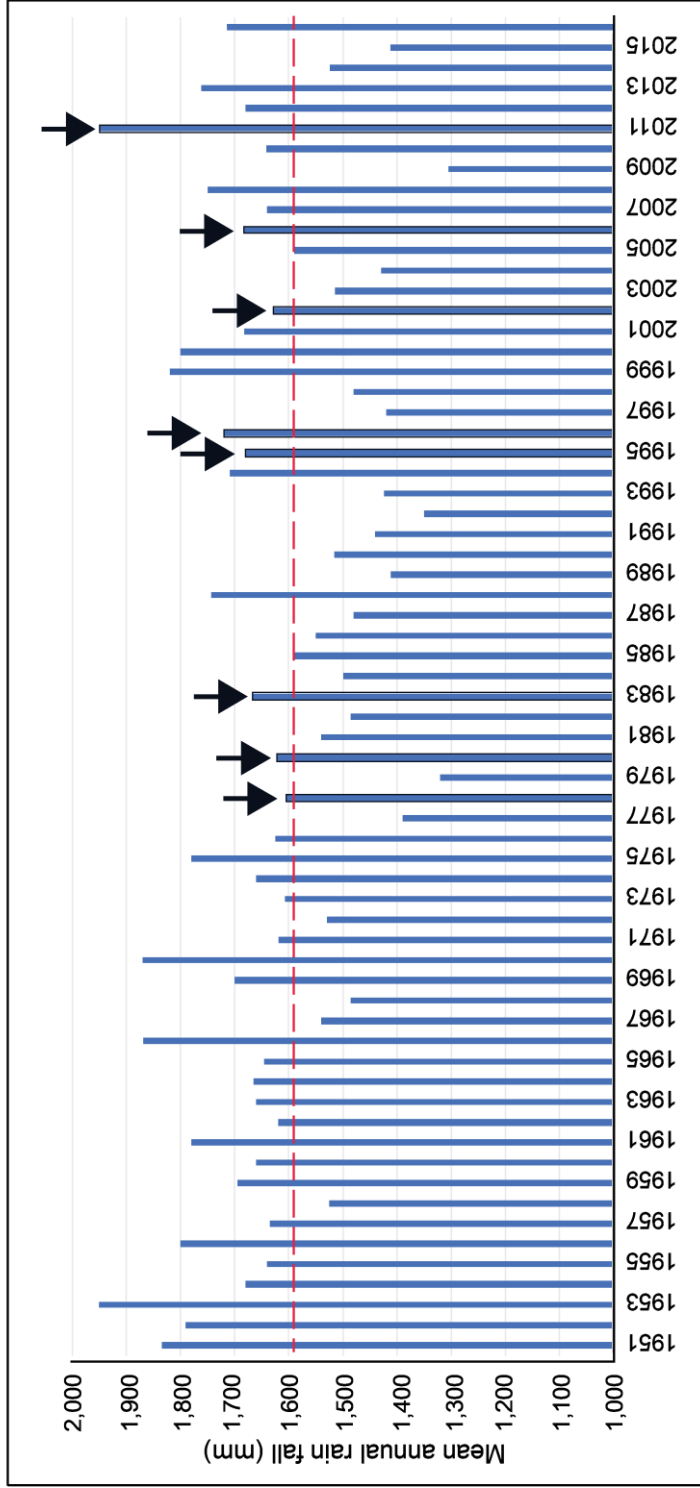
Figure 2.2 Mean annual rainfall for country from 1951 to 2016, the significant flood years (1978, 1980, 1983, 1995, 1996, 2002, 2006, and 2011) are highlighted with arrows; note that, in many cases, the large flood years are not associated with the highest rainfall (TMD, 2015).

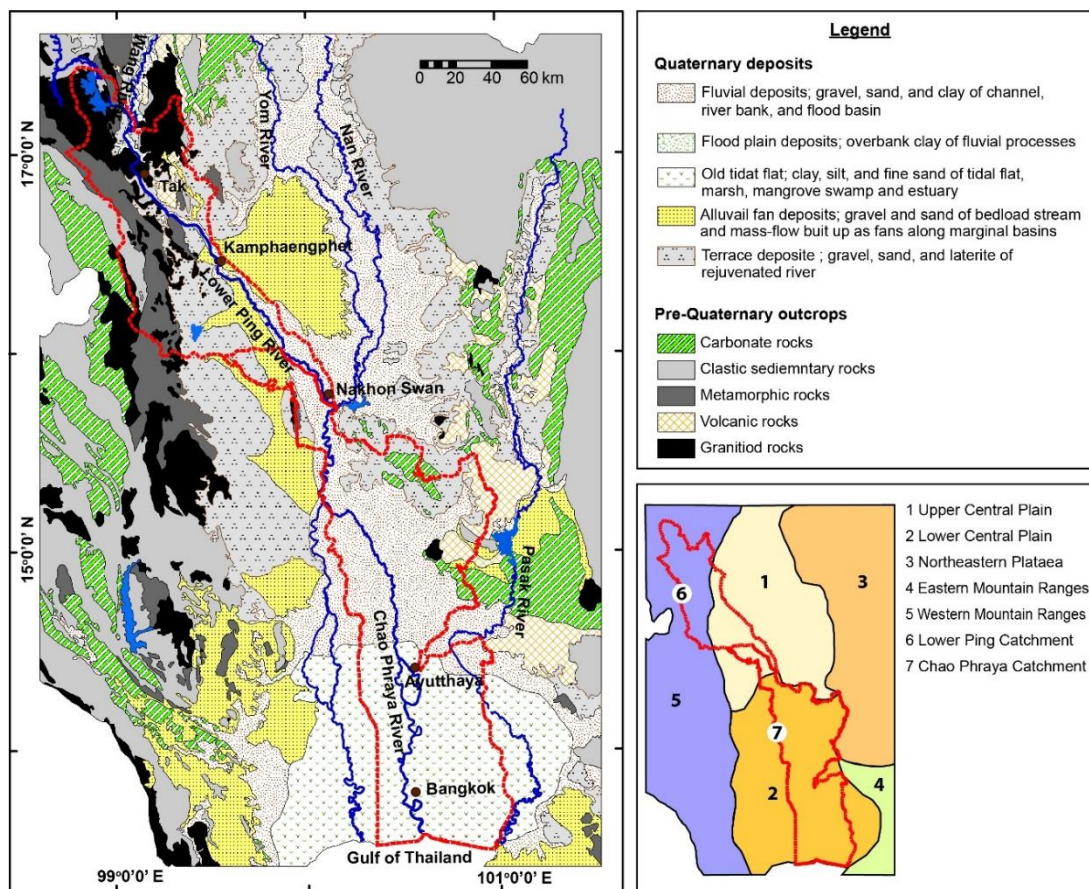
Figure 2.3 The geologic setting of the Central Plain of Thailand, and the surrounding areas.

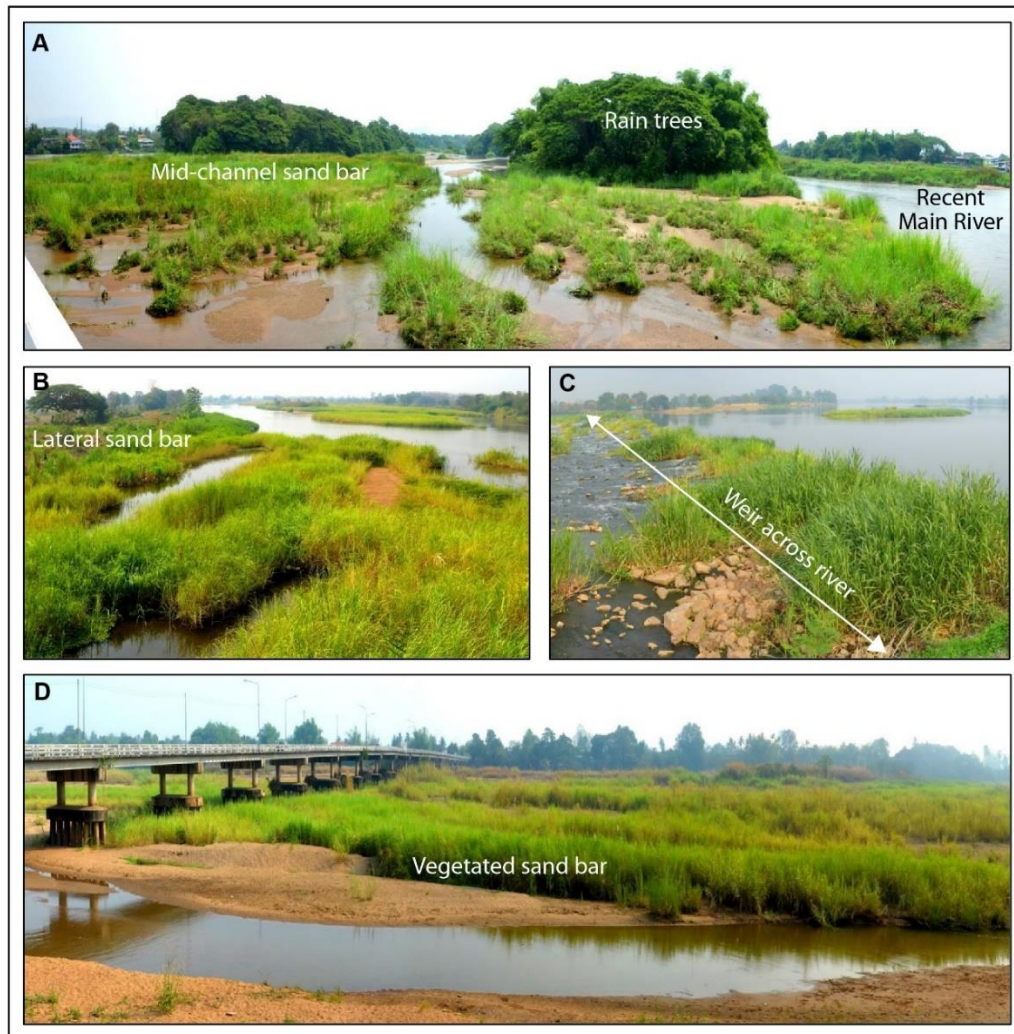
Figure 2.4 Characteristics of sand bars deposited in the Lower Ping River. (A) Downstream view of the Lower Ping River immediately below the Ban Tak Bridge. (B) Downstream view of sand bars the Lower Ping River immediately below the Thammarong Bridge. (C) An example of the temporarily weir built across the Lower Ping River, view is on the west. (D) Downstream view along the Lower Ping River immediately below the Thap Na Khon Tri Truing Bridge. Note vegetation encroachment onto sand bars and inside channels.

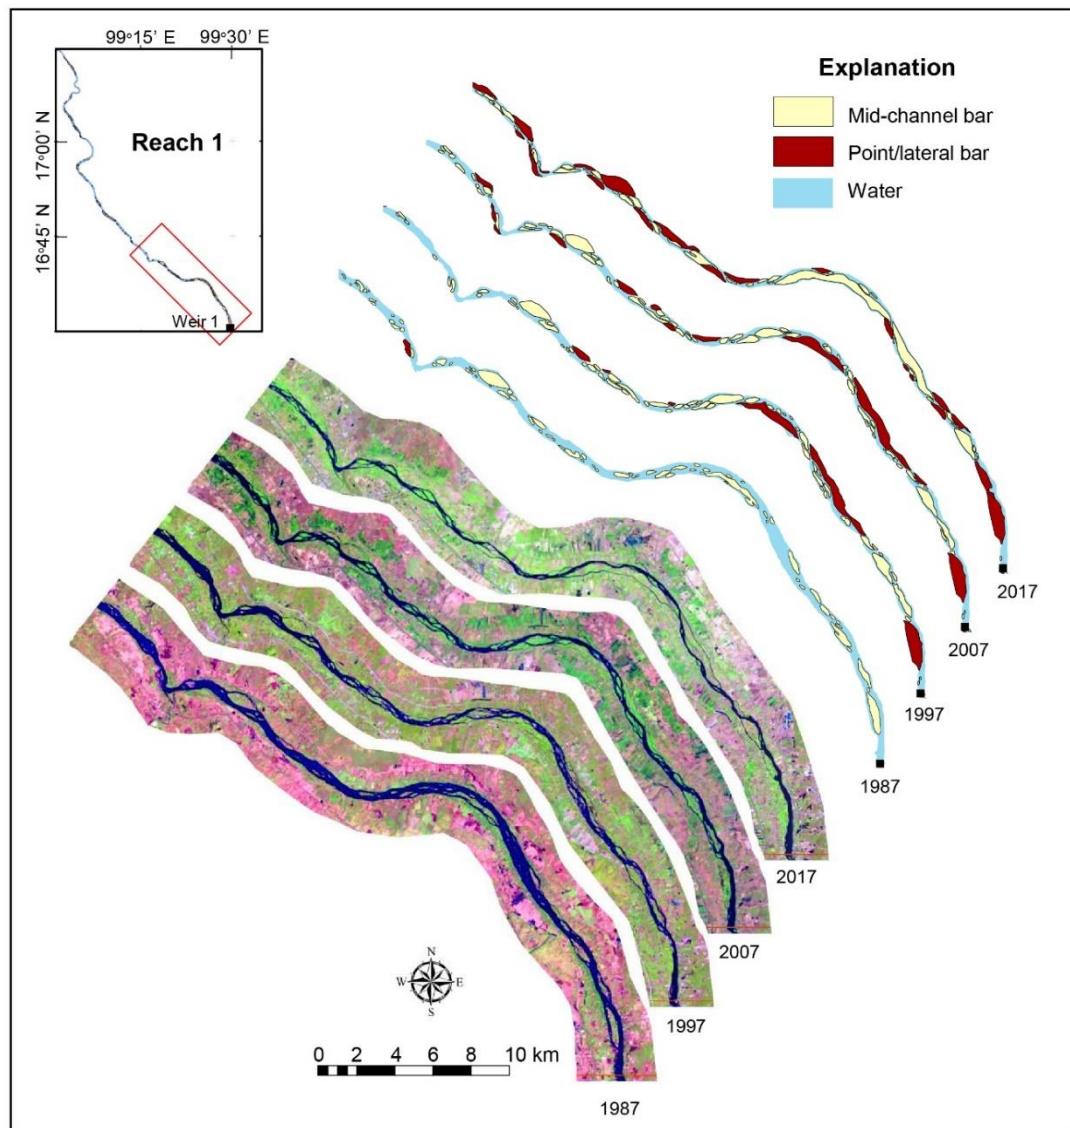
Figure 2.5 Detection of channel dynamic of the Lower Ping River near the end of Reach 1 above the 1st weir of the Lower Mae Ping Weir Project.

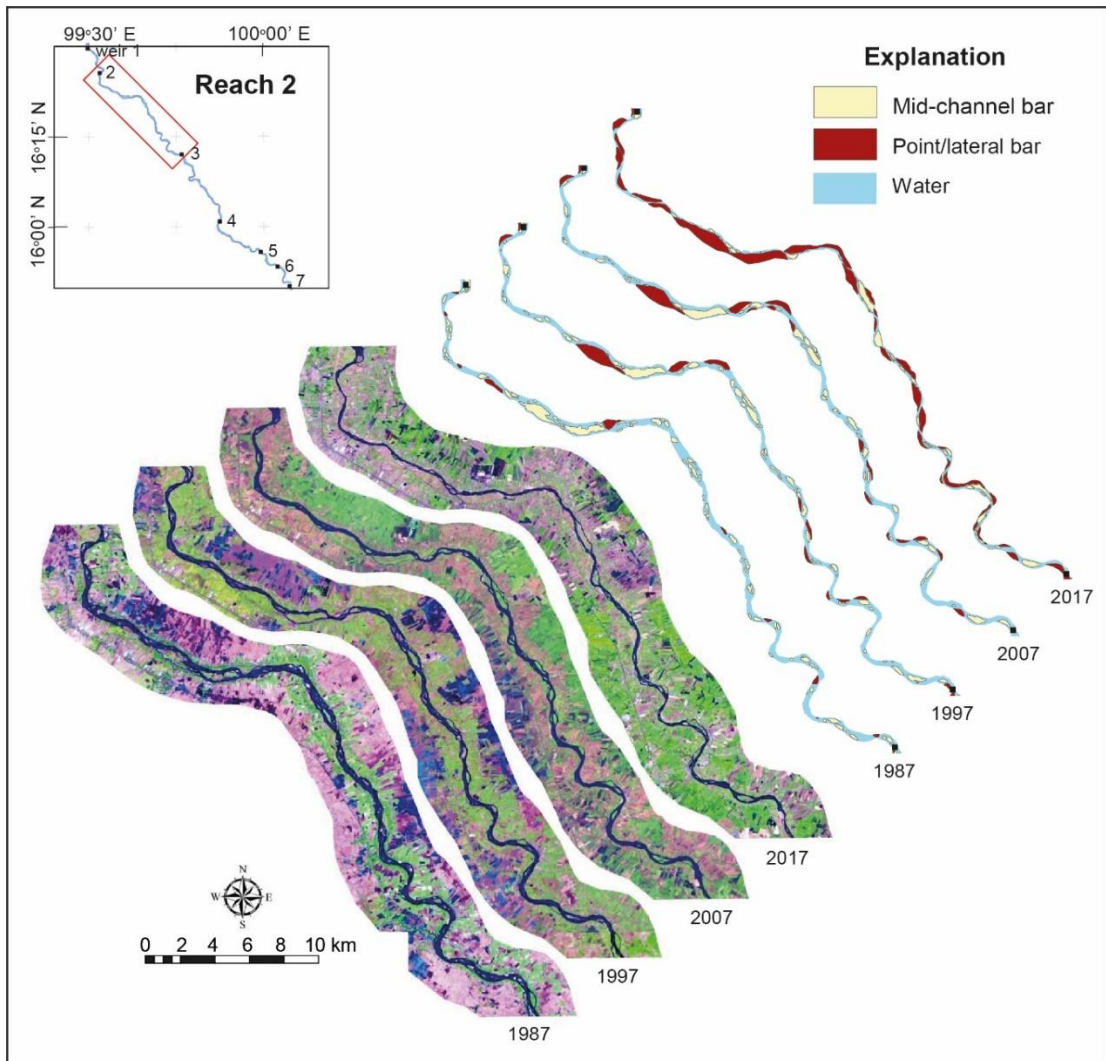
Figure 2.6 Sequential changes in the planform of the Lower Ping River over 30 years period. Series of Landsat images show the sand bars had been increasing progressively from 1987 onwards in Reach 2.

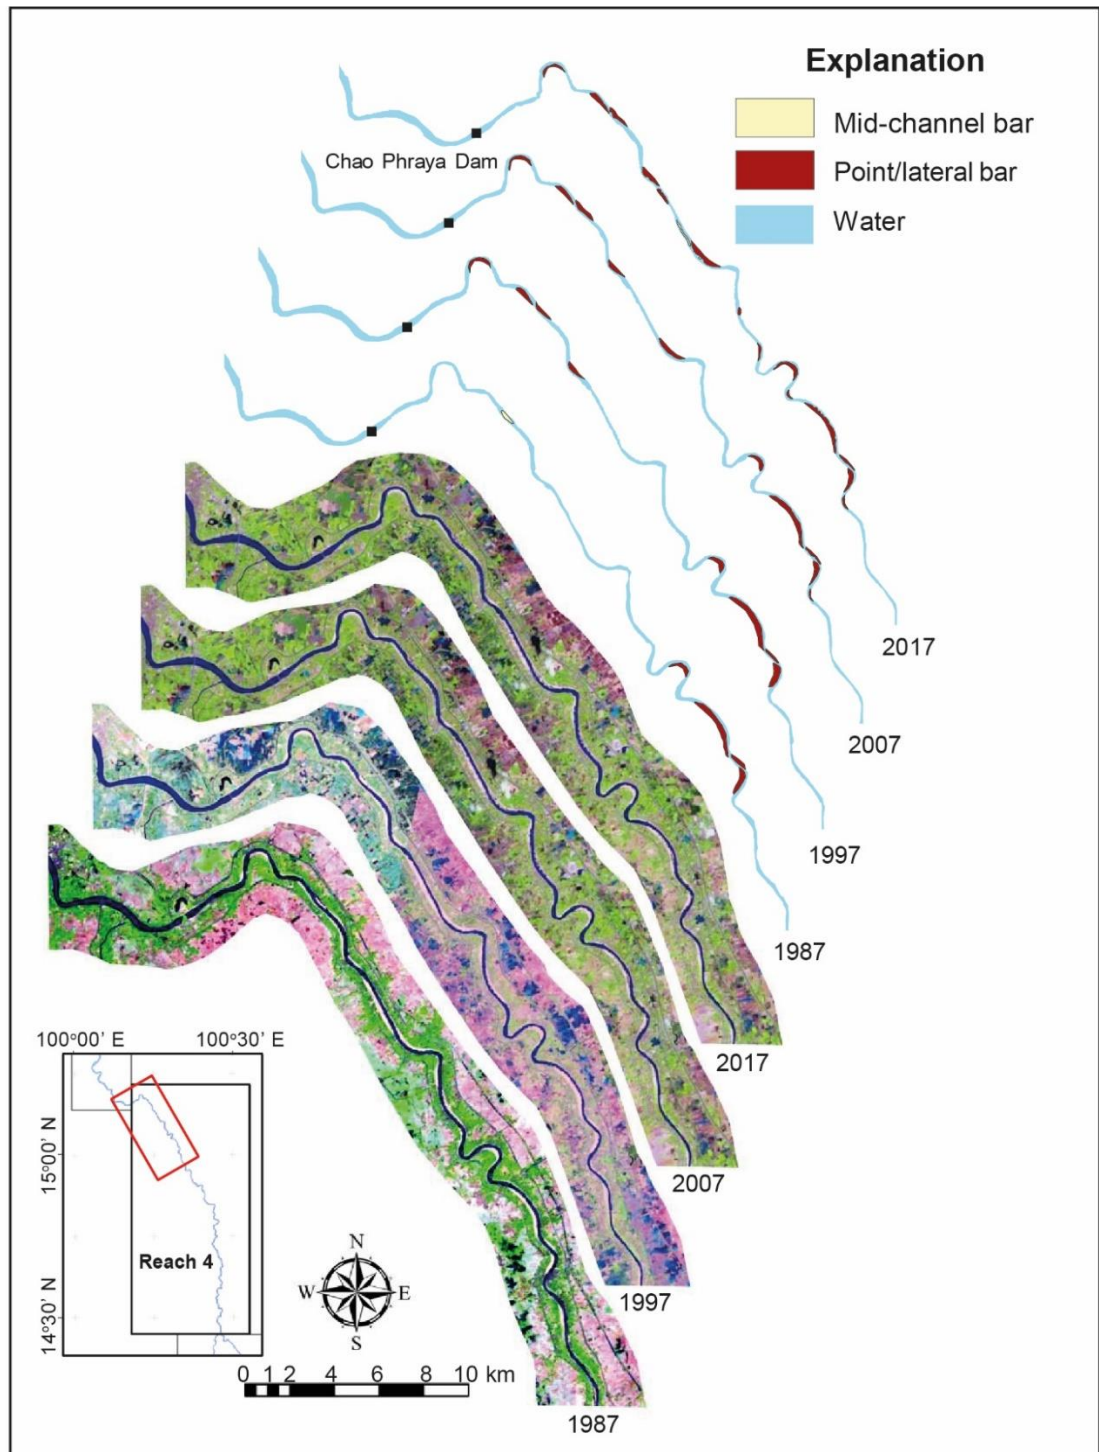
Figure 2.7 Landsat imageries of the Chao Phraya River downstream from the Chao Phraya.

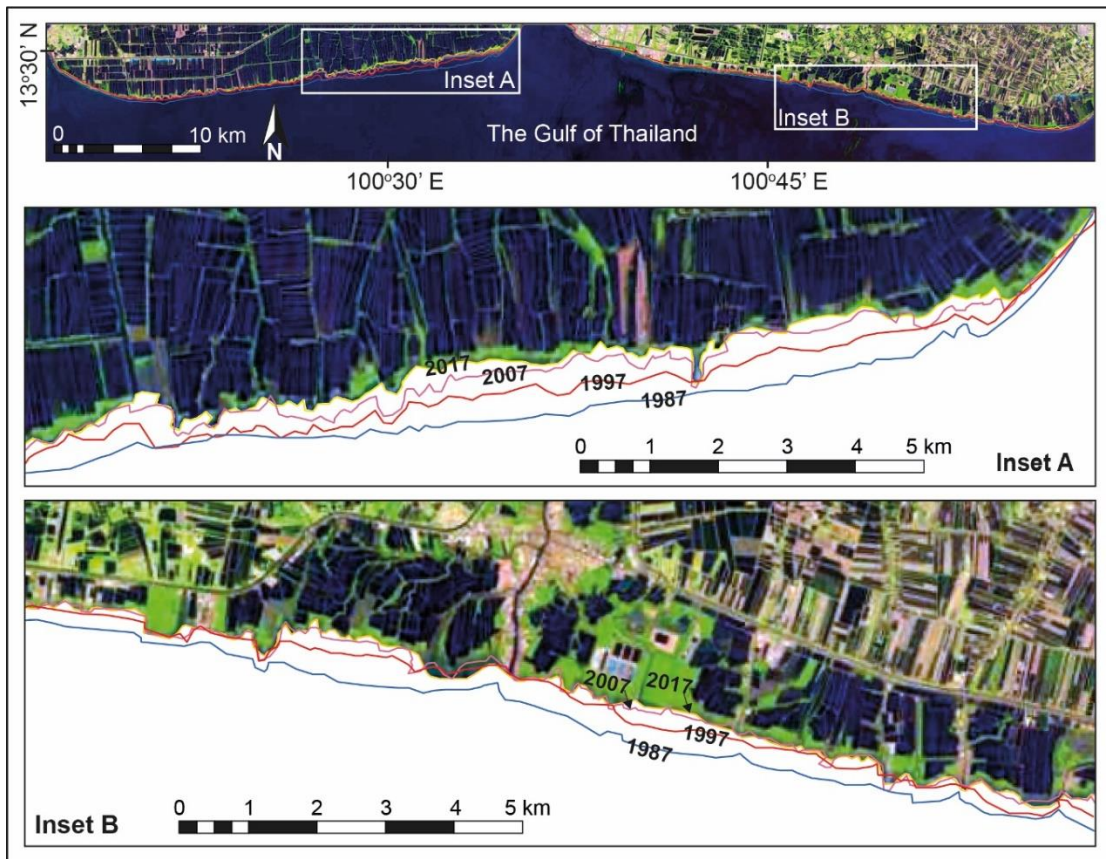
Figure 2.8 Coastal erosion in the Chao Phraya Delta during the period 1987-2017 observed from Landsat imageries. Inset A cover the western part and inset B is in the eastern part.

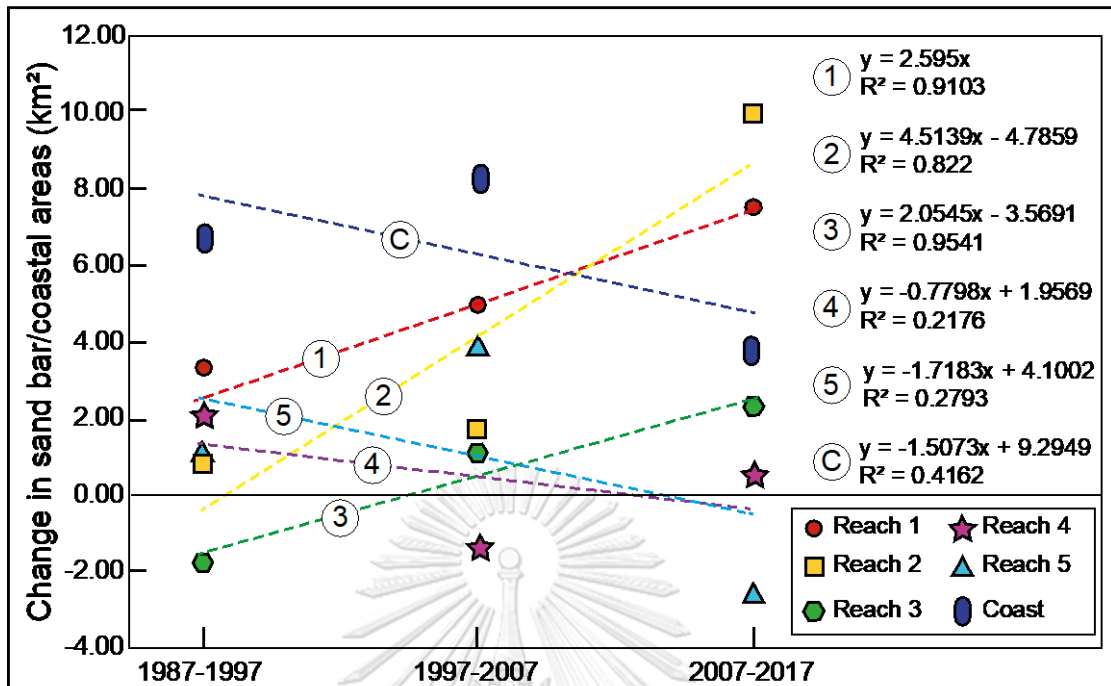
Figure 2.9 Graph illustrates the increasing and decreasing of sand bar areas of the Reaches 1-5 and coastal erosion area during 10 year-intervals of 1987-1997, 1997-2007 and 2007-2017. The trendlines 1-5 represent the changing trend of sand bar areas of the Reaches 1-5 respectively, and the trendline “C” represent the changing trend of erosion area along the delta coast.

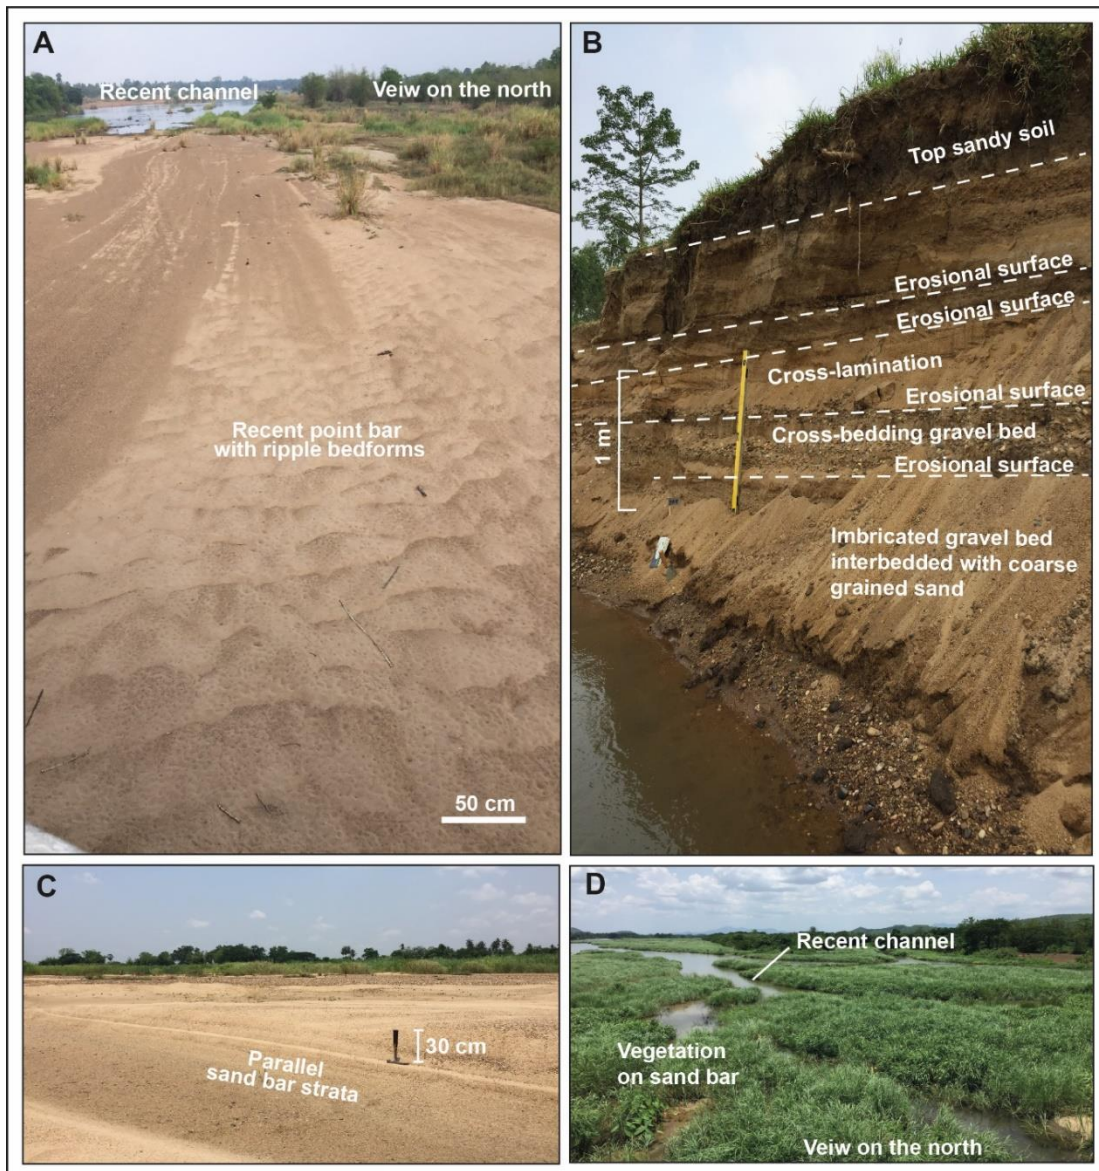
Figure 2.10 (A) Ripple mark bedforms on sand bar surface, (B) three meters thick of eroded sand bar deposit showing cobble and pebble beds interbedded with cross-bedding gravel bed and overlain by cross-bedding sand, (C) parallel sand bar strata (hammer as scale, view is on the west) and (D) modern vegetarian encroachment on sand bar (view is on the north).

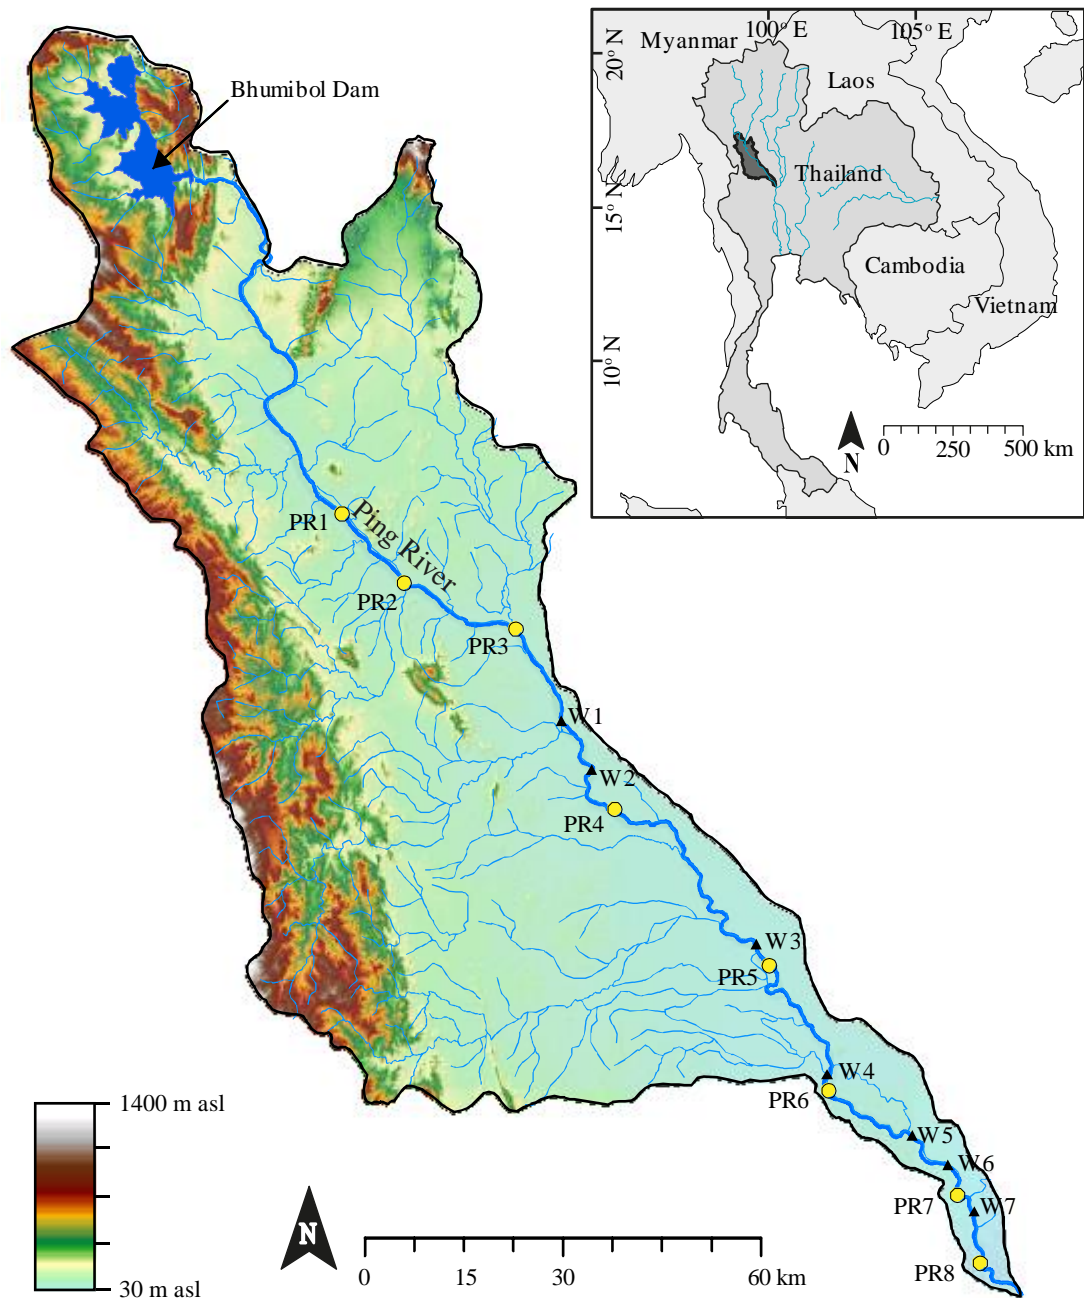
Figure 3.1 The Lower Mae Ping Watershed covering the Ping River downstream from the Bhumibol Dam to the Ping-Nan Confluence, with eight sampling stations (PR1-8) and seven weir locations (W1-7) shown along the river.

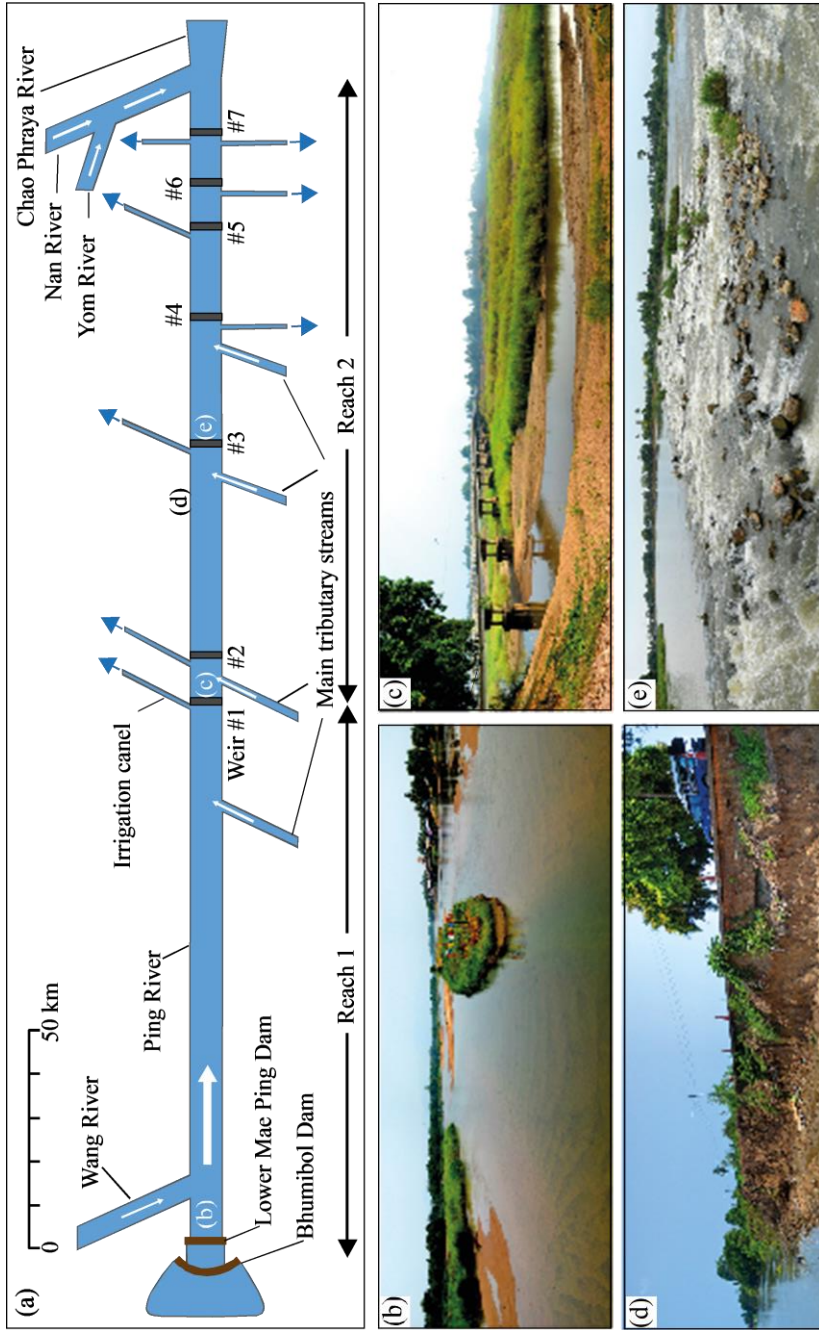
Figure 3.2 (a) Illustration drawing of the Lower Ping River encompassing the irrigation system, and including the main tributaries; (b) the Ping River widening and shallowing at the upper reach above the succession of weir; (c) Island and bar construction, with vegetation encroachment; (d) Bank erosion due to rapid deposit of sandbar on the opposite side; (e) Weir #3 built across the river creating a reservoir behind it.

In this study, the Lower Ping River is divided in 2 reaches (Figure 3.2). According to (Chaiwongsaen and Choowong, 2018) et al. (2018), the upper reach called “*Reach 1: Downstream from the Lower Mae Ping Dam*” has the gradient of 51 cm/km; and has not been regulated by any weirs. The length of this reach is about 130 km with the average width of 340 m. Further downstream, “*Reach 2: The Lower Mae Ping Weir Project area*” has defined. Within this reach, succession of seven weirs has been built by the Royal Irrigation Department (RID) for irrigation purpose. The Reach 2 ends at the Ping-Nan confluence (Pak Nam Poh). The length of this reach is approximately 140 km, with the average width of 191 m.

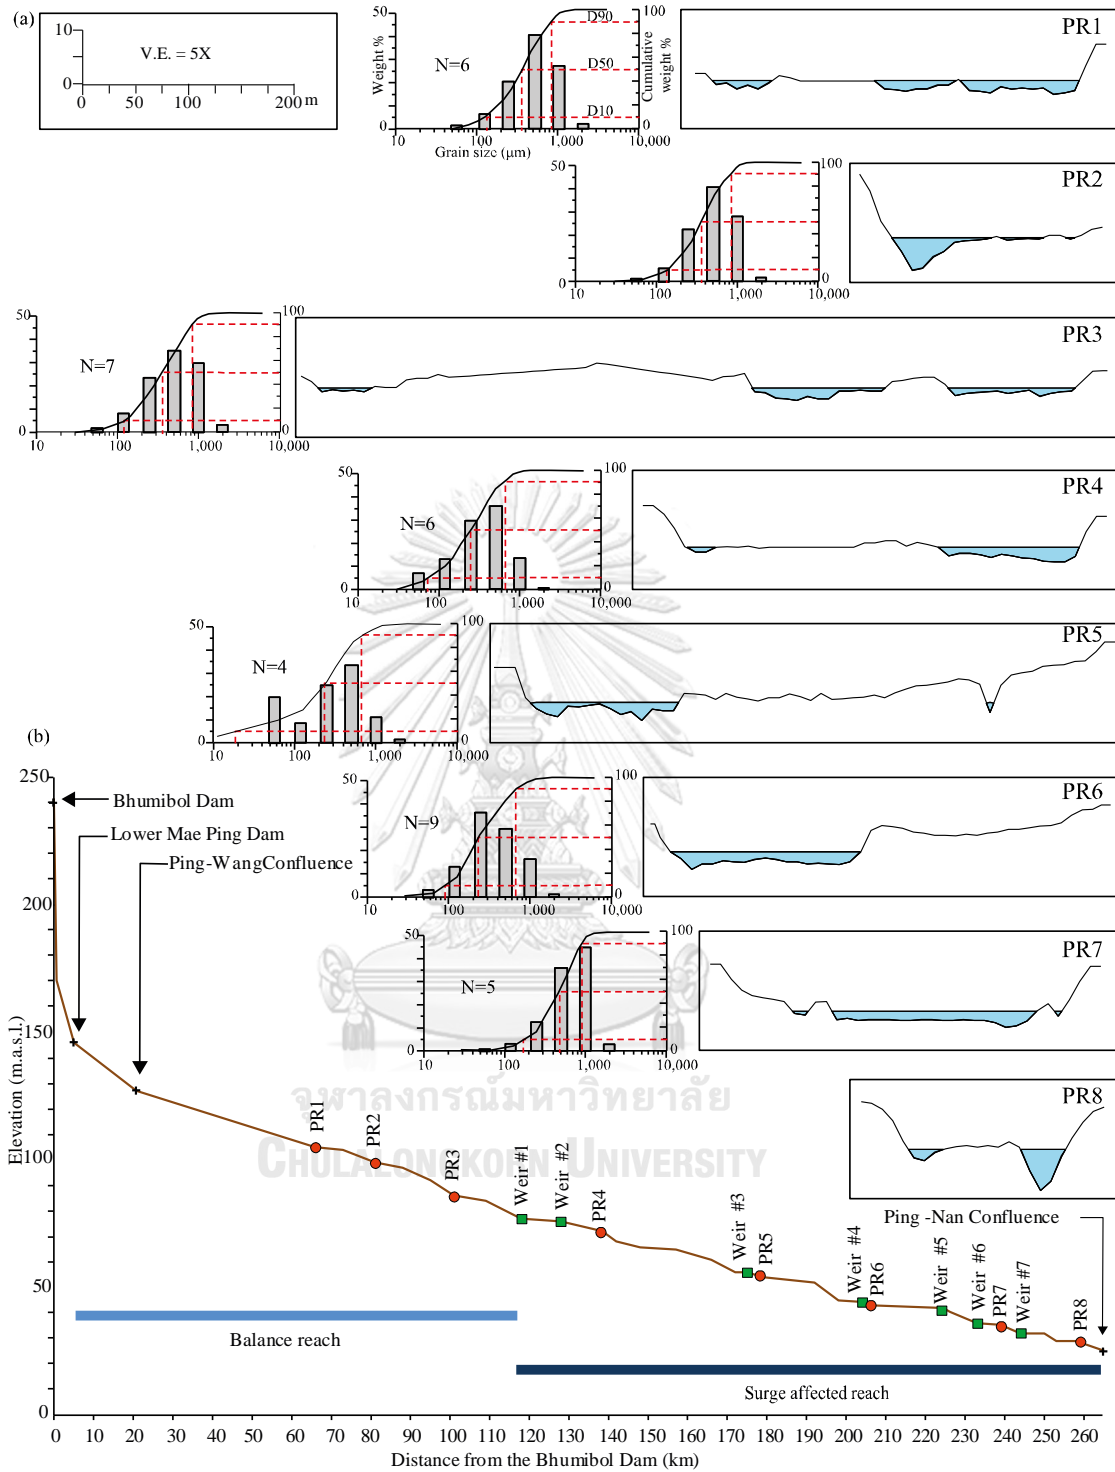
Figure 3.3 The cross-sectional profiles of the Ping River and graphs of average bedload grain size analysis; (b) Longitudinal profile of the Lower Ping River including the sampling locations and weirs.

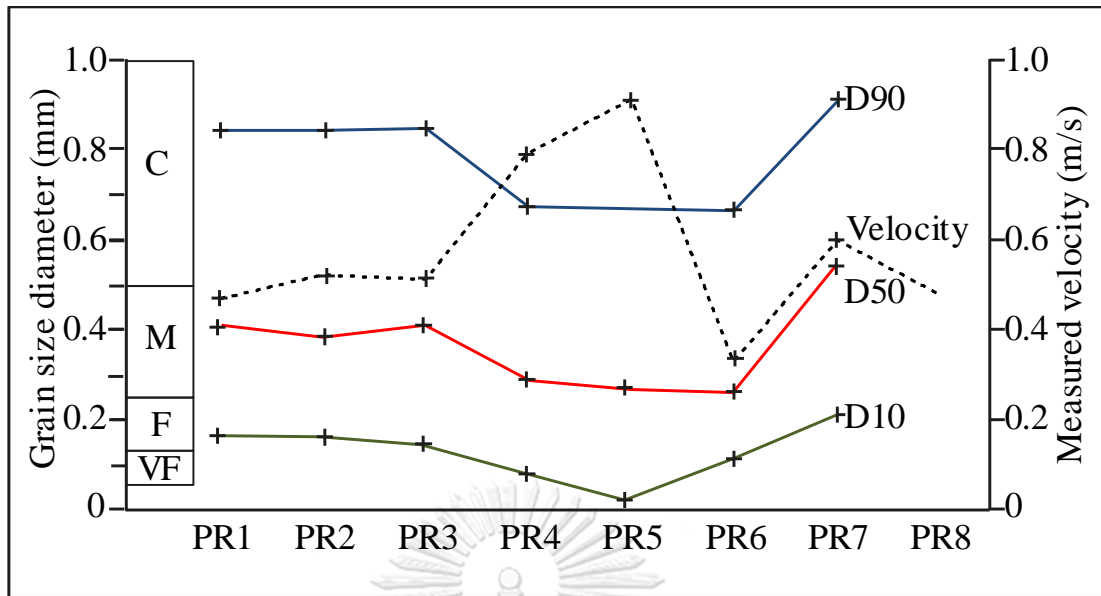
Figure 3.4 The variation bedload grain size in correlation with the flow velocity along the Lower Ping River; VF= Very Fine Sand, F= Fine Sand, M=Medium Sand, and C=Coarse Sand.

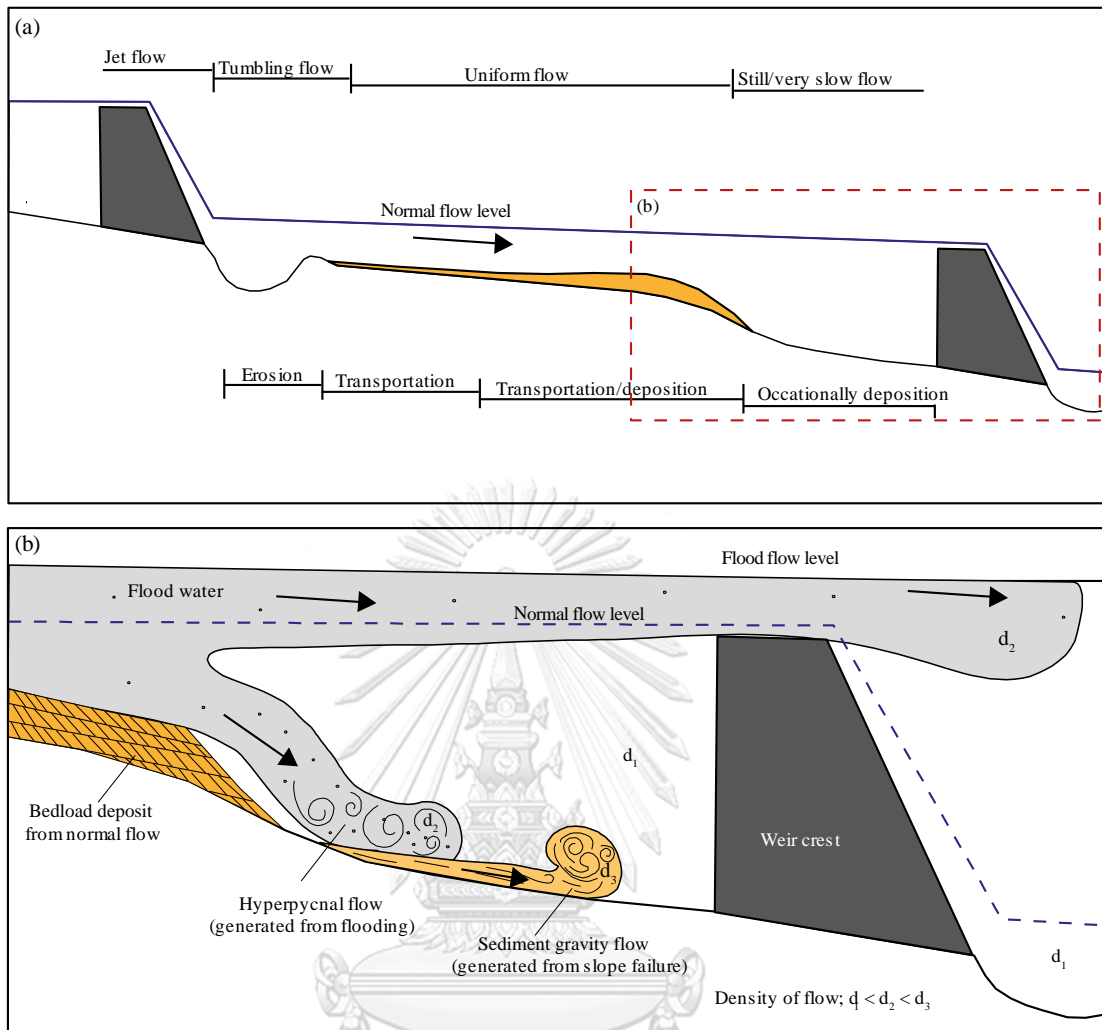
Figure 3.5 (a) Characteristics of river flow and planform processes in response to changing sediment supply in relation to transport capacity along the succession of weir; (b) Possibility of bedload transportation modes within the still water behind weir including sediment gravity flow generated from slope failure of dune front and hyperpycnal flow generated during flood events.

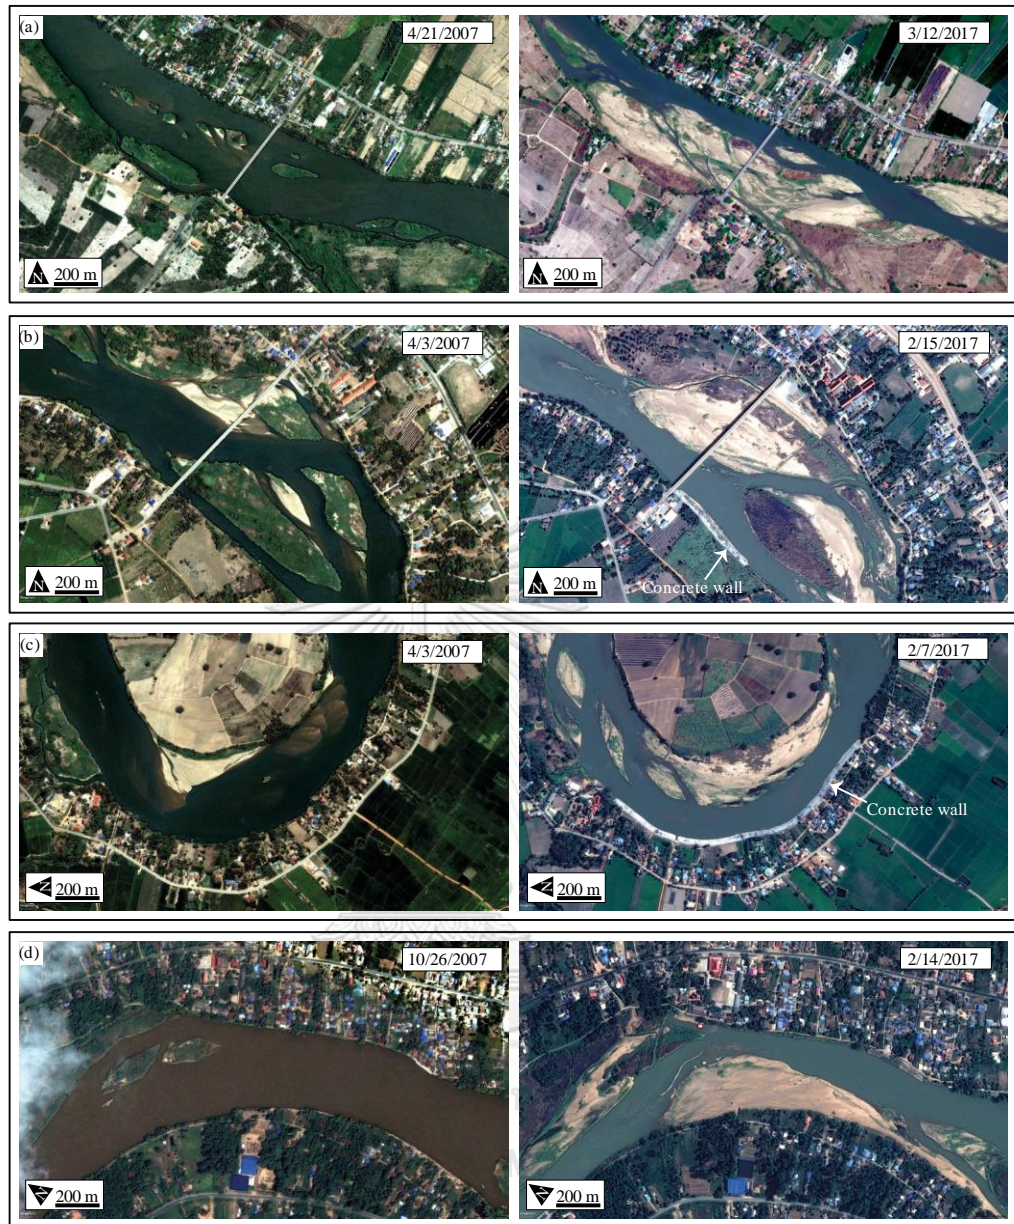
Figure 3.6 Google Earth images compare decadal changes in river morphology from 2007-2017; (a) the Ping River at latitude $16^{\circ}22'25.67''$ N and longitude $99^{\circ}34'17.22''$ E between the Weir #2 and 3; (b) located at latitude $16^{\circ}10'10.14''$ N and longitude $99^{\circ}47'31.81''$ E between the Weir #3 and 4; (c) latitude $16^{\circ}7'49.91''$ N and longitude $99^{\circ}47'14.84''$ E between the Weir #3 and 4; (d) located at latitude $15^{\circ}55'9.92''$ N and longitude $100^{\circ}0'16.71''$ E between the Weir #5 and 6. Note that all location shows rapid aggradation trend of the river in response to changing sediment supply and transport capacity along the succession of weir.

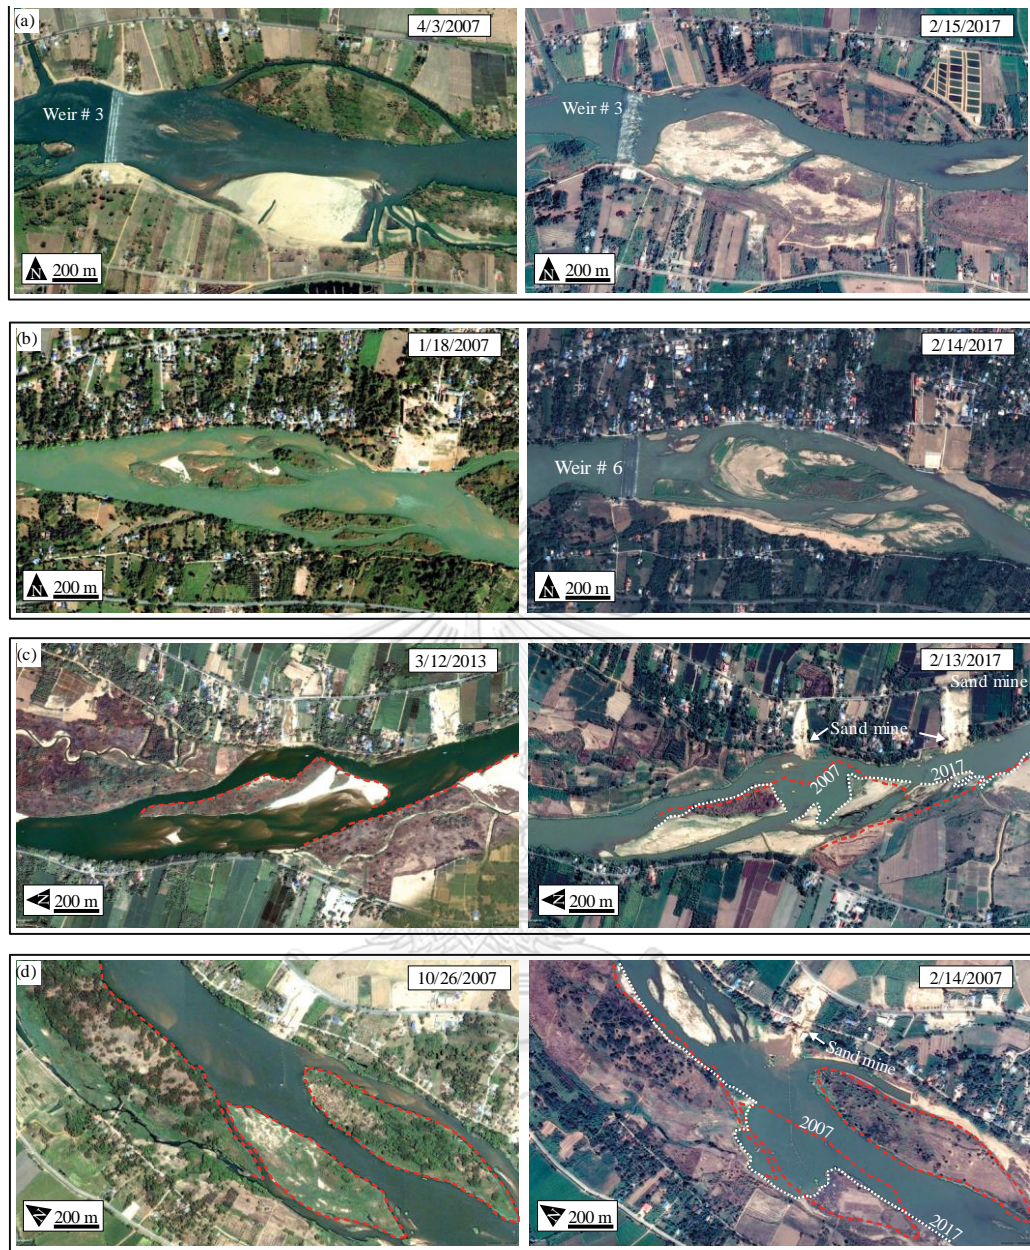
Figure 3.7 Google Earth images compare the decadal changes in river morphology from 2007-2017; (a) Weir #3 constructed in 2006 at latitude $16^{\circ}11'42.58''\text{N}$ and longitude $99^{\circ}46'10.28''\text{E}$; (b) Weir #6 constructed in 2010 at latitude $16^{\circ}10'10.14''\text{N}$ and longitude $99^{\circ}47'31.81''\text{E}$; (c) A sand mine located at latitude $15^{\circ}59'2.39''\text{N}$ and longitude $99^{\circ}53'0.07''\text{E}$ between the Weir #4 and 5; (d) A sand mine located at latitude $16^{\circ}10'36.75''\text{N}$ and longitude $99^{\circ}46'52.59''\text{E}$ between the Weir #3 and 4.
