INFLUENCES OF GEOLOGIC CONDITIONS AND
ANTHROPOGENIC ACTIVITIES ON CHANGES
OF GEOMORPHOLOGY AND SEDIMENT LOAD
CHARACTERISTICS OF THE PING
AND CHAO PHRAYA RIVERS

A Dissertation Submitted in Partial Fulfillment of the Requirements
for the Degree of Doctor of Philosophy in Geology
Department of Geology
Faculty of Science
Chulalongkorn University
Academic Year 2018
Copyright of Chulalongkorn University

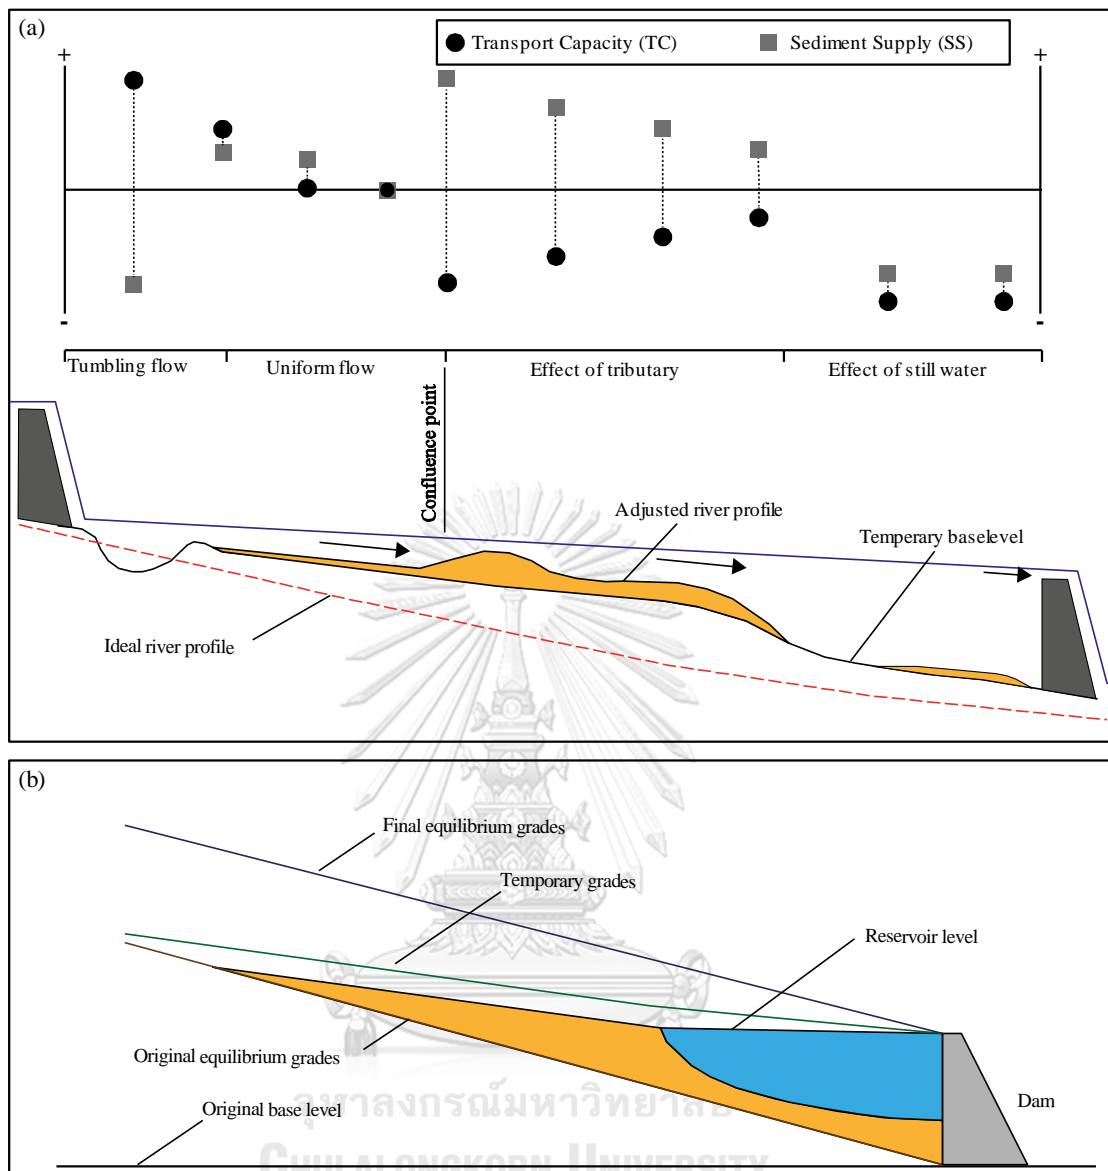
Figure 3.8 (a) The adjustments of the river in response to changing sediment supply and transport capacity due to regulated by succession of weir; (b) Predicting the stream profile changes according to the falling and rising of base level (Leopold, 1992). This one is the “Class 3”: grade of the stream suddenly raised at one point (dams, lakes), which similar to the situation of the Lower Ping River where the succession of weir has been constructed along the river course.

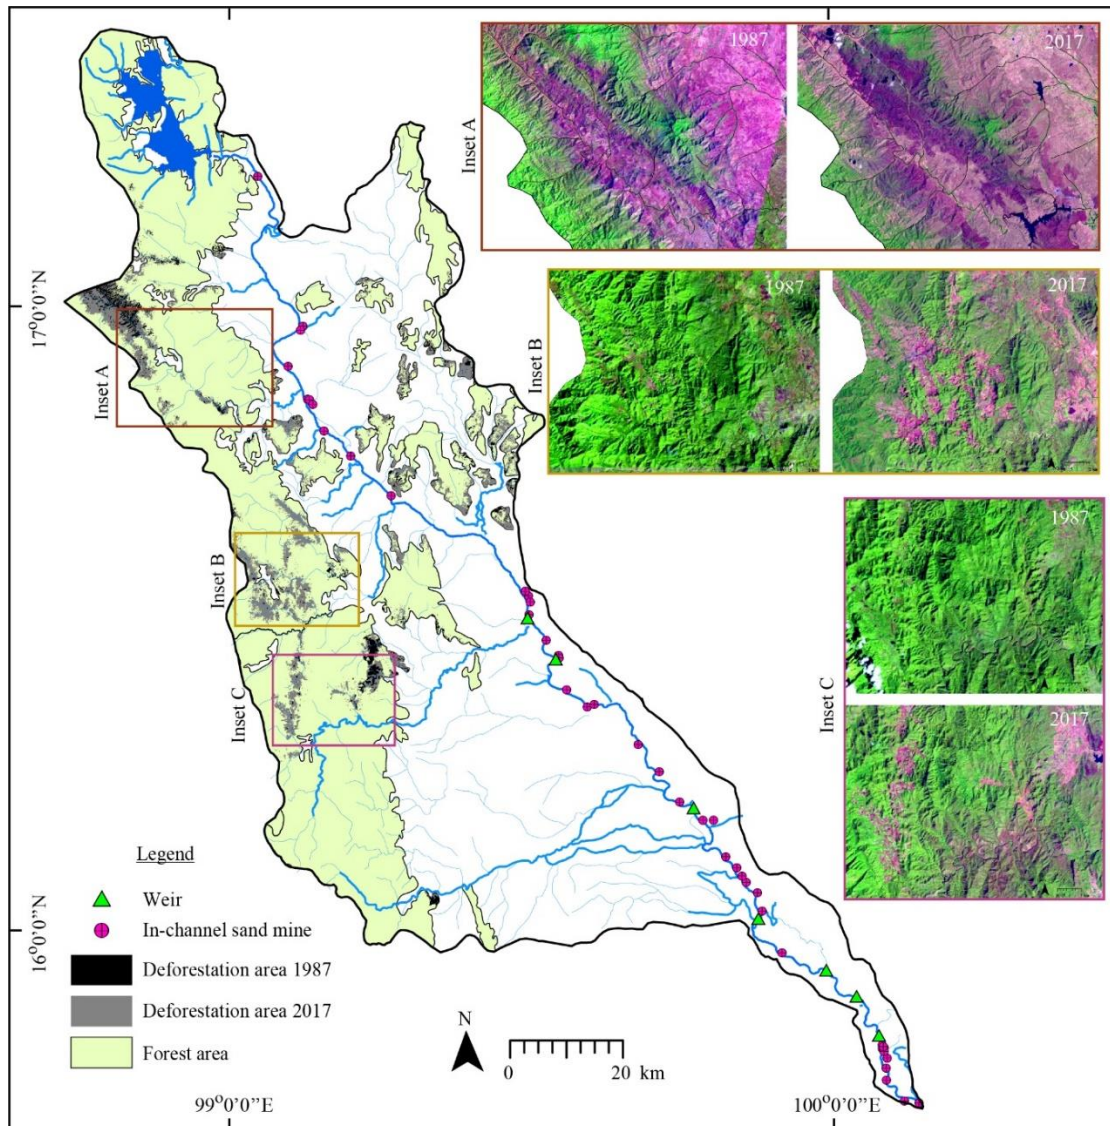
Figure 3.9 The map showing the forest areas, including the National Parks and the National Reserved Forests areas, and the deforestation areas of the Lower Ping River Watershed Area in 1987 and 2017; with the insets of comparing Landsat images in some areas from 1987 and 2017.

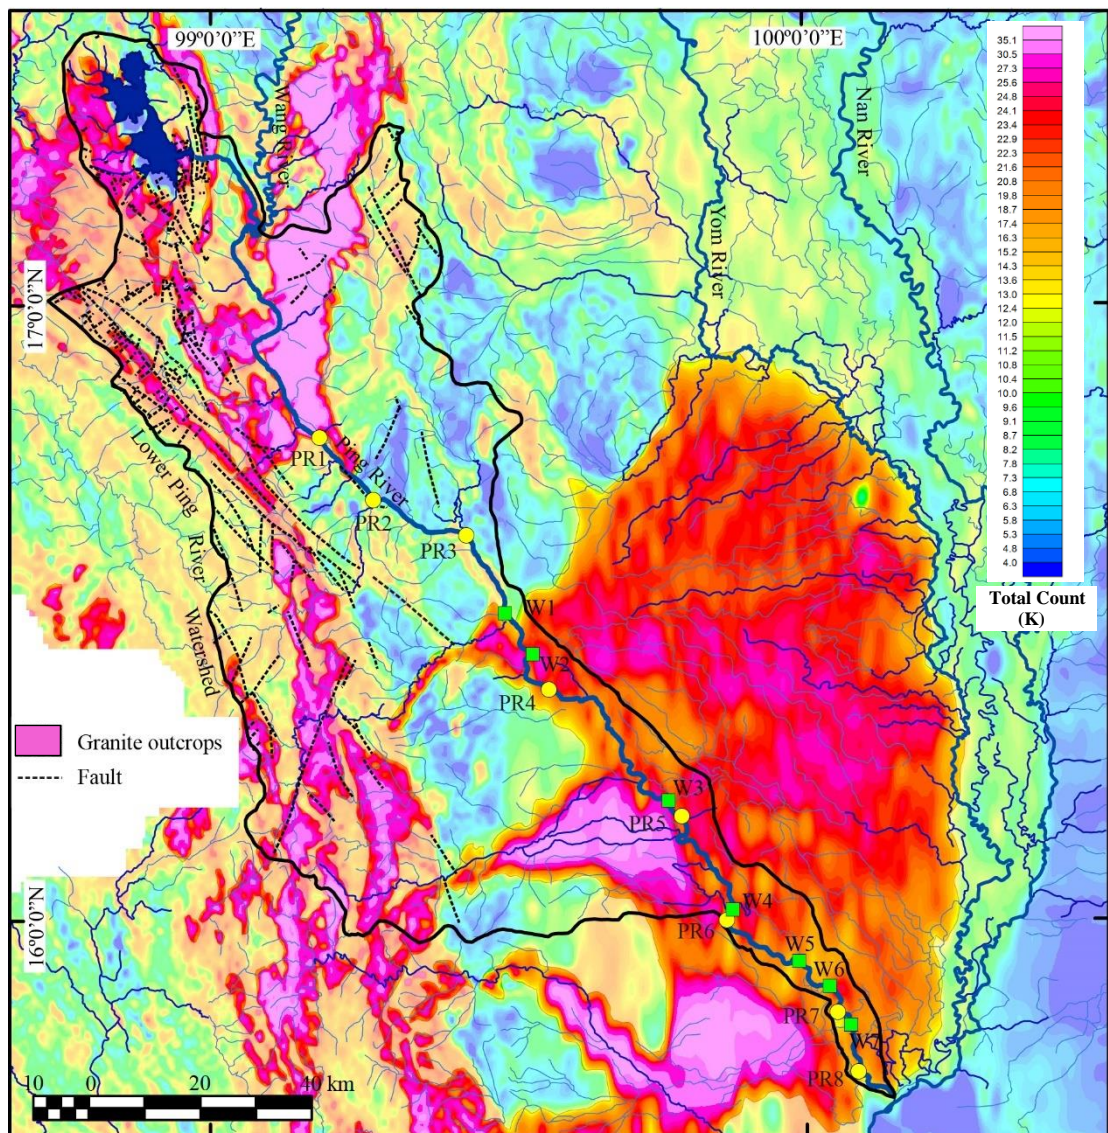
Figure 3.10 The map of the Lower Mae Ping Watershed Area with distribution of granitoid outcrops and the background of the Airborne Radiometric data showing the dark color (pink) as high detected Potassium areas which interpreted as either granitoid outcrops or sediment deposits derived from them. It demonstrates that enormous amount of sediment has been supplied from the mountain ranges in the west and deposited as alluvial fans east of the Ping River in the past. This also indicates that there is still large amount of sediment supplied into the Ping River in the present.

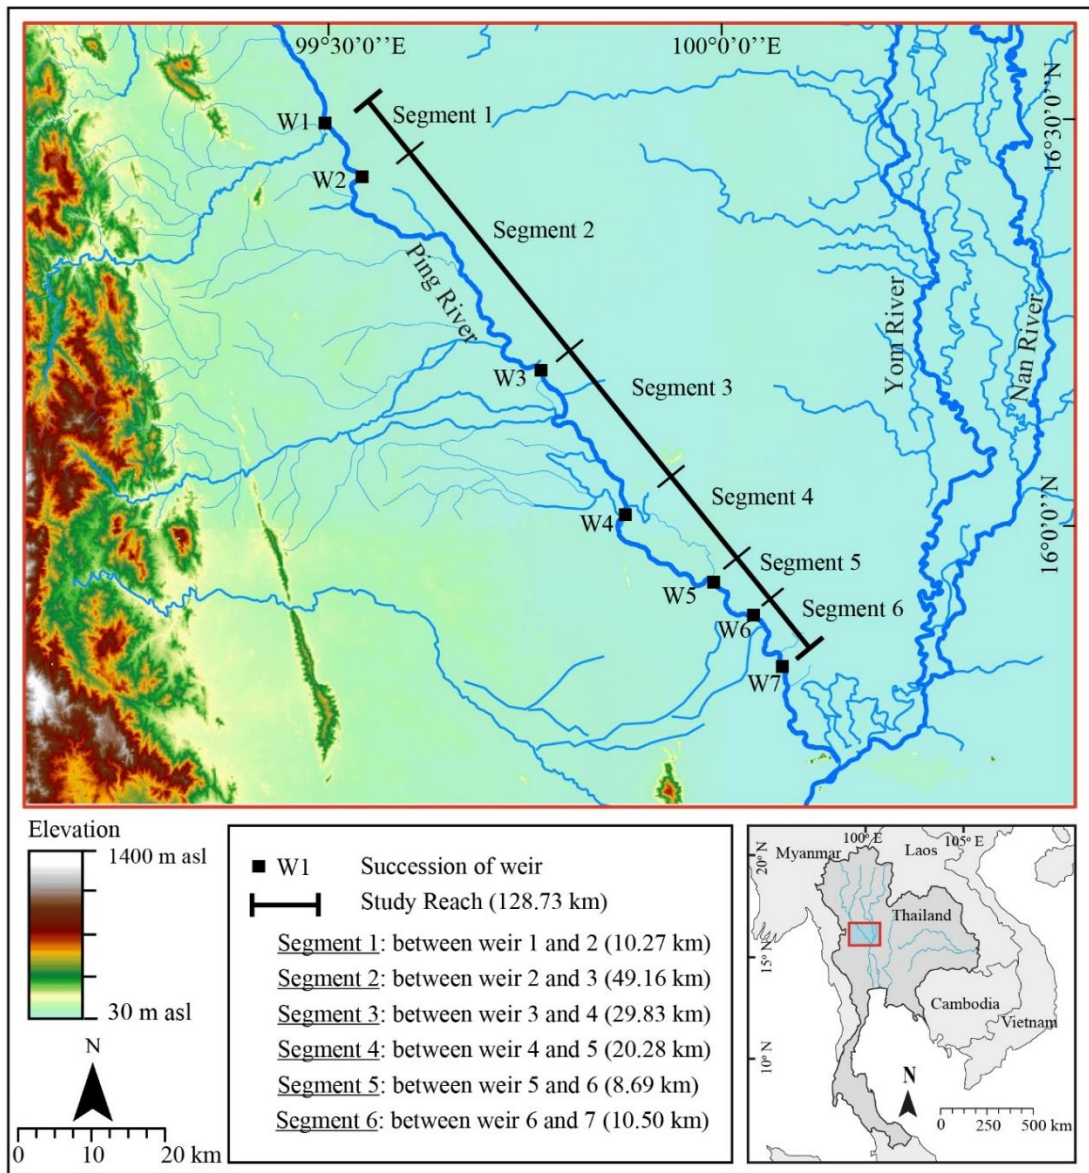
Figure 4.1 Map of the study area showing the succession of weir along the Lower Ping River and 6 segments of this study.

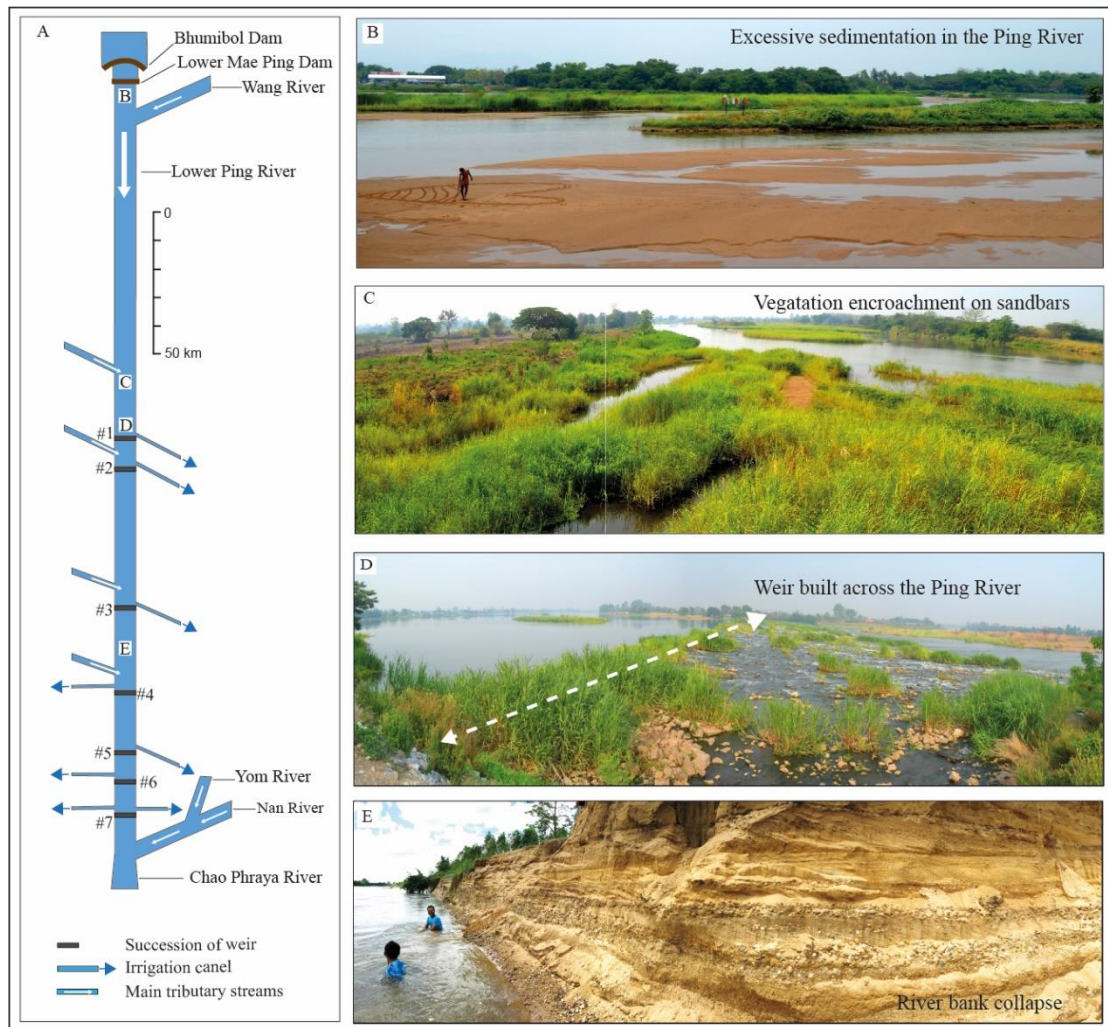
Figure 4.2 A) the illustration drawing of the Lower Ping River; B) excessive sedimentation along the river, C) vegetation encroachment on sandbars, D) Weir # 1 of the succession of weir, E) severe riverbank erosion of the Lower Ping River.

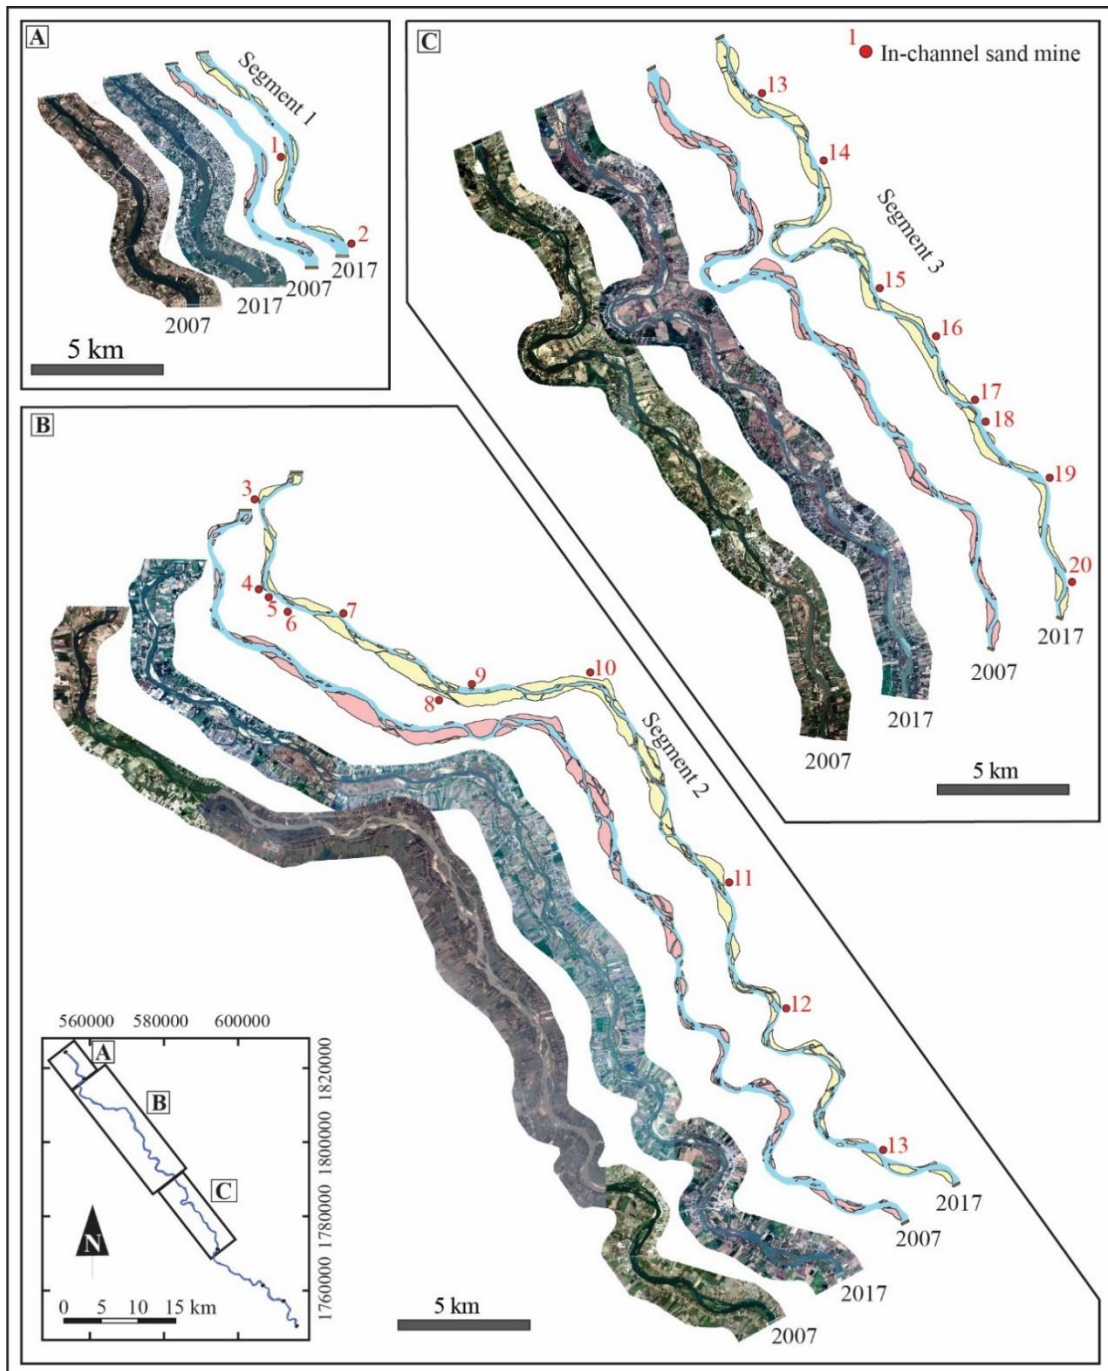
Figure 4.3 Maps showing sandbars deposited during 2007 and 2017 with the locations of existing in-channel sand mine; A) along segment 1, B) along segment 2, and C) along segment 3.

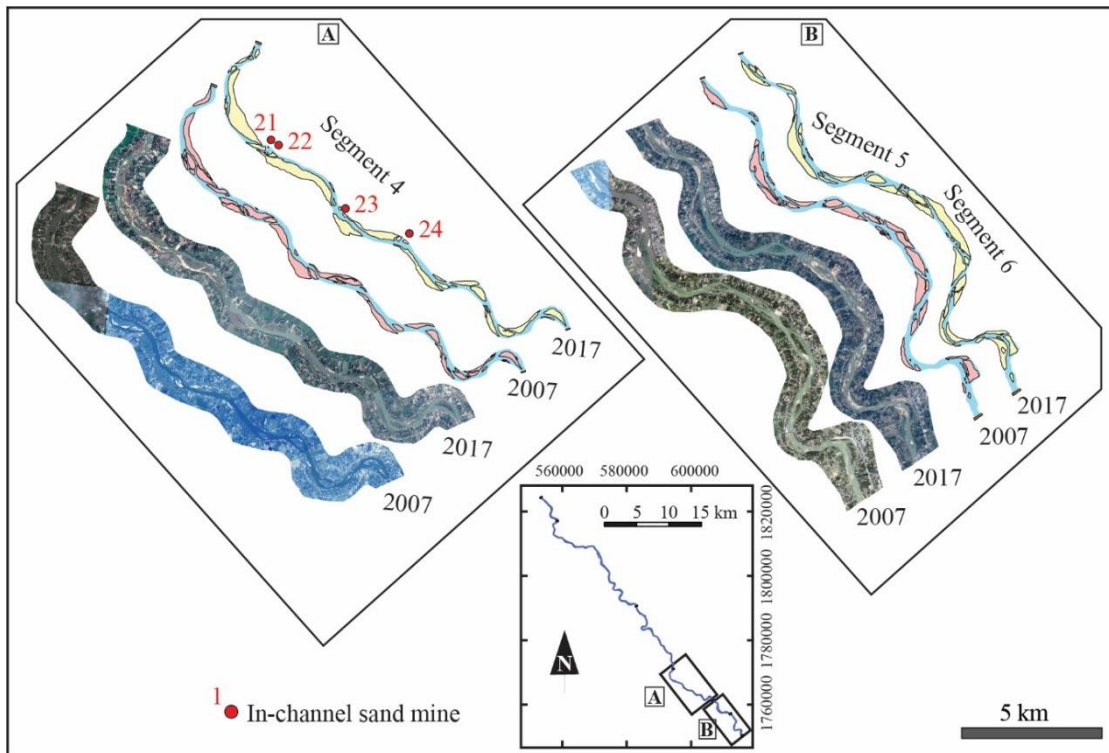
Figure 4.4 Maps showing sandbars deposited during 2007 and 2017 with the locations of existing in-channel sand mine; A) along segment 4, and B) along segments 5 and 6.

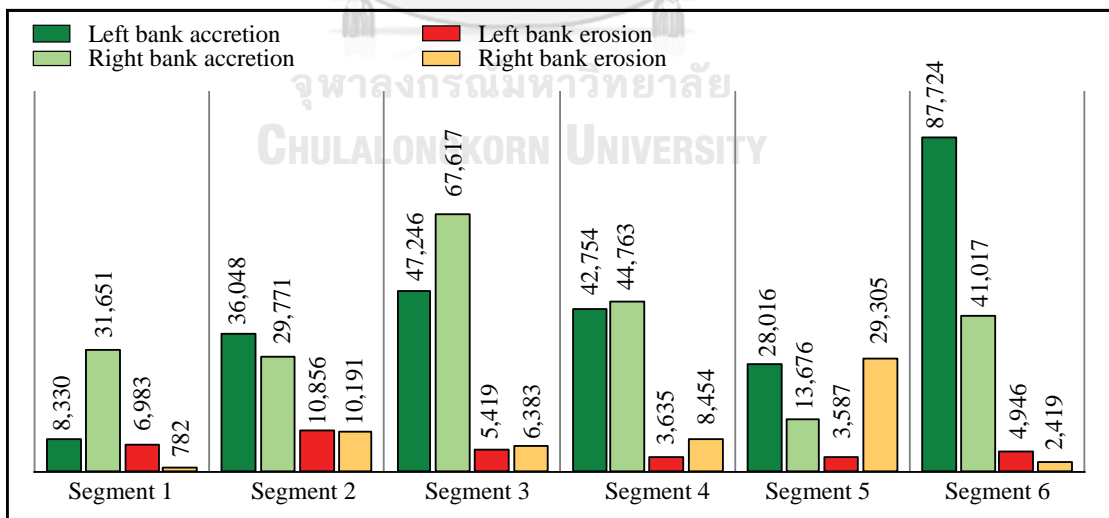
Figure 4.5 Graph of accretion/erosion area per km (m^2/km) for both sides of riverbank of each segment.

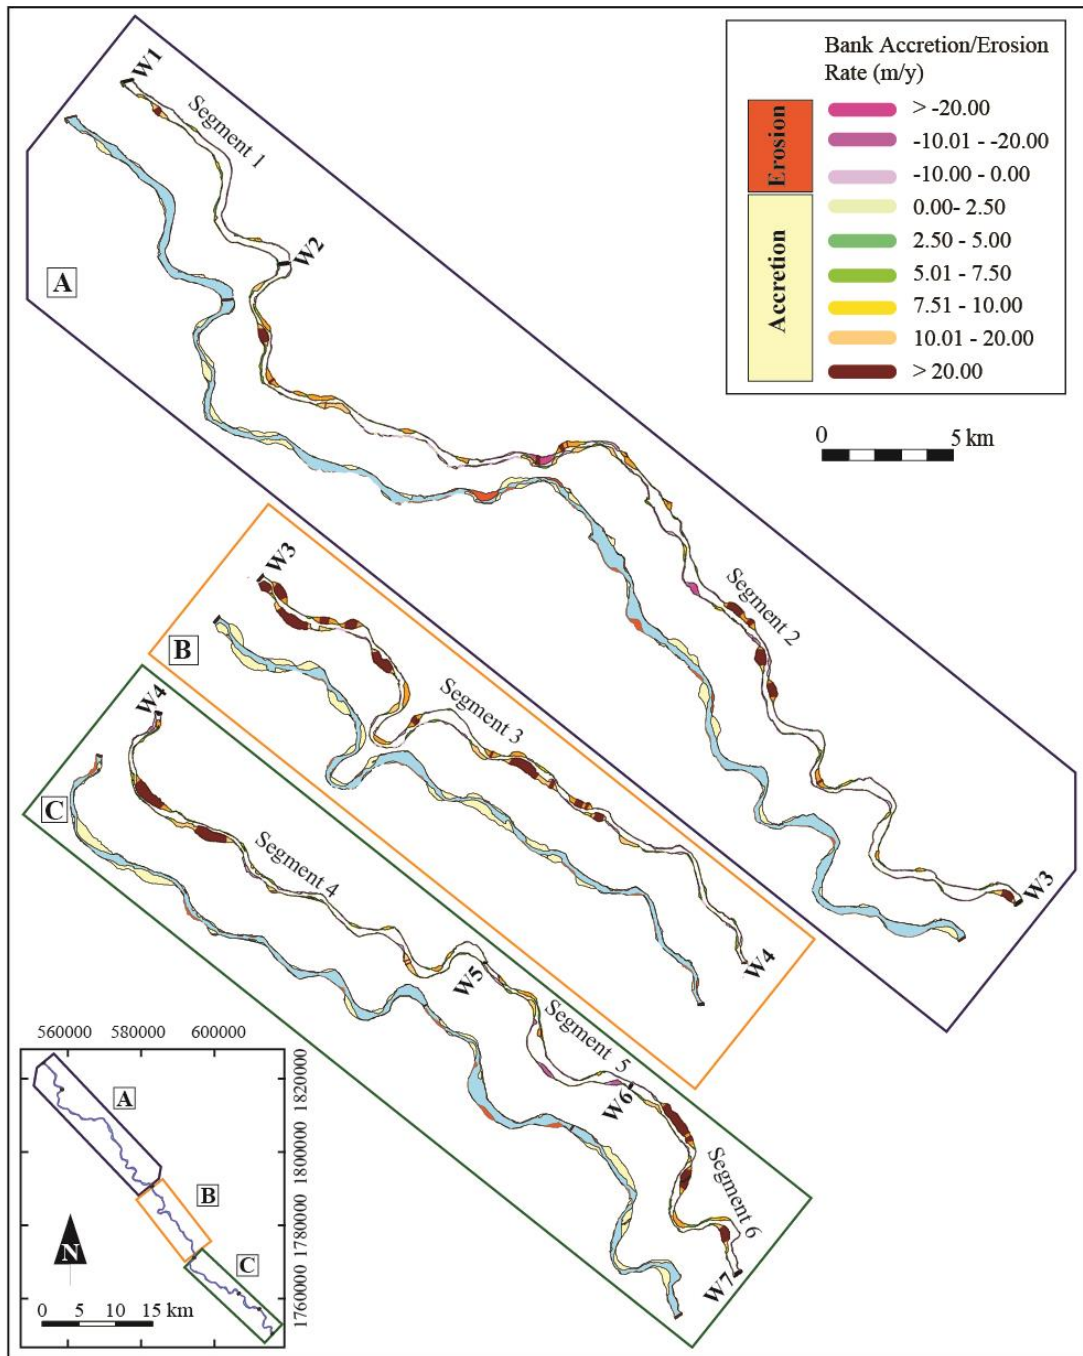
Figure 4.6 Map showing accretion area (yellow) and erosion area (orange) of the riverbank line and the End Point Rate (EPR) of these accretion/erosion areas in m/y.

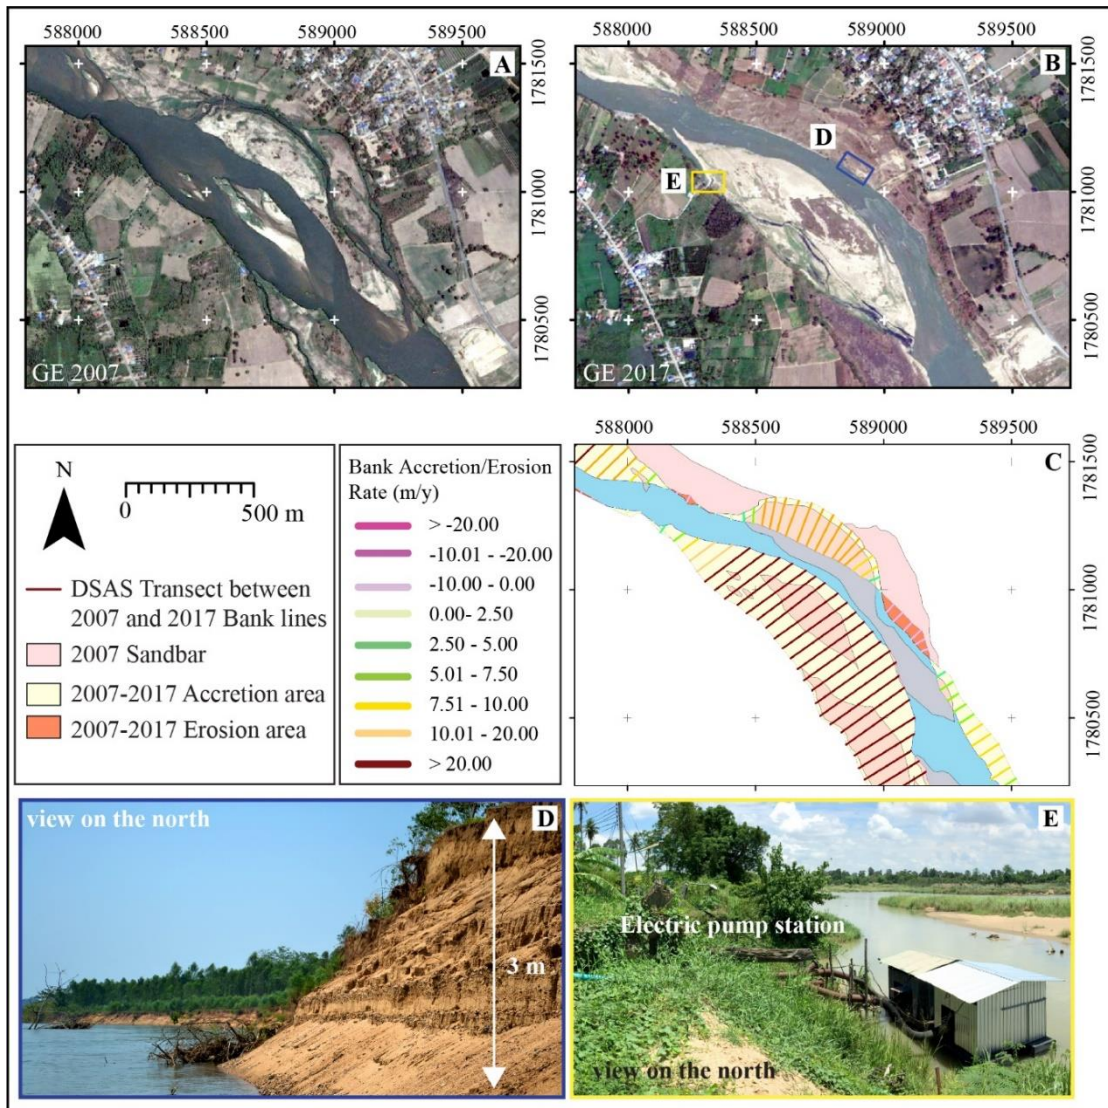
Figure 4.7 A) and B) the GE images showing example of a rapid growth sandbar detected from 2007 and 2017, C) the illustration showing EPR rates of the river riverbank imposed on the accretion/erosion areas, D) the severe riverbank collapse on the opposite side which caused by the rapid growth of sandbar, and E) The shallowing and rapid accretion of riverbank cause problems for pump stations installed along the river reach.

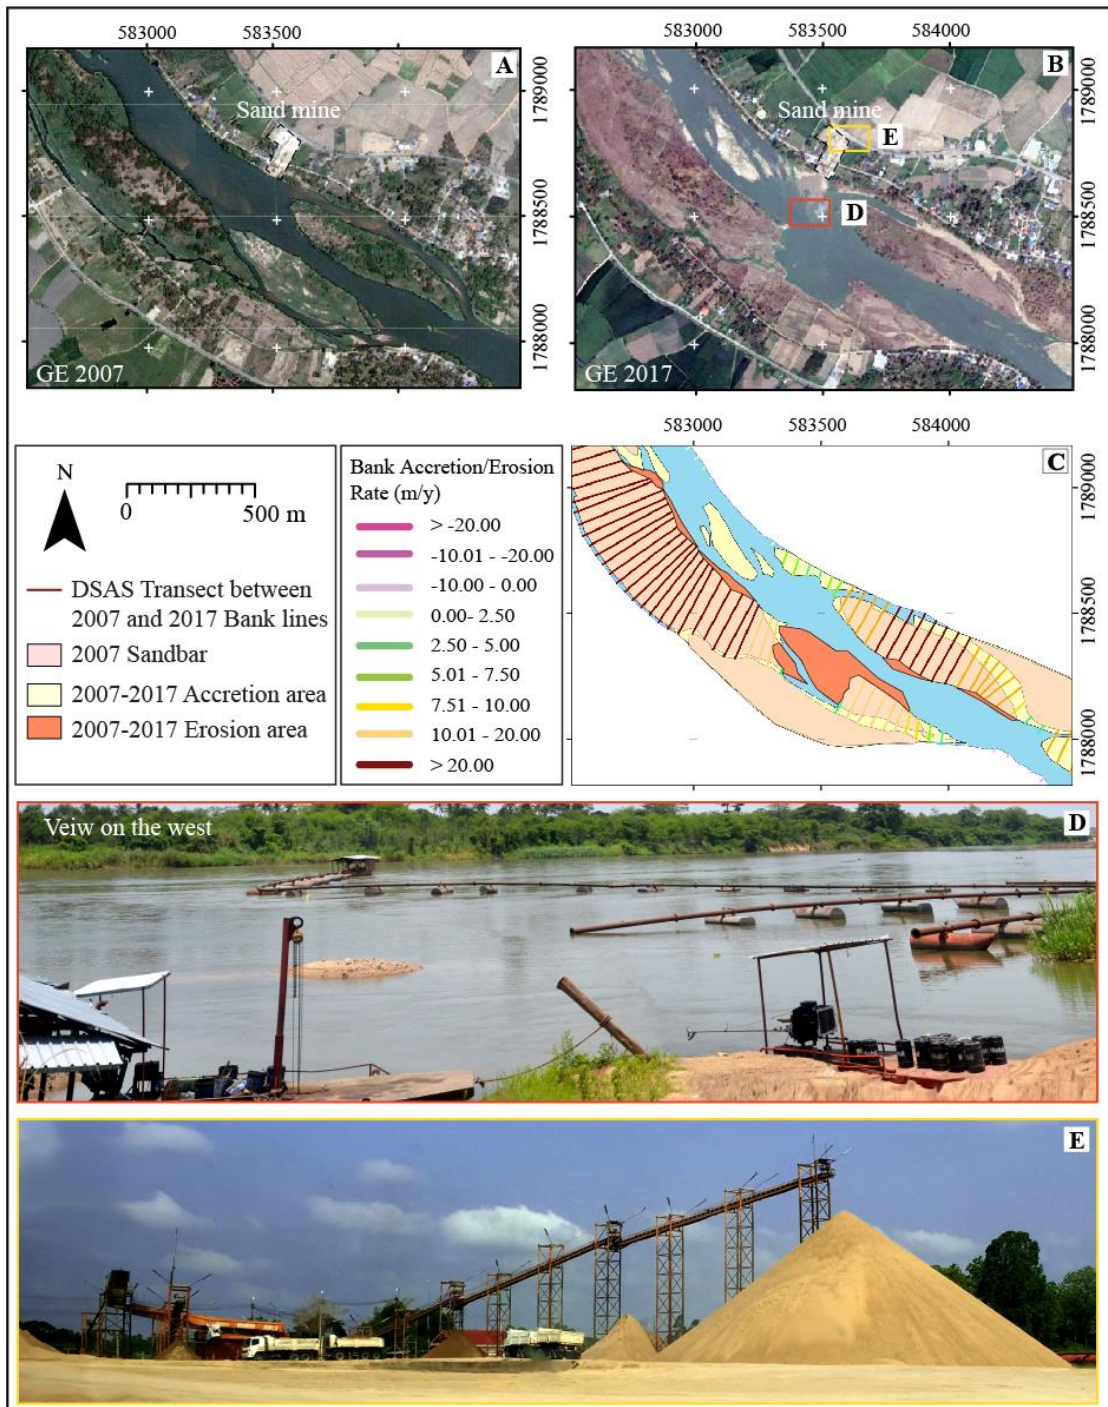
Figure 4.8 Map showing effect of in-channel mining on riverbank erosion; A) and B) comparison of riverbanks and sandbar from GE images in 2007 and 2017, C) the EPR rates of the river riverbank are imposed on the accretion/erosion areas, D) and E) the operation of in-channel sand mining.

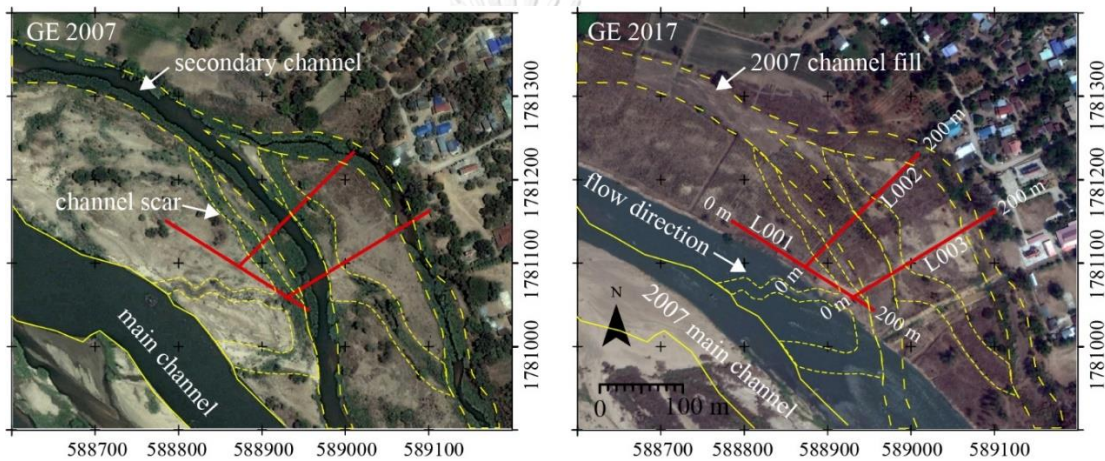
Figure 5.1 Location of GPR and Electrical Resistivity Survey lines, and secondary channels deposited illustrated on 2007 and 2017 Google Earth (GE) images.

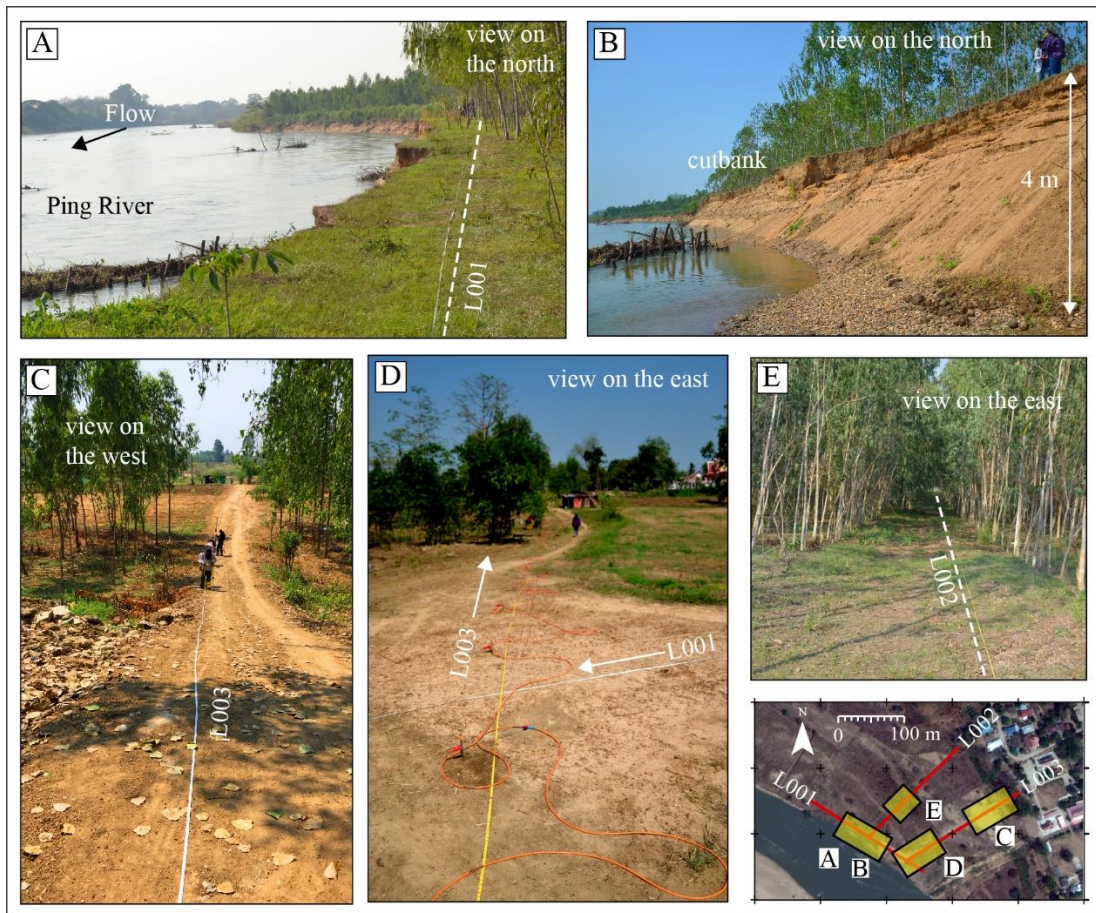
Figure 5.2 A) Photo of L001 survey line along the cut bank, B) 4 m-thick cut bank parallel to L001, C) Photo of L003 survey line perpendicular to the cut bank, D) The intersection between L001 and L003, and E) Photo of L002 survey line perpendicular to the cut bank.

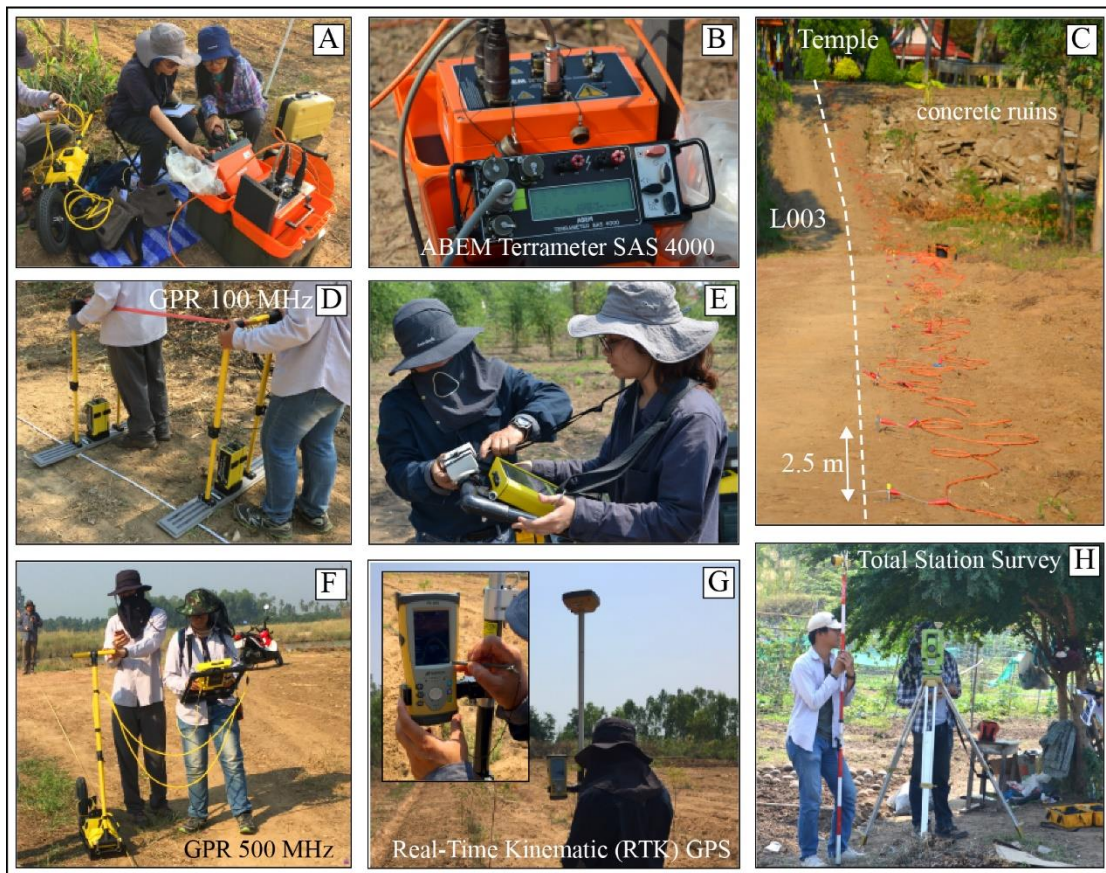
Figure 5.3 Photos of field survey; (A and B) Electric Resistivity survey using ABEM Terrameter SAS 4000, C) Dipole-Dipole array along the L003 survey line, (D, E and F) GPR survey using pulse EKKO PRO instrument, G) Real-Time Kinematic GPS recording positions along the survey lines, and H) Total Station survey.

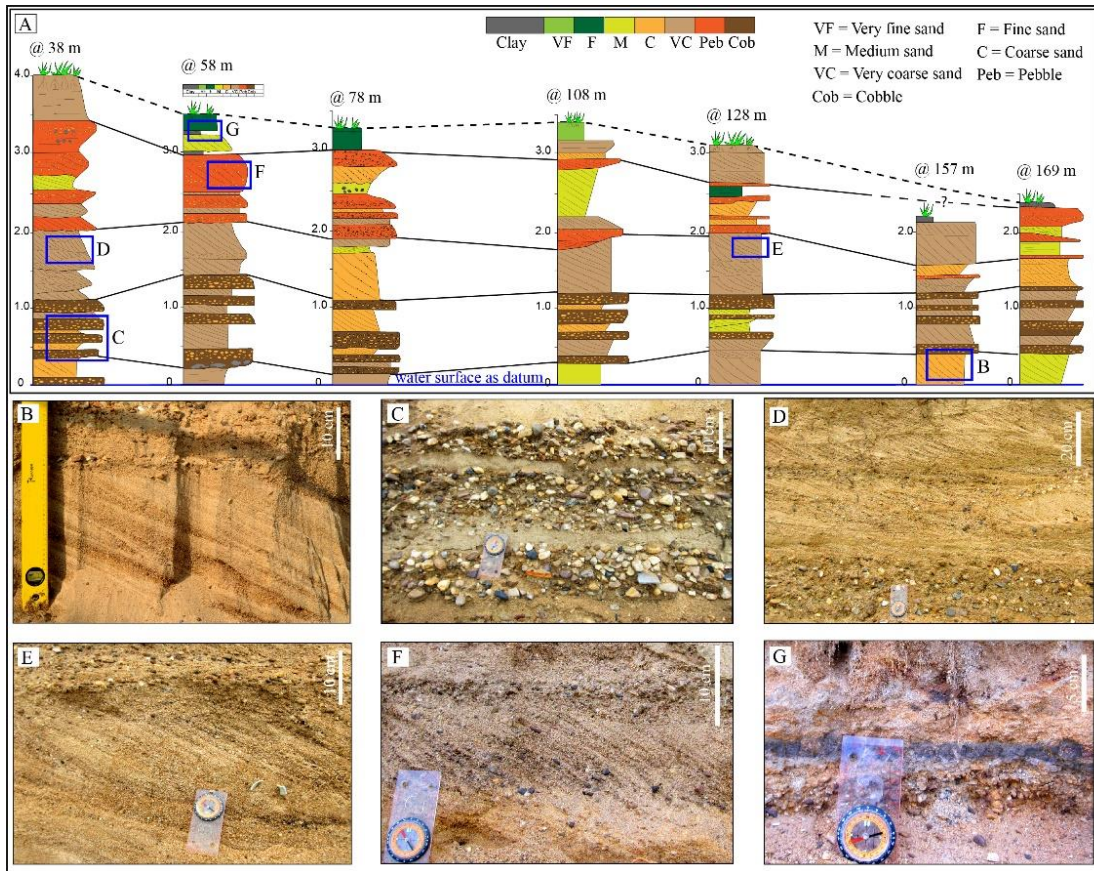
Figure 5.4 Eight sedimentary profiles along the river cut bank cliff and detailed picture of sediment facies of the sandbar deposit

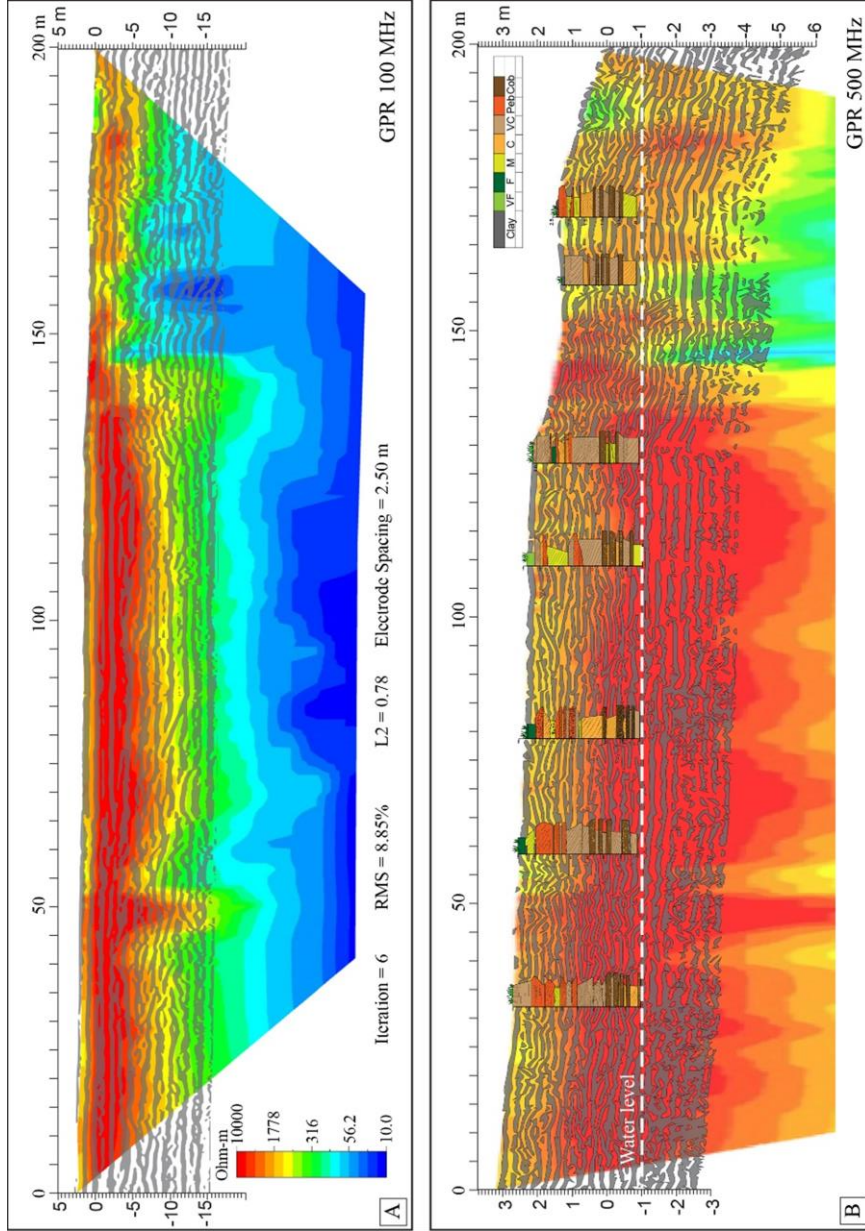
Figure 5.5 Integrated GPR- Electrical Resistivity profile of L001 survey line; A) GPR frequency 100 MHz and B) GPR frequency 500 MHz.

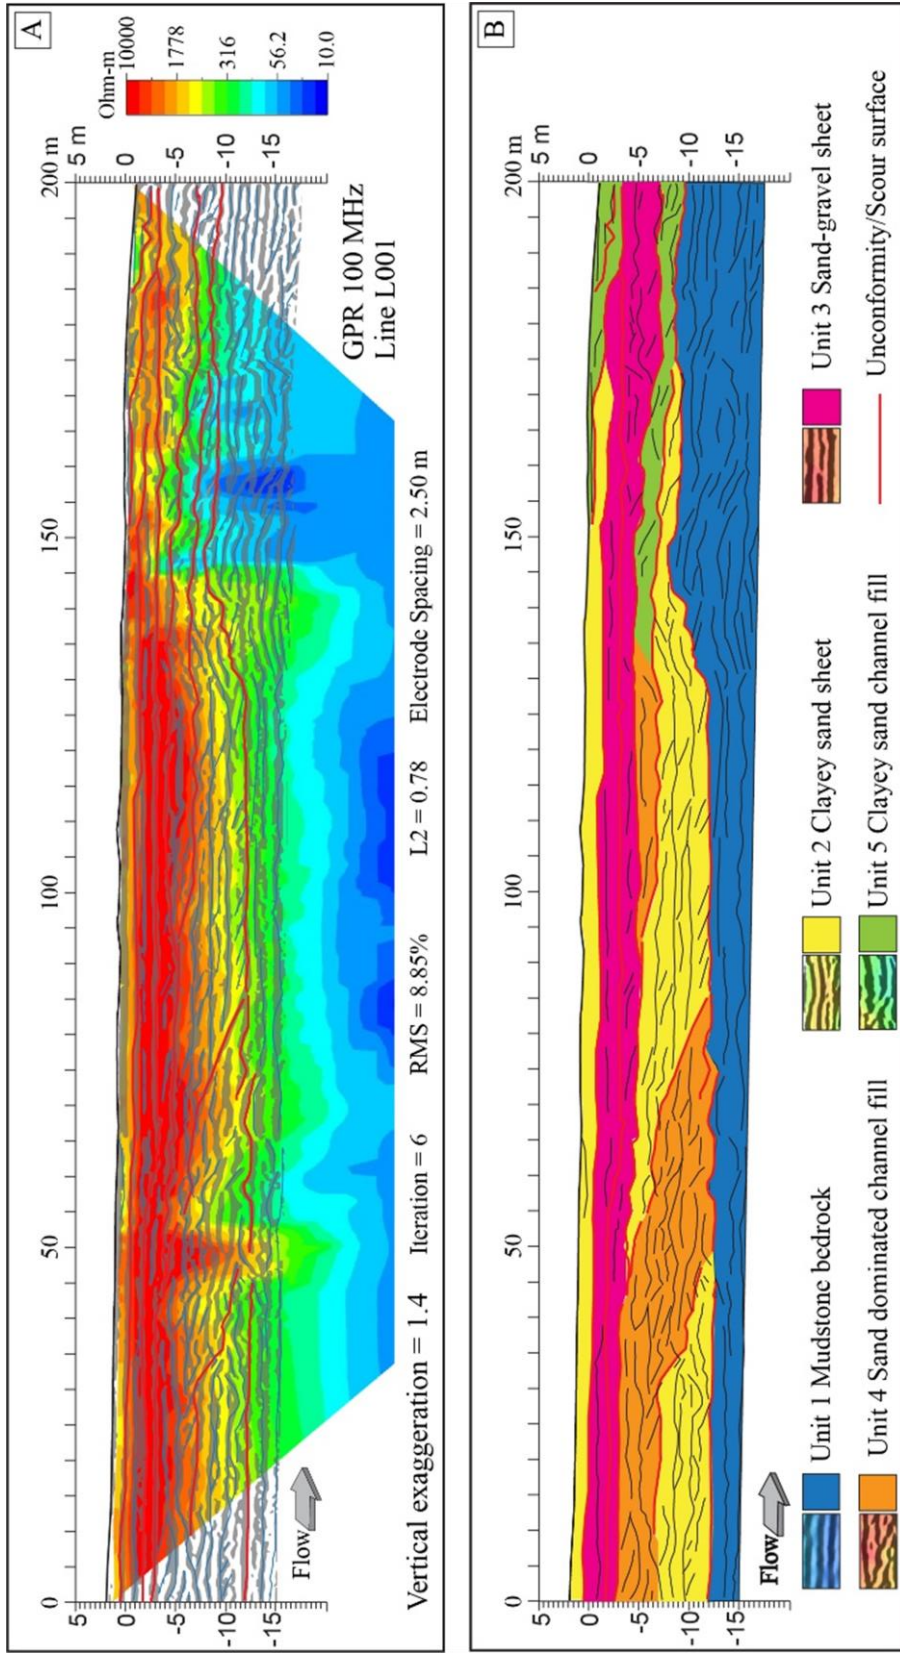
Figure 5.6 Interpretation of sandbar architectural structure from Integrated GPR- Electrical Resistivity profile of L001 survey line; A) IGRS profile of GPR frequency 100 MHz and B) Interpreted sandbar architectural structure and sediment units.

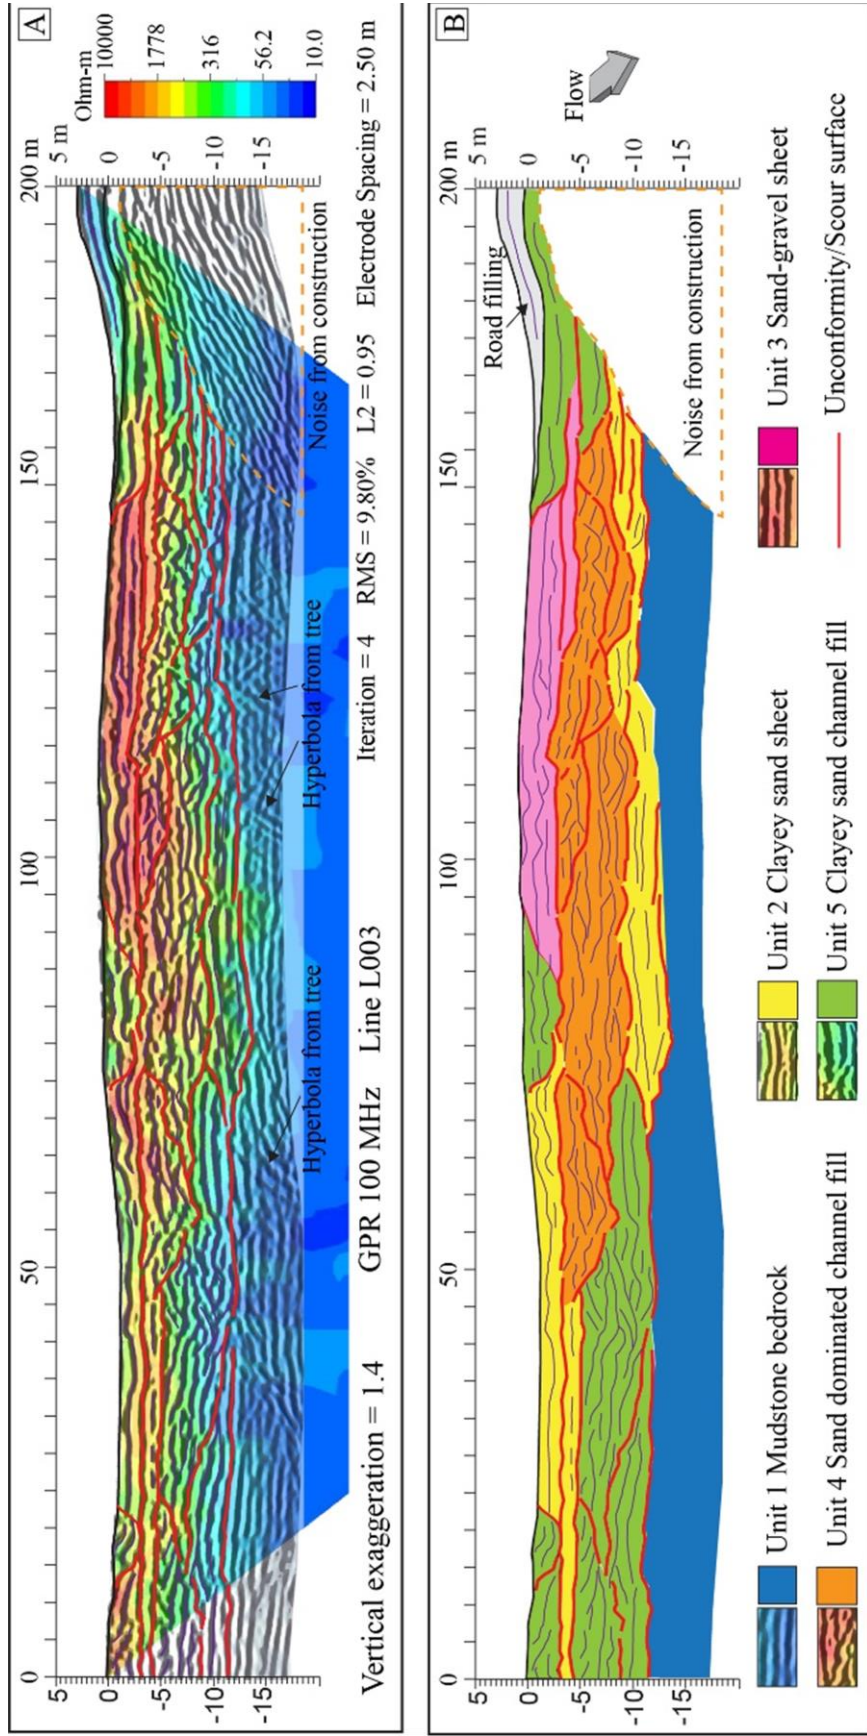
Figure 5.7 Interpretation of sandbar architectural structure from Integrated GPR - Electrical Resistivity profile of L003 survey line; A) IGRS profile of GPR frequency 100 MHz and B) Interpreted sandbar architectural structure and sediment units.
