INFLUENCES OF GEOLOGIC CONDITIONS AND
ANTHROPOGENIC ACTIVITIES ON CHANGES
OF GEOMORPHOLOGY AND SEDIMENT LOAD
CHARACTERISTICS OF THE PING
AND CHAO PHRAYA RIVERS

A Dissertation Submitted in Partial Fulfillment of the Requirements
for the Degree of Doctor of Philosophy in Geology
Department of Geology
Faculty of Science
Chulalongkorn University
Academic Year 2018
Copyright of Chulalongkorn University

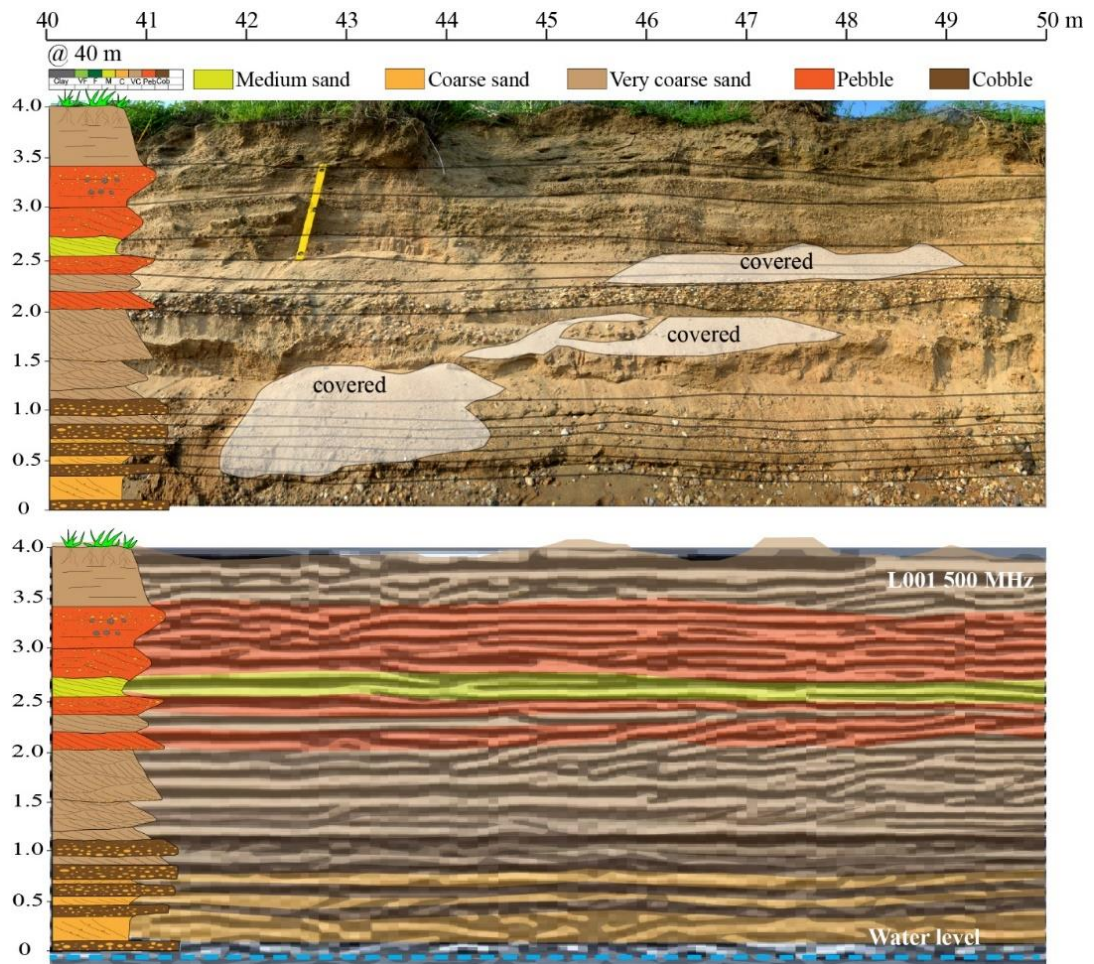
Figure 5.8 Comparing GPR profile of L001 survey line with outcrop photo panel at 40-50 m of the survey line.

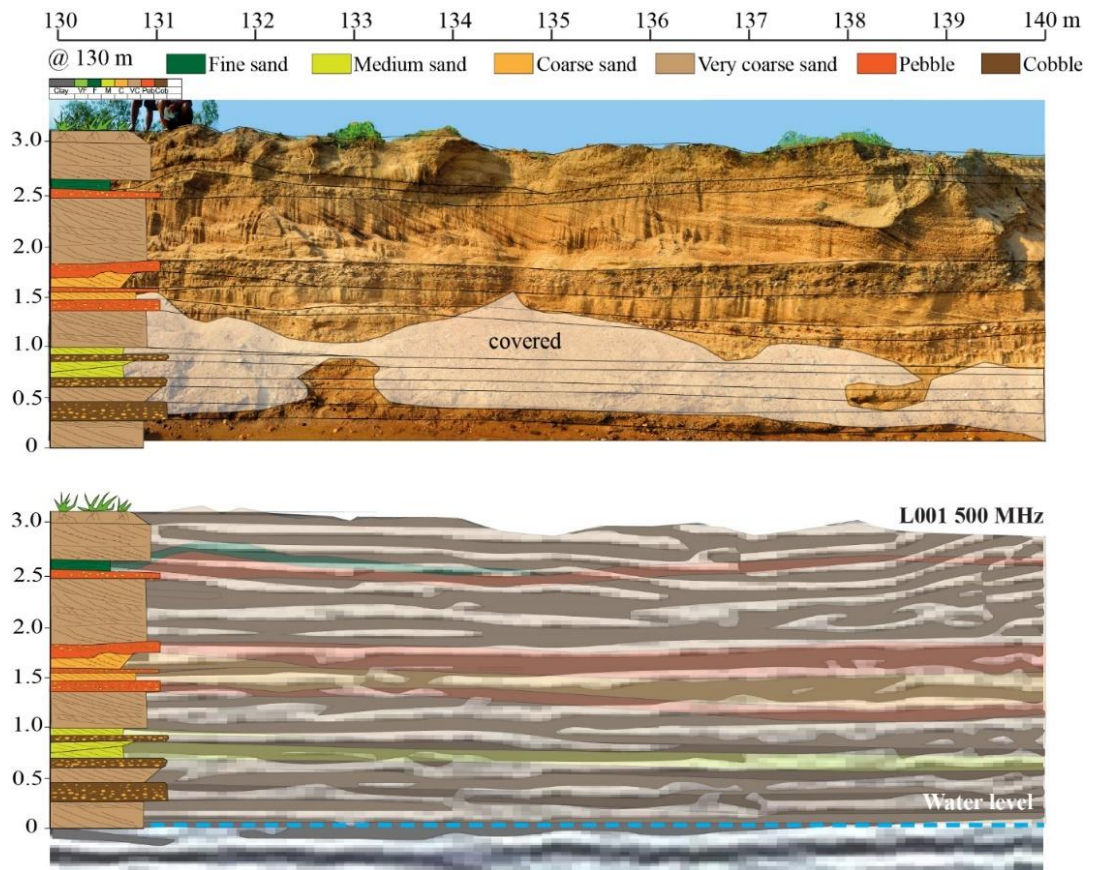
Figure 5.9 Comparing GPR profile of L001 survey line with outcrop photo panel at 130-140 m of the survey line.

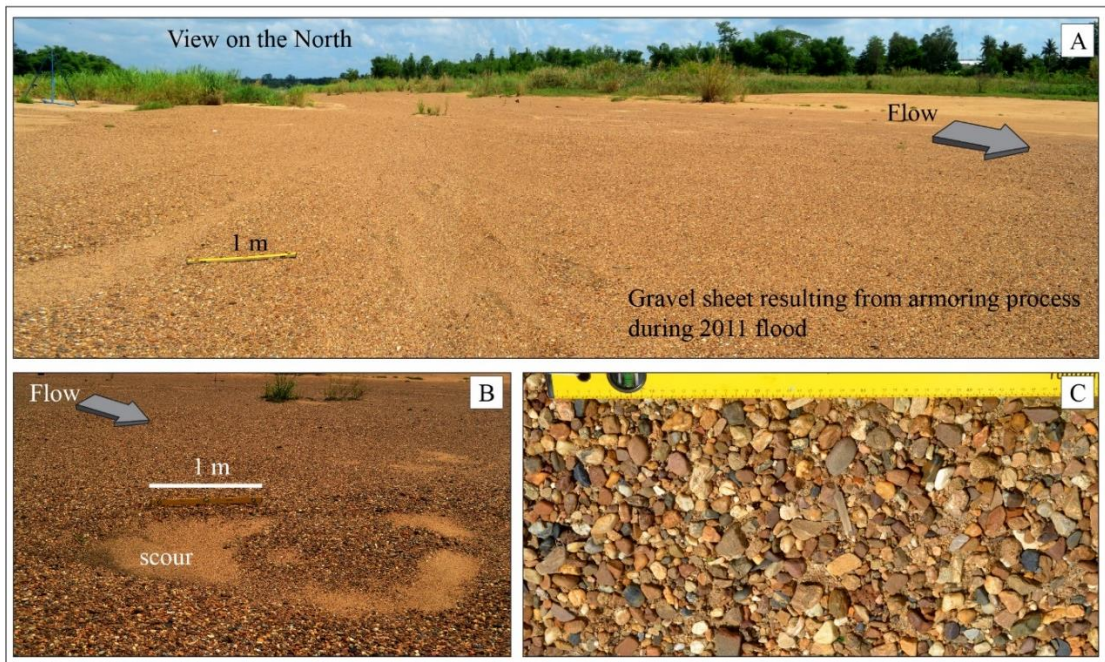
Figure 5.10 A) Gravel sheet on sandbar located 8 km north of the study site, B) and C) These gravels are product of armoring process active under the 2011 flood flow conditions

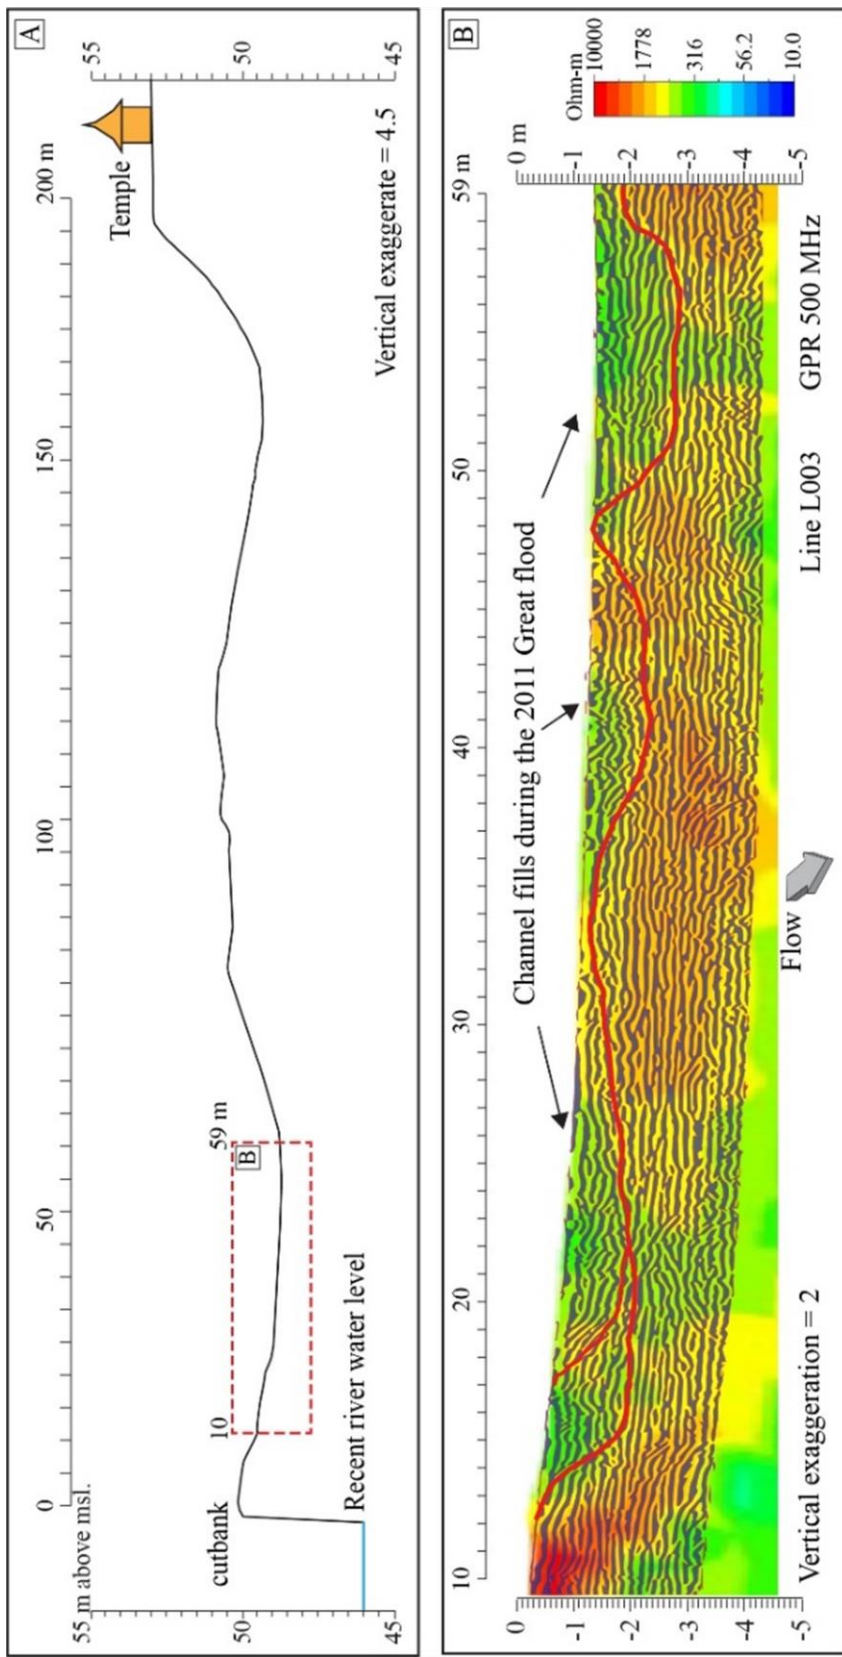
Figure 5.11 A) Cross-sectional profile along the L003 line and B) the IGRS profile of the GPR 500 MHz and interpreted channel fills deposited during the 2011 Great flood.

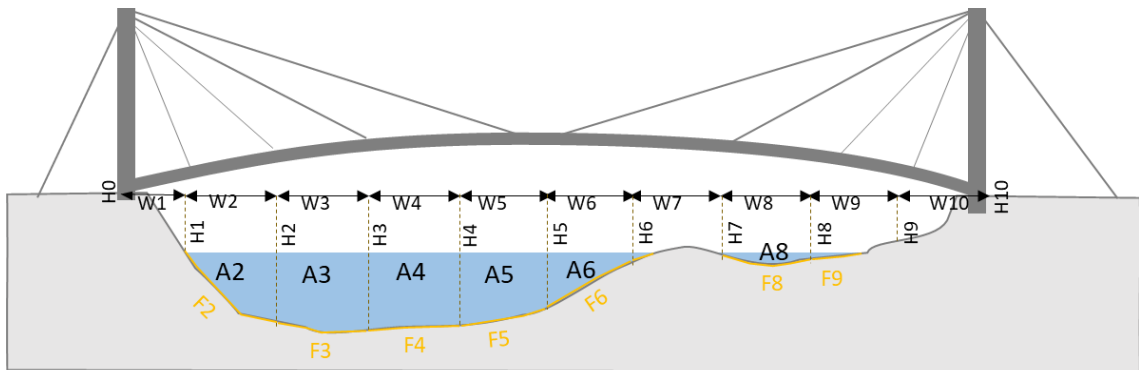
SEDIMENT LOAD TRANSPORT RATE CALCULATION

S; Suspension (g/L) – measured in the field
