Photographs illustrating the locations of collected rock samples for geotechnical laboratorial studies and technique of point load testing in the Rock Mechanics Laboratory, Geological Engineering, Suranaree University of Technology

Photographs illustrating laboratorial instruments and technique in soil-geotechnical testing in the Rock Mechanics Laboratory, Geological Engineering, Suranaree University of Technology

On 11 August 2001 (8/11) at 3:30 a.m., a disastrous debris flow and associated debris flood (debris flow-flood) severely damaged Nam Ko Yai village on the alluvial fan just below the canyon mouth of the Nam Ko Yai stream (Fig. 1), a major tributary of Pa Sak river in Lom Sak district, Phetchabun province, central Thailand. The flood water, full of debris and fallen trees, destroyed several houses on the stream banks and claimed 136 lives with over 5 million US dollars in property damage. This is one of many severe tragedies caused by the debris flow-flood in Thailand in the past few decades.

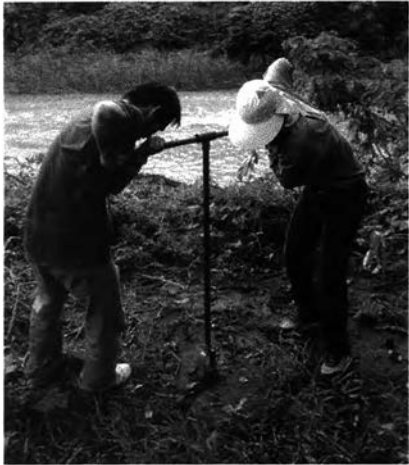
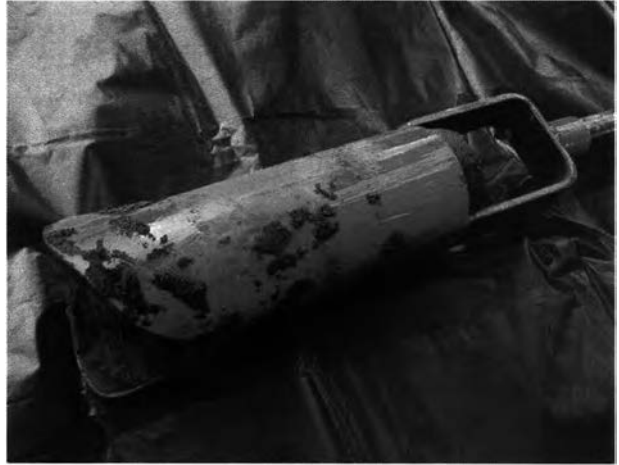
Appendix A-1 Location A-1

Photographs illustrating seventeen locations of the rock and soil samples collected for geotechnical study (sample locations referred to Figure 5-1)

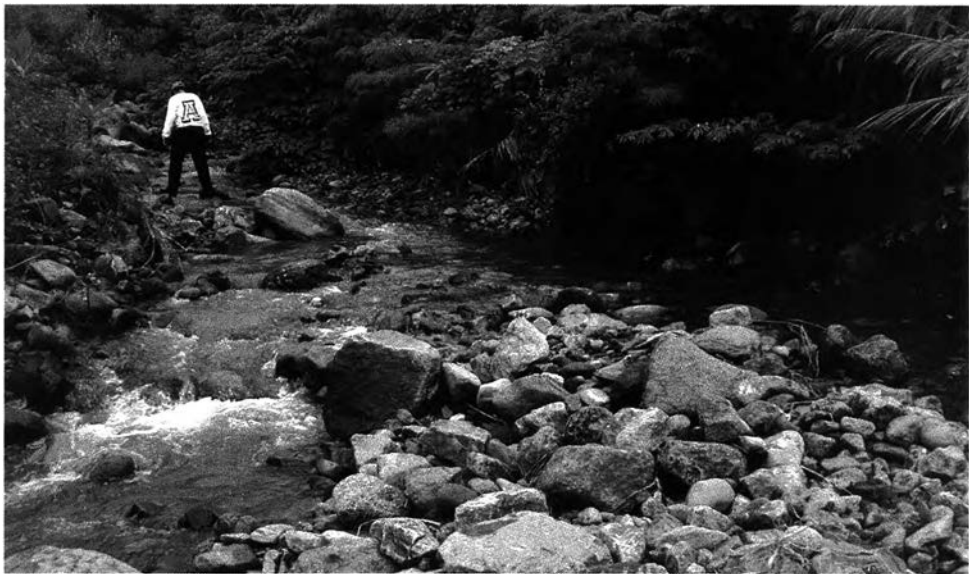
Appendix B-1 Field location along a stream (location B-2 as shown in Figure 5-1) from where rock specimens were collected for point load testing

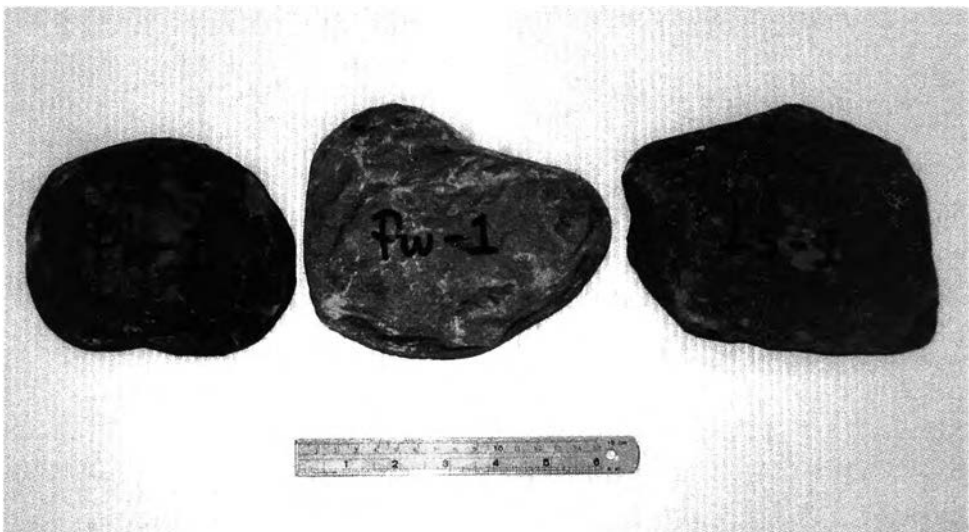
Appendix B-2 The representative three rock-sample types of Phra Wihan sandstone/siltstone (lithologic unit Pw), Phu Kradung sandstone (lithologic unit Pk), and Lom Sak volcanic complex (lithologic unit Ls) respectively, that used in the point load testing

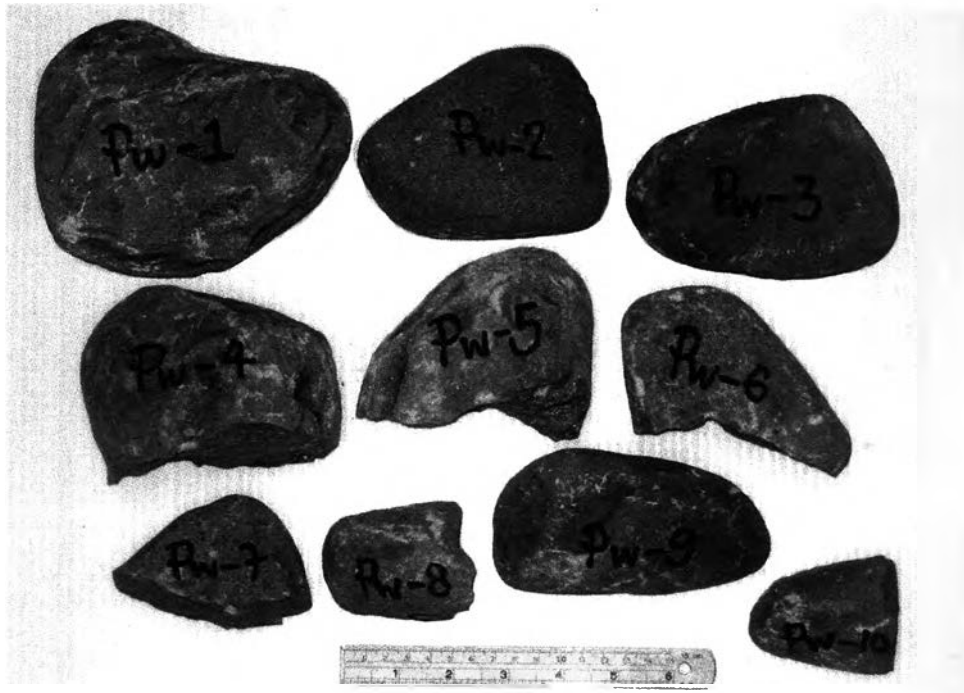
Appendix B-5 Characteristics of ten rock specimens of Phra Wihan sandstone/siltstone (lithologic unit Pw) before point load testing

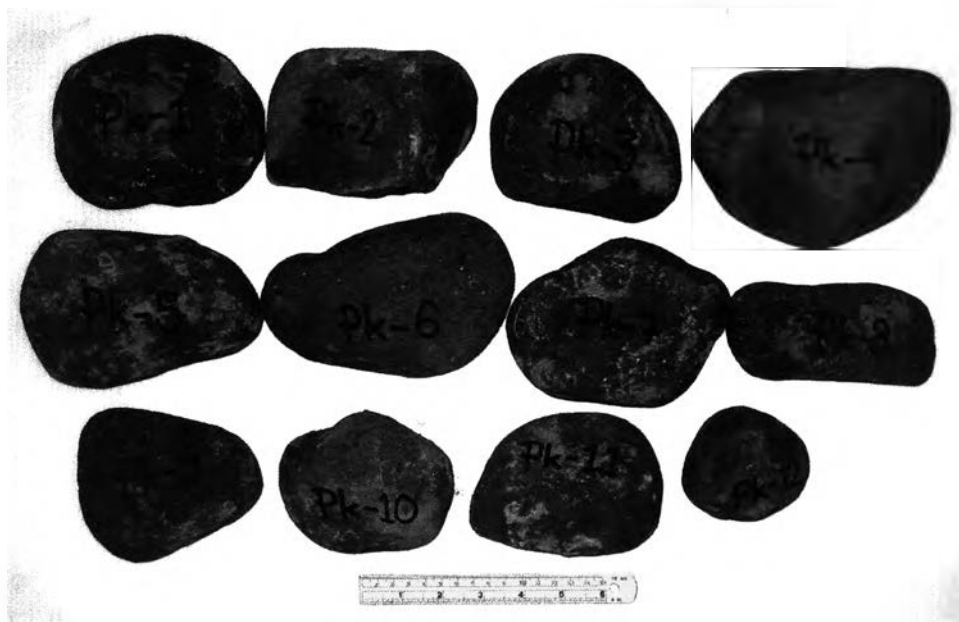
Appendix B-7 Characteristics of twelve rock specimens of Phu Kradung sandstone/siltstone (lithologic unit Pk) before point load testing

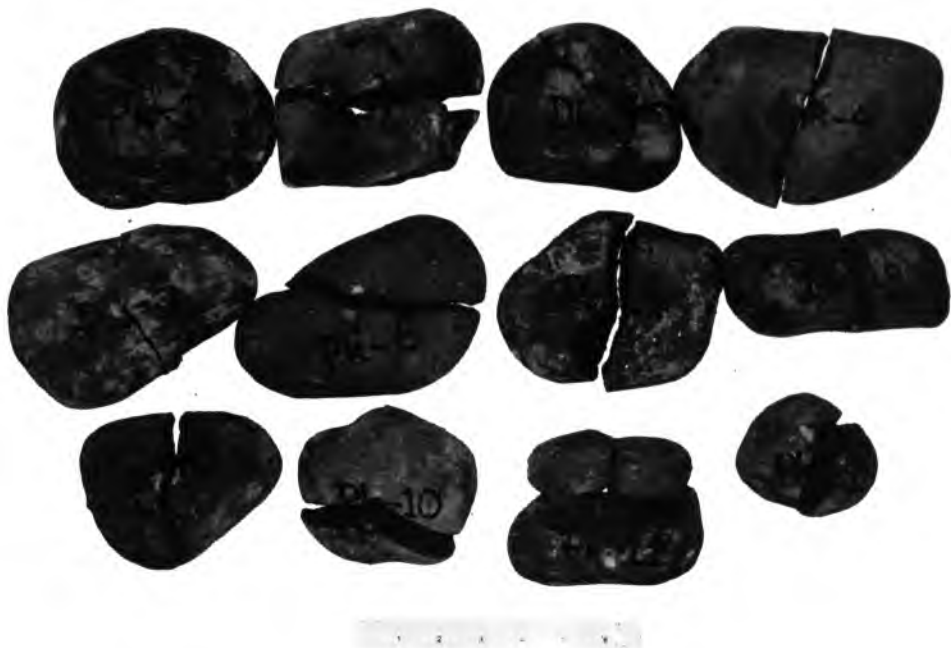
Appendix B-8 Characteristics of twelve rock specimens of Phu Kradung sandstone/siltstone (lithologic unit Pk) after point load testing

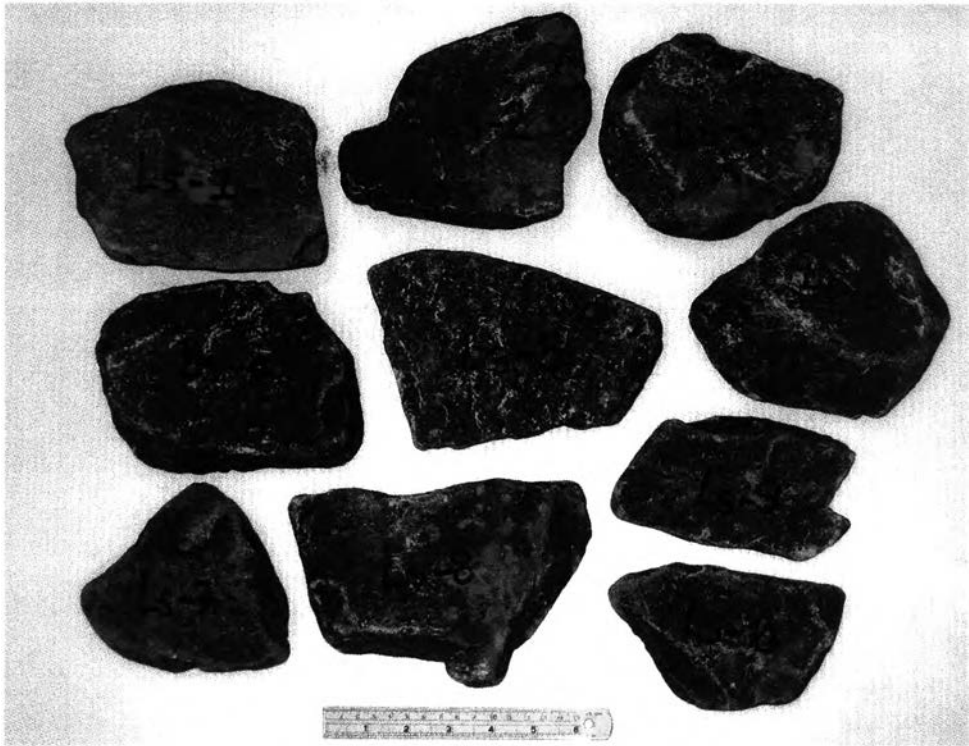
Appendix B-9 Characteristics of ten rock specimens of Lom Sak volcanic complex (lithologic unit Ls) before point load testing

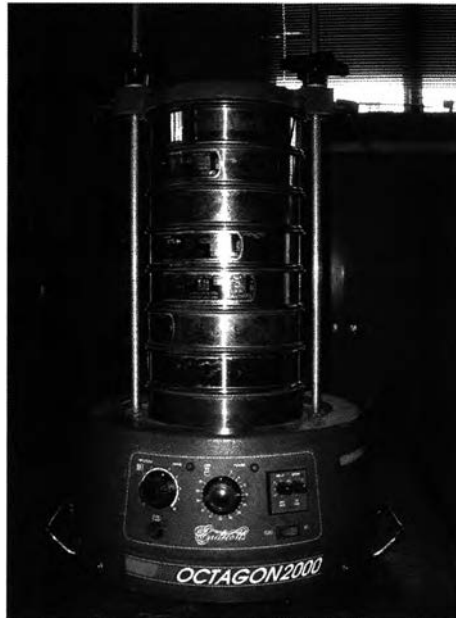
Appendix C-1 Sieve Analysis used for grain size distribution

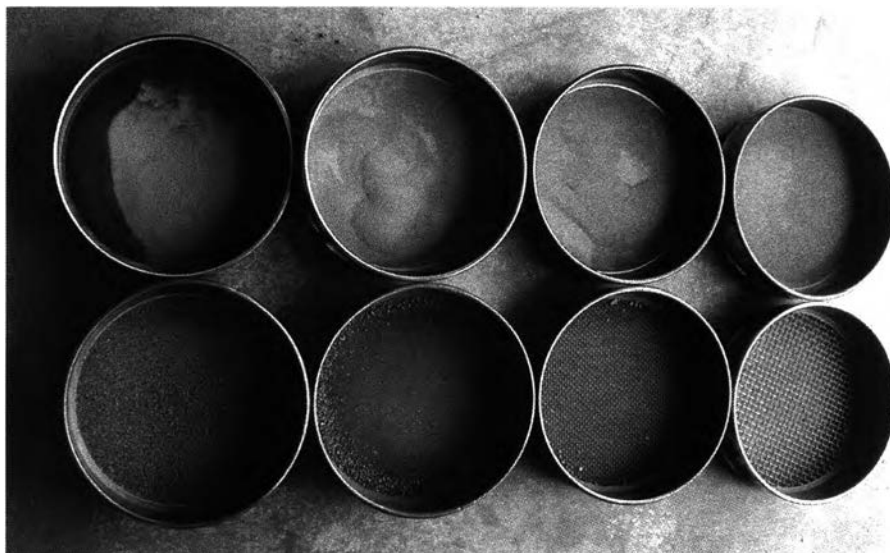
Appendix C-2 Retained soils from each sieve class

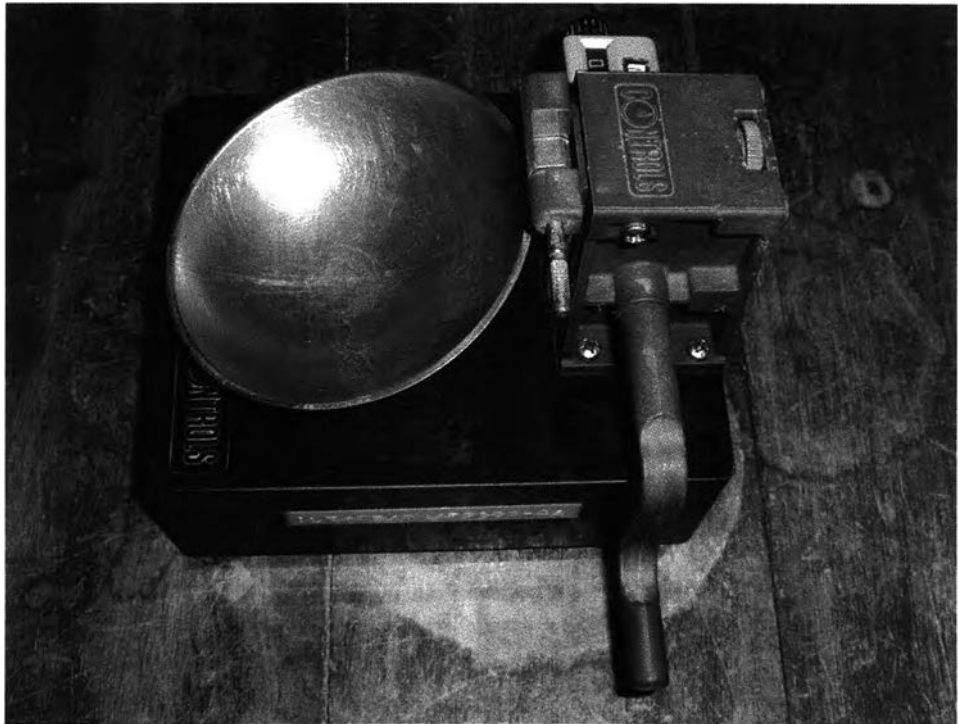
Appendix C-4 Copper bowl apparatus for liquid limit of soil samples

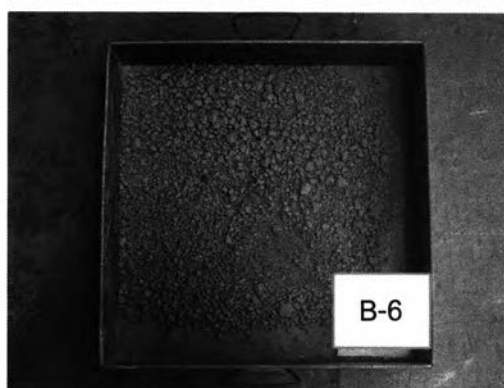
Appendix C-5 Dried and crushed soil samples (number A-1, B-2, B-3, B-6, B-7 and B-10) used for soil-geotechnical testing

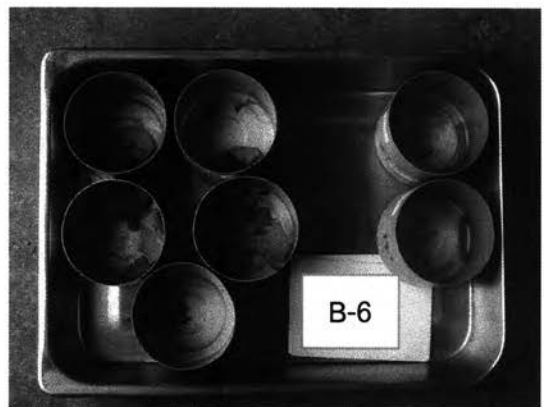
Appendix C-6 Oven-dried soil samples (number A-1, B-2, B-3, B-6, B-7 and B-10) used for Plastic Limit ( $w_p$ ) and Liquid Limit ( $w_L$ ) testing

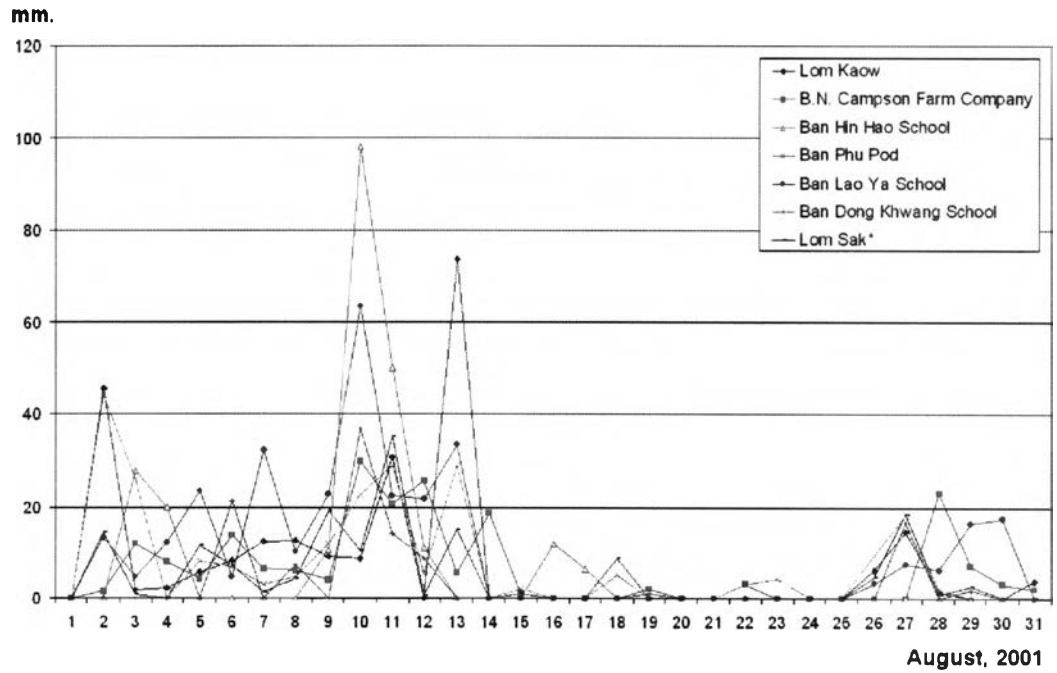
Fig. 12 The graph showing the pattern distribution of rainfall measurements in August 2001 recorded from the seven locations (Fig. 10) near the study area

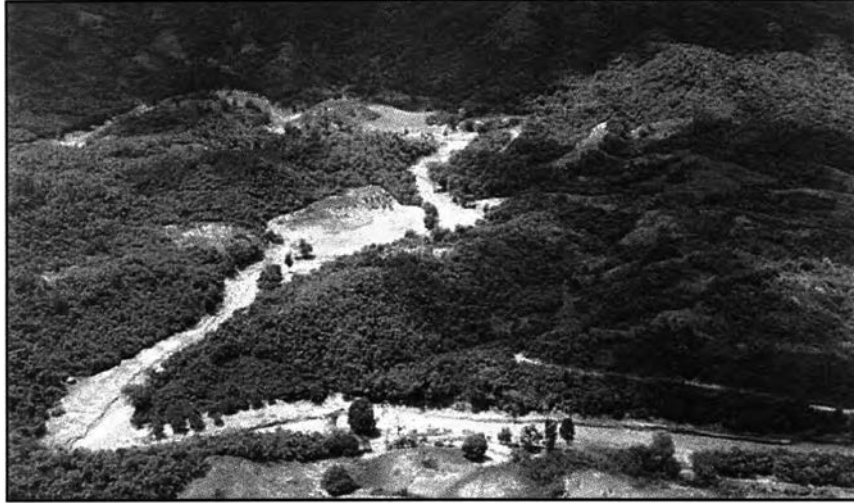
Fig. 14 The oblique aerial photograph (taken on 22 August 2001, 11 days after the event) along the channel of Nam Ko Yai stream with the high sinuosity characteristic illustrating the debris flow-flood track along plant debris and soils had been strongly eroded and transported from its banks before reaching the canyon mouth outlet of the stream
