CHAPTER IV

IMPLEMENTATION AND RESULTS

4.4 Example Case (After Implementation)

Roof Drip Water Strip Problem

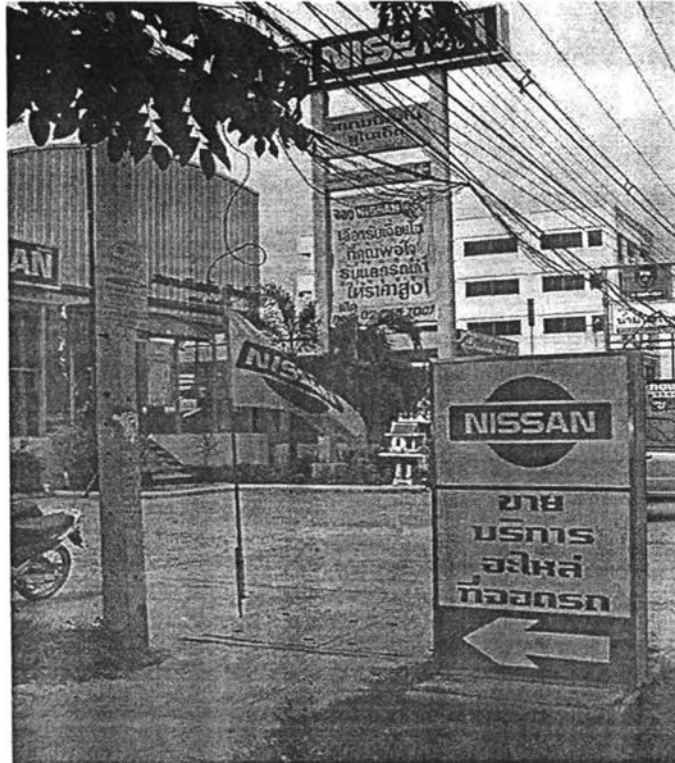
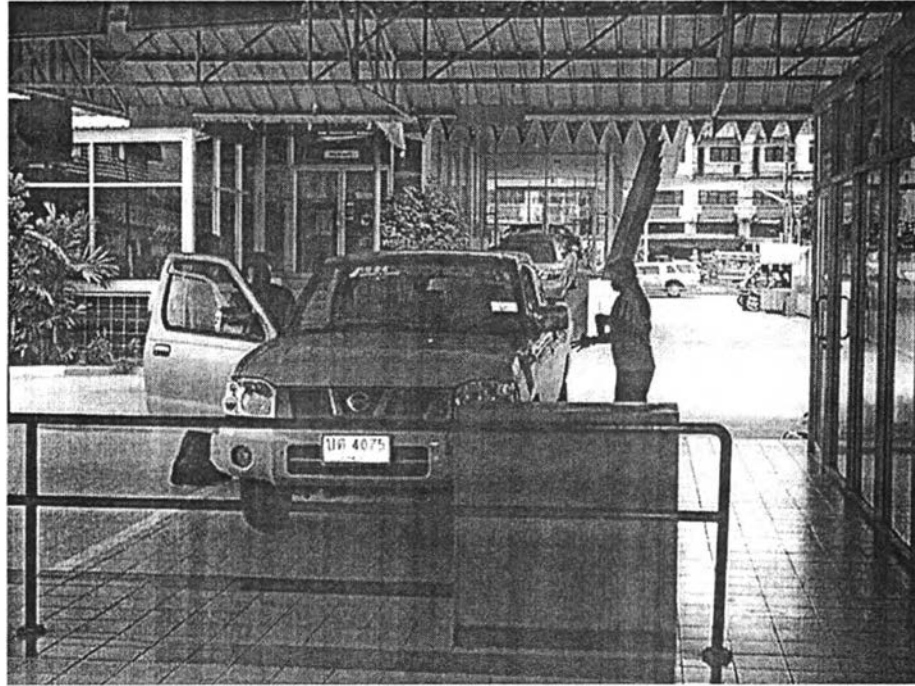
Figure 4.1: Customer Complaint

The Customer came to dealer and claim about tear of the roof rubber. He used the car for two months and found that the rubber was destroyed. Therefore the customer wants to change the new roof rubber. Reception records the customer objective and he basically investigate the condition of the rubber that the customer complained.

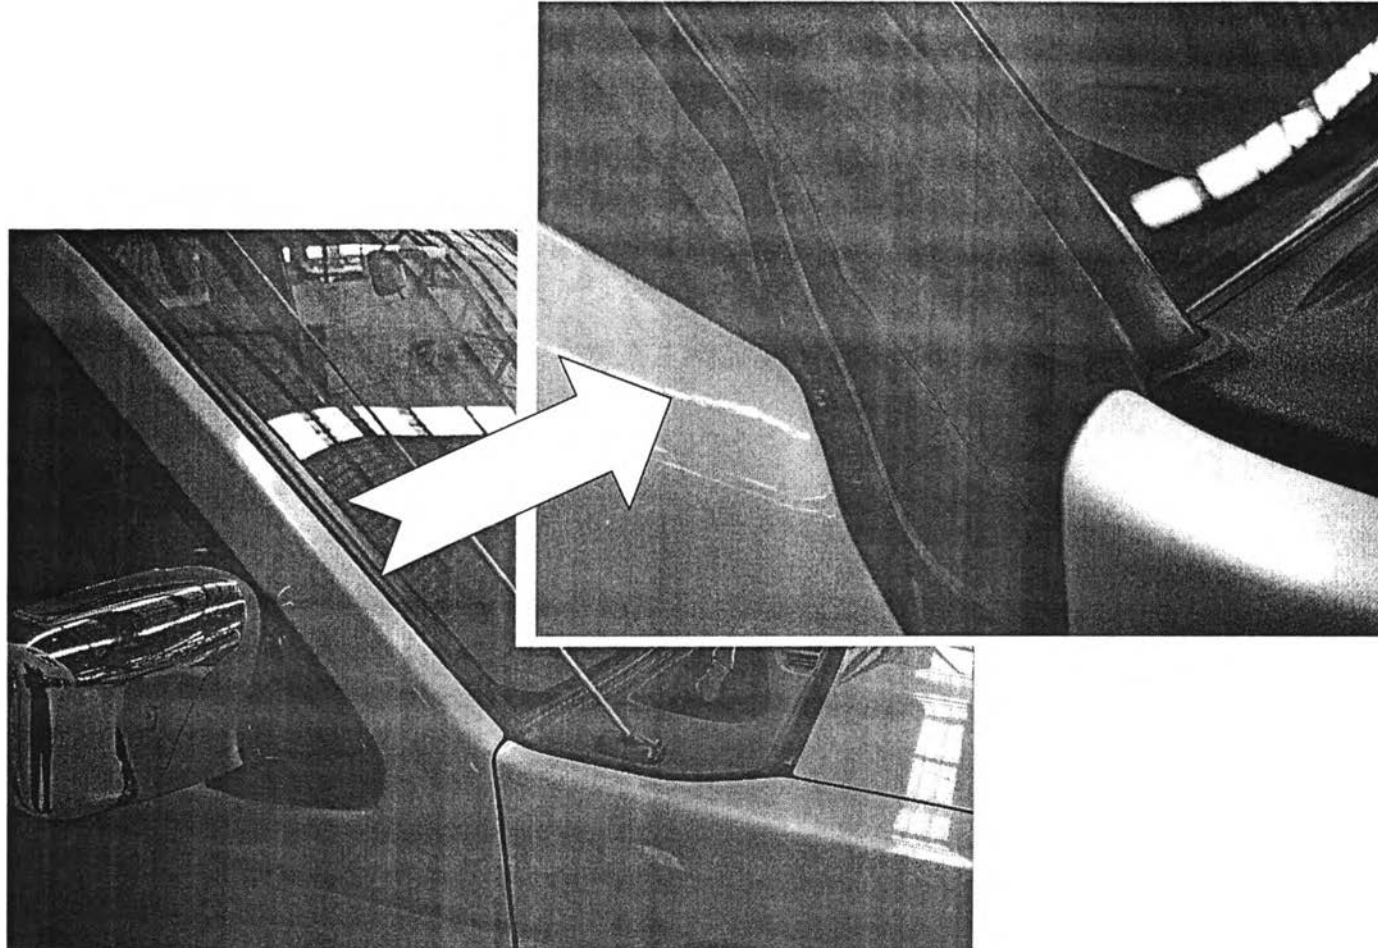
Figure 4.2: Basically Inspection

The technician performed basically inspection. He analyzed that this occurred from the alignment of the door.

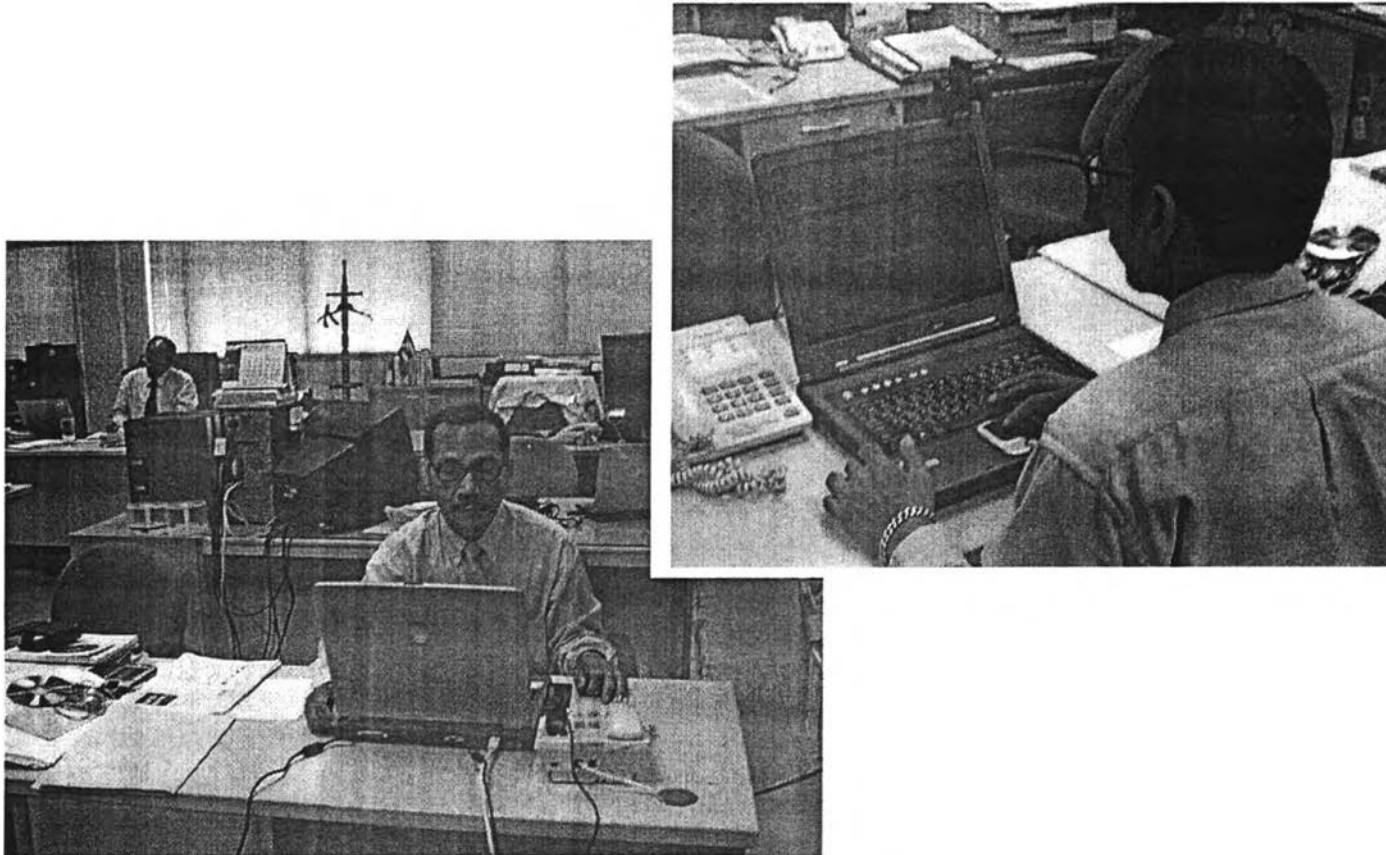
Figure 4.4: Expert was received the technical report

In a couple of minutes, expert got technical report, which attaching with the picture of the incident. The report is not clearly to identify cause of problem so he asks technician to unassembled the rubber and connect the web-cam to see more of it.

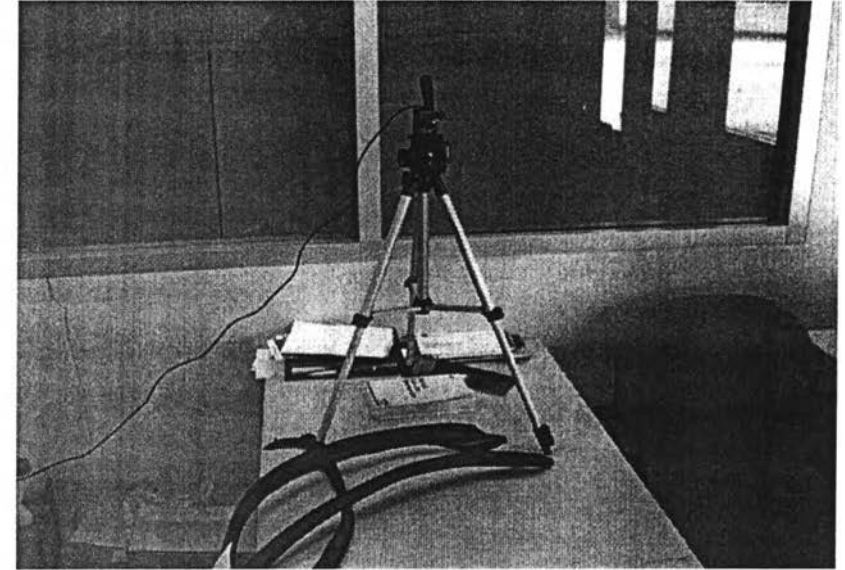
Figure 4.6: Web Camera setting

Technician received the call of expert, so he set up the camera, which focuses on the roof rubber part

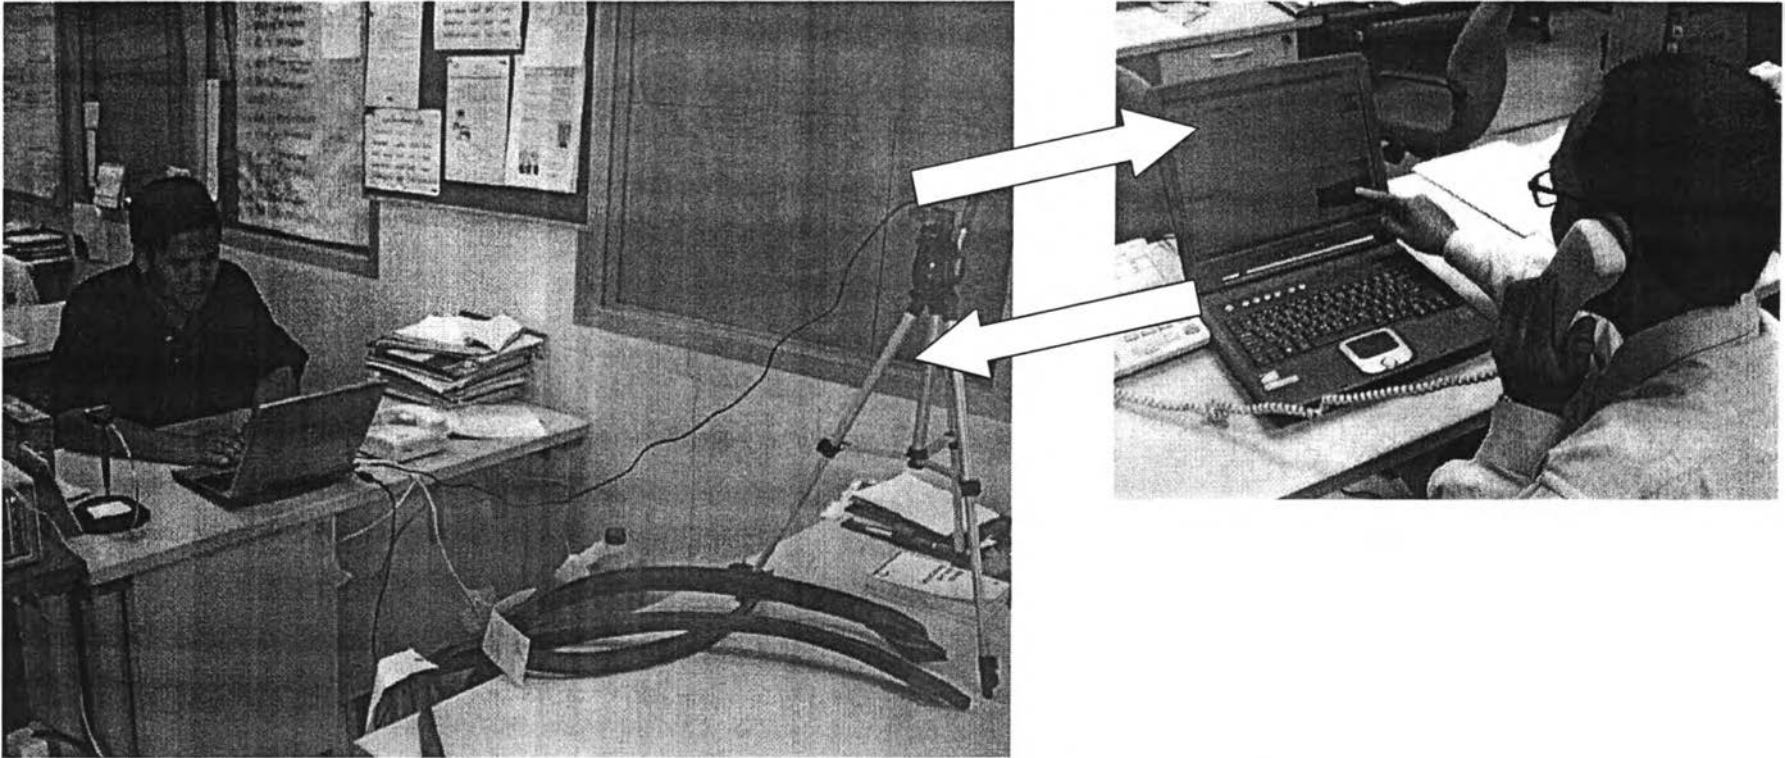
Figure 4.7: Expert analyses the condition of the rubber

After expert see the web cam picture, which was focused the entire angle he want, so he clearly see the position of the tear so he give the approval to technician. And recommend for position point to correct the problem.

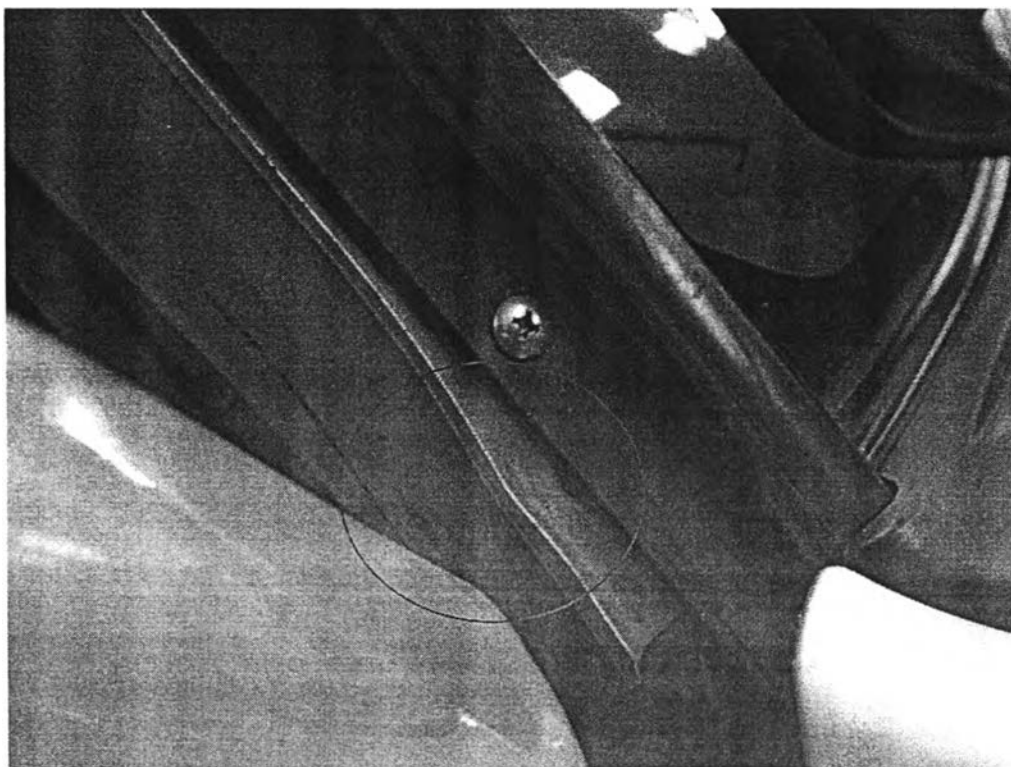
Figure 4.8: Door is not alignment
(additional Picture)

The cause of problem is the alignment of the door. It is not the mistake of the roof rubber producer but manufacturing.
