CHAPTER 4

EXPERIMENTAL INVESTIGATION

4.1 Full-Scale Testing

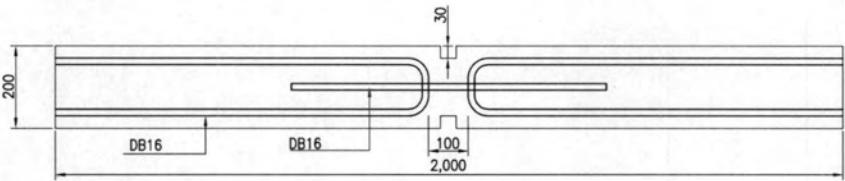
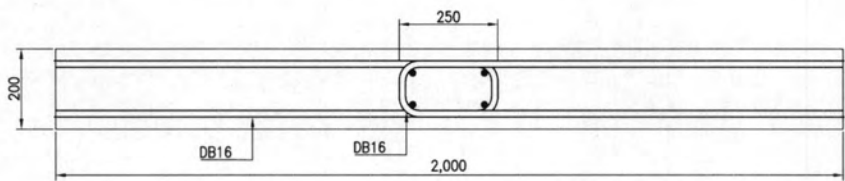
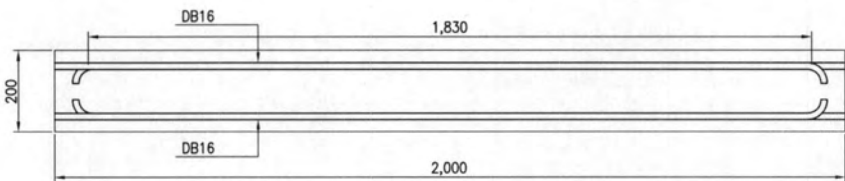
Table 4.1 Test program

<p style="text-align: center;">Hinged</p>
LS_S

<p style="text-align: center;">Semi-continuous</p>
LS_F

<p style="text-align: center;">Fully continuous</p>

Only the mid-span loading was simulated and the length of the lap reinforcement was the key parameter in the test. Three link slab specimens, with a thickness of 200 mm, span length of 2000 mm and width of 1000 mm were tested as shown in test program (Table 4.1). The characteristic compressive strength of concrete was 300 kg/cm^2 and the yield strength of reinforcing steel was 4000 kg/cm^2 . Table 4.2 shows actual dimensions of test specimens with their corresponding concrete and reinforcement steel strength.

For the LS_S slab, it acts as a continuous slab until the flexural shear crack occurs because the positive moment cannot be fully developed due to the insufficient double lap reinforcement. The weak section is at the location of lap reinforcement, the failure cracking plane is then close to the loading pad and lap reinforcement. In the LS_F slab, the positive moment can be fully developed due to double reinforcement at

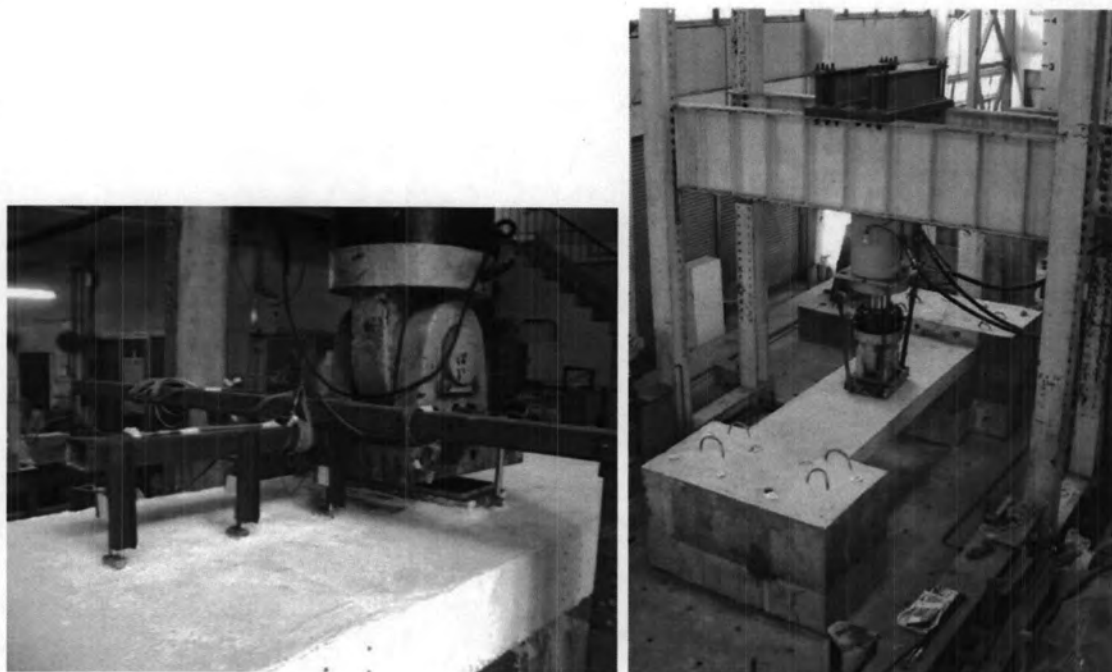
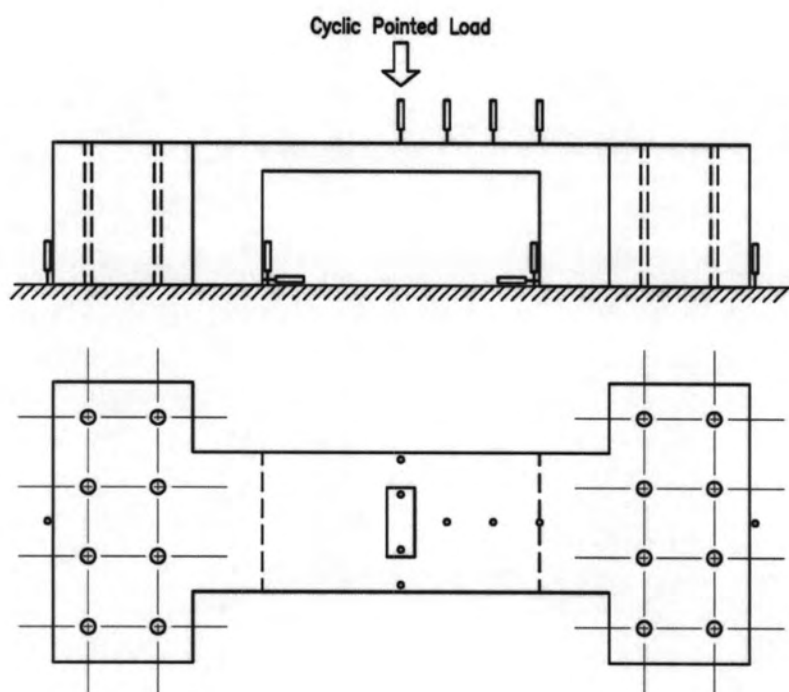
Fig. 4.1 Test set-up

(a) Loading arrangement

(b) LVDT position

The quantities that were measured in the test included strain in reinforcement, deflections, support movement, crack distribution, crack width, corresponding load and ultimate load capacity. Electrical resistance strain gauges with a length of 5 mm were fixed across the mid and edge sections of the link slabs at both top and bottom reinforcements in order to measure the tensile and compressive strains. Out-of-plane deflections at four points along the mid-section, at one-sixth span and at both supports were measured by using linear variable deflection transducers (LVDT) as shown in Fig. 4.1.

Three link slab specimens were tested to failure under a central point loading of an actuator of 100 ton capacity. To represent the AASHTO HS20-44 wheel load, the load was transmitted over a rectangular steel plate of 500 mm x 200 mm x 20 mm (AASHTO, 2002). The test set-up is shown in Fig. 4.1. The test was performed right after the concrete reached the specified strength, and the LVDT, load cell and strain gauge signals were the input for the computerized data acquisition system.

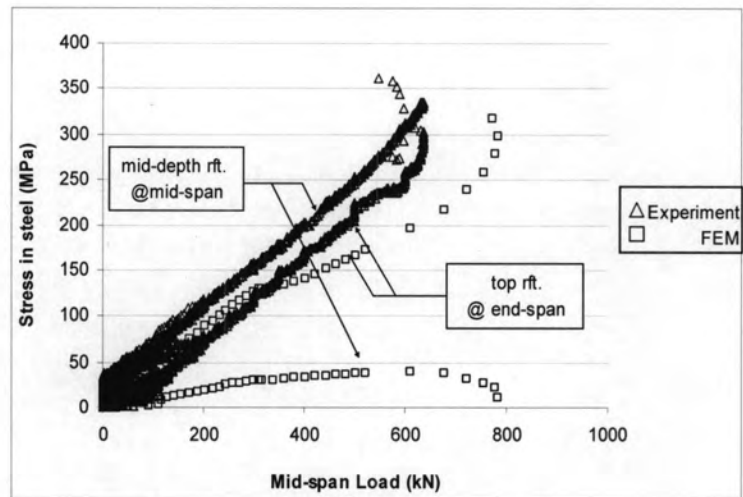
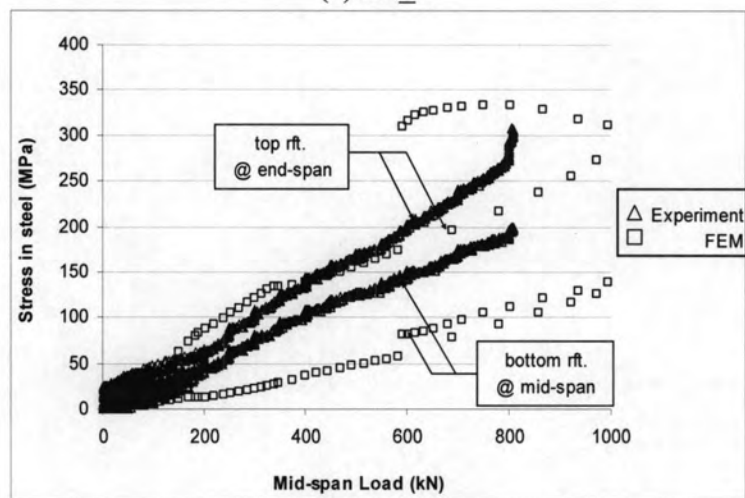
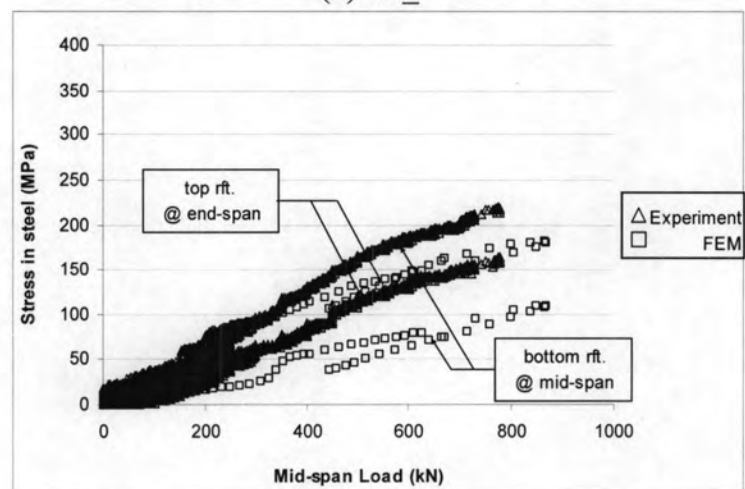
Fig. 4.2 Tensile stress in reinforcing steel comparison of FE analysis to experimental

(a) LS_H

(b) LS_S

(c) LS_F

Failure loads and corresponding mid-span deflections from the full-scale test are presented in Table 4.3 and they are compared with the finite element solutions. Comparisons of tensile stresses in reinforcing steel at the end-span (top reinforcement) and the mid-span (bottom reinforcement) for all reinforcement details between finite element and experimental results are also shown in Fig. 4.2. Both results agree well on the top reinforcement stresses at the end-span for all reinforcement details because the locations of strain gauges were close to the estimated crack positions. However, the stresses in the bottom reinforcement at mid-span from FEM and the experiment are quite different due to the discrepancy in the locations of strain gauges and random cracks as well as the deformed curve of the experiments under the loading pad.

Numerical results presented in Fig. 4.2 also indicate that the stresses in reinforcement at the mid-depth across the saw cut obtained from the test of LS_H specimen is much higher than the finite element results. The reason for this inconsistency is that the depth of the compression zone at the mid-span section from the finite element analysis is about twice as larger as that shown in the experiment. Therefore, the mid-span section of the LS_H slab from the present FEM is stiffer, and

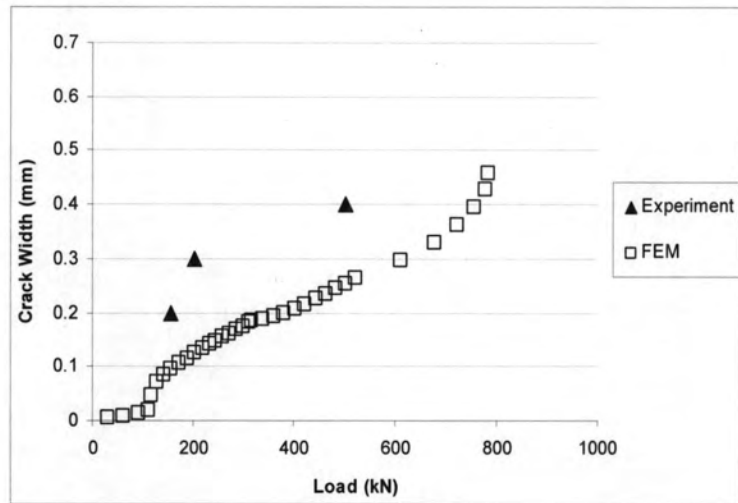
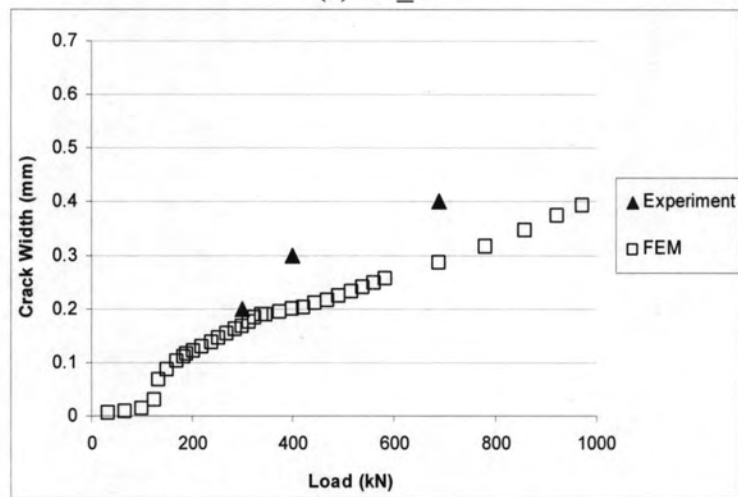
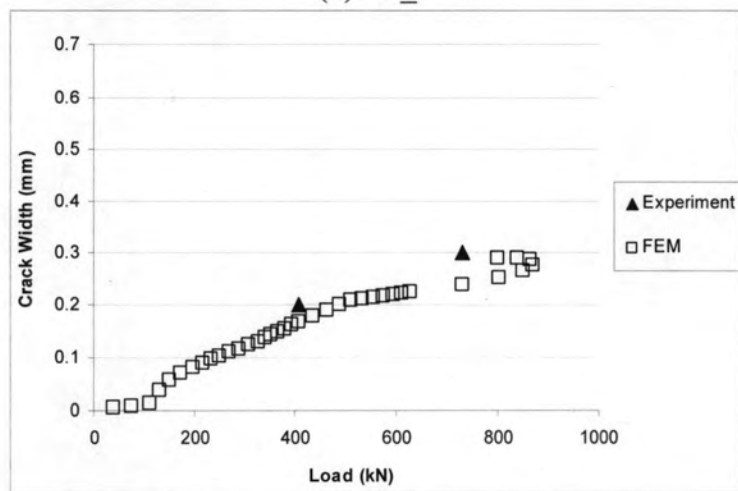
Fig. 4.3 Maximum crack width comparison of FE analysis to experimental

(a) LS_H

(b) LS_S

(c) LS_F

Figure 4.3 presents a comparison between the maximum crack widths estimated from reinforcement stresses due to finite element analysis and those measured in the experiment. The maximum surface crack width at each loading step from finite element analysis is estimated by using the AASHTO (2002) and ACI Building Code (2005), which is given by

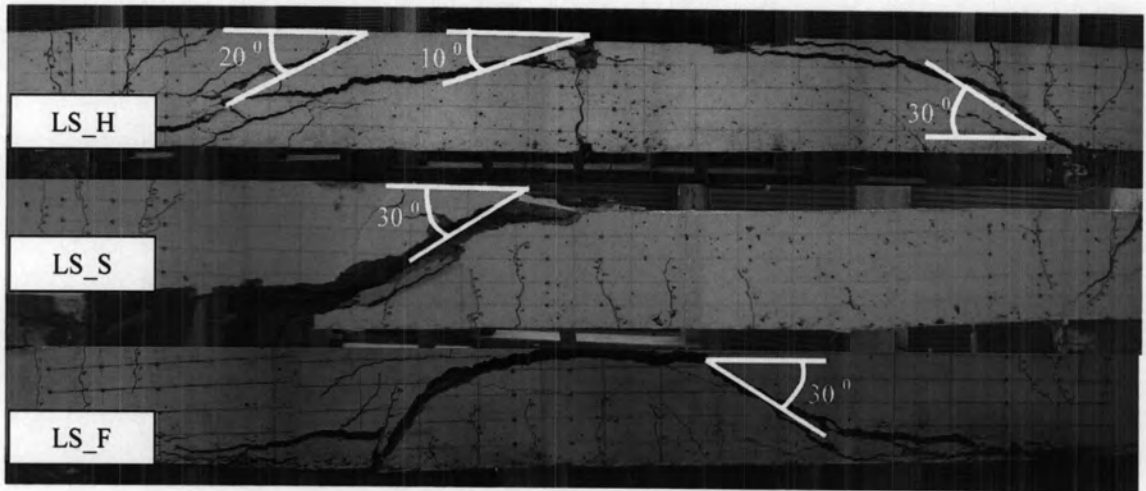
Fig. 4.4 Crack pattern and mode of failure

(a) Experimental

(b) FE analysis

The crack distribution and the direction of failure cracking planes from the experiment and finite element analysis are presented in Figs. 4.5(a) and 4.5(b) respectively. Those numerical results can be used to verify the inclined angle of a tie in the strut-and-tie model, in which the angle of 60 degrees for a flexural member without transverse reinforcement is proposed (Reineck, 1991). The angle of the inclined tie is perpendicular to the direction of the cracking plane. A good agreement between the two results is observed for all specimens as shown in Fig. 4.4.

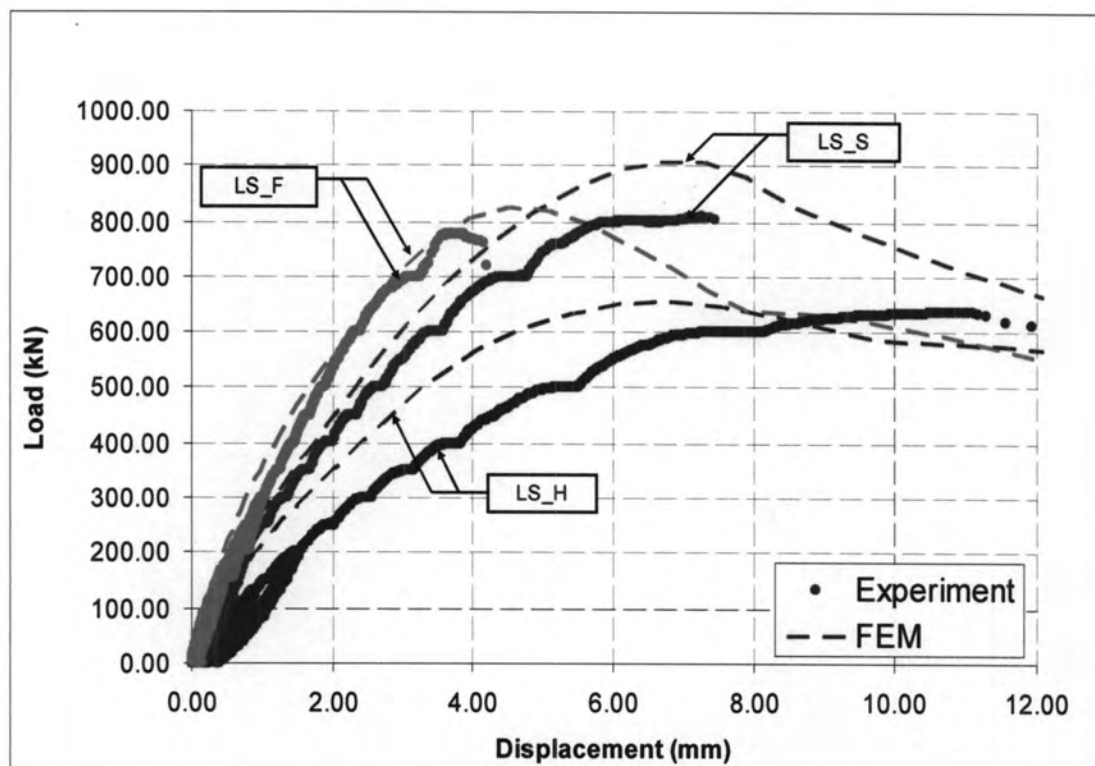
Fig. 4.5 Load and mid-span displacement comparison of FE analysis to experimental

A comparison of the load-deflection curves in Fig. 4.5 indicates a close agreement between the experiment and finite element results for the LS_S and LS_F slabs. However for the LS_H slab, in addition to the different depth of the compression zone at the mid-span section between the two results as previously discussed, the tension stiffening is partially lost resulting in lower stiffness in the test specimen than the finite element model when the load is sustained or applied repeatedly. This is due to the fact that the bending moment cannot be redistributed in a determinate structure after a crack is formed at the mid-span of the LS_H slab.

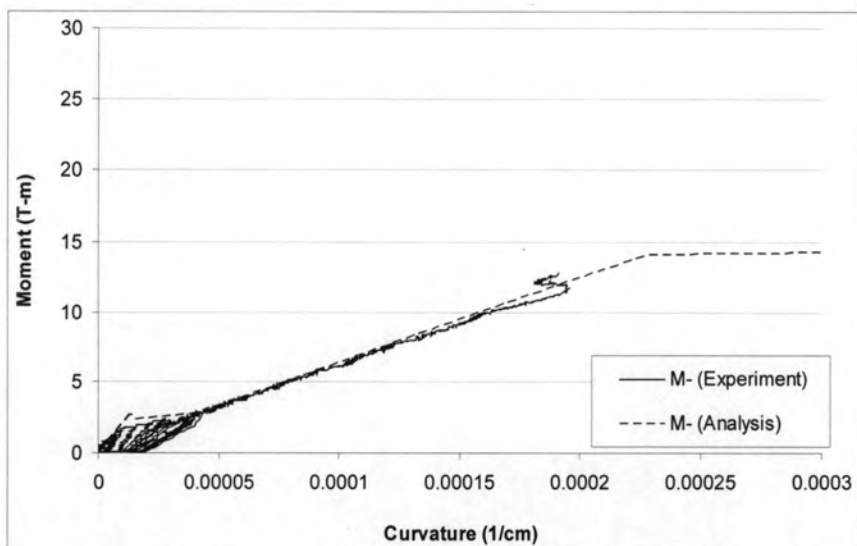
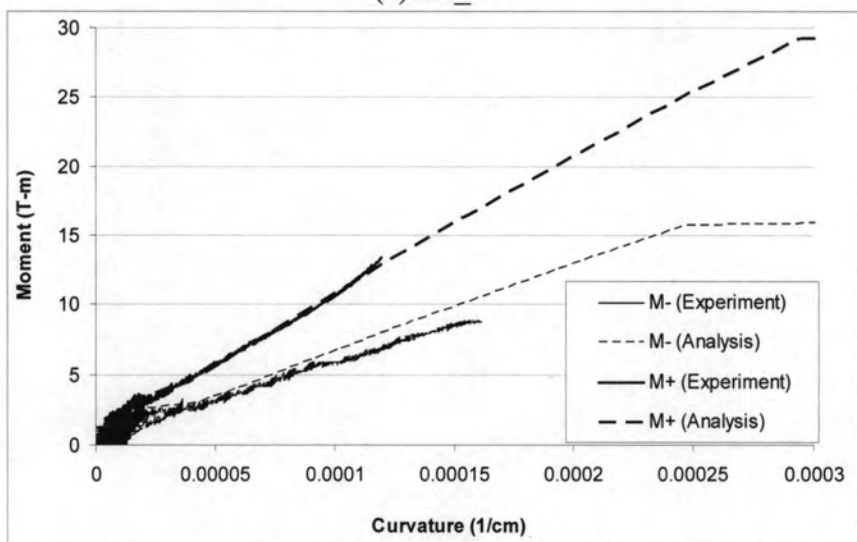
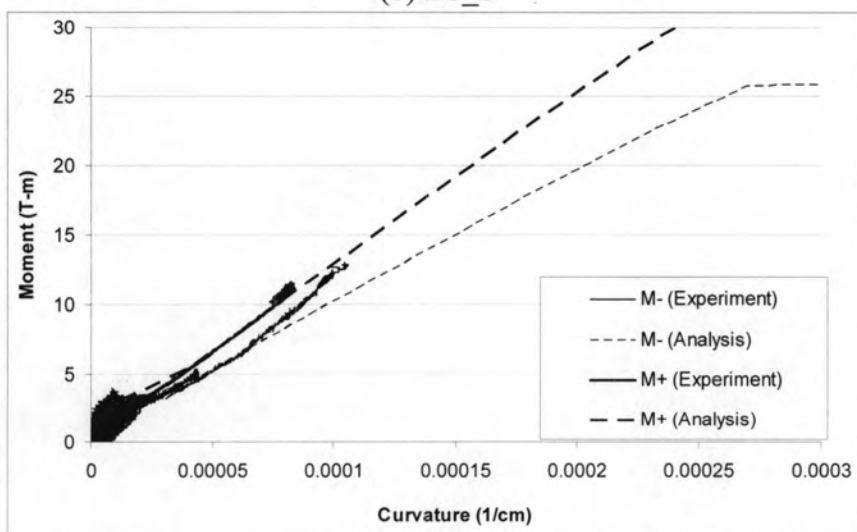
Fig. 4.6 Moment-curvature relationship comparison of FE analysis to experimental

(a) LS_H

(b) LS_S

(c) LS_F

The moment and curvature at the edge and mid-span where has maximum moment from strain gauge which is attached on reinforcing steel can be determined. Moment-curvature relationship is compared with section analysis and with the experimental result as shown in Fig. 4.6. It is shown that in each specimen that reinforcing steel did not yield, however, stress in reinforcing steel in LS_H is more than in LS_S and LS_F respectively. Maximum stresses in reinforcing steel in LS_H, LS_S and LS_F are about 3400 ksc, 3100 ksc, and 2000 ksc respectively. They are from negative moment at the edge of the slab. They show that in each reinforcing detailing they have a different moment distribution. LS_H acts as a more cantilever structure than others at the same load in which most moment is transferred to the edge. From the deflected curve, the curvatures at each point can be determined by differentiation of deflection equation. In addition, from the inflection point, the bending moment diagram can be approximated due to mid-span loading. The moment-curvature relationship from the deflected curve is also shown in Fig. 4.6. This moment-curvature is not quite correct because of shear deformation and data accuracy, however, it can approximate the sectional behavior.

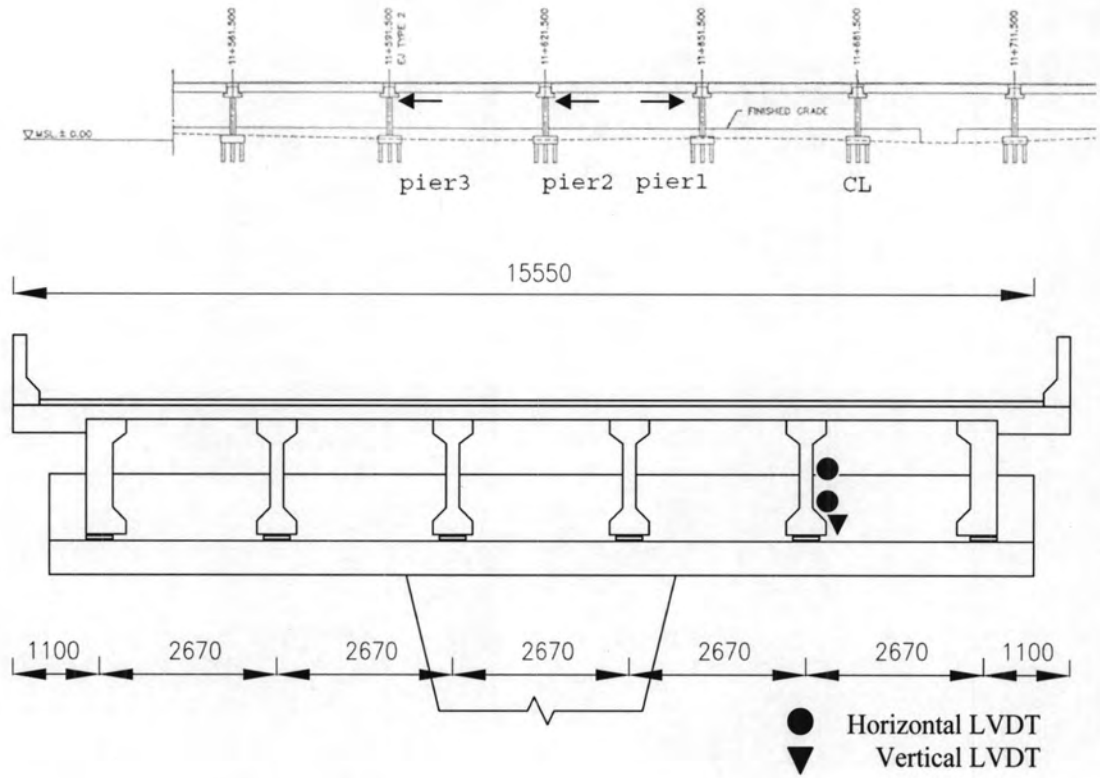
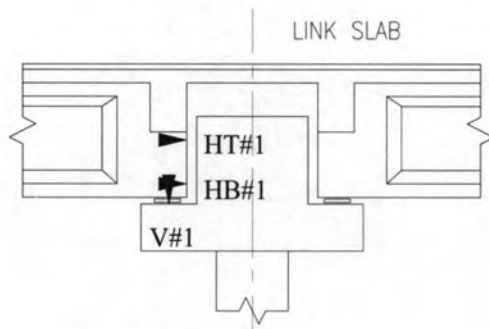
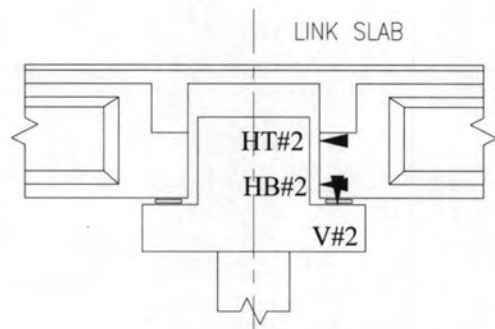
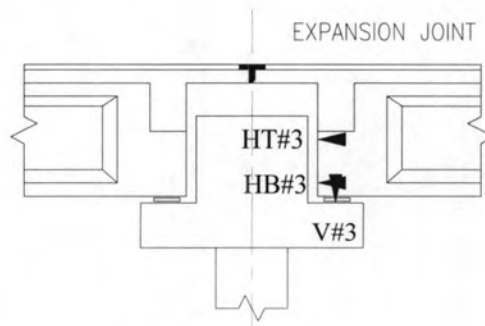
Fig. 4.7 Schematic of on-site monitoring and instrument setting-up

(a) Sectional elevation, typical cross-section (units in mm) and LVDT position

(b) Pier 1 set-up

(c) Pier 2 set-up

(d) Pier 3 set-up

The overview of the highway site and the instrument installation are shown in Figs. 4.7 – 4.8. Two different levels of longitudinal movement and one vertical movement of end girder at each pier are measured by using linear variable deflection transducers (LVDT). The monitoring points are on only 3 piers along the route and each pier has 3 LVDTs because of site limitations. Two horizontal LVDTs installed at different levels (50 centimeters) at each pier (HT#1,2,3 and HB#1,2,3) measured the longitudinal movement and were calculated to end rotation by dividing the differential longitudinal movement by the length between two horizontal LVDTs. One vertical LVDT at the center of elastomeric bearing on each pier (V#1,2,3) measured the vertical movement due to elastomeric bearing that its pin must be allowed free horizontal movement to prevent the wrong data and instrument damage. During

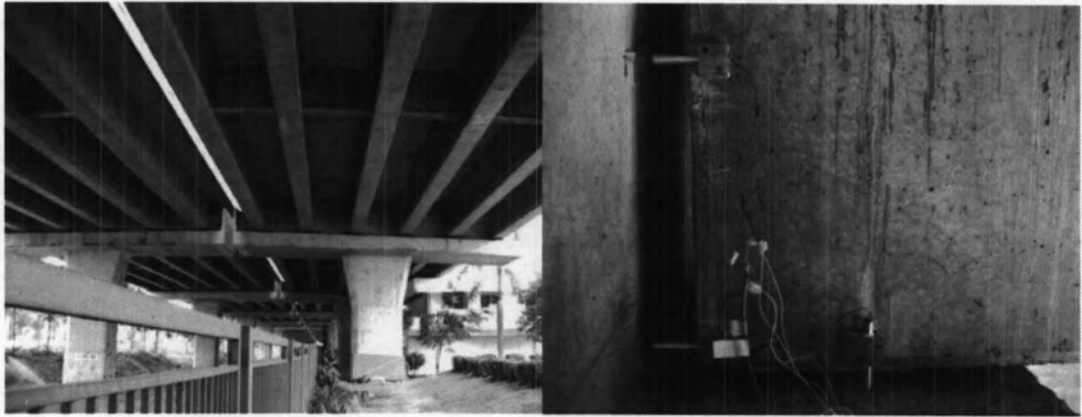
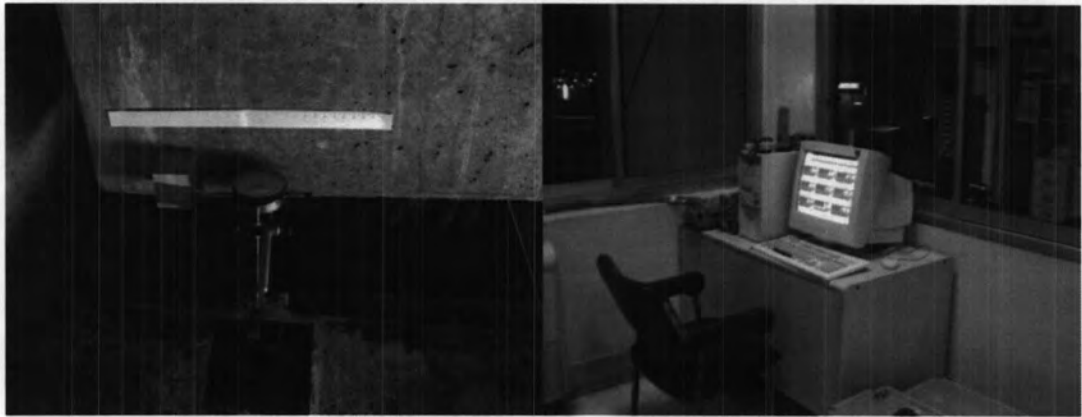
Fig. 4.8 On-site monitoring and instrument setting-up

(a) Structural system

(b) End girder set-up

(c) End girder set-up (Alt.)

(d) Data acquisition system

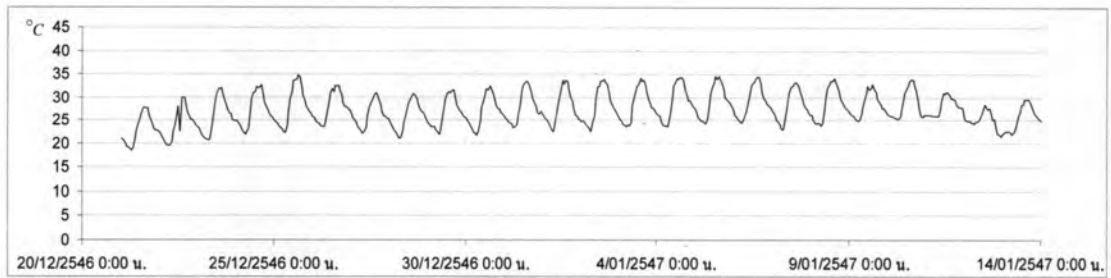
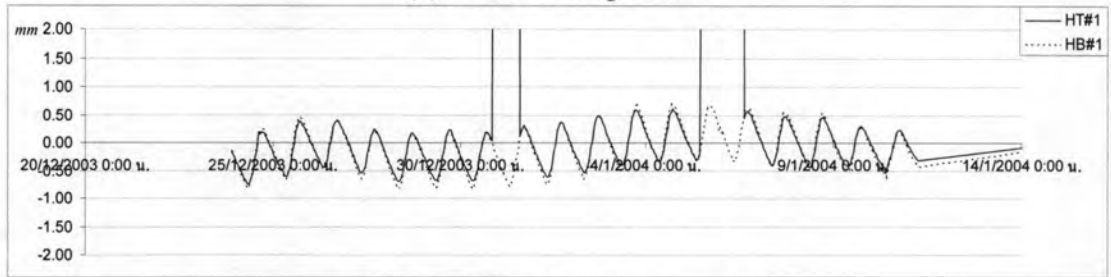
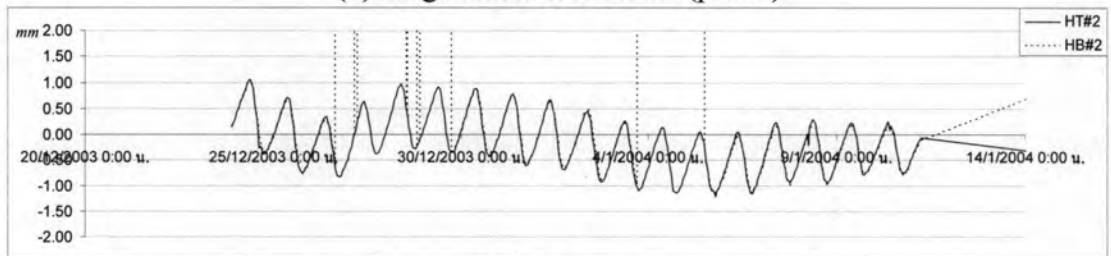
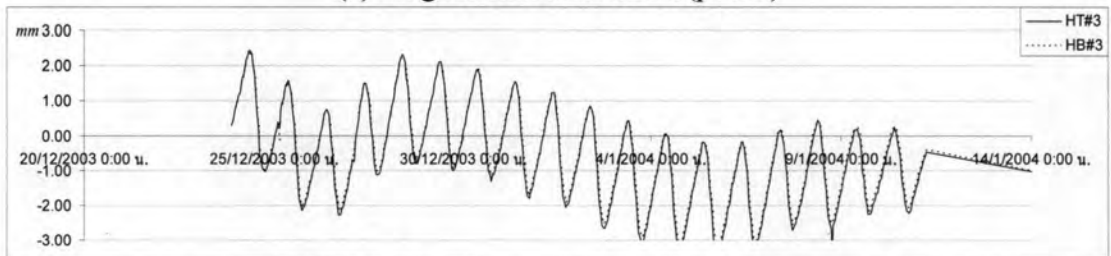
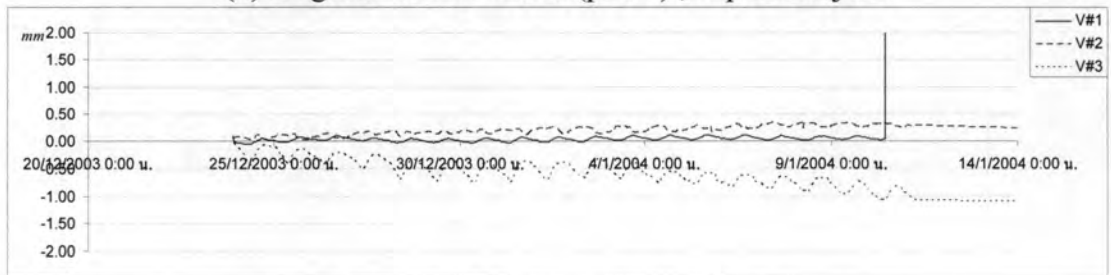
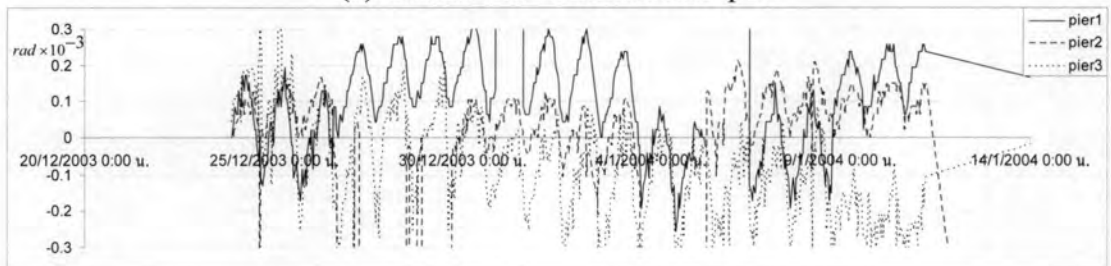
Fig. 4.9 On-site monitoring records (note that there are some losses of signal)

(a) ambient temperature

(b) longitudinal movement (pier 1)

(c) longitudinal movement (pier 2)

(d) longitudinal movement (pier 3) ; expansion joint

(e) vertical movement at each pier

(f) End rotation at each pier

From axial movement of each end girder, the ambient temperature affects the axial movement of girders which has a mid-span of continuous deck as the fixed point because of the elastomeric bearing pad has more horizontal stiffness at this point. So the longitudinal movement of end girders at pier 3 (LVDT no. HT#3 and HB#3) is more than that at pier 2 (LVDT no. HT#2 and HB#2) and pier 1 (LVDT no. HT#1 and HB#1) respectively as shown in Fig. 4.9.

40% more than the result from monitoring at the pier 1, 2, 3 respectively as shown in Fig. 4.9.

From end rotation results, the temperature gradient affects the camber and deflection of the girders. The end rotation of girders from monitoring is comparable to results from the girder model as mentioned in chapter 3. The differential temperature between the top and bottom of girders is assumed to be about 25°C that results in $0.3\text{E-}3$ to $0.7\text{E-}3$ radian of end rotation from the girder model. The result from monitoring results are in the bound of the results from girder model as shown in Fig. 4.9.
