## **CHAPTER 4**

### **RESULTS OF TESTING AND INTERPRETATION**

On line partial discharge tests on Sirikit hydroelectric generator unit 2 was taken on 4 conditions of test procedure. The tests applied to each of coupler of three phases winding (total 9 couplers). The test data were displayed in form of partial discharge graphs. Using experience papers as defined in section 2.65 of CHATER 2. The measuring procedure was set up into four conditions of test in order to see some effects of temperature and load forces. That experience literature also guided to interpret the data of measurement and table of Chart I and Chart II were also very useful to guide to interpret all data of measurement of generator unit 2.

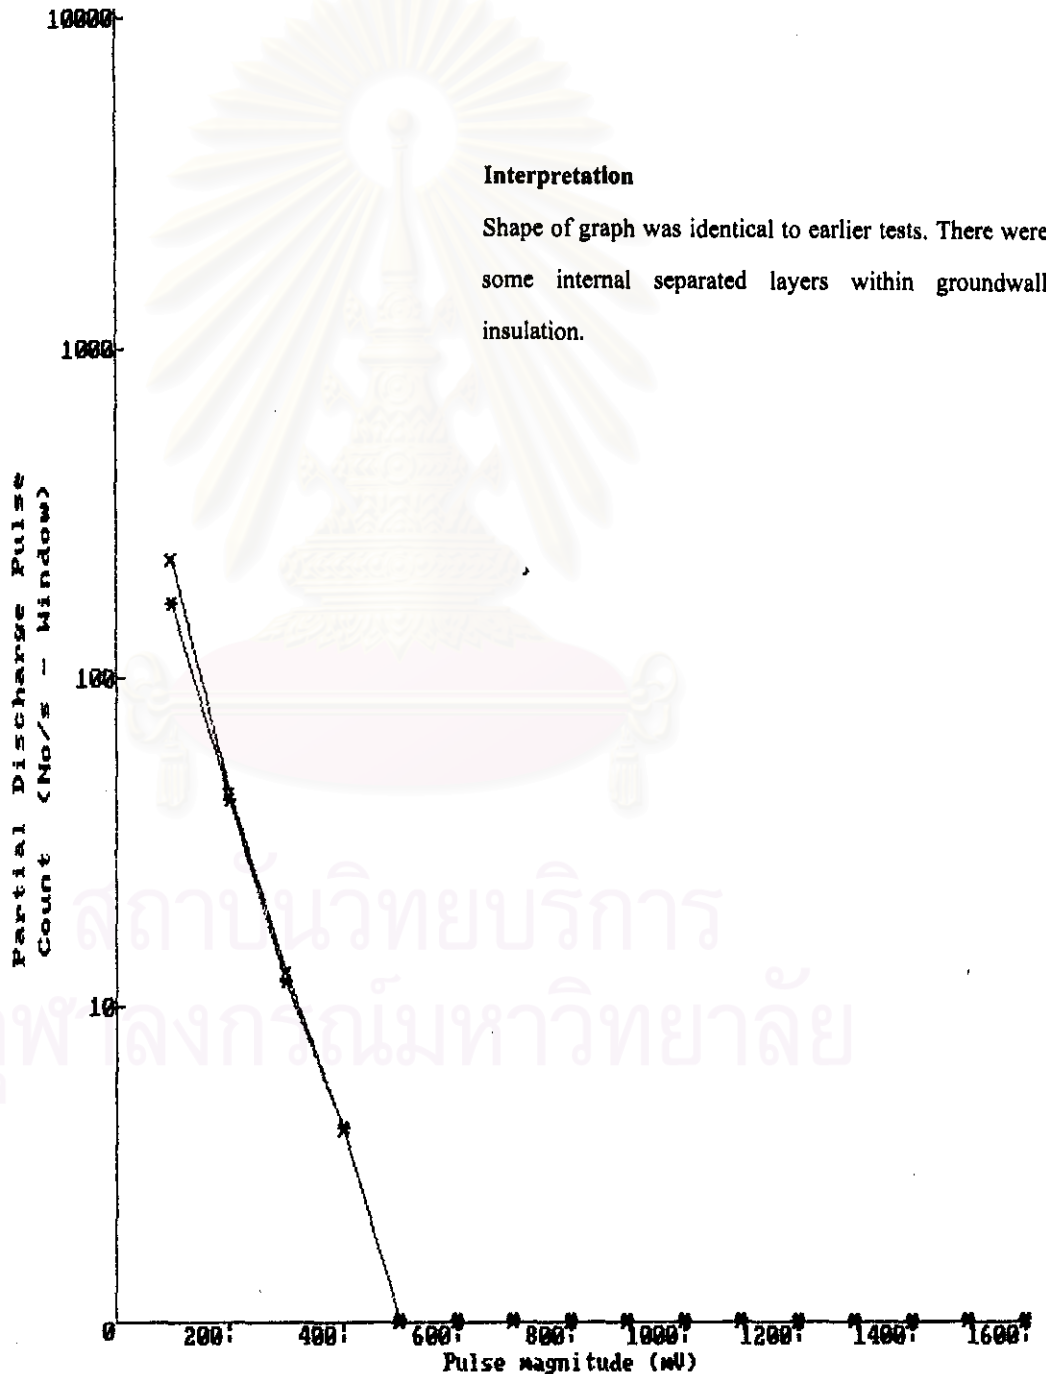
Fig. 4.1.1.5 Data measurement of B Phase, parallel 2

D:\PDAH\PDAH\STATIONA\GEN1\SKT02B03.039 B Phase Coupler 2  
 Tested on Thu Jun 23, 1998 at 09:15:32 Coupler pair B03 Gain 1.00  
 Voltage reference 222 Temp 50 C No Load, Cold Synchronized  
 Power 0 MW Reactive 0 MX Voltage 13.8 Differential Mode  
 Positive Pulses (x) NQN 447 Negative Pulses (\*) NQN 434

Winding parallel path 2 and 3, phase B have similarly graphs that showed only internal discharge occurred. The meaning was some delamination occurred within ground wall insulation. Both NQN were not high values, showing in low partial discharge activities occurred also low insulation deterioration in the overall picture.

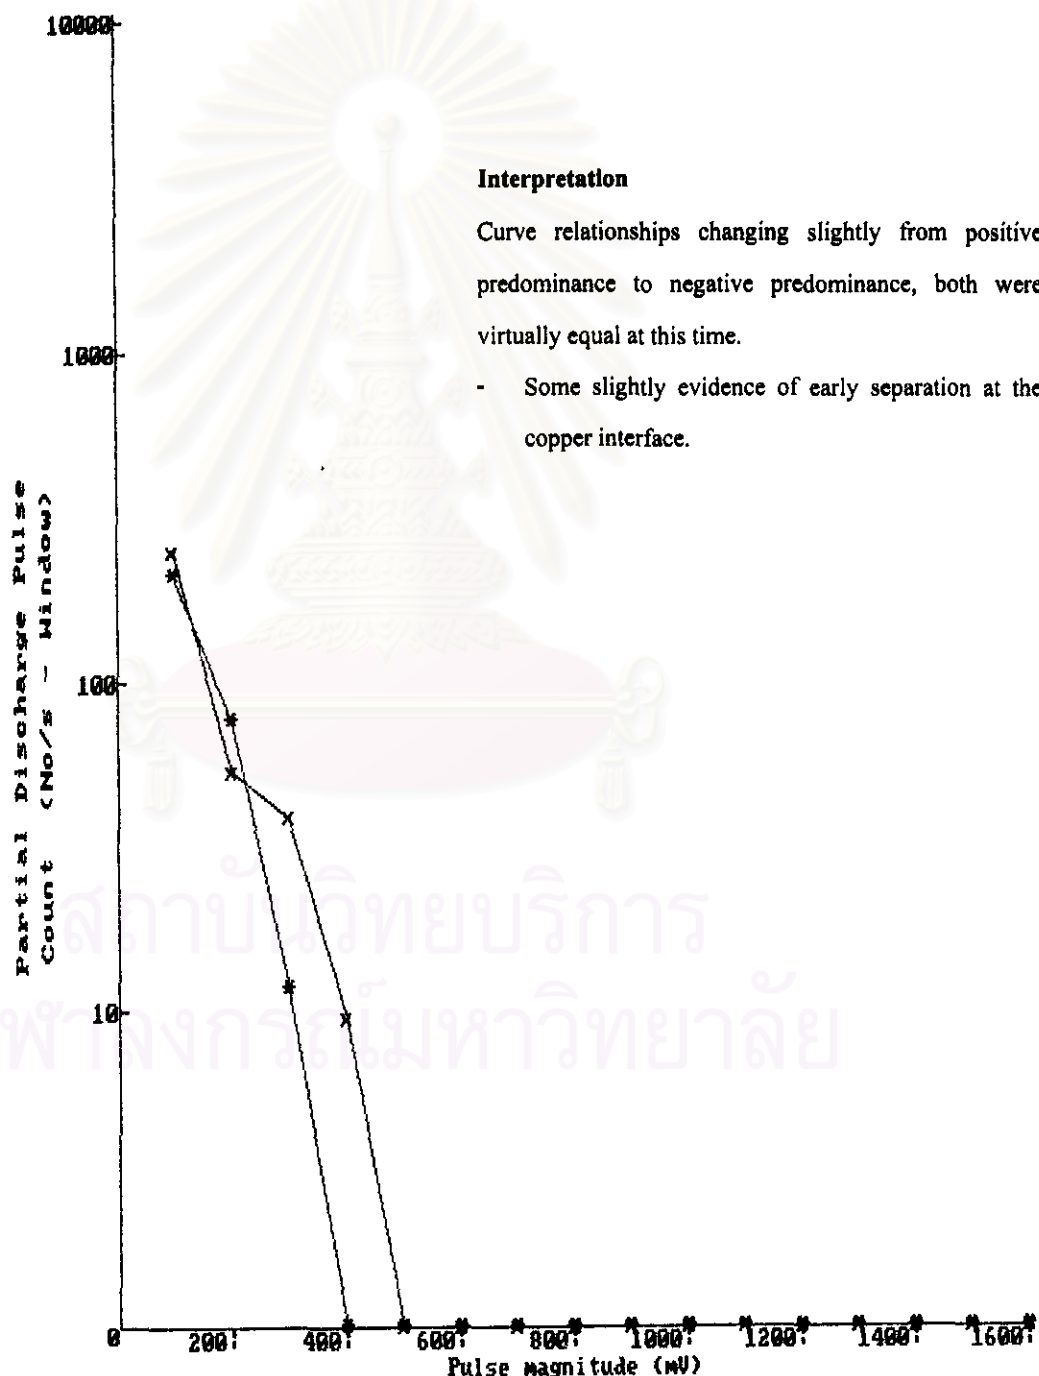
Fig. 4.1.1.6 Data measurement of B Phase, parallel 3

D:\PDAH\PDAH\STATIONA\GEN1\SKT02B04.040 B Phase Coupler 2  
 Tested on Thu Jun 23,1998 at 09:17:52 Coupler pair B04 Gain 1.00  
 Voltage reference 225 Temp 50 C No Load, Cold Synchronized  
 Power 0 MW Reactive 0 MX Voltage 13.8 Differential Mode  
 Positive Pulses (x) NQN 541 Negative Pulses (\*) NQN 405

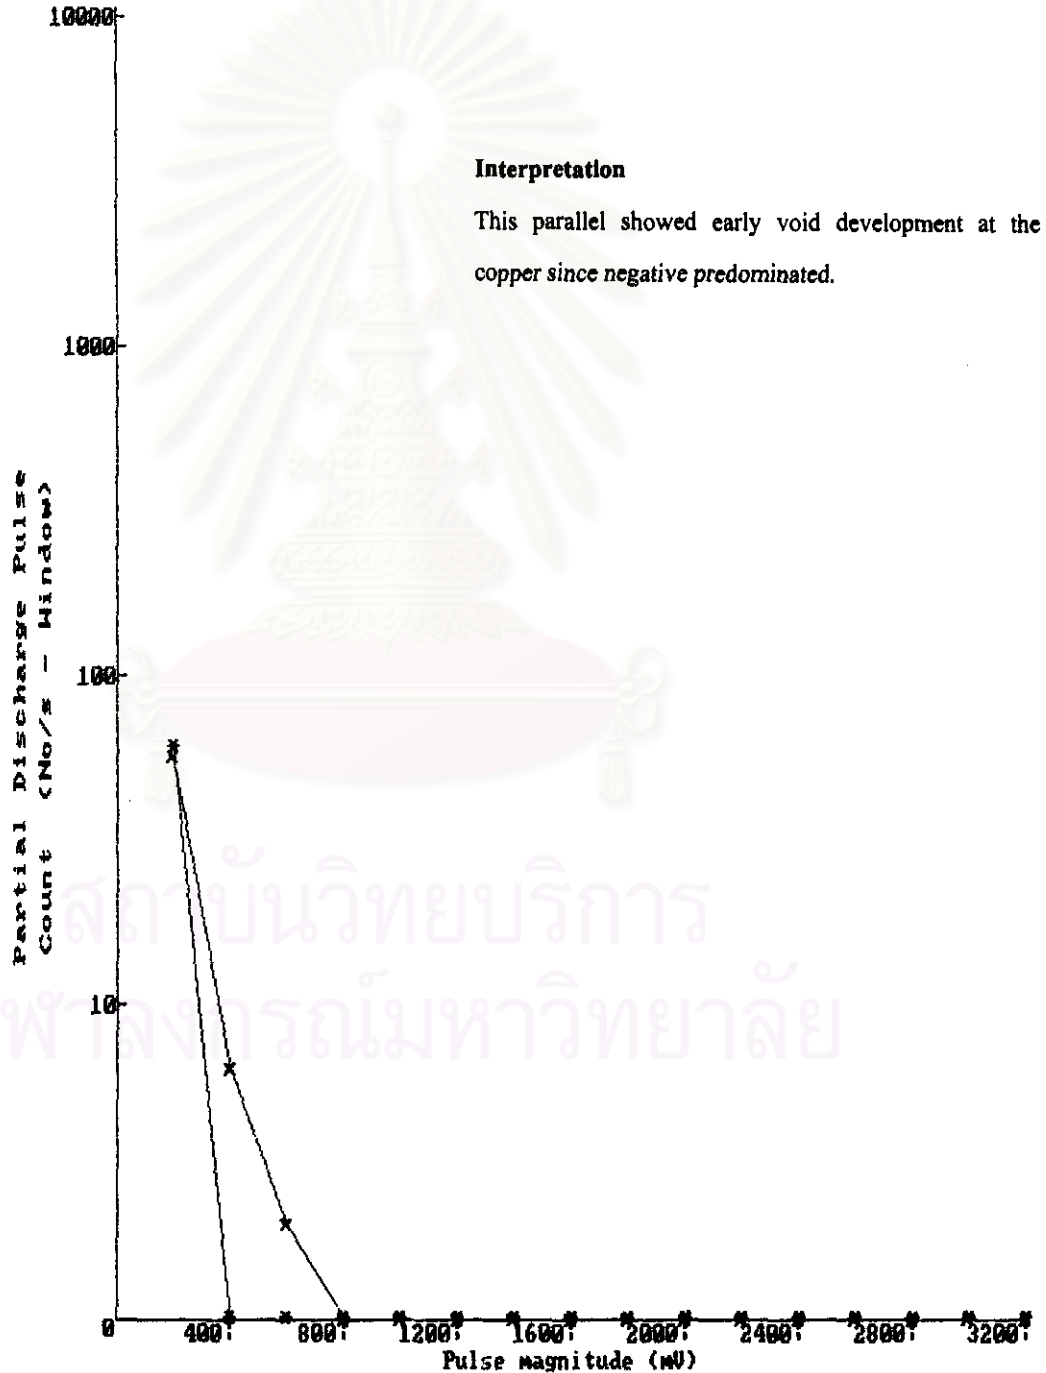
Fig. 4.1.1.7 Data measurement of C Phase, parallel 1

D:\PDAH\PDAH\STATIONA\GEN1\SKT02C05.041 C Phase Coupler 1  
Tested on Thu Jun 23,1998 at 09:20:22 Coupler pair C05 Gain 0.50  
Voltage reference 215 Temp 50 C No Load, Cold Synchronized  
Power 0 MW Reactive 0 MX Voltage 13.8 Differential Mode  
Positive Pulses (x) NQN 389 Negative Pulses (\*) NQN 175

Winding parallel path 1 and 3, phase C have similarly graphs same as path 2 and 3 of phase B. there were internal discharge occurred due to ground wall deterioration.

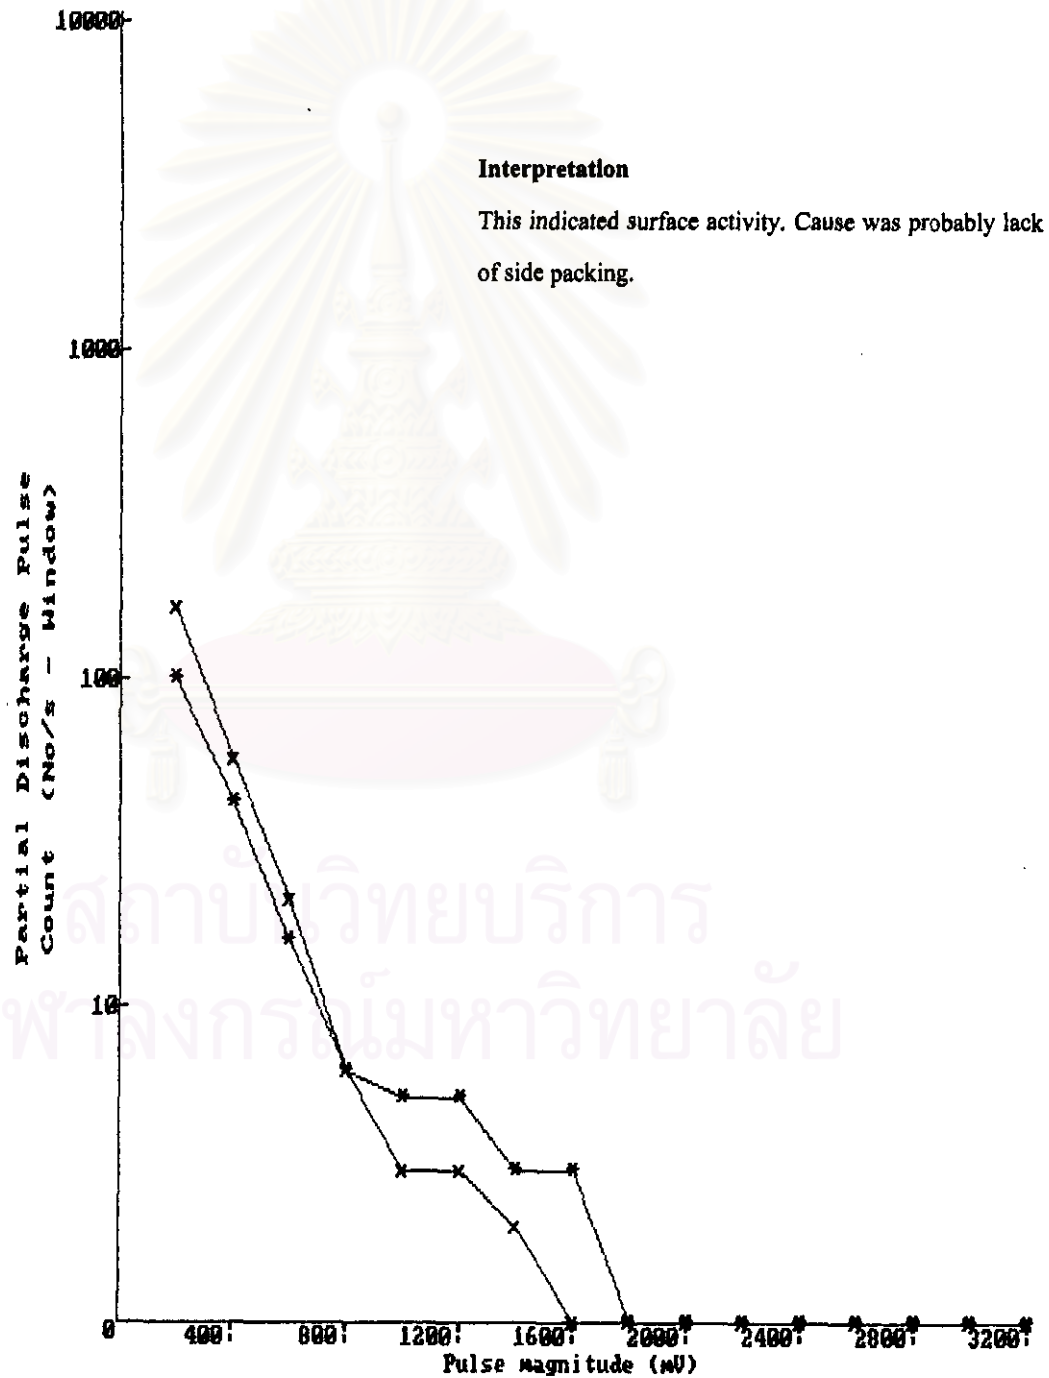
Fig. 4.1.1.9 Data measurement of C Phase, parallel 3

D:\PDAH\PDAH\STATIONA\GEN1\SKT02C06.042 C Phase Coupler 2  
 Tested on Thu Jun 23, 1998 at 09:22:55 Coupler pair C06 Gain 0.50  
 Voltage reference 218 Temp 50 C No Load, Cold Synchronized  
 Power 0 MW Reactive 0 MX Voltage 13.8 Differential Mode  
 Positive Pulses (x) NQN 1232 Negative Pulses (\*) NQN 1379

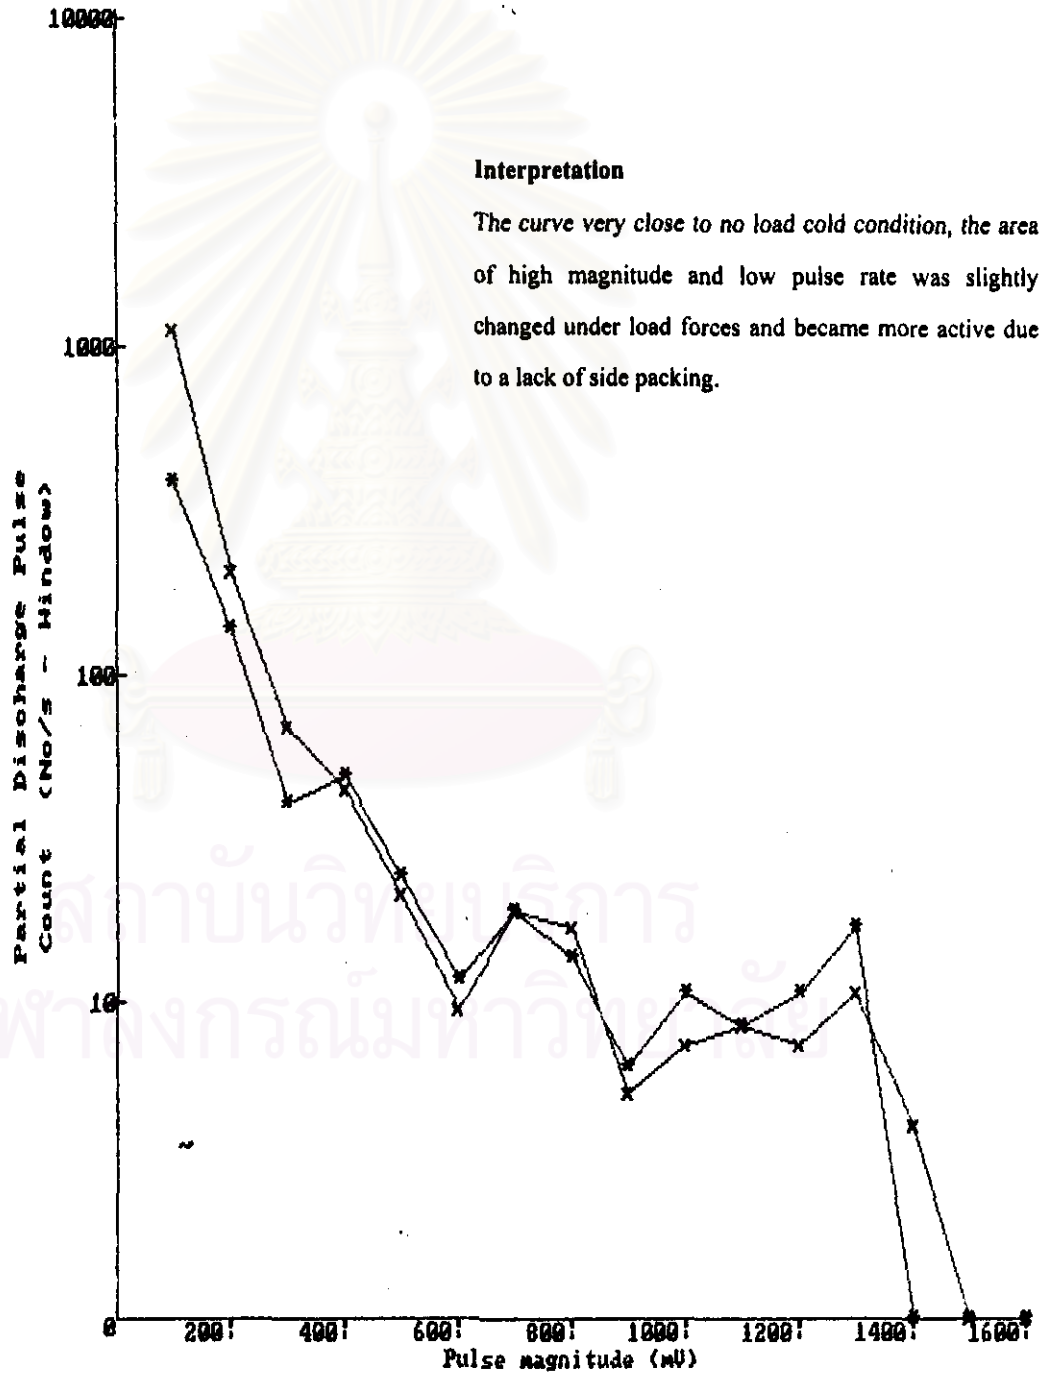
Fig. 4.1.2.3 Data measurement of A Phase, parallel 3

D:\PDAH\PDAH\STATIONA\GEN1\SKT02A02.044 A Phase Coupler 2  
 Tested on Thu Jun 23, 1998 at 09:34:05 Coupler pair A02 Gain 1.00  
 Voltage reference 214 Temp 50 C Full Load, Cold Synchronized  
 Power 81 MW Reactive 0 MX Voltage 13.8 Differential Mode  
 Positive Pulses (x) NQN 1685 Negative Pulses (\*) NQN 1629

Winding parallel path 1, and 3, phase A showed high value of both NQN and had internal separation in ground-wall and some surface deterioration. The total partial discharge activities were slightly increased more than no load condition.

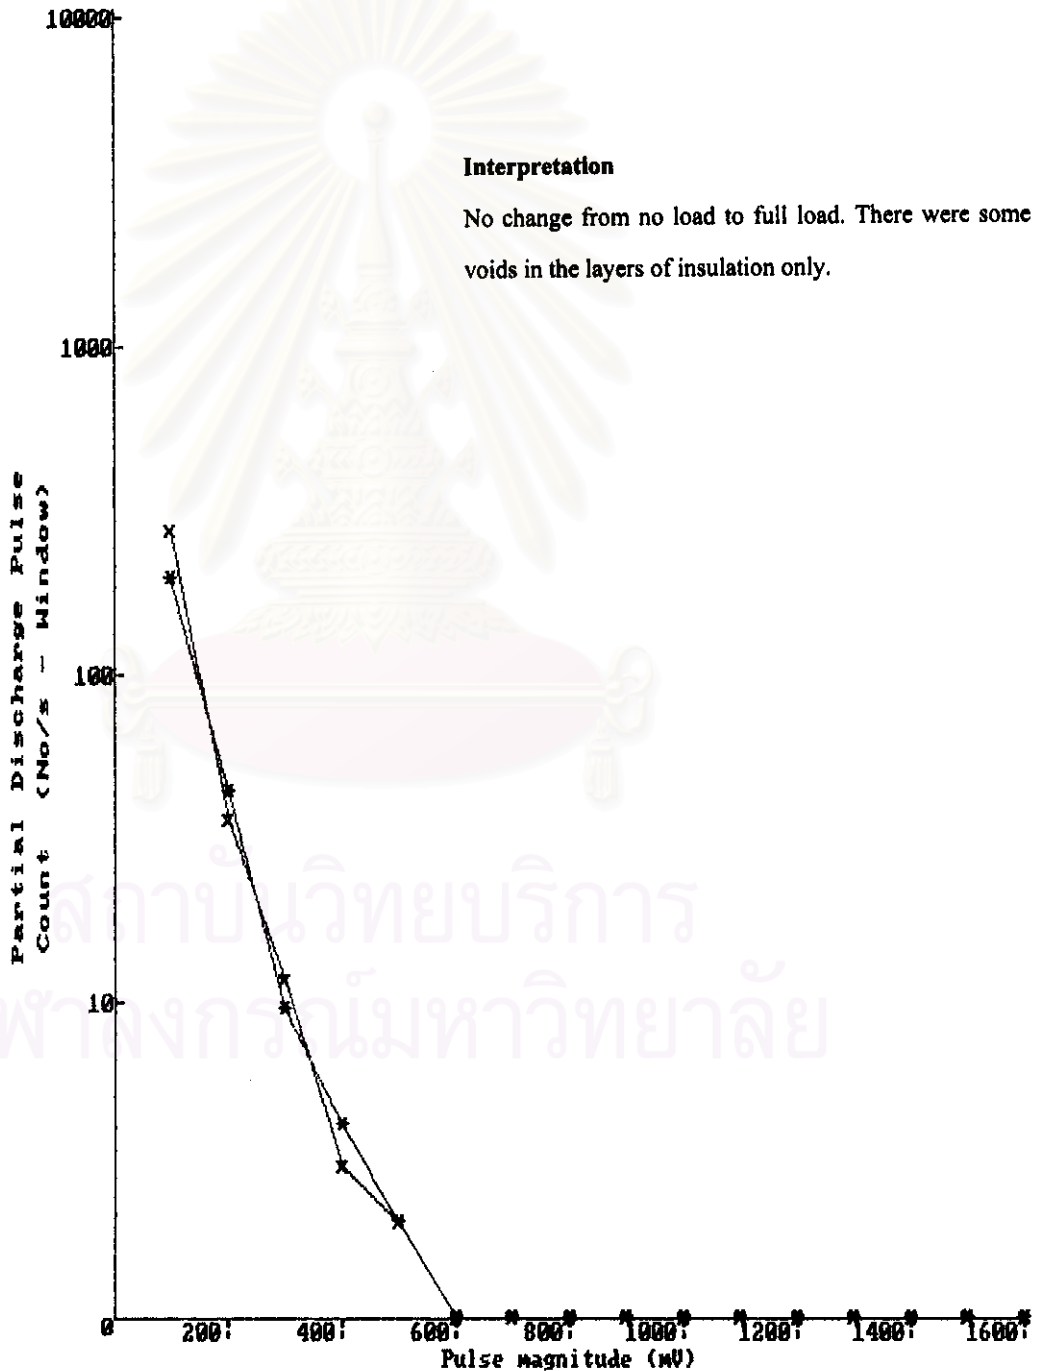
Fig. 4.1.2.5 Data measurement of B Phase, parallel 2

D:\PDAH\PDAH\STATIONA\GEN1\SKT02B03.045 B Phase Coupler 2  
 Tested on Thu Jun 23,1998 at 09:36:23 Coupler pair B03 Gain 1.00  
 Voltage reference 215 Temp 50 C Full Load, Cold Synchronized  
 Power 81 MW Reactive 0 MX Voltage 13.8 Differential Mode  
 Positive Pulses (x) NQN 455 Negative Pulses (\*) NQN 460

Winding parallel path 2 and 3, phase B showed status same as no load condition. The quantity of NQN was not so high, so that it had lower deterioration within insulation than parallel path 1.

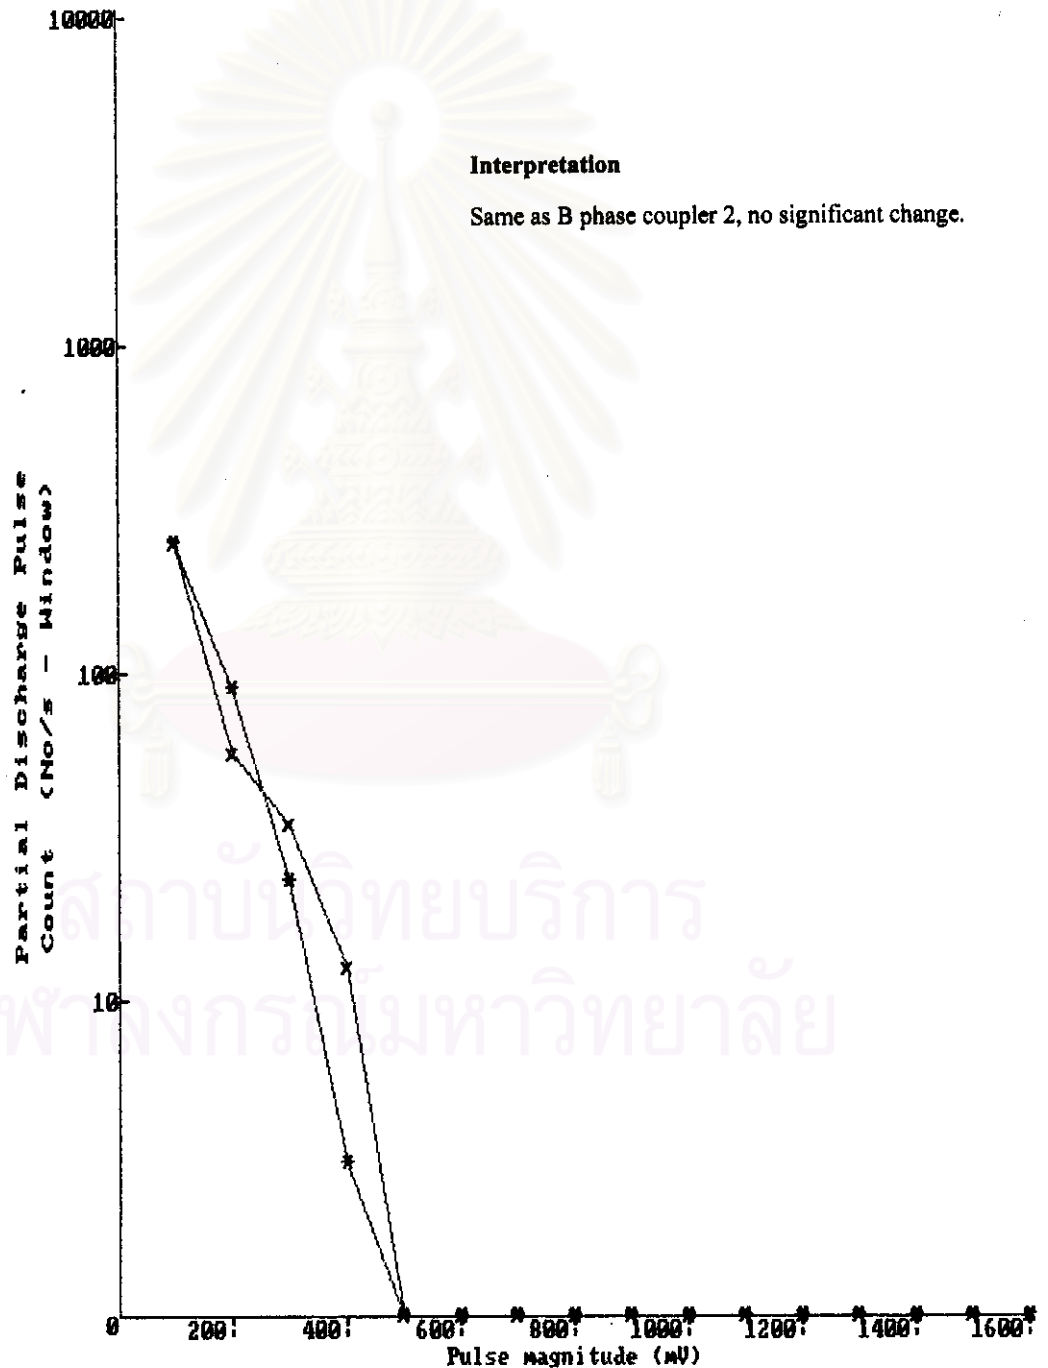
Fig. 4.1.2.6 Data measurement of B Phase, parallel 3

D:\PDAH\PDAH\STATIONA\GEN1\SKT02B04.046 B Phase Coupler 2  
 Tested on Thu Jun 23,1998 at 09:38:39 Coupler pair B04 Gain 1.00  
 Voltage reference 221 Temp 50 C Full Load, Cold Synchronized  
 Power 81 MW Reactive 0 MK Voltage 13.8 Differential Mode  
 Positive Pulses (x) NQN 551 Negative Pulses (\*) NQN 493

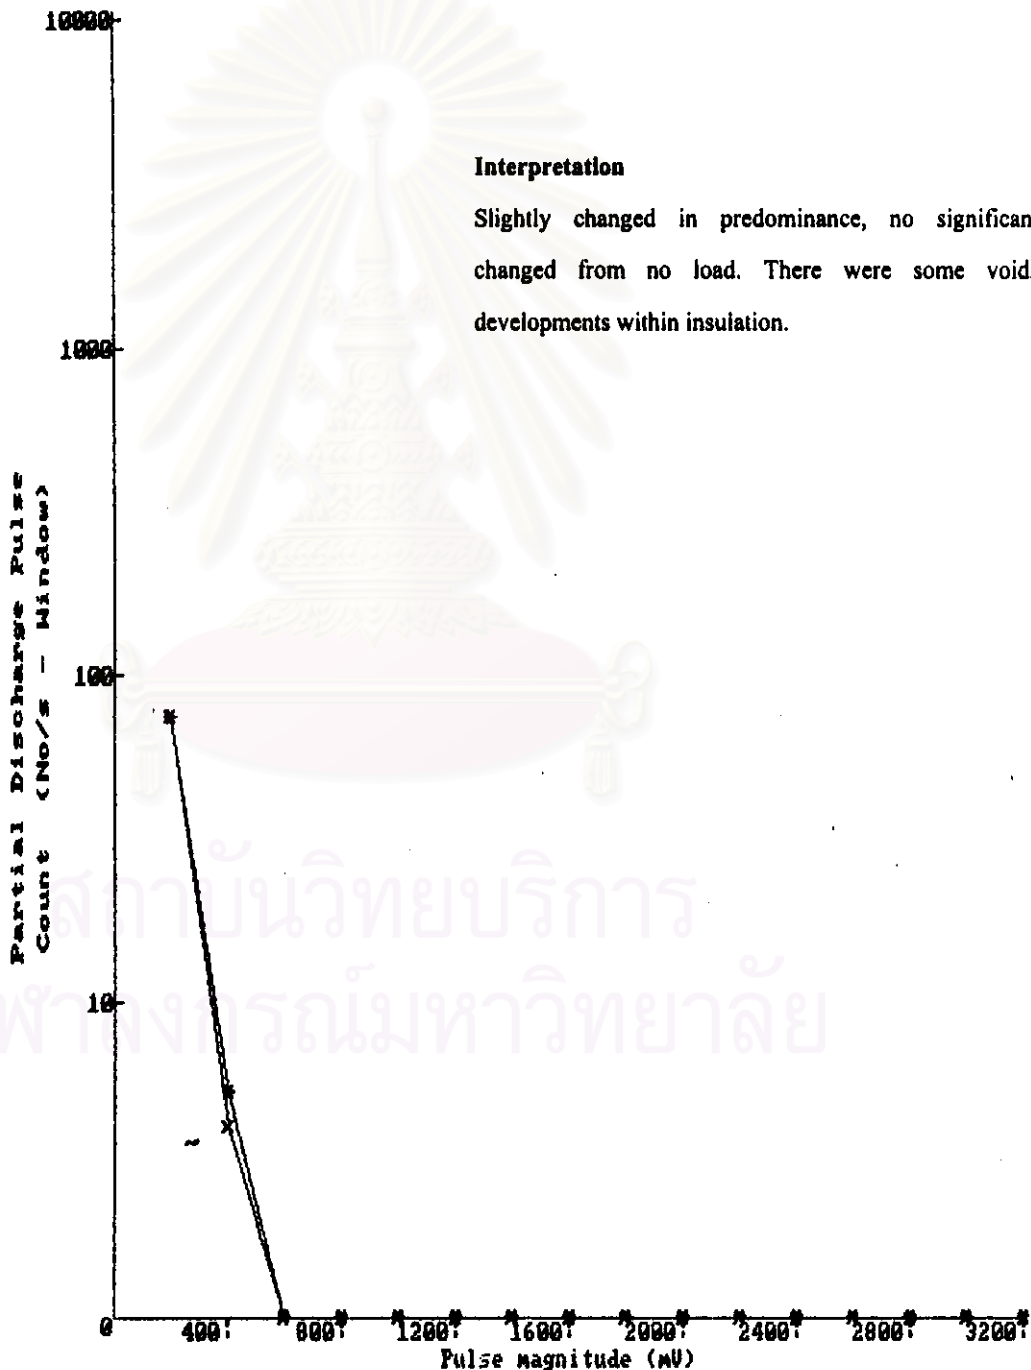
Fig. 4.1.2.7 Data measurement of C Phase, parallel 1

D:\PDAH\PDAH\STATIONA\GEN1\SKT02C05.047 C Phase Coupler 1  
 Tested on Thu Jun 23,1998 at 09:40:59 Coupler pair C05 Gain 0.50  
 Voltage reference 209 Temp 50 C Full Load, Cold Synchronized  
 Power 81 MW Reactive 0 MX Voltage 13.8 Differential Mode  
 Positive Pulses (x) NQN 305 Negative Pulses (\*) NQN 324

Winding parallel path1 and 3, phase C showed negative pulses were predominance. This meant internal discharge occurred within winding cause of ground wall delamination.

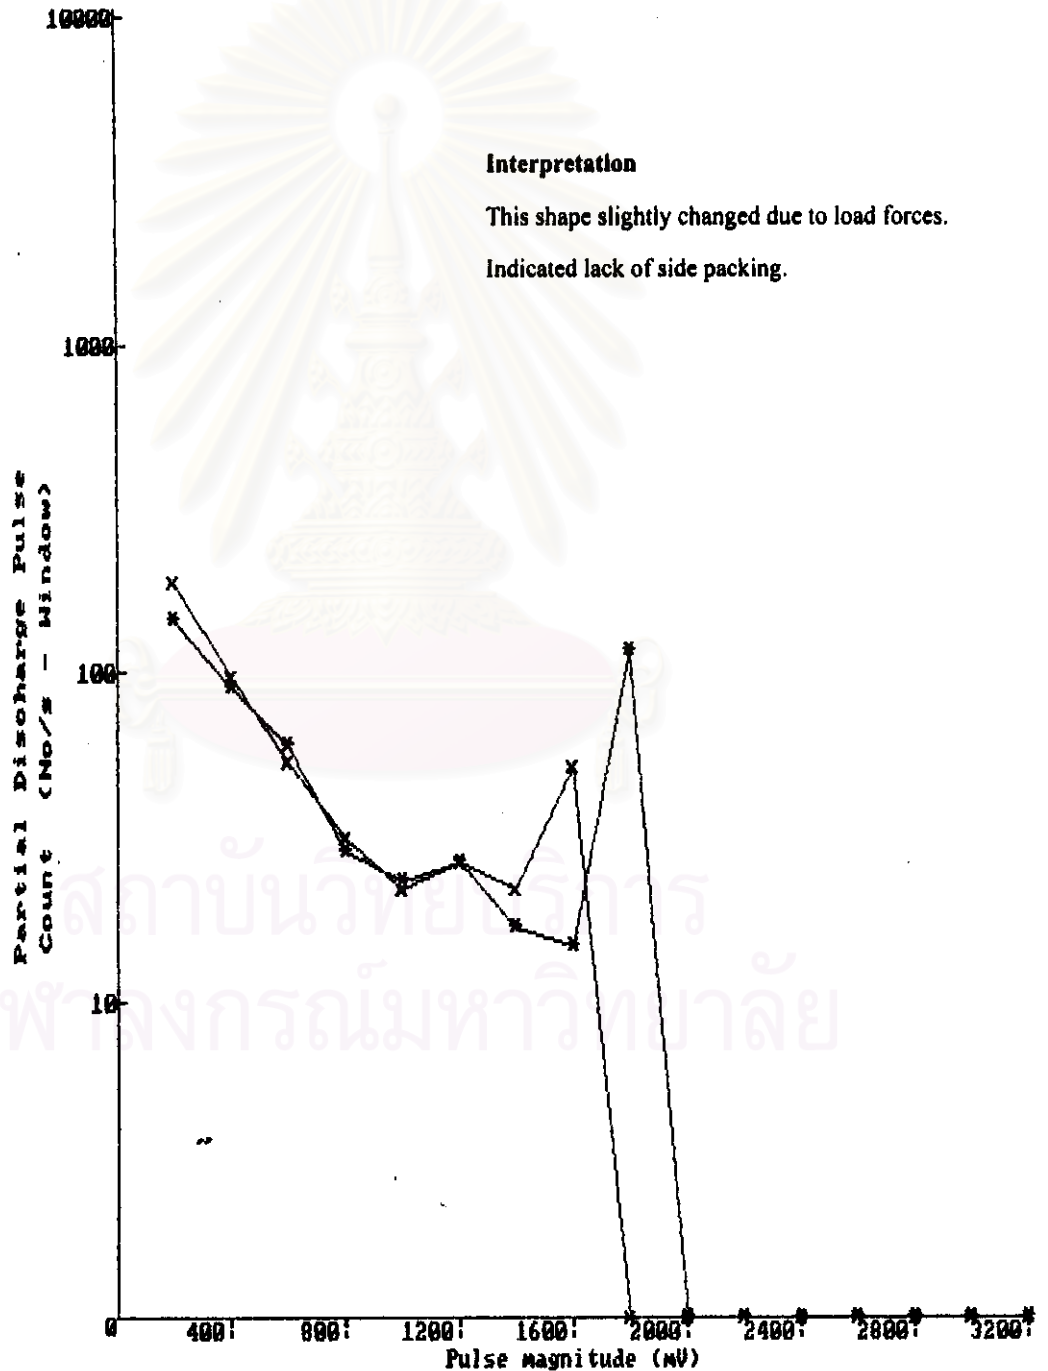
Fig. 4.1.2.9 Data measurement of C Phase, parallel 3

D:\PDAH\PDAH\STATIONA\GEN1\SKT02C06.048 C Phase Coupler 2  
 Tested on Thu Jun 23,1998 at 09:43:17 Coupler pair C06 Gain 0.50  
 Voltage reference 213 Temp 50 C Full Load, Cold Synchronized  
 Power 81 MW Reactive 0 MX Voltage 13.8 Differential Mode  
 Positive Pulses (x) NQN 2400 Negative Pulses (\*) NQN 2661

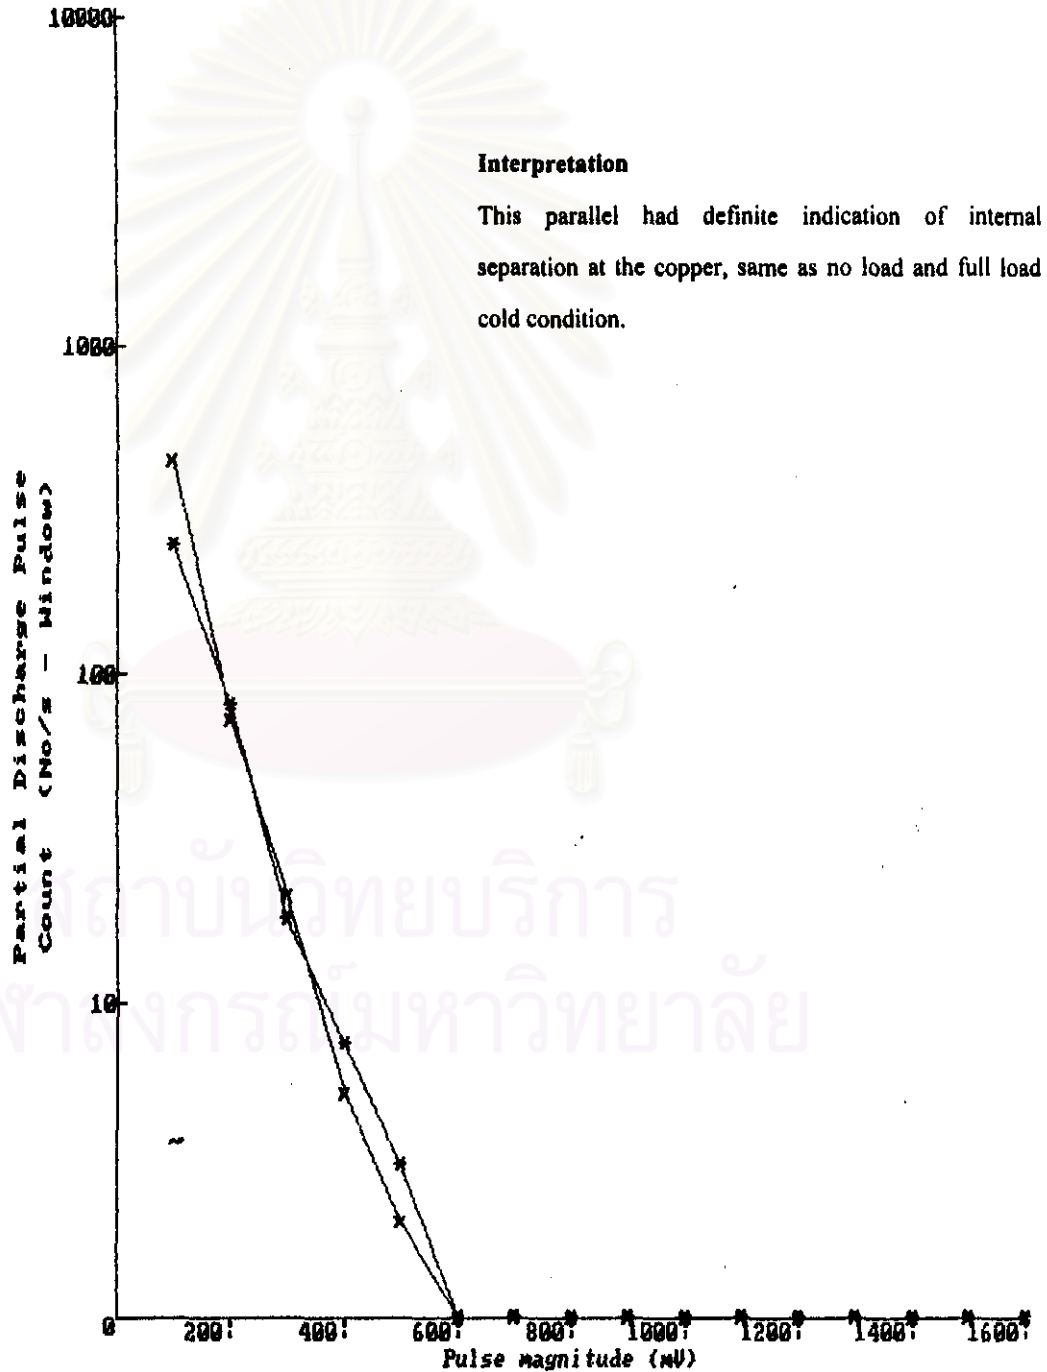
Fig. 4.1.3.4 Data measurement of B Phase, parallel 1

D:\PDAH\PDAH\STATIONA\GEN1\SKT02B04.052 B Phase Coupler 1  
Tested on Thu Jun 23,1998 at 10:04:58 Coupler pair B04 Gain 1.00  
Voltage reference 221 Temp 68 C Full Load, Hot Synchronized  
Power 81 MW Reactive 0 MX Voltage 13.8 Differential Mode  
Positive Pulses (x) NQN 545 Negative Pulses (\*) NQN 561

Winding parallel path 1 of phase B showed less partial discharge activities than other paths. The negative and positive pulses were about equal, meaning in internal discharges occurring. There was less deterioration of coil surface.

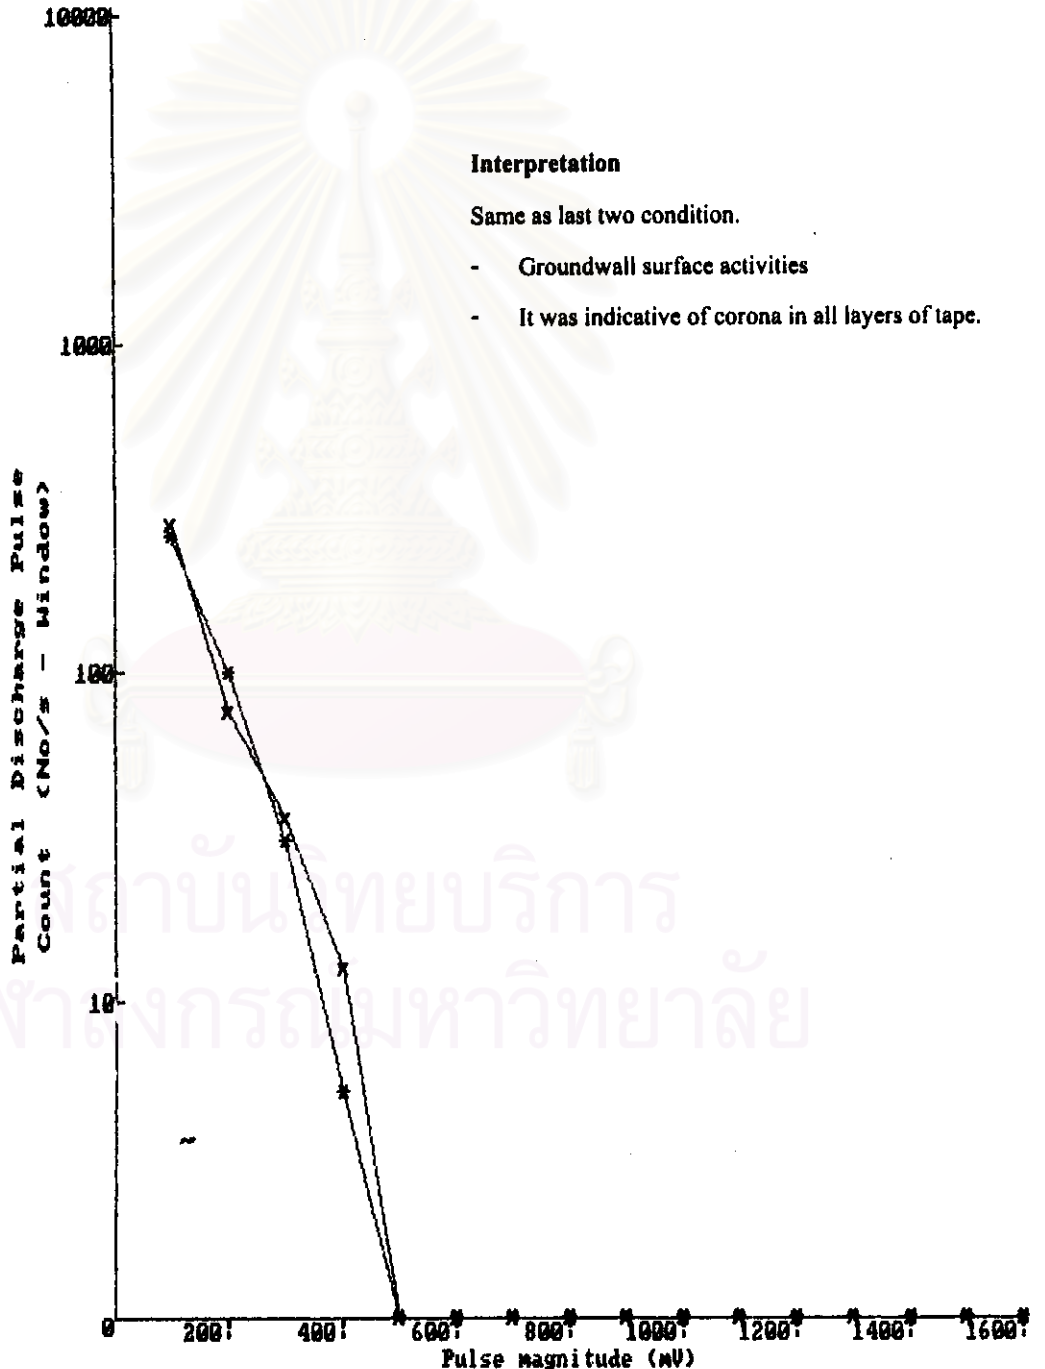
Fig. 4.1.3.5 Data measurement of B Phase, parallel 2

D:\PDAH\PDAH\STATIONA\GEN1\SKT02B04.052 B Phase Coupler 2  
 Tested on Thu Jun 23, 1998 at 10:04:58 Coupler pair B04 Gain 1.00  
 Voltage reference 221 Temp 68 C Full Load, Hot Synchronized  
 Power 81 MW Reactive 0 MX Voltage 13.8 Differential Mode  
 Positive Pulses (x) NQN 568 Negative Pulses (\*) NQN 532

Winding parallel path 2 and 3 of phase B were the same as path 1. Only internal discharges occurred within winding, the total partial discharge activities were less than other paths, meaning in less deterioration of winding insulation.

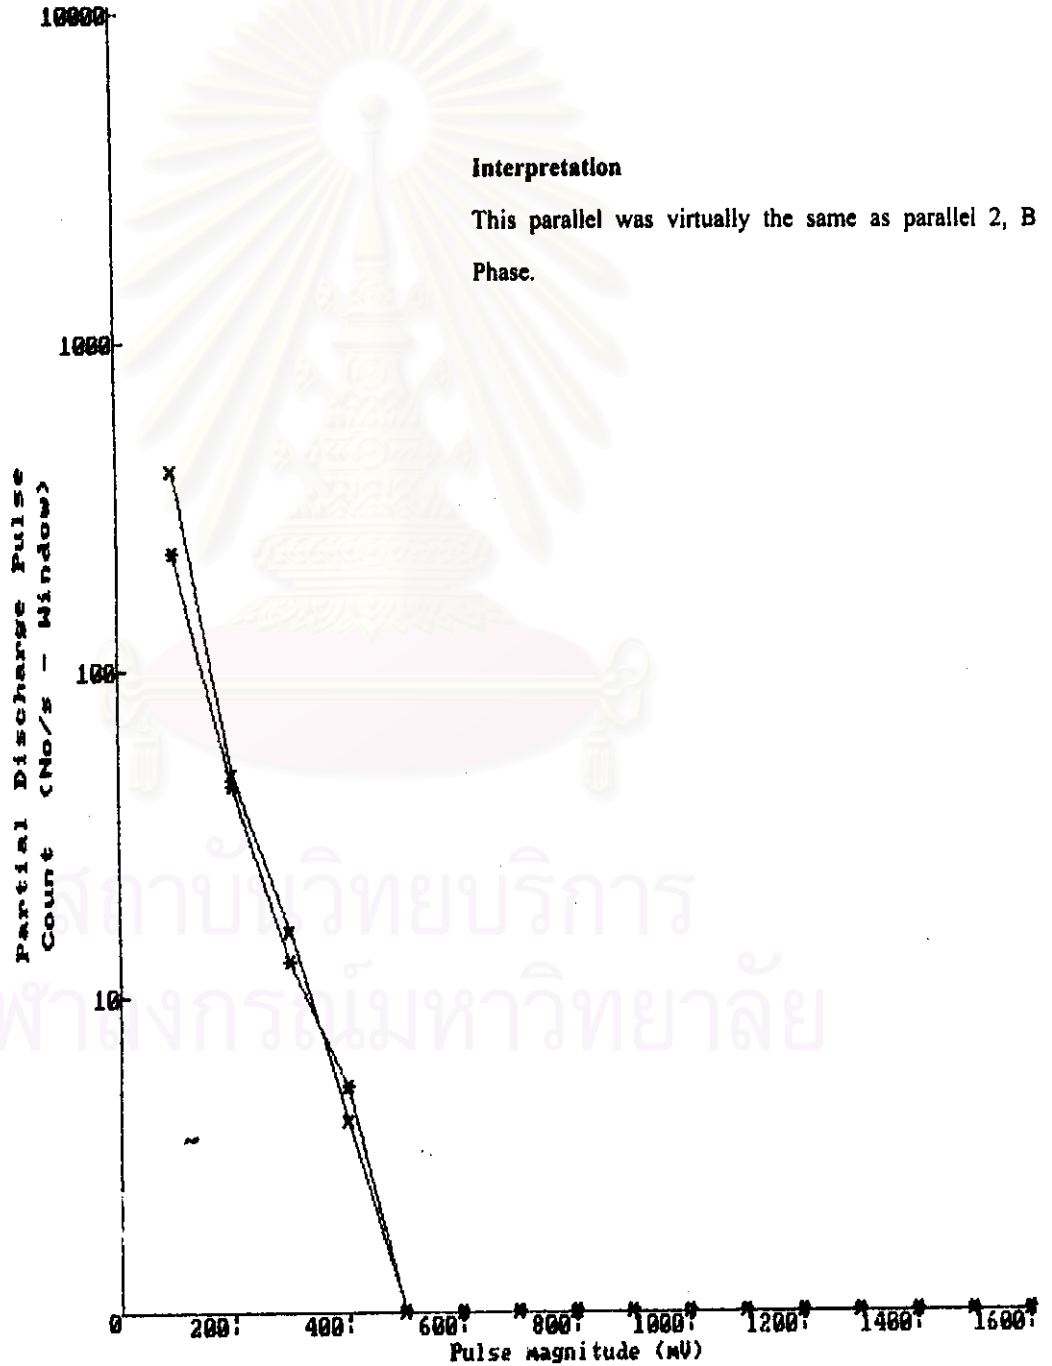
Fig. 4.1.3.6 Data measurement of B Phase, parallel 3

D:\PDAH\PDAH\STATIONA\GEN1\SKT02B03.051 B Phase Coupler 2  
 Tested on Thu Jun 23,1998 at 10:02:41 Coupler pair B03 Gain 1.00  
 Voltage reference 217 Temp 68 C Full Load, Hot Synchronized  
 Power 81 MW Reactive 0 MX Voltage 13.8 Differential Mode  
 Positive Pulses (x) NQN 472 Negative Pulses (\*) NQN 455

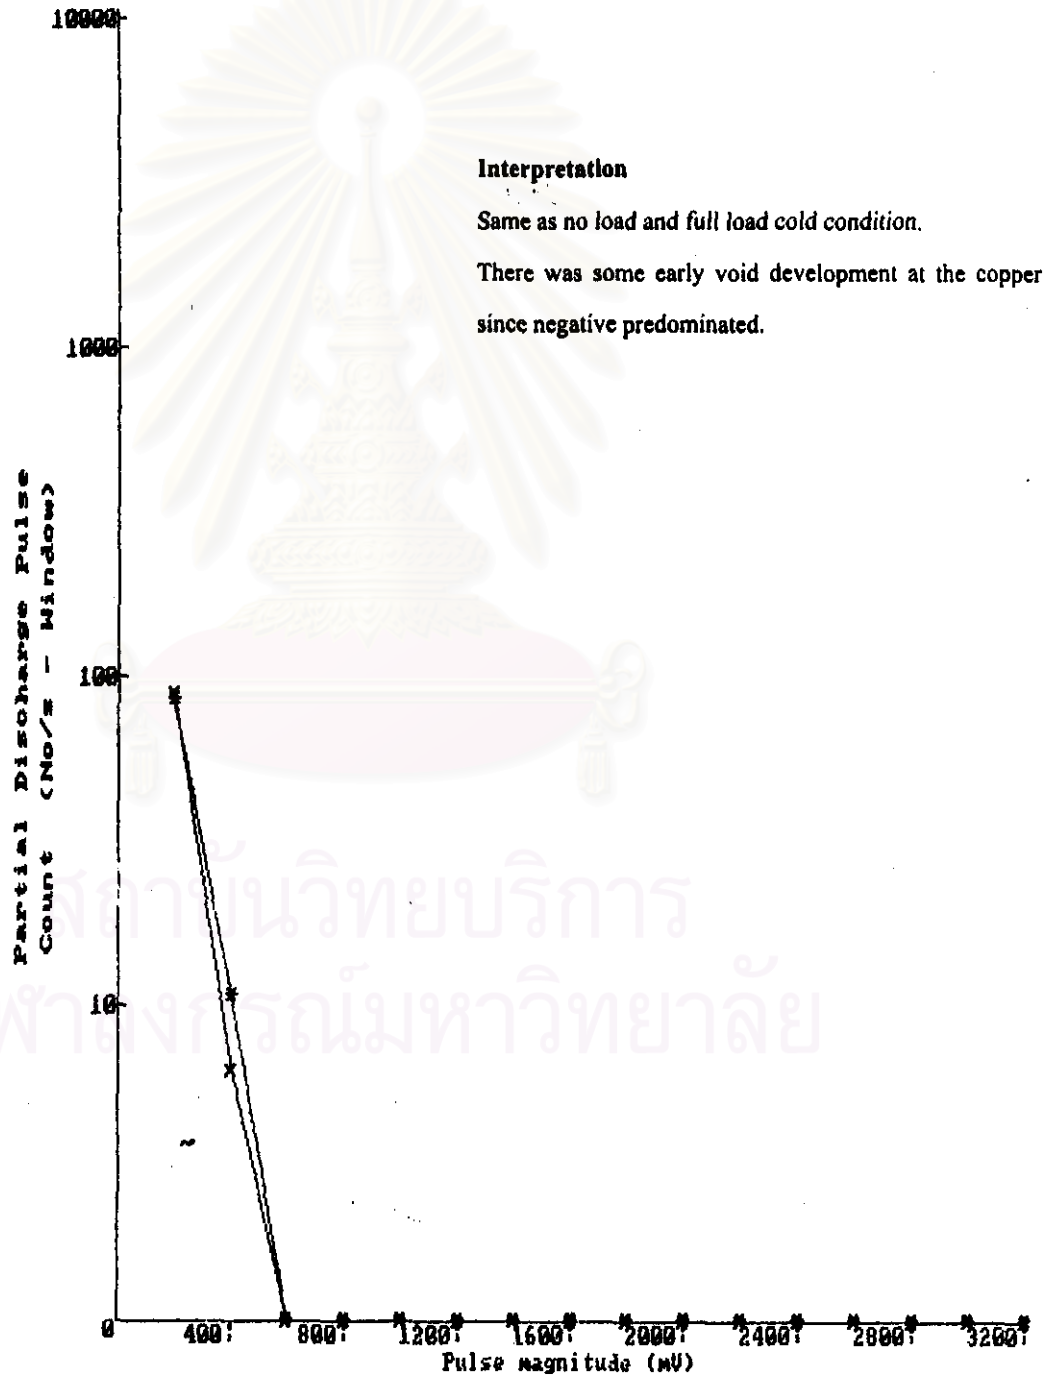
Fig. 4.1.3.7 Data measurement of C Phase, parallel 1

D:\PDAH\PDAH\STATIONA\GEN1\SKT02C05.053 C Phase Coupler 1  
 Tested on Thu Jun 23,1998 at 10:07:17 Coupler pair C05 Gain 0.50  
 Voltage reference 207 Temp 68 C Full Load, Hot Synchronized  
 Power 81 MW Reactive 0 MX Voltage 13.8 Differential Mode  
 Positive Pulses (x) NQN 348 Negative Pulses (\*) NQN 390

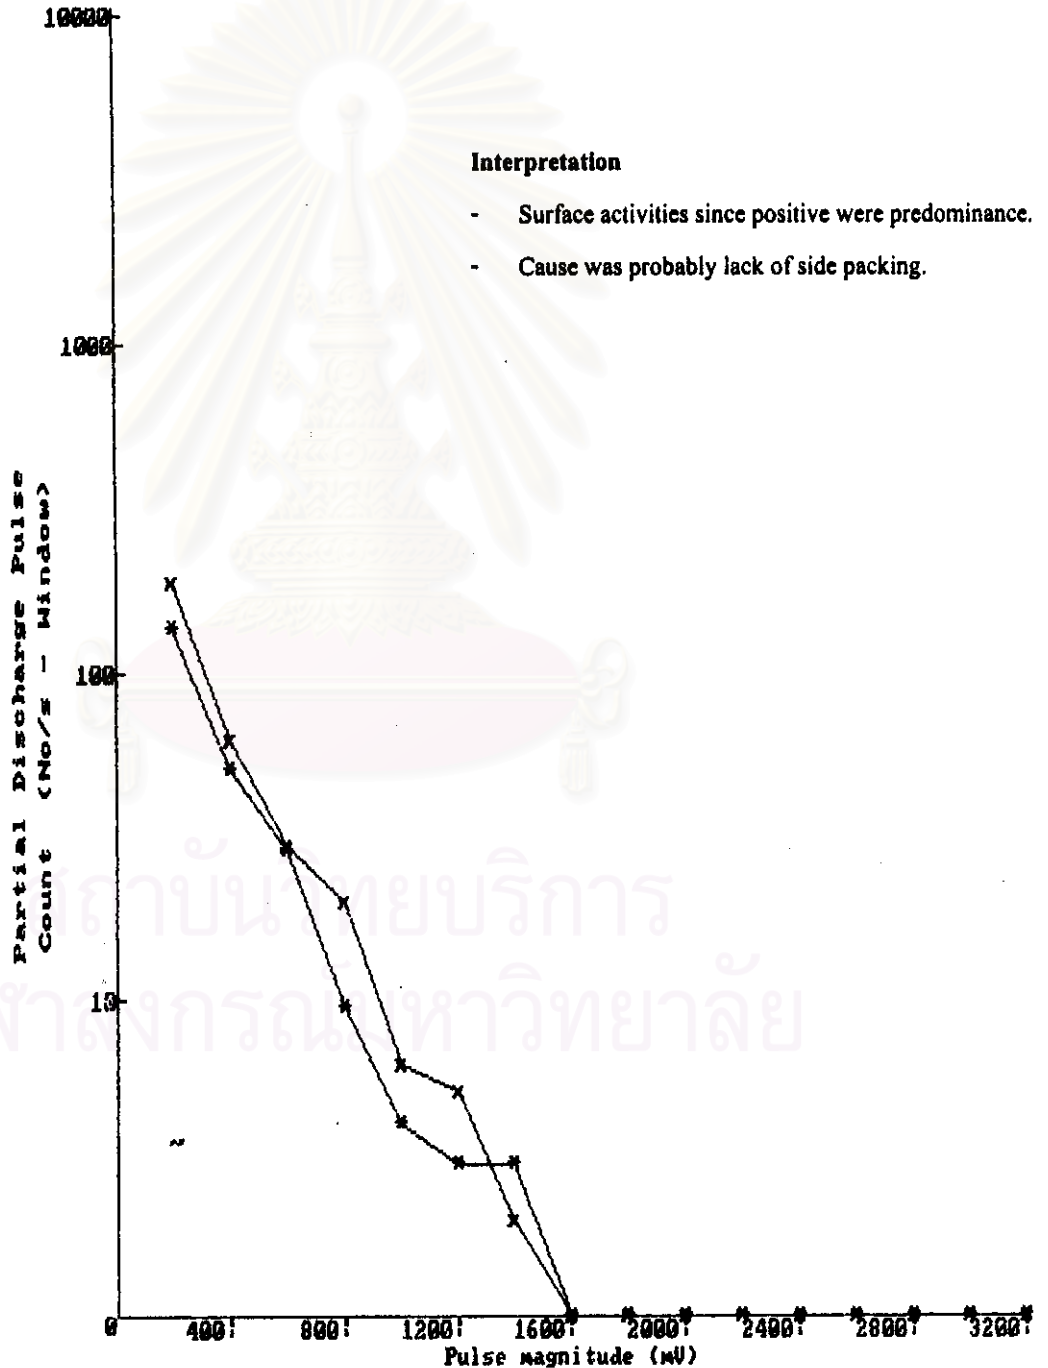
Fig. 4.1.3.9 Data measurement of C Phase, parallel 3

D:\PDAH\PDAH\STATIONA\GEN1\SKT02C06.054 C Phase Coupler 2  
 Tested on Thu Jun 23,1998 at 10:09:32 Coupler pair C06 Gain 0.50  
 Voltage reference 212 Temp 68 C Full Load, Hot Synchronized  
 Power 81 MW Reactive 0 MX Voltage 13.8 Differential Mode  
 Positive Pulses (x) NQN 1480 Negative Pulses (\*) NQN 1335
