## **CHAPTER 4**

### **RESULTS OF TESTING AND INTERPRETATION**

On line partial discharge tests on Sirikit hydroelectric generator unit 2 was taken on 4 conditions of test procedure. The tests applied to each of coupler of three phases winding (total 9 couplers). The test data were displayed in form of partial discharge graphs. Using experience papers as defined in section 2.65 of CHATER 2. The measuring procedure was set up into four conditions of test in order to see some effects of temperature and load forces. That experience literature also guided to interpret the data of measurement and table of Chart I and Chart II were also very useful to guide to interpret all data of measurement of generator unit 2.

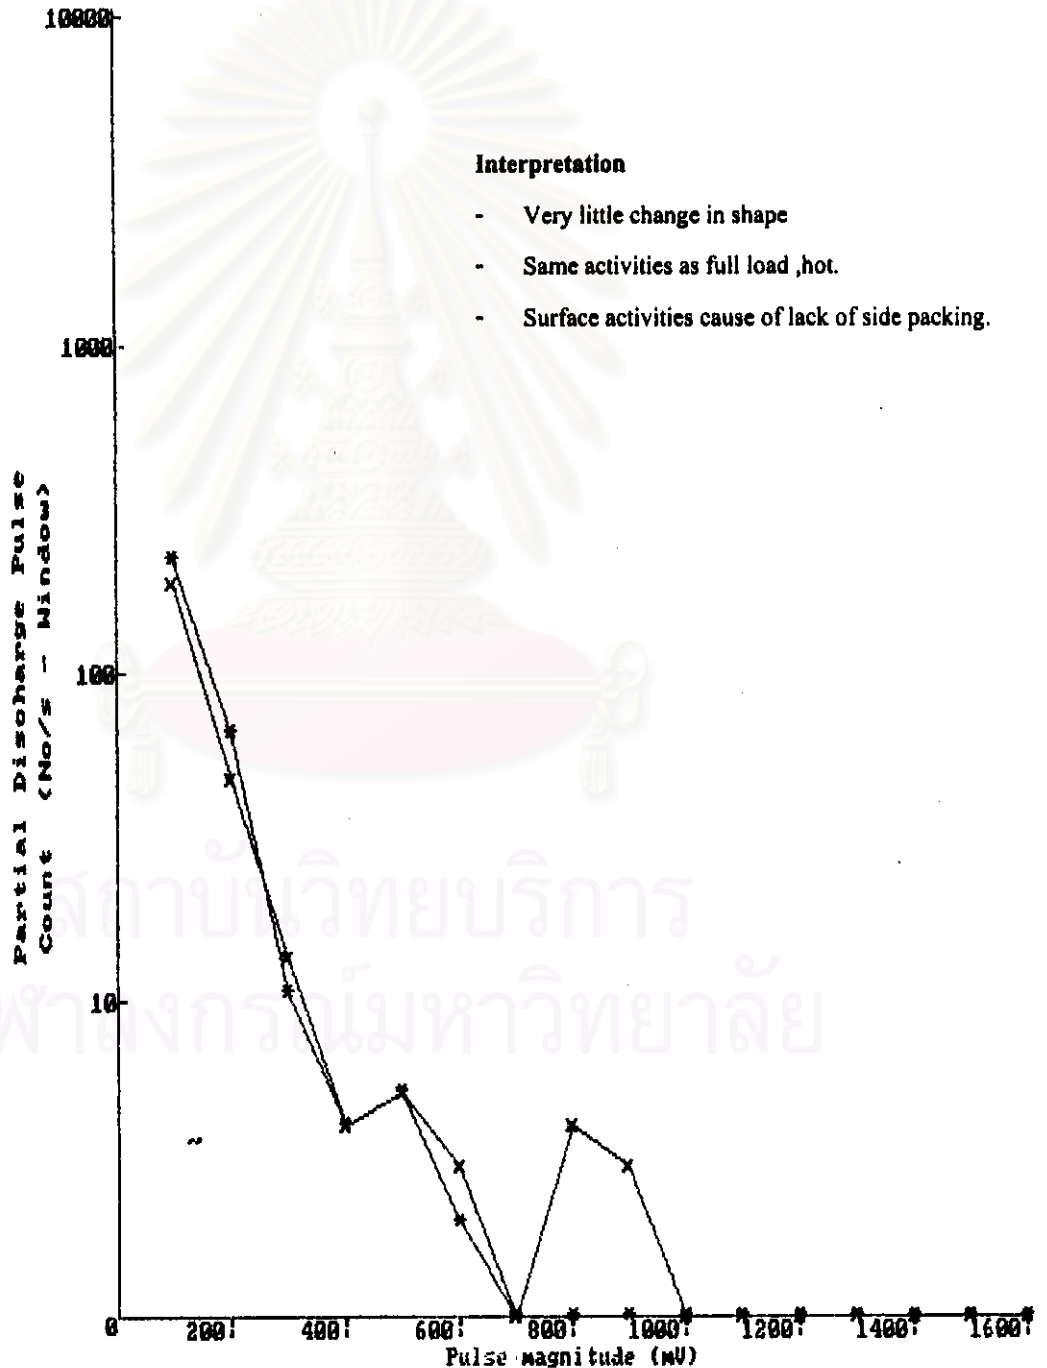
Fig. 4.1.4.1 Data measurement of A Phase, parallel 1

D:\PDAH\PDAH\STATIONA\GEN1\SKT02A01.055 A Phase Coupler 1  
 Tested on Thu Jun 23,1998 at 10:36:13 Coupler pair A01 Gain 1.00  
 Voltage reference 218 Temp 64 C No Load, Hot Synchronized  
 Power 0 MW Reactive 0 MX Voltage 13.8 Differential Mode  
 Positive Pulses (x) NQN 675 Negative Pulses (\*) NQN 556

Winding parallel path 1 and 3 of phase A were the same. There were internal discharges and surface deterioration within winding insulation. Path 3 also had positive pulses predominated cause of surface discharges around coil surface in slot portion

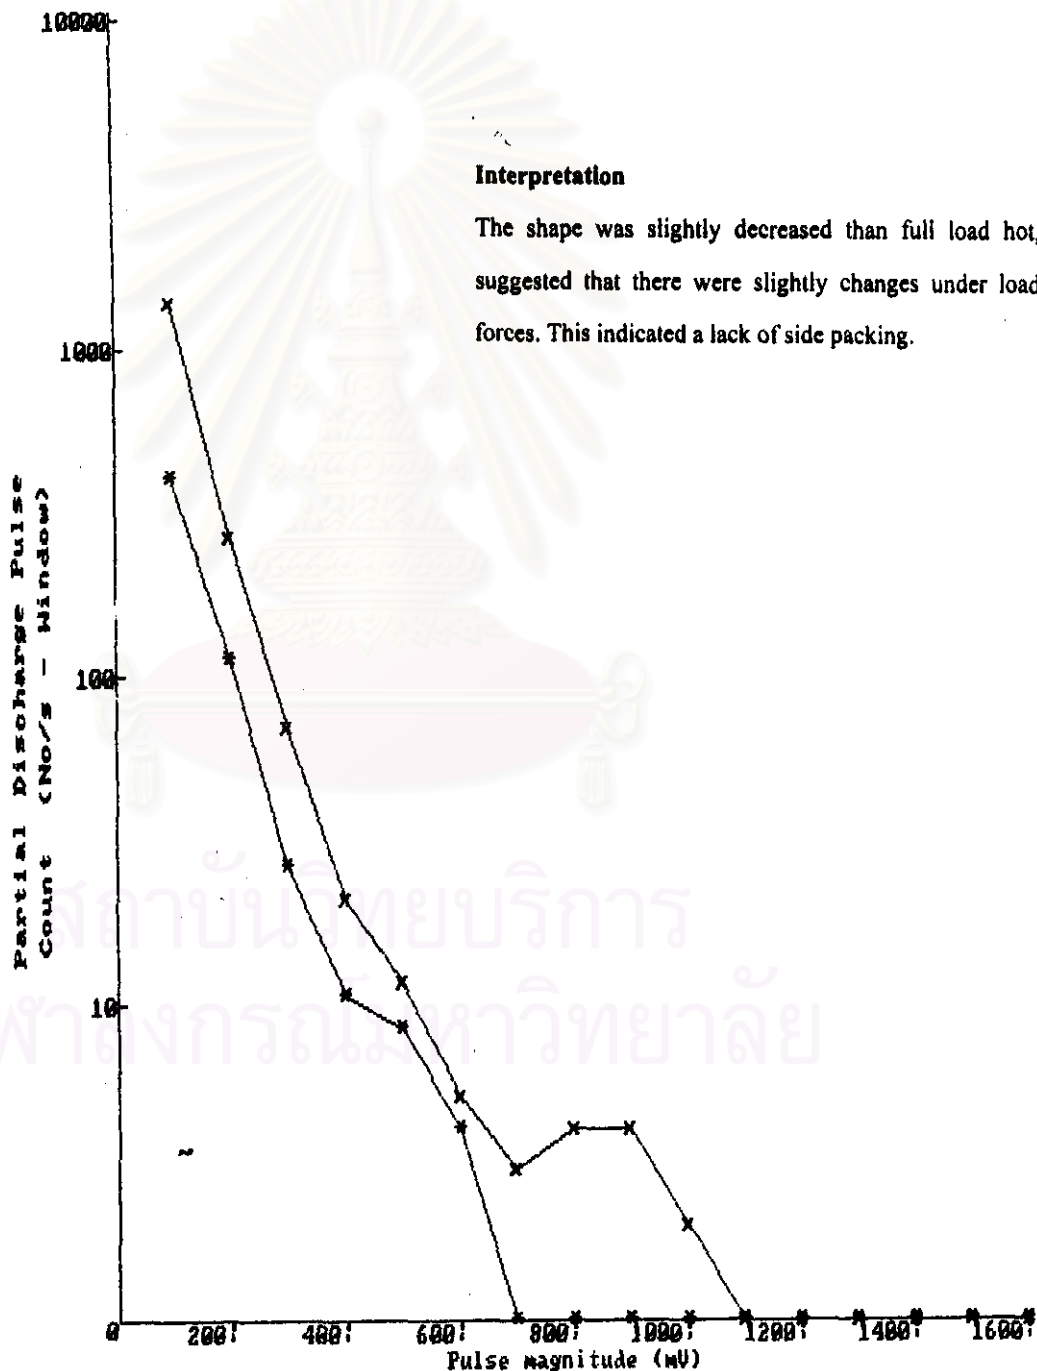
Fig. 4.1.4.3 Data measurement of A Phase parallel 3

D:\PDAH\PDAH\STATIONA\GEN1\SKT02A02.056 A Phase Coupler 2  
 Tested on Thu Jun 23,1998 at 10:38:21 Coupler pair A02 Gain 1.00  
 Voltage reference 226 Temp 64 C No Load, Hot Synchronized  
 Power 0 MW Reactive 0 MX Voltage 13.8 Differential Mode  
 Positive Pulses (x) NQN 1080 Negative Pulses (\*) NQN 722

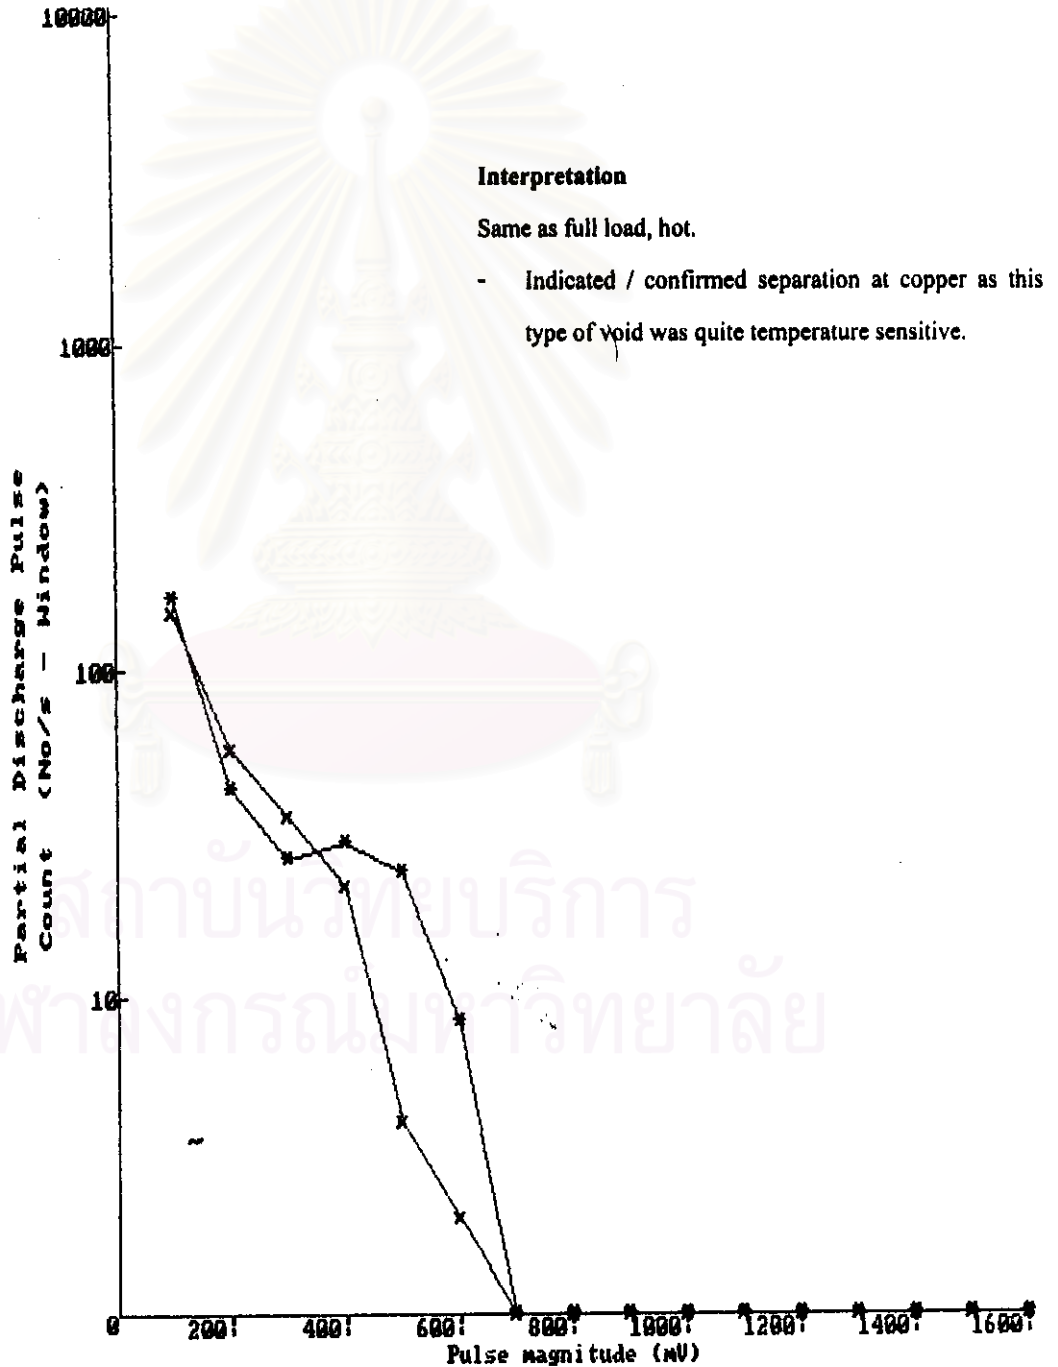
Fig. 4.1.4.4 Data measurement of B Phase, parallel 1

D:\PDAH\PDAH\STATIONA\GEN1\SKT02B03.057 B Phase Coupler 1  
 Tested on Thu Jun 23,1998 at 10:40:36 Coupler pair B03 Gain 1.00  
 Voltage reference 218 Temp 64 C No Load, Hot Synchronized  
 Power 0 MW Reactive 0 MX Voltage 13.8 Differential Mode  
 Positive Pulses (x) NQN 657 Negative Pulses (\*) NQN 781

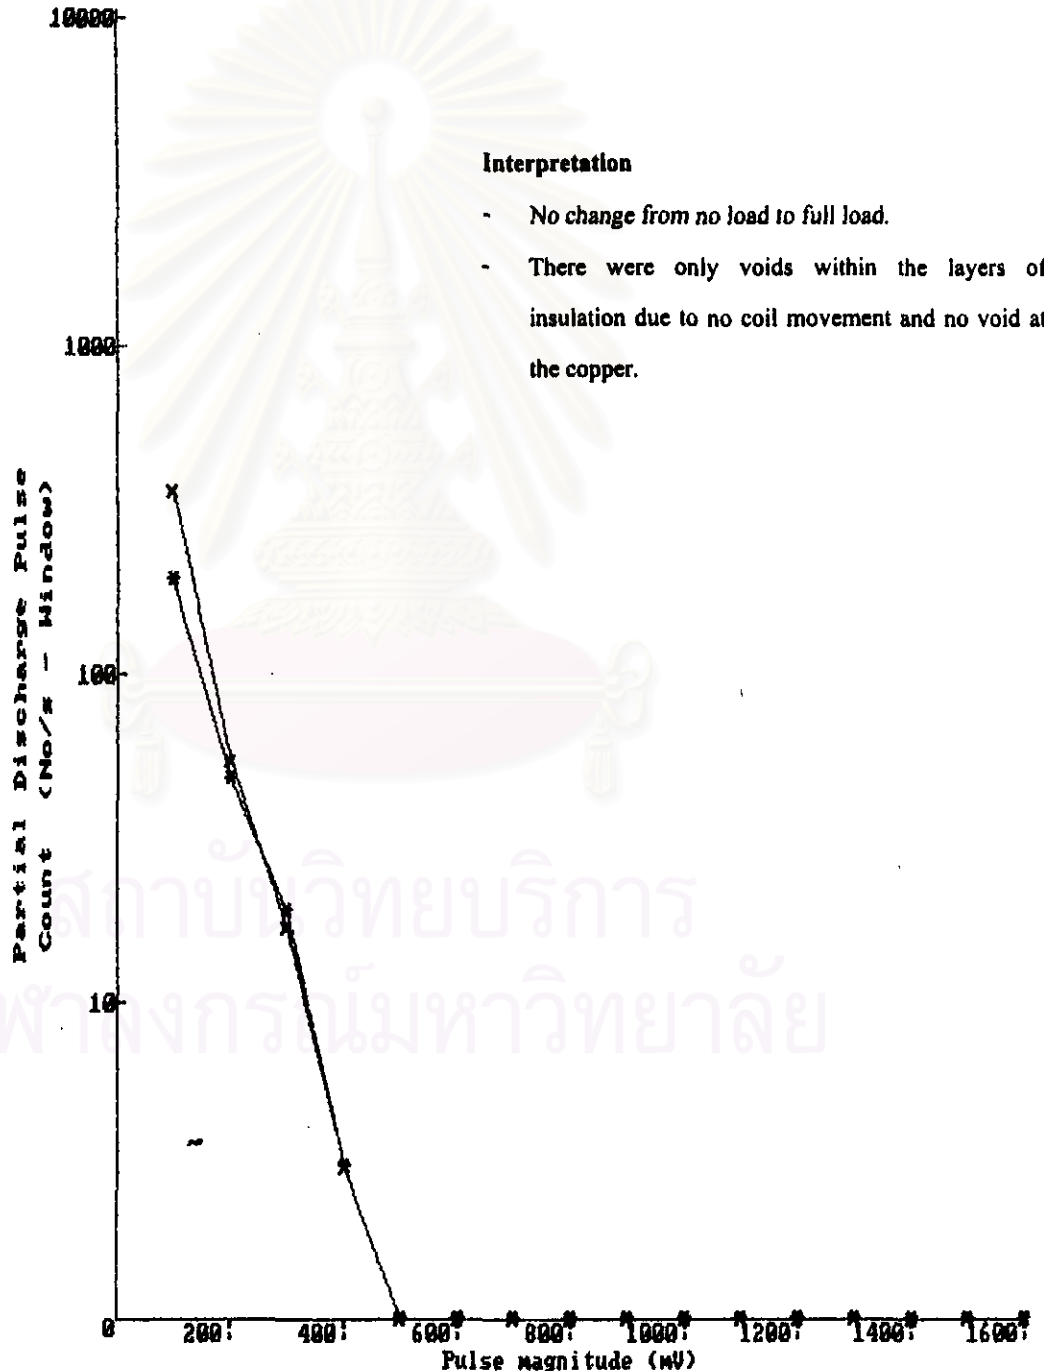
Fig. 4.1.4.5 Data measurement of B Phase, parallel 2

D:\PDAH\PDAH\STATIONA\GEN1\SKT02B03.057 B Phase Coupler 2  
 Tested on Thu Jun 23, 1998 at 10:40:38 Coupler pair B03 Gain 1.00  
 Voltage reference 218 Temp 64 C No Load, Hot Synchronized  
 Power 0 MW Reactive 0 MX Voltage 13.8 Differential Mode  
 Positive Pulses (x) NQN 466 Negative Pulses (\*) NQN 451

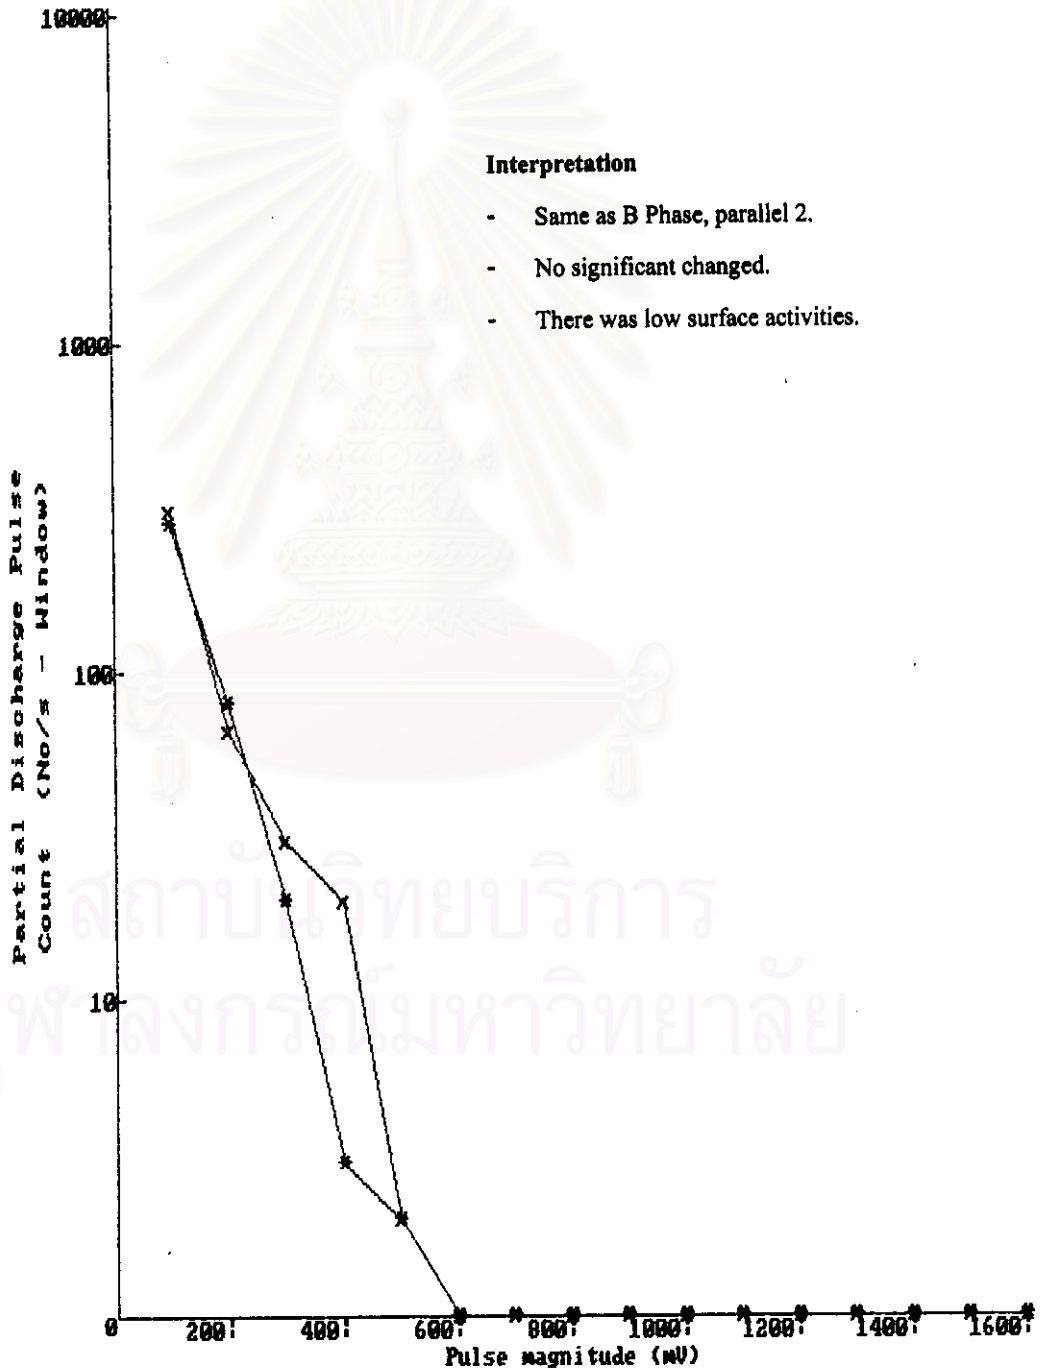
Fig. 4.1.4.6 Data measurement of B Phase, parallel 3

D:\PDAH\PDAH\STATIONA\GEN1\SKT02B04.058 B Phase Coupler 2  
Tested on Thu Jun 23,1998 at 10:42:46 Coupler pair B04 Gain 1.00  
Voltage reference 222 Temp 64 C No Load, Hot Synchronized  
Power 0 MW Reactive 0 MX Voltage 13.8 Differential Mode  
Positive Pulses (x) NQN 607 Negative Pulses (\*) NQN 515

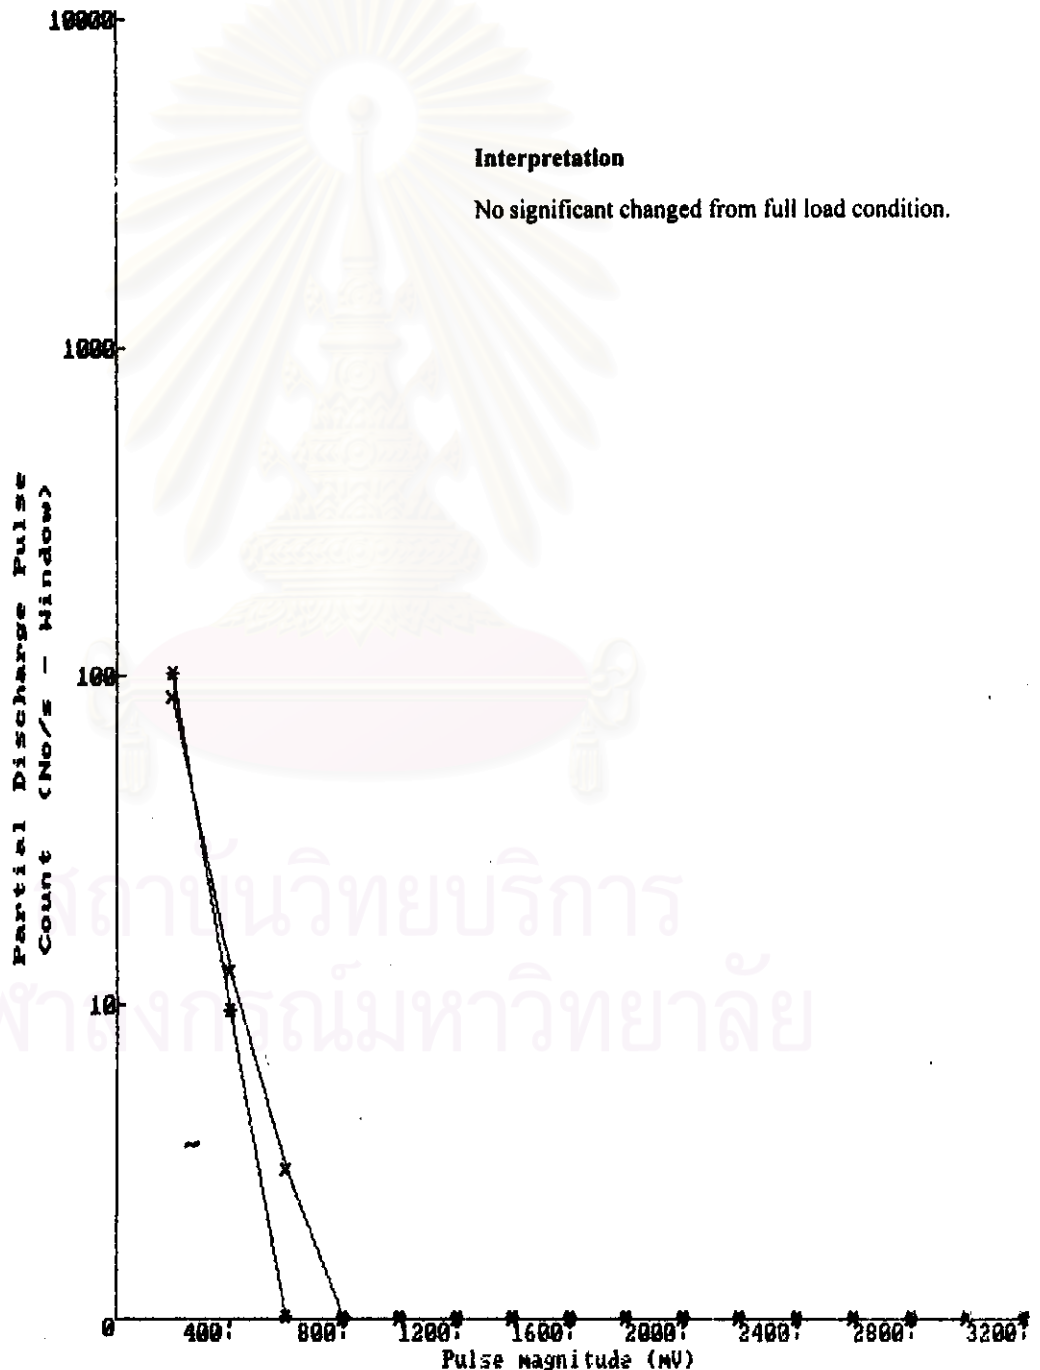
Fig. 4.1.4.7 Data measurement of C Phase, parallel 1

D:\PDAH\PDAH\STATIONA\GEN1\SKT02C05.059 C Phase Coupler 1  
 Tested on Thu Jun 23,1998 at 10:45:11 Coupler pair C05 Gain 0.50  
 Voltage reference 217 Temp 64 C No Load, Hot Synchronized  
 Power 0 MW Reactive 0 MX Voltage 13.8 Differential Mode  
 Positive Pulses (x) NQN 502 Negative Pulses (\*) NQN 388

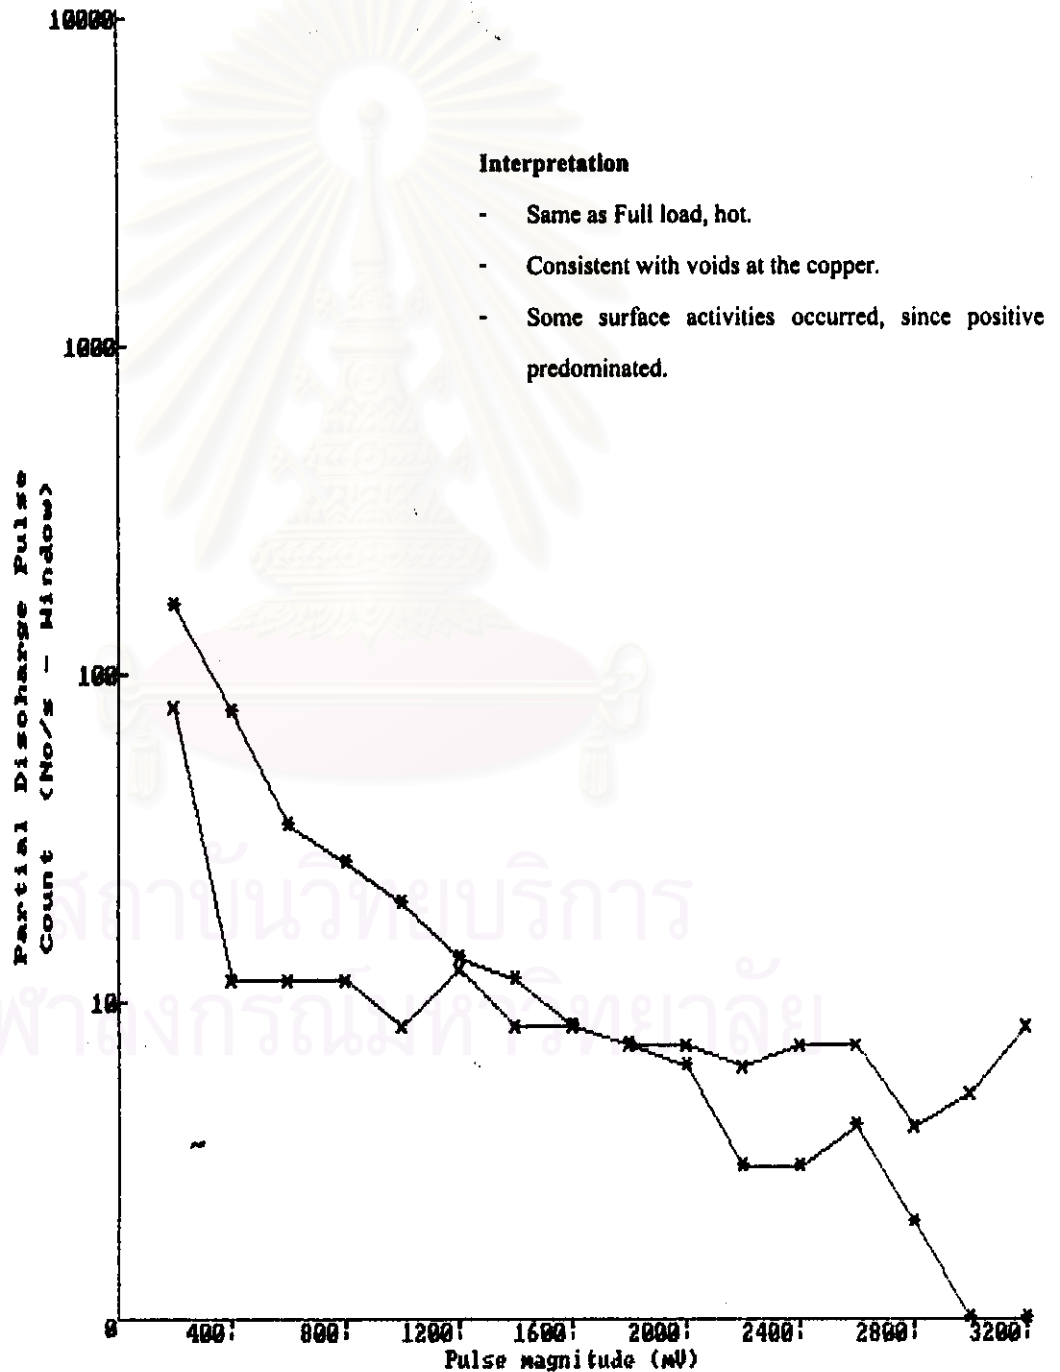
Fig. 4.1.4.8 Data measurement of C Phase, parallel 2

D:\PDAH\PDAH\STATIONA\GEN1\SKT02C05.059 C Phase Coupler 2  
 Tested on Thu Jun 23,1998 at 10:45:11 Coupler pair C05 Gain 0.50  
 Voltage reference 217 Temp 64 C No Load, Hot Synchronized  
 Power 0 MW Reactive 0 MX Voltage 13.8 Differential Mode  
 Positive Pulses (x) NQN 3033 Negative Pulses (\*) NQN 2738  
 NQN inaccurate due to high PD activity

From 4 condition test data, there were high partial discharge activities occurred within parallel path 2 of phase C. the overall picture of stator winding showed a lot of partial discharge activities occurred around stator winding, mostly were interface discharges and surface discharge respectively. There was a few effect of a change in vibration that might be less looseness of coils in slot portion. The temperature had effected to partial discharge activities. High temperature condition showed higher partial discharge activities than low temperature.

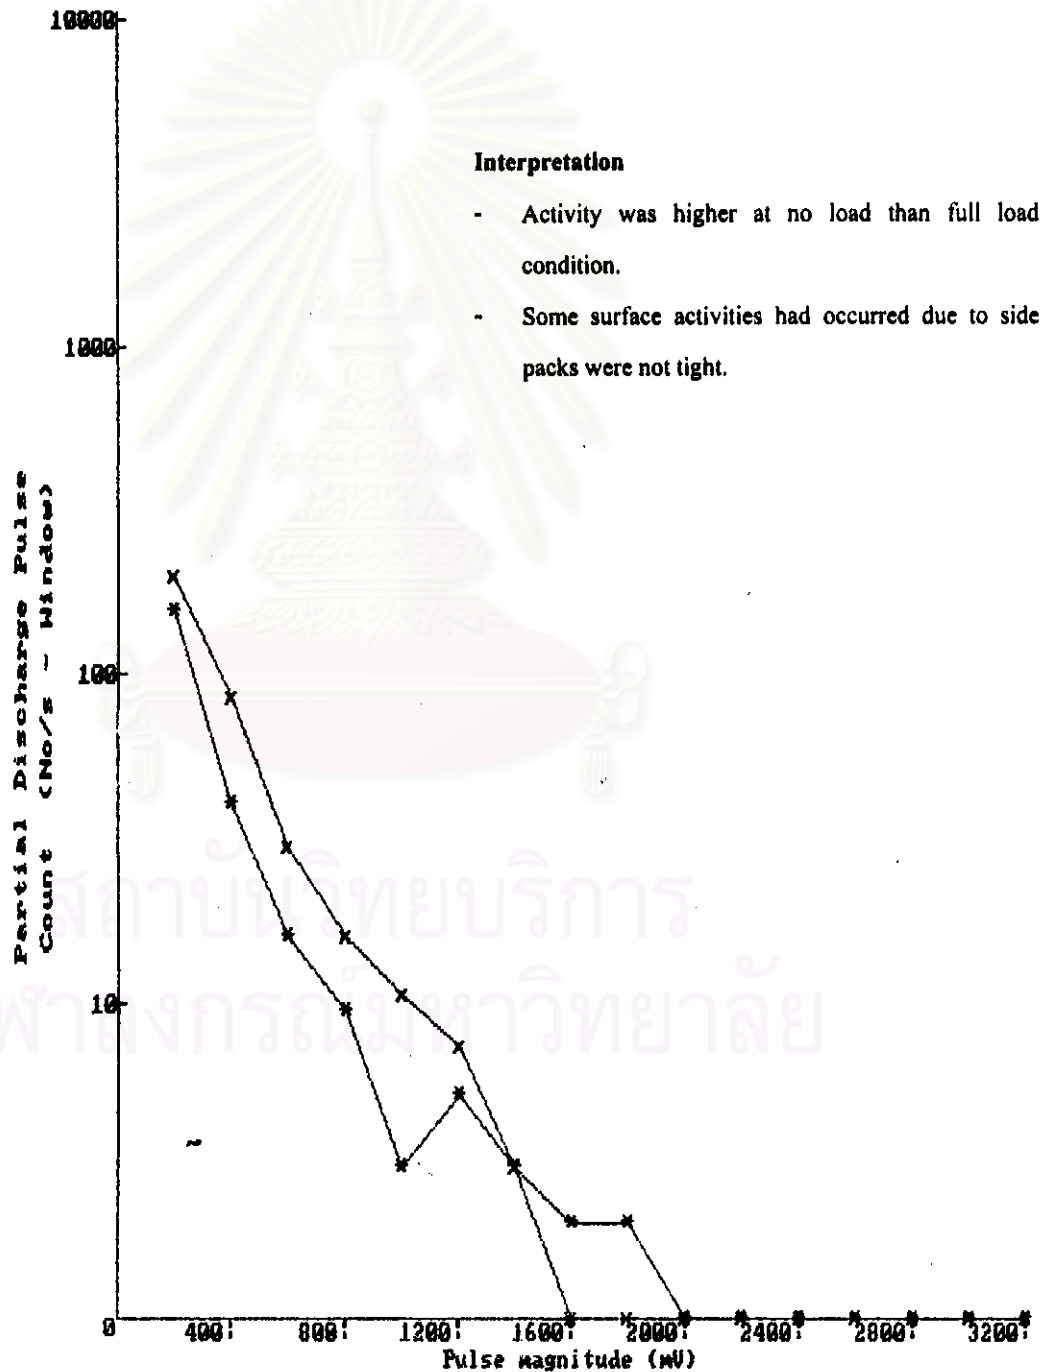
Fig. 4.1.4.9 Data measurement of C Phase, parallel 3

D:\PDAH\PDAH\STATIONA\GEN1\SKT02C06.060 C Phase Coupler 2  
 Tested on Thu Jun 23, 1998 at 10:47:33 Coupler pair C06 Gain 0.50  
 Voltage reference 221 Temp 64 C No Load, Hot Synchronized  
 Power 0 MW Reactive 0 MX Voltage 13.8 Differential Mode  
 Positive Pulses (x) NQN 1597 Negative Pulses (\*) NQN 1410

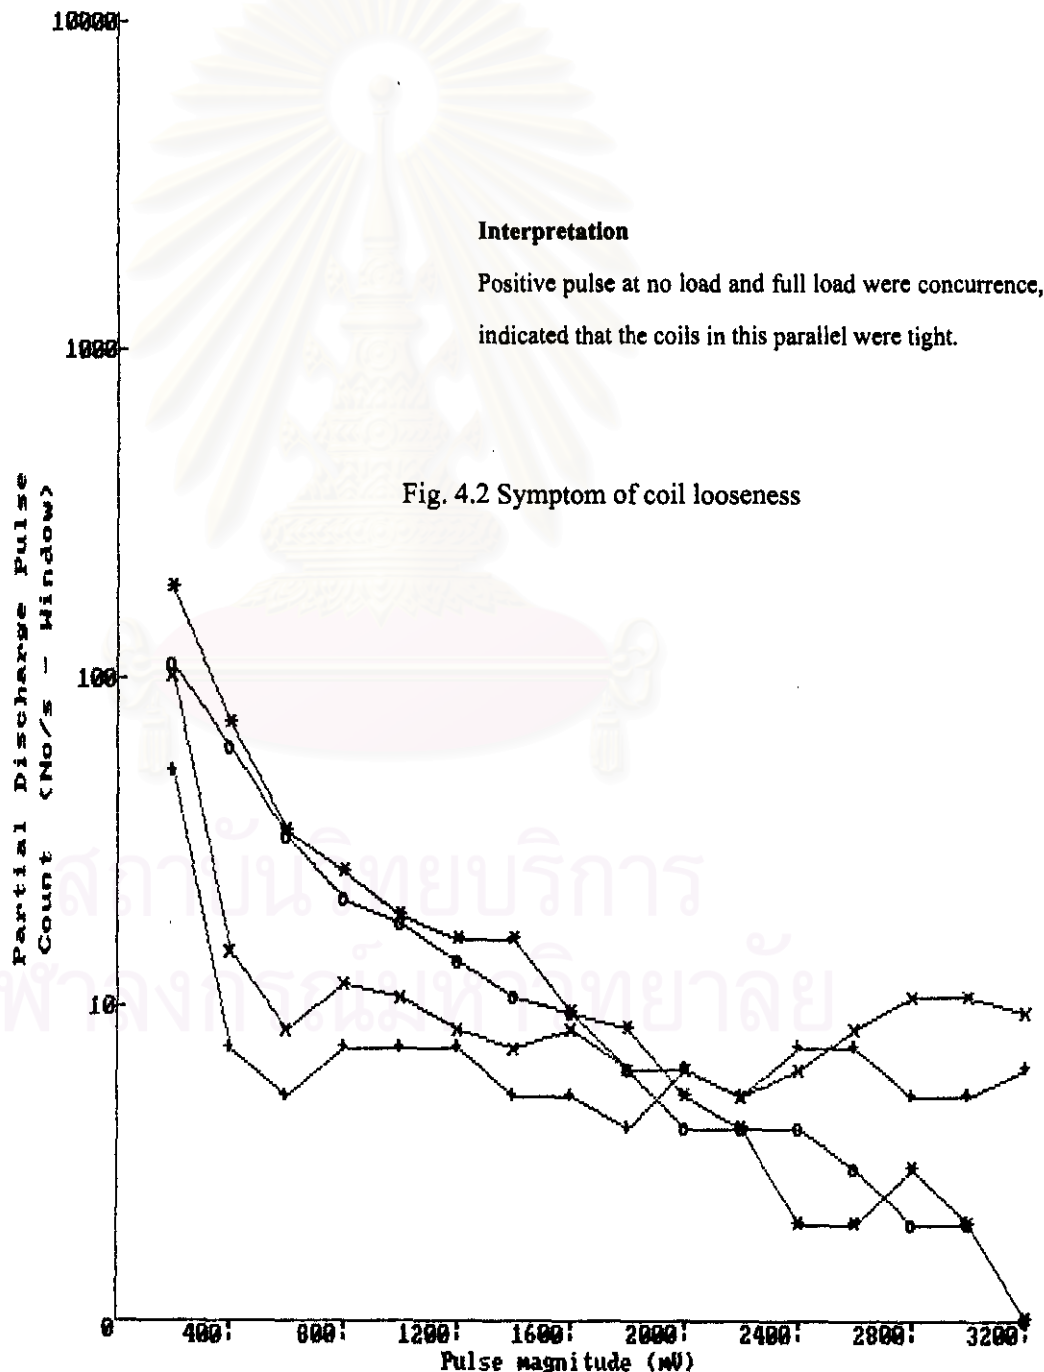
Winding parallel path 2 of phase C showed the same pattern of curves as two conditions in the first stage. With higher vibration and temperature, there was large amount of partial discharge activities occurring. The negative pulses were predominance, showing in high interface discharges occurring. There were delaminating between copper conductor and main ground insulation. However, the positive pulses were also predominant, meaning in high surface discharges occurring on coil surfaces. The overall picture showed high partial discharge activities occurred around stator winding (high amount of NQN, high magnitude and pulse rate).

D:\PDAH\PDAH\STATIONA\GEN1\SKT02C05.053 C Phase Coupler 2  
 Tested on Thu Jun 23,1998 at 10:07:17 Coupler pair C05 Gain 0.50  
 Voltage reference 207 Temp 68 C Full Load, Hot Synchronized  
 Power 81 MW Reactive 0 MX Voltage 13.8 Differential Mode  
 Positive Pulses (x) NQN 3080 Negative Pulses (\*) NQN 2798  
 NQN inaccurate due to high PD activity
