CHAPTER VIII

ROCK PORTAL SLOPE STABILITY ANALYSIS

MASTER THESIS: *GEOMECHANICAL ASPECTS AND THEIR APPLICATIONS TO THE DIVERSION TUNNEL STABILITY AT CHIEW LARN DAM SITE, CHANWAT SURAT THANI*

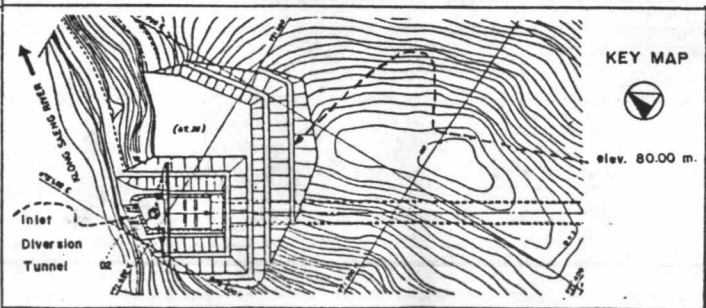
Figure 8.6

The orientation and the traces of major discontinuities are illustrated in Figures 8.6 and 8.7. These discontinuities are favorable oriented, with respect to the slope stability, as they dip into the rock mass. In a case of two discontinuities, the line of intersection also dips into the slope. For the left channel side of the diversion tunnel upstream portal, however, the orientation of the discontinuities is less favorable and at the elevation 41.50 to 47.30 m two small wedges were inferred (Figure 8.8). They might become unstable once the excavation reaches the final depth, provided that the discontinuities are assumed persistent.

The rocks are subarkosic sandstones and slightly weathered pebbly graywackes. The subarkosic sandstones overlie the pebbly graywackes with a sharp contact as illustrated in Figure 8.6. The rock mass quality is good for both rock types. The observed stability condition is stable and from the analysis result, it is also stable.

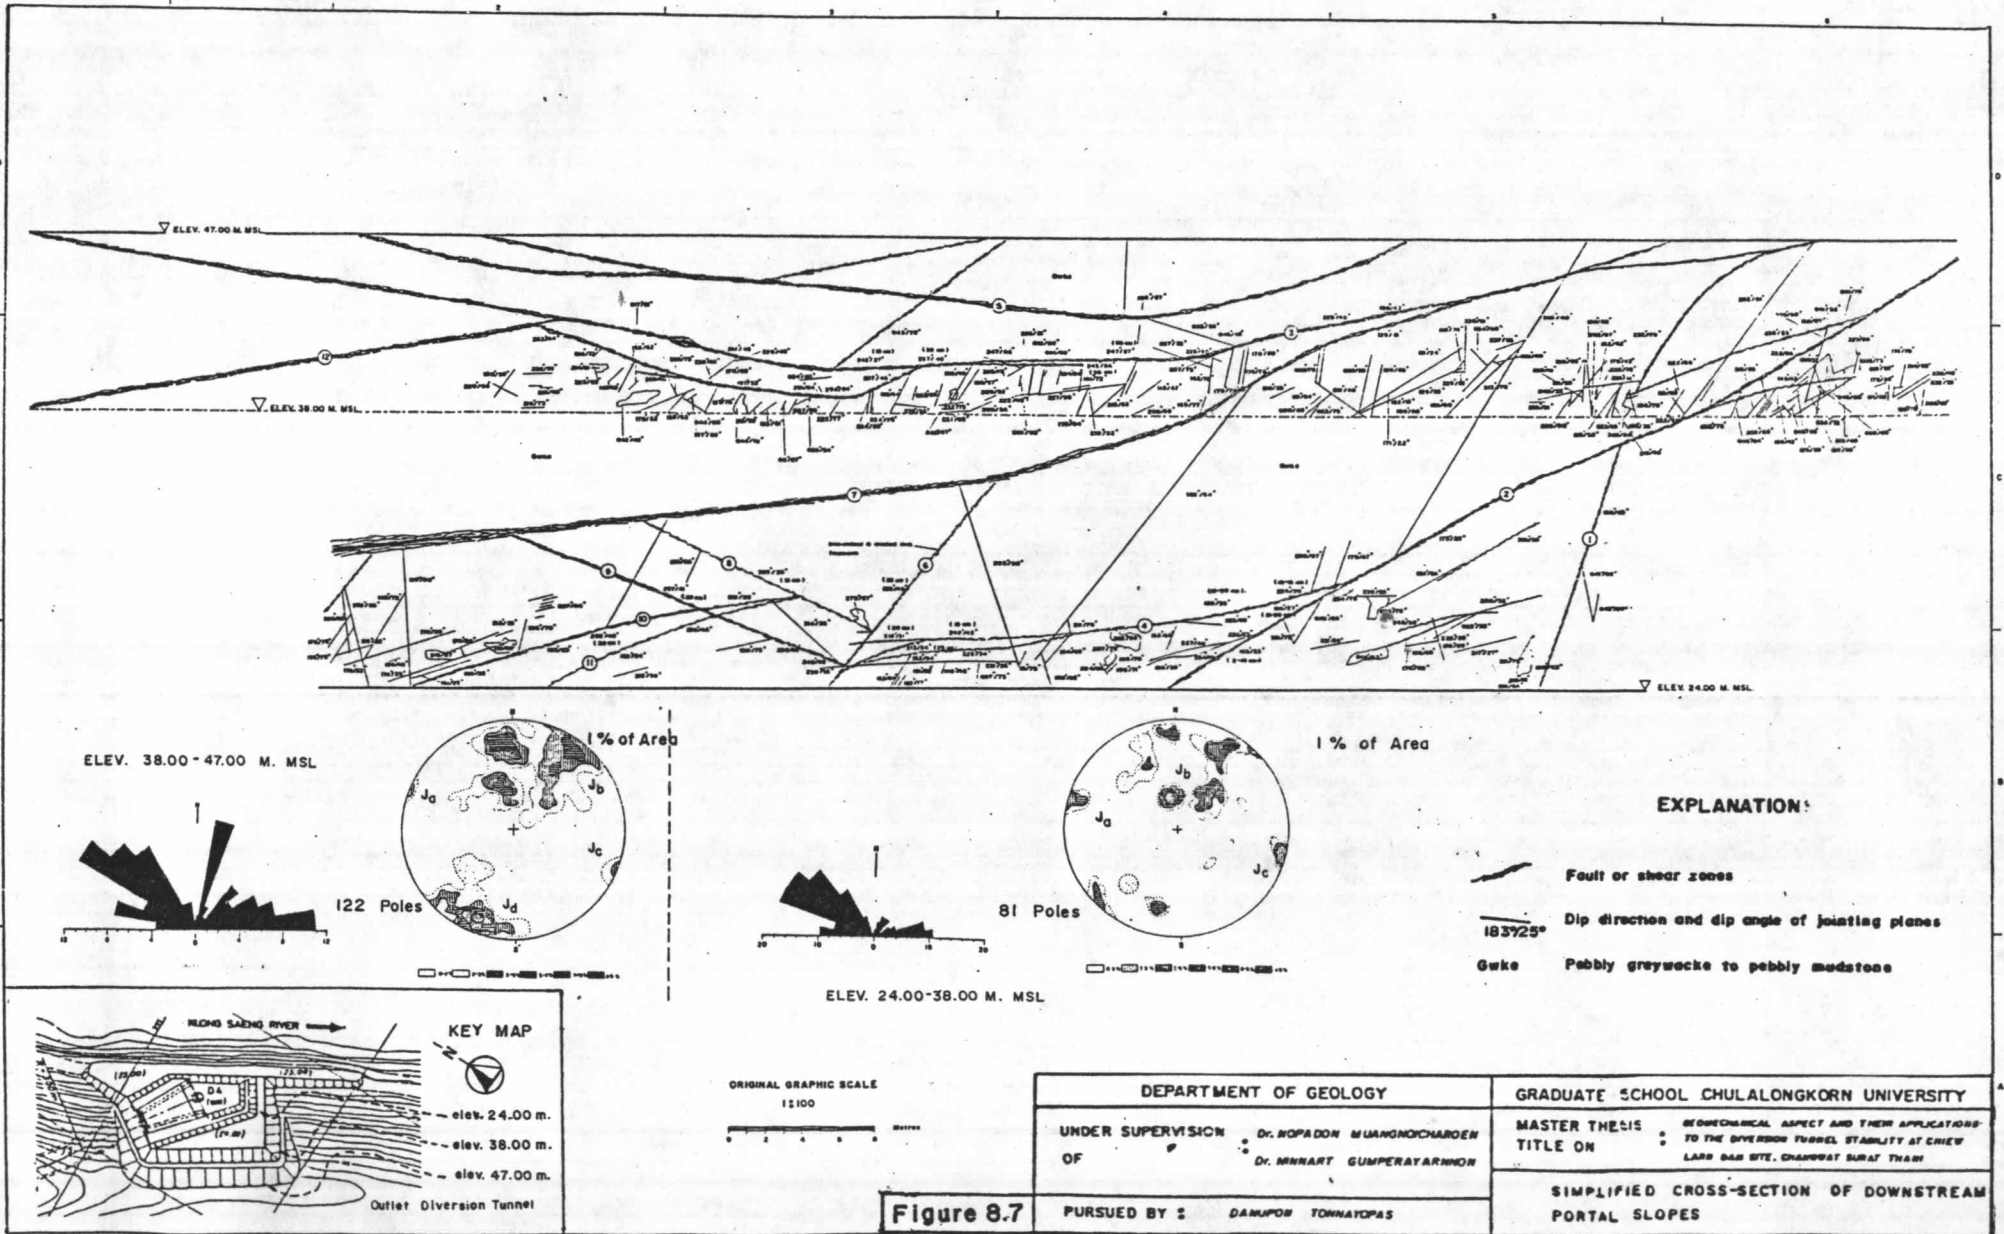
Figure 8.8 Panorama of upstream diversion tunnel.

The geologic condition at the downstream portal is more critical as the rocks more weathered and fractured than at the upstream side (Figures 8.8 and 8.9). The rocks of downstream portals similar to the zone above elevation 60.00 m at the upstream portal.
