CHAPTER VII

HYDROLOGICAL INVESTIGATION

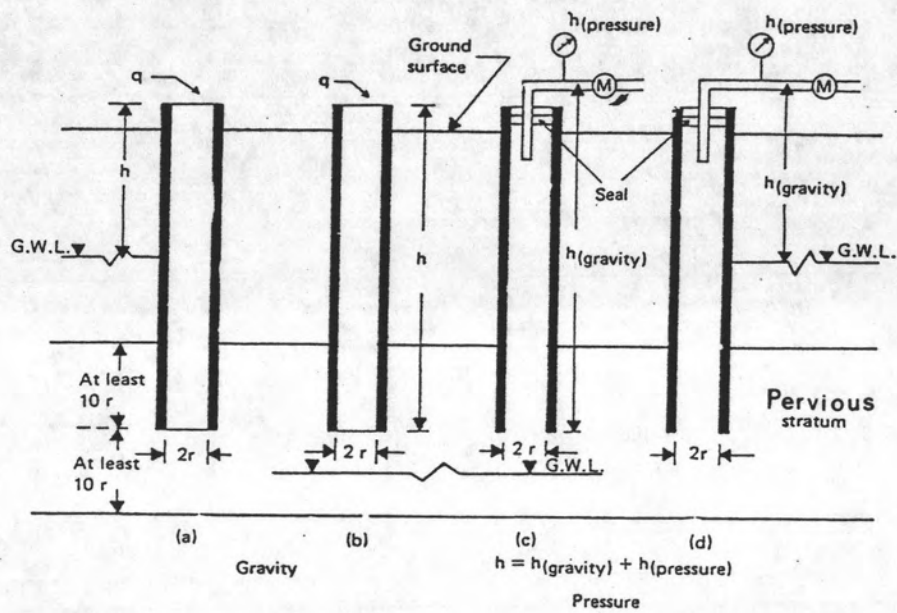
Figure 7.3 Open-end test for soil permeability in the field. (After U.S. Bureau of Reclamation, 1961).

The in-place permeability tests were performed in the soils at the slide area using bore hole test techniques namely open-end test method recommended by United States Bureau of Reclamation (USBR), (1961). The condition in Figure 7.3b was chosen to determine the permeability. The determination procedure is as follows:
