CHAPTER 6

EVIDENCES OF DEBRIS FLOW-FLOOD ACTIVITIES IN THE ALLUVIAL FAN

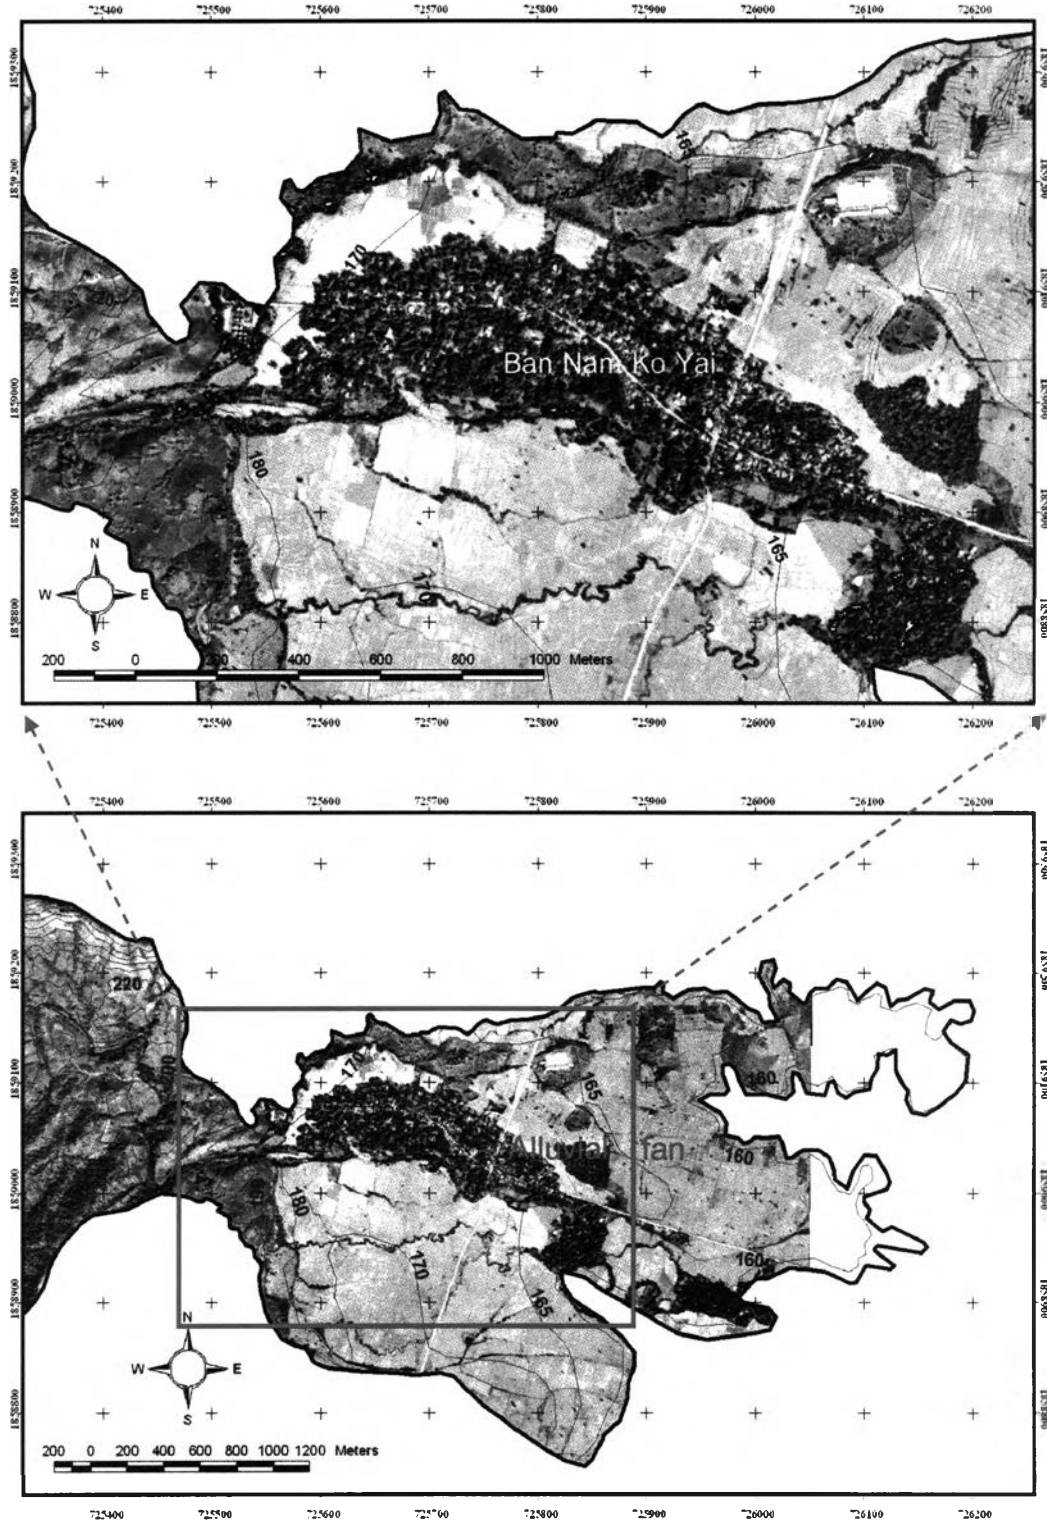
Figure 6-1 Aerial photograph (1:15,000 scale) acquired on 24th December 1974 showing characteristics of the alluvial fan at the canyon mouth of Nam Ko Yai stream with contour intervals (in the solid red-line block).

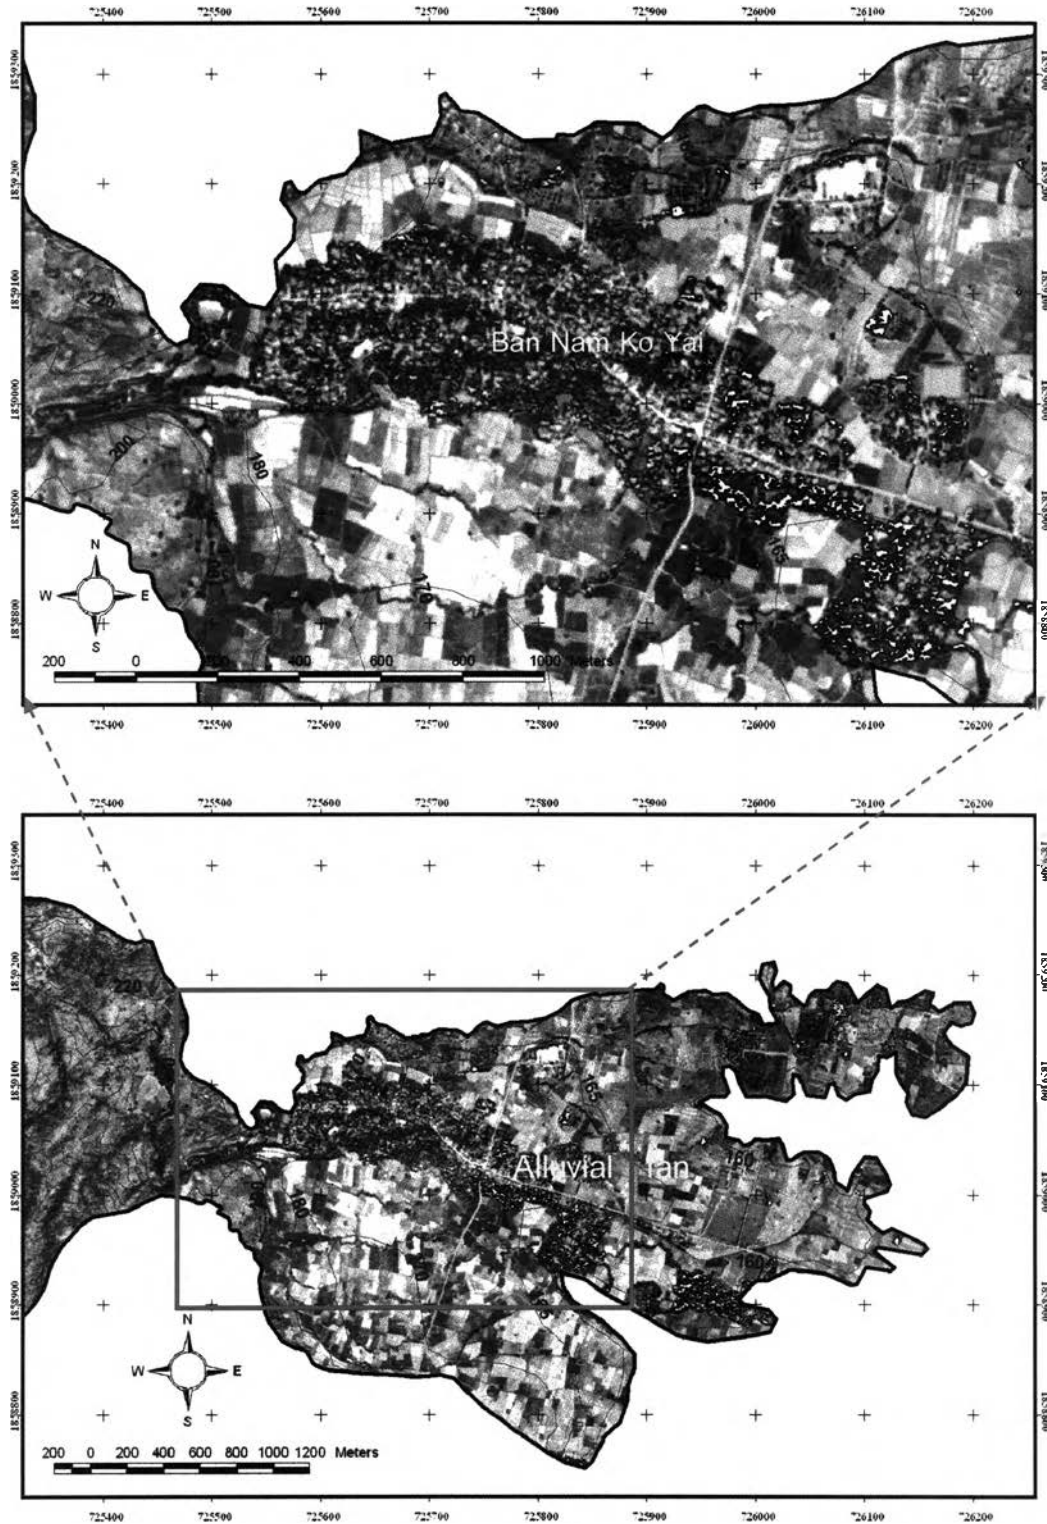
Figure 6-2 Orthophotograph (1:50,000 scale) acquired on 6th January 1996 showing characteristics of the alluvial fan at the canyon mouth of Nam Ko Yai stream without significant change in land cover.

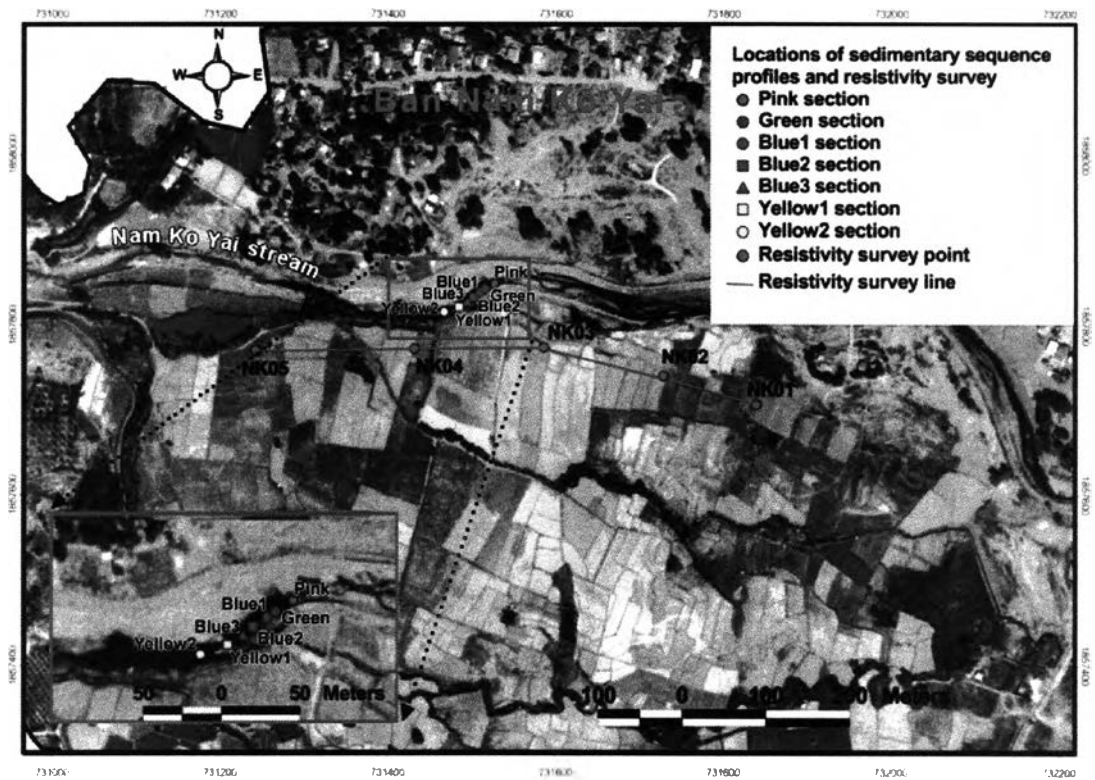
According to the resistivity survey in the alluvial fan along the lines NK 01 – NK 05 (as shown in Figure 6-9) to identify the local subsurface geology (thickness and depth of the previous alluvial fan deposits), the results revealed four sedimentary units at a total depth of less than 100 m below ground surface (Figure 6-10). The lowest unit was semi-unconsolidated sediments or weathered rocks of at least 70 m thick to the west with the bed top be noted at a depth of about 30 m below ground surface, and much thinner, less than 10 m to the east, with the bed top be noted at the depth of about 80 m below ground surface.

Figure 6-9 Location map of the seven measured stratigraphic profiles and a line of five resistivity survey points used for investigating the stratigraphic recognition and local subsurface geology of the previous alluvial fan deposits.

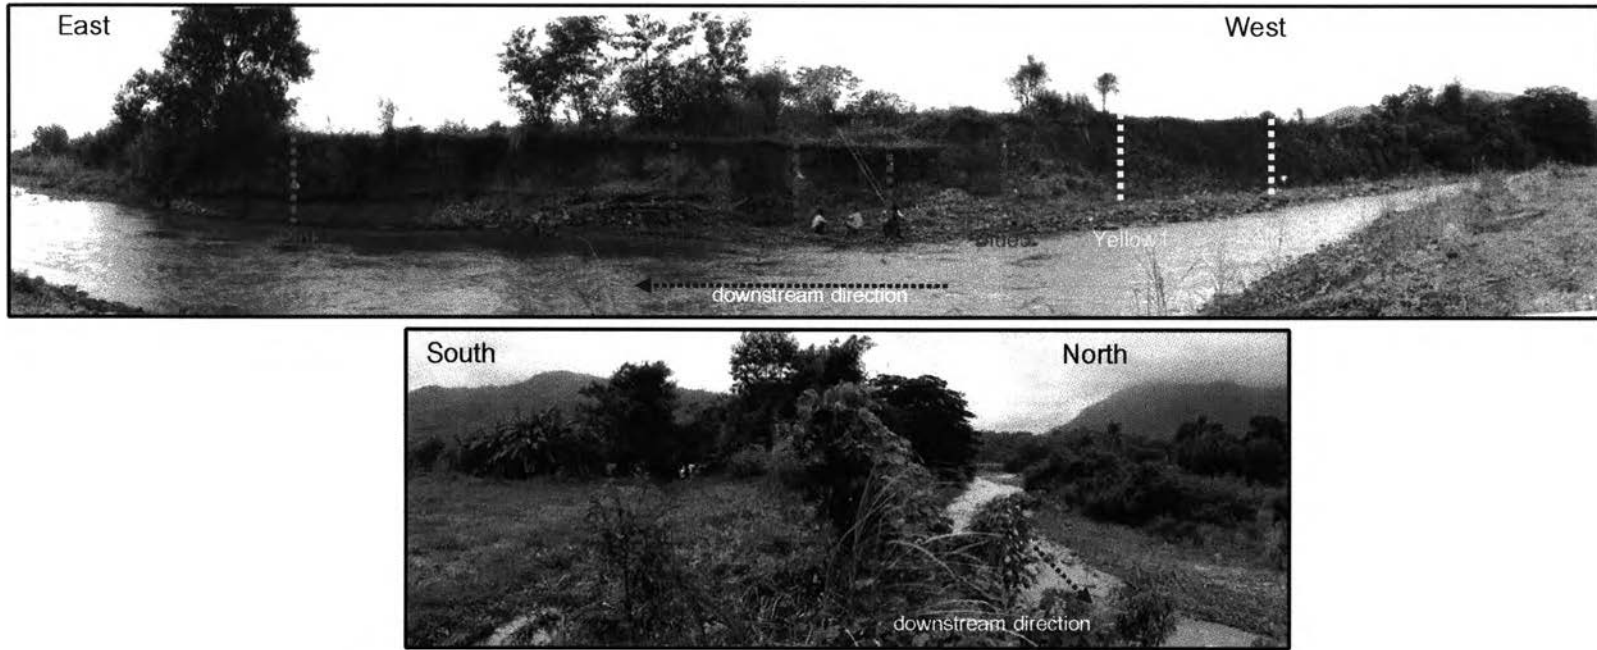
Figure 6-11 Photographs illustrating the actual location of the seven measured stratigraphic profiles (zones Pink, Green, Blue1, Blue2, Blue3, Yellow1 and Yellow2) along the eroded-bank of Nam Ko Yai stream.

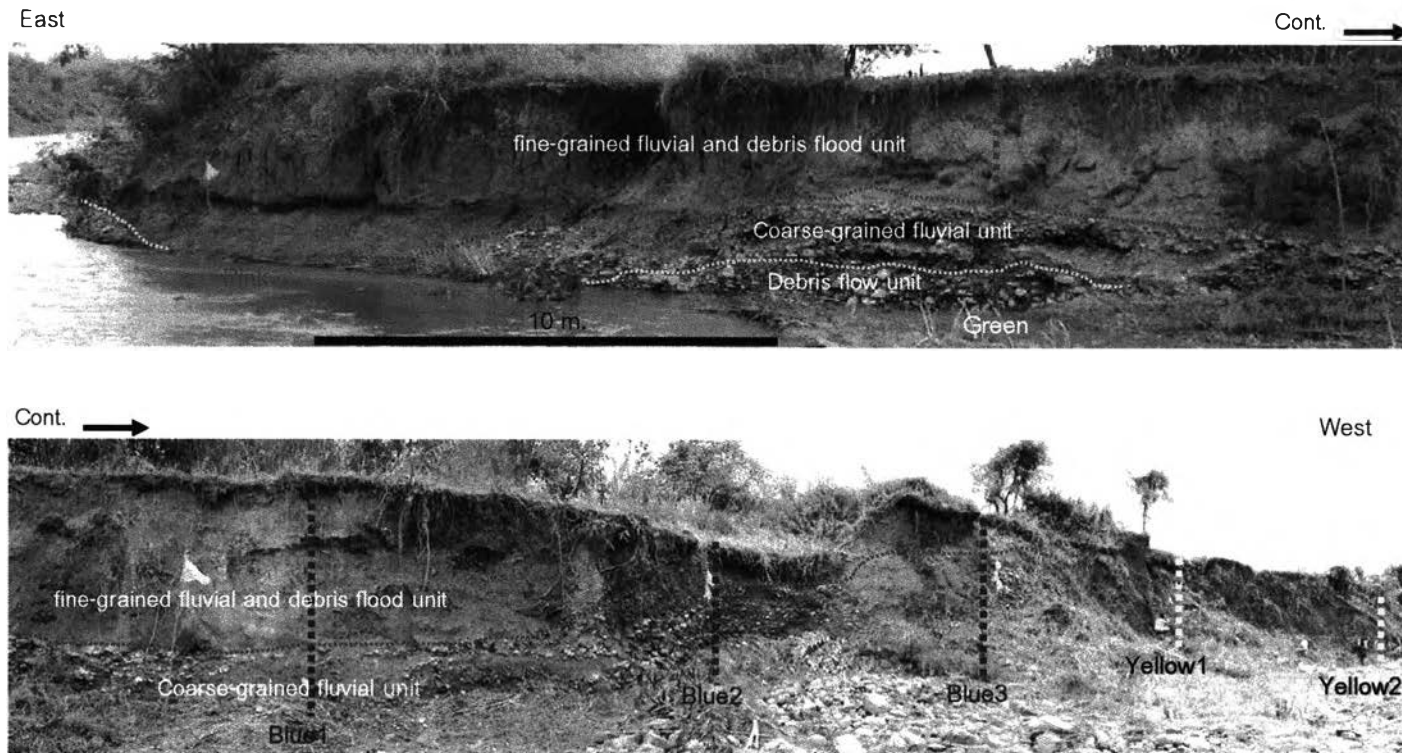
The uppermost part of this eroded-bank profile was a fine-grained fluvial and debris flood unit that was dominantly deposited to form a sharp contact on top of the coarse-grained fluvial unit (as shown in Figures 6-12 to 6-15). The uppermost unit is thicker to the east, especially in the eastern part of the zone Pink. The representative sedimentary and stratigraphic characteristics in completely detailed vertical succession are shown in the zone Green (Figure 6-13) and are from bottom to top the debris flow unit, the coarse-grained fluvial unit, and the fine-grained fluvial and debris flood unit, respectively.

Figure 6-12 Photographs illustrating lateral and vertical stratigraphic characteristics of three sedimentary units (debris flow unit, coarse-grained fluvial unit, and fine-grained fluvial and debris flow unit) of the previous alluvial fan that well exposed along the eroded-bank of Nam Ko Yai stream. (Note: locations of the seven stratigraphic profiles referred to Figures 6-9 and 6-11)

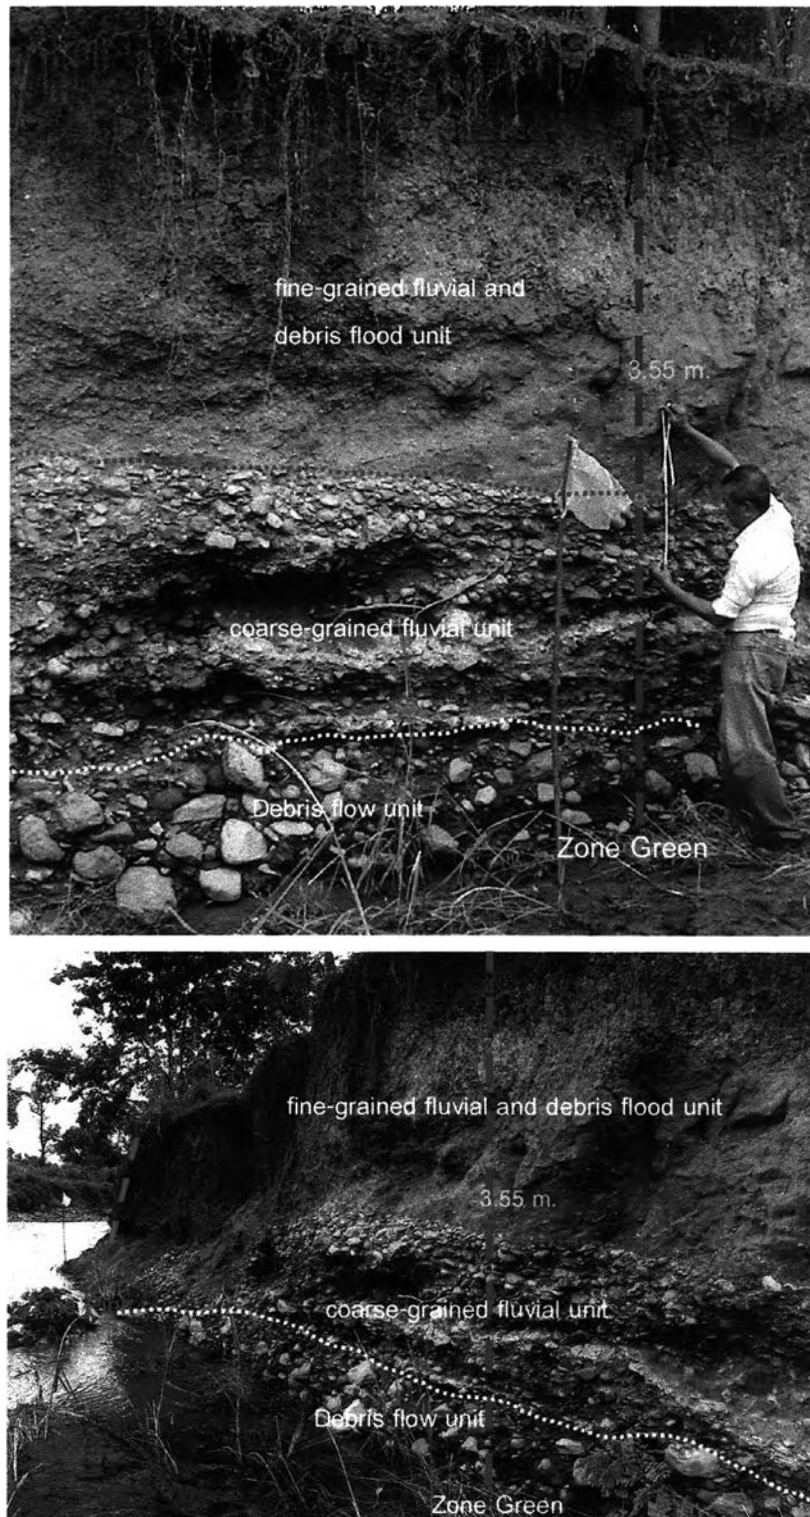
In the observed stream-bank profiles, the lowest sedimentary unit of the previous alluvial fan deposits was a debris flow unit of floating texture, unsorted, and un-stratified material that was exposed in the stream-bed only in the lowest part of the zone Green (Figure 6-13). The coarse-grained fluvial unit of clast-supported texture and fining-upward graded bedding was transitionally deposited on top of the debris flow unit, especially in the middle part of the zone Green, and extended westward (upstream) beyond the zone Yellow2 (Figure 6-14). This coarse-grained fluvial unit was the thickest in the western part and became thinner to the east.

Figure 6-13 Photographs illustrating detailed sedimentary and stratigraphic characteristics in vertical and lateral succession of three sedimentary units (debris flow unit, coarse-grained fluvial unit, and fine-grained fluvial and debris flow unit) of the previous alluvial fan deposits at the zone Green.

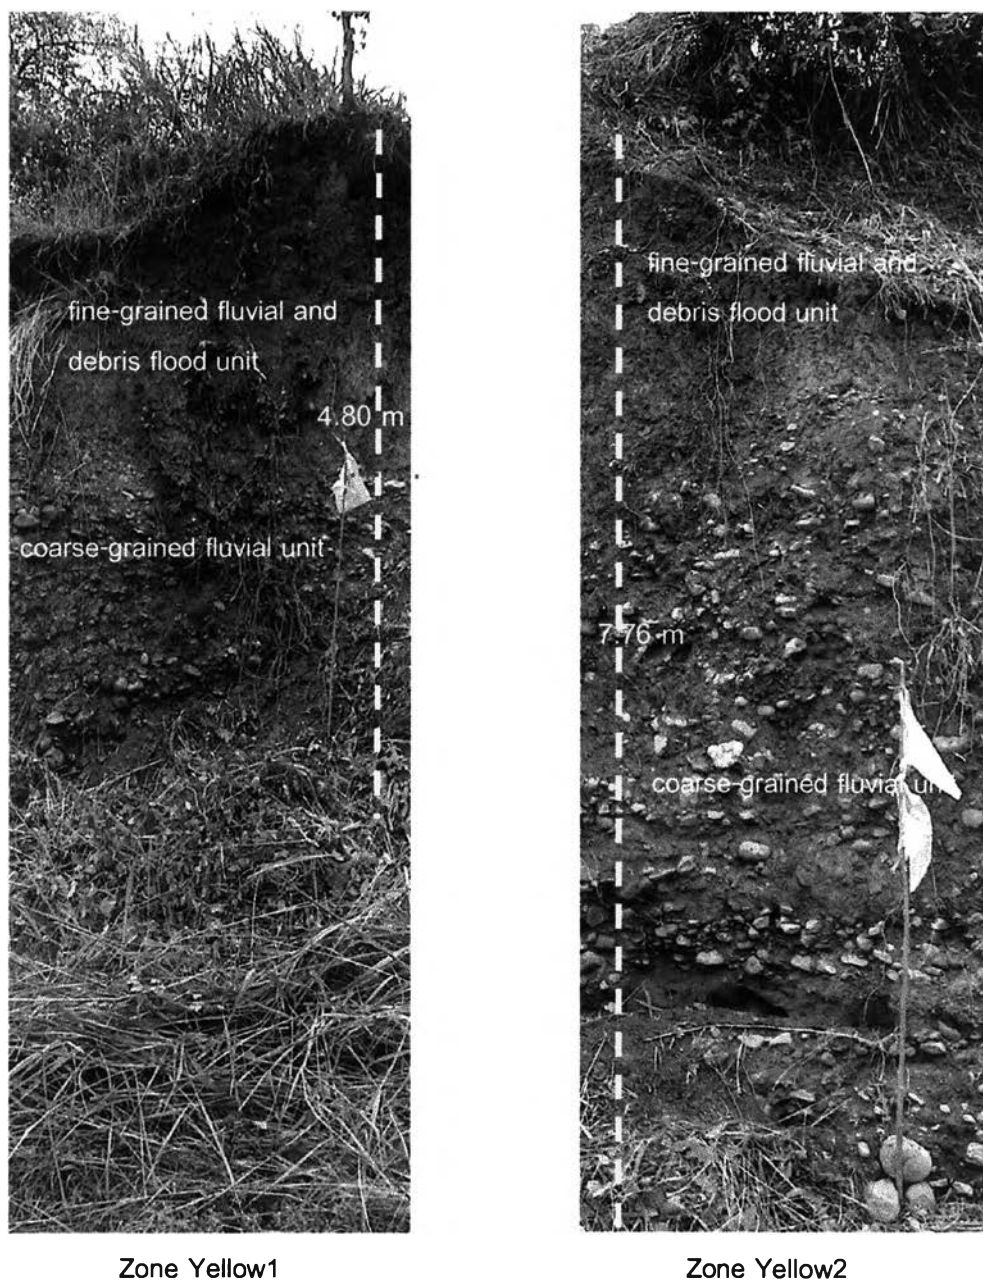
Figure 6-14 Photographs illustrating detailed sedimentary and stratigraphic characteristics in vertical succession of two sedimentary units (coarse-grained fluvial unit, and fine-grained fluvial and debris flow unit) of the previous alluvial fan deposits at the zones Yellow1 and Yellow2.

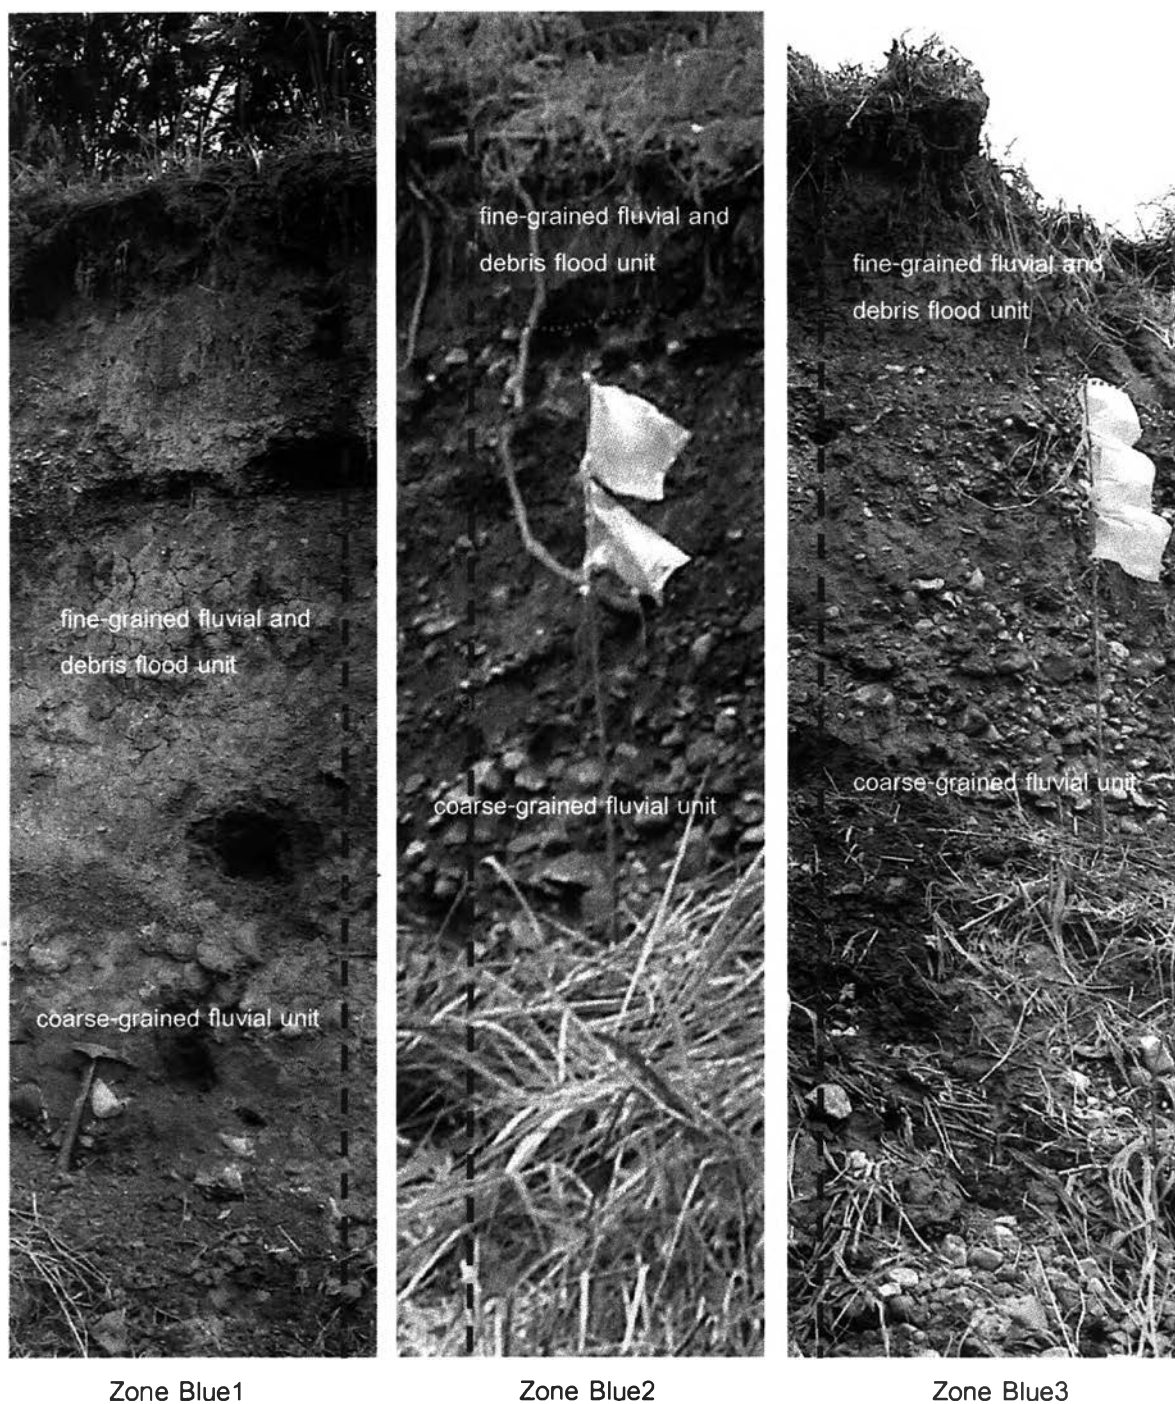
Figure 6-15 Photographs illustrating detailed sedimentary and stratigraphic characteristics in vertical succession of the fine-grained fluvial and debris flood unit that overlay with the sharp contact manner on top of the coarse-grained fluvial unit at the zones Blue1, Blue2 and Blue3.
